THE OLD BAKERY, 65-65A HIGH STREET,  
LINDFIELD, WEST SUSSEX, RH16 2HN

## HISTORIC BUILDING ASSESSMENT & RECORD OF THE GEORGIAN ERA CEILING

Mid Sussex District Council Reference: DM/23/2298

Report No. 2023544  
February 2025

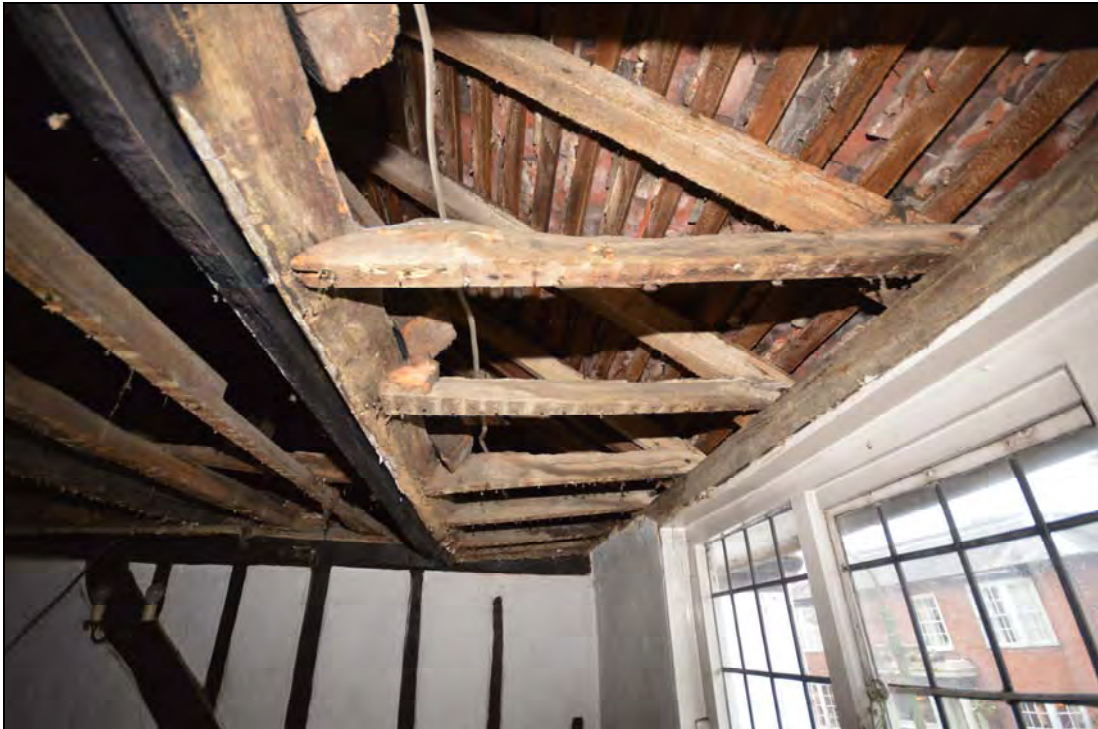
Plate 29: Short lengths of ceiling joists between the inserted southeast plate and the wall plate over the front wall

- 7.2.3 A series of short ceiling joists oriented northwest – southeast were nailed to the side of the flying plate, their outer ends supported over the wall-plate of the new street-front elevation (Plate 29).
