# Bat Emergence Survey Report

Rose Cottage

High Street

Cuckfield

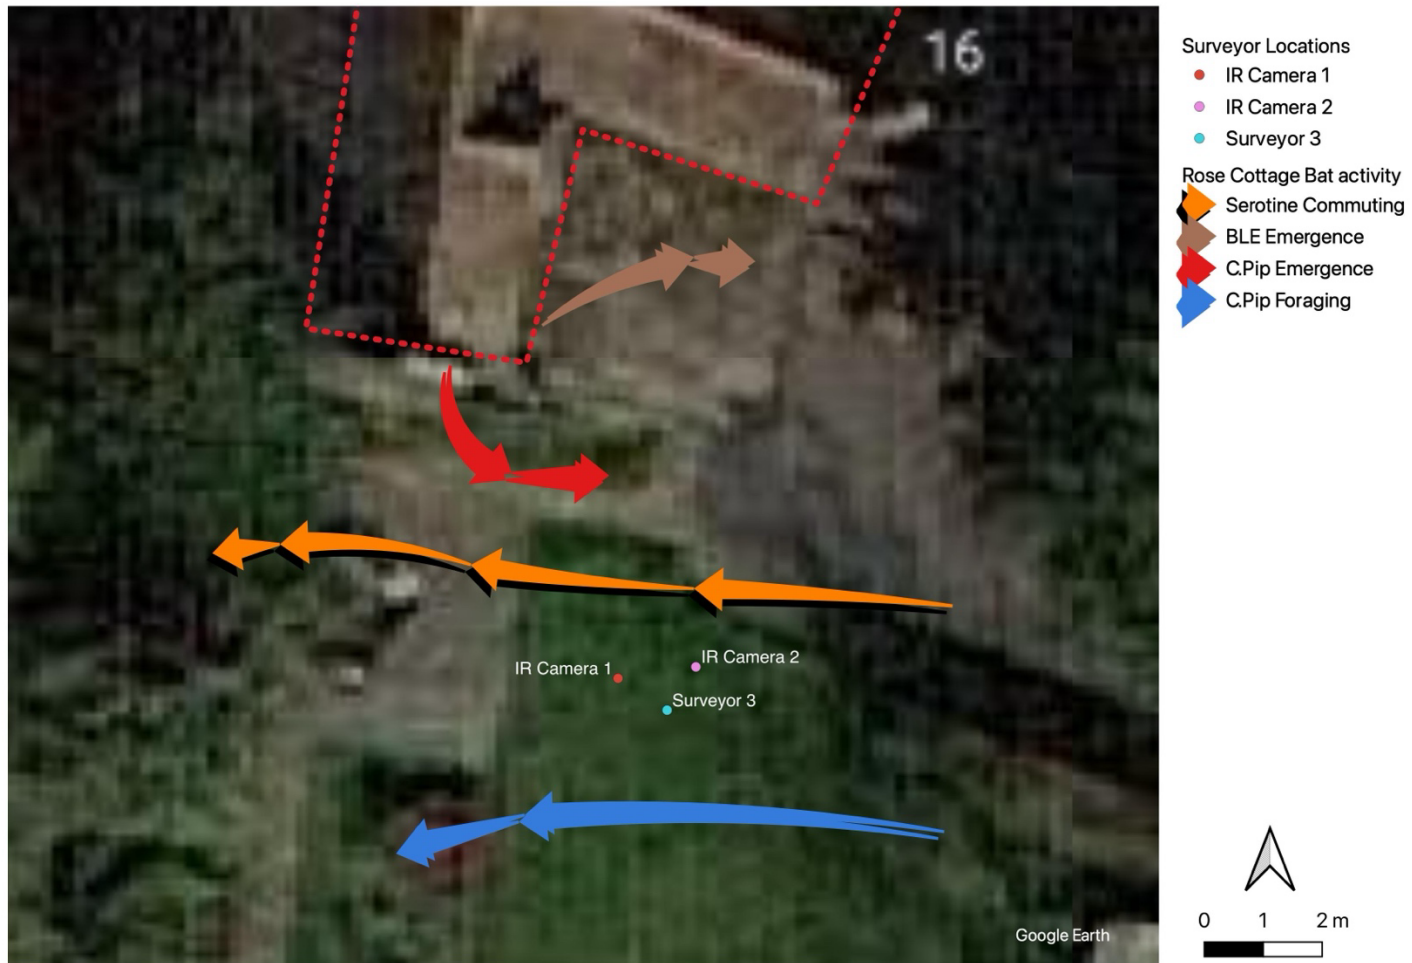
## 7.0 SUMMARY OF BAT ACTIVITY

- 5.1 A maximum of two common pipistrelle bats were observed emerging from under the hanging tiles on the southern face of the building and a maximum of one brown long eared bat was observed emerging and re-entering to and from under the eaves on the southeastern corner of the building. Both of these roosts were close to the eaves of the buildings, notably the brown long eared roost, which was likely to be within the roof void with egress and ingress via the eaves.

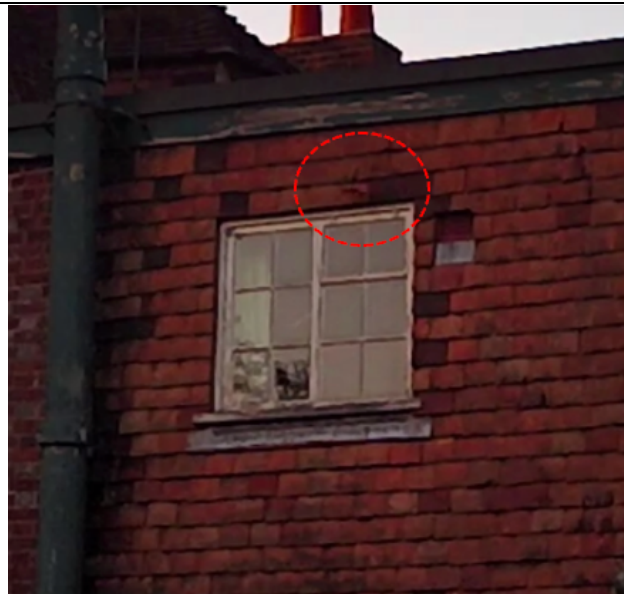
***Plate 1: Common Pipistrelle Emergence***

| Time | Species | Passes | Activity and Location |
|---|---|---|---|
| 20:26 | C.pip | 1 | Emergence from under hanging tile on southern face |

- 4.9 Two common pipistrelle were observed emerging from under a hanging tile on the southern face of the building, early into the survey. Foraging activity of common pipistrelle was observed around the southern garden, with brief passes of soprano pipistrelle and brown long eared bat recorded.

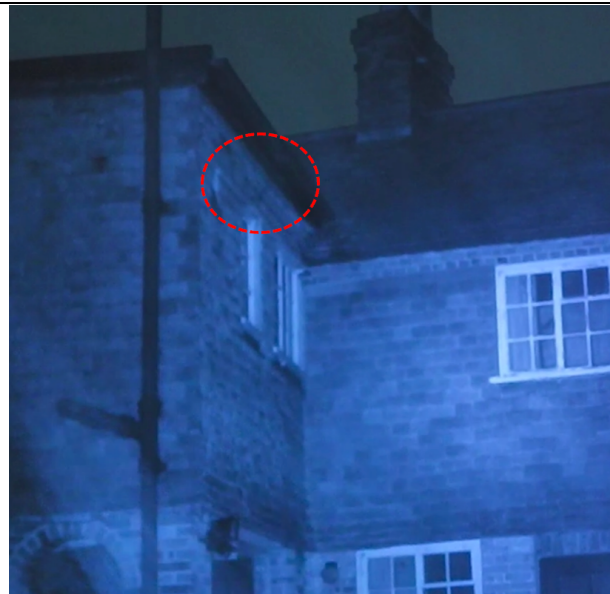
***Plate 2: Brown Long Eared Bat Emergence***

| Time | Species | Passes | Activity and Location |
|---|---|---|---|
| 20:48 – 21:40 | BLE | Multiple | Repeated emergence and then re-entry within the hanging tiles on the southeastern face wall, located just below the roof ridge. |

- 4.7 A brown long eared bat was observed emerging from the southeastern face of the building, with repeated cycles of emergence and re-entry throughout the survey. A single common pipistrelle was also observed emerging from under the hanging tiles on the southern face, just prior. Common pipistrelle foraging activity was observed around the southern garden. A single serotine commuting pass, flying low to the ground, was observed at the start of the survey.

- 5.7 Avoidance is always the preferable course of action. If this can't be achieved, then replacement roosts would be required during the works, which would comprise of bat boxes installed on adjacent trees or buildings. Access into the roof void would also need to be maintained, notably for the brown long eared bat. This would be achieved, by the use, of an access tile, to permit ingress into the roof void. Temporary replacement of the common pipistrelle roost would also be required, which would take the form of a bat box installed on adjacent trees or structure, and this roost then re-instated on completion of the works, if the hanging tiles are to be removed and replaced.
