For the Site of: Costells Stables, Church Road, Scaynes Hill, RH17 7NH

# Emergence and Activity Bat Survey (EBS)

The following report details the findings and recommendations for the site of Costells Stables, Church Road, Scaynes Hill, RH17 7NH, where proposals include for the construction of a replacement stable building.

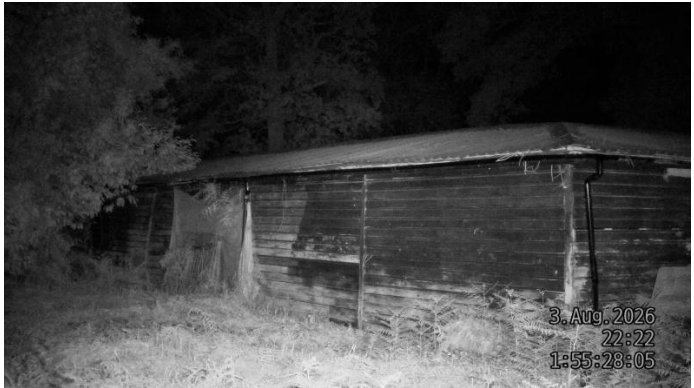
| Surveyor | Building, Tree or Structure | Dates, Times and Survey Type | Bat Activity Observed |
|---|---|---|---|
| ZH | B1 | As above | <p>Regular passes of SP were heard between 20:43 and 21:06, with occasional passes of CP heard between 21:11 and 21:39.</p> <p>Two passes of SER were heard at 21:20 and 21:26, with bats observed foraging over the buildings.</p> <p>Figure 3: Surveyor IR image</p> |

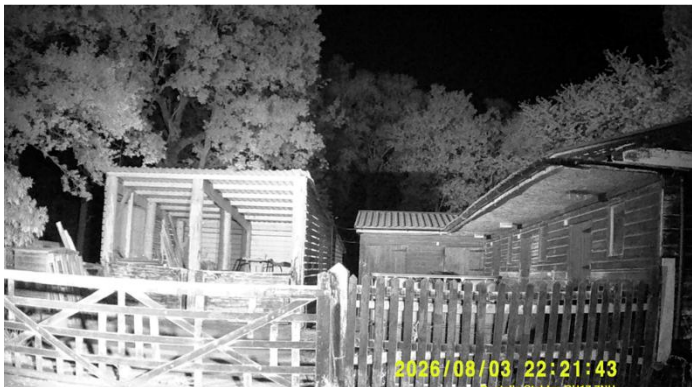
| TH | B2 | As above | <p>Regular passes of SP and CP were heard between 21:40 and 21:59, with bats observed foraging to the south of the buildings.</p> <p>SER was first heard at 21:19, with constant foraging activity recorded until 21:30.</p> <p>Figure 4: Surveyor IR image</p> |

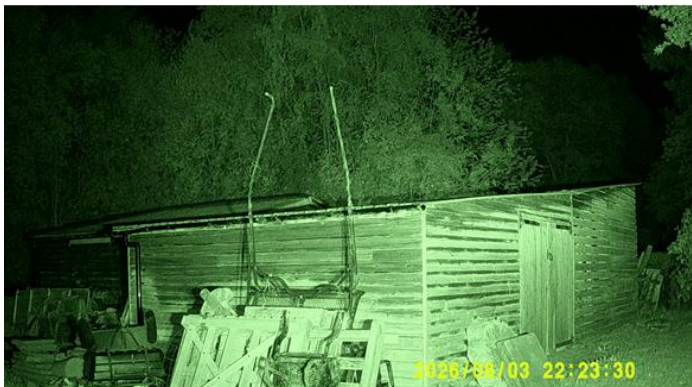
| ER | B2 | As above | <p>Passes of SP and CP were heard between 20:45 and 21:46. Many passes were distant, likely those picked up to the south of the buildings. Three SER passes were heard at 21:19, “1,23 and 21:26.</p> <p>Figure 5: Surveyor IR image</p> |

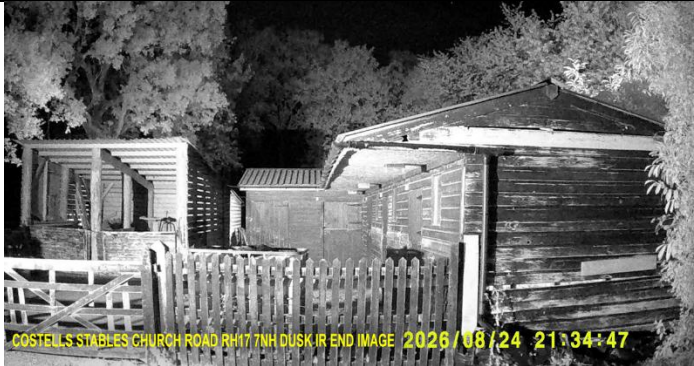
| PH | B1 | <p>24/08/2026<br/>19:49 to 21:49<br/>SS: 20:04</p> | <p>SP and CP passes were heard between 20:02 and 21:30, with bouts of constant foraging activity observed to the south of B1.</p> <p>Four SER passes were heard between 20:43 and 21:29 and a single pass of BLE was heard at 21:13.</p> |

| | | | <p>Figure 6: Surveyor IR image</p> |

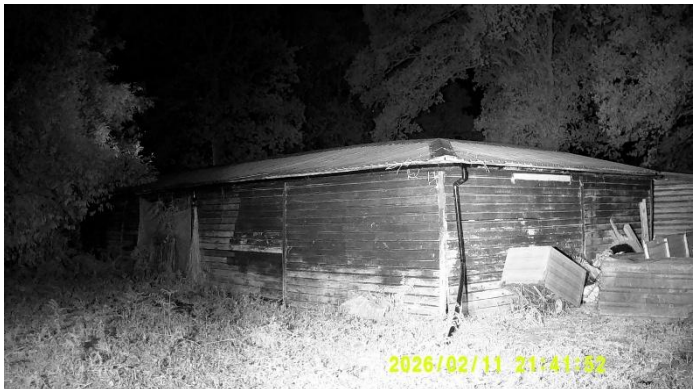
| ZH | B1 | As above | <p>Occasional passes of CP and SP passes were heard between 20:19 and 21:34.</p> <p>Two passes of SER were heard at 20:45 and 21:29.</p> <p>Figure 7: Surveyor IR image</p> |

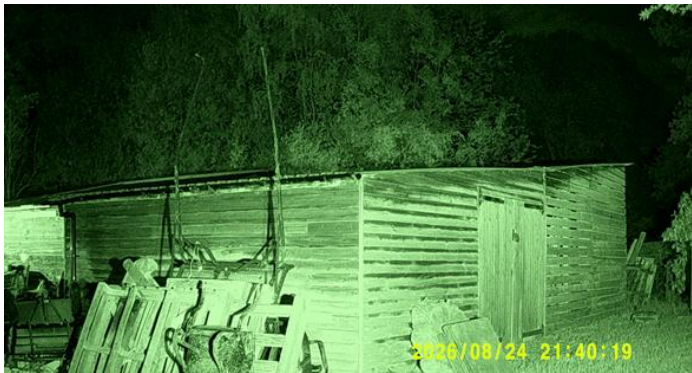
| ER | B2 | As above | <p>Passes of CP and SP were heard between 21:10 and 21:29, many of the passes were distant, likely those picked up tot the south of the buildings.</p> <p>Three passes of SER were heard at 20:35, 20:47 and 21:01, again recorded as distant passes.</p> <p>Figure 9: Surveyor IR image</p> |
