# SuDS Drainage Statement

Barn Cottage, Cuckfield Road, Ansty, RH17 5AG

Places Architecture

Date: July 2025

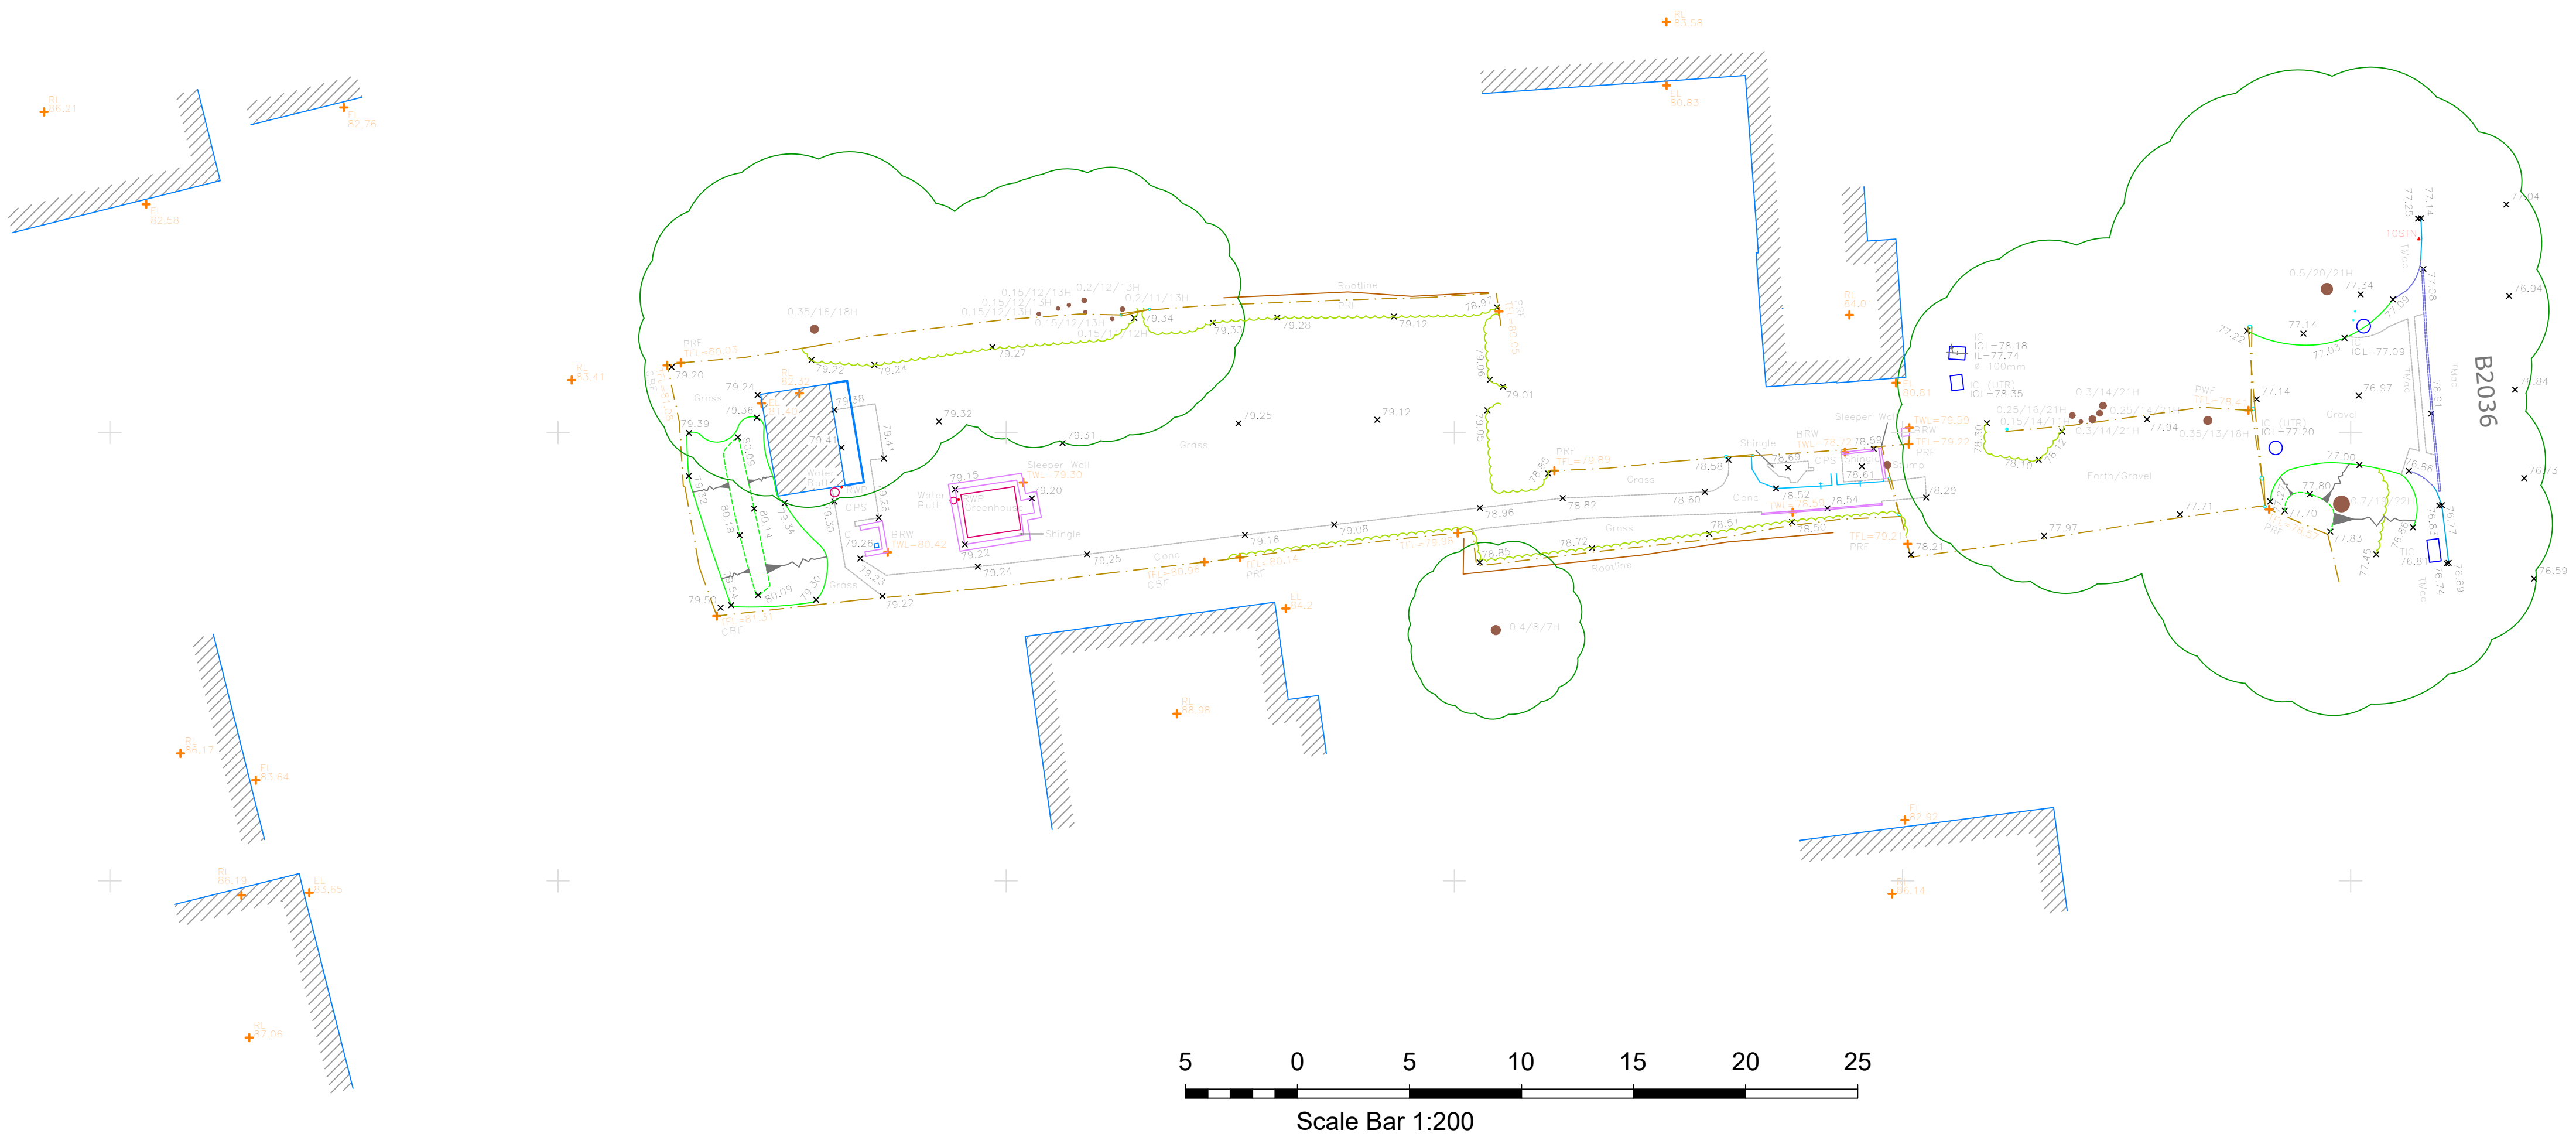
## Topographical Survey

- 2.3 Topography: a topographic survey is included in Appendix B. The site slopes gently from west to east, with levels ranging from approximately 79.30m Above Ordnance Datum (AOD) to 77m AOD where it meets Cuckfield Road (B2036). There is an existing raised bund in the western corner of the site with a top level of 80.20m AOD.

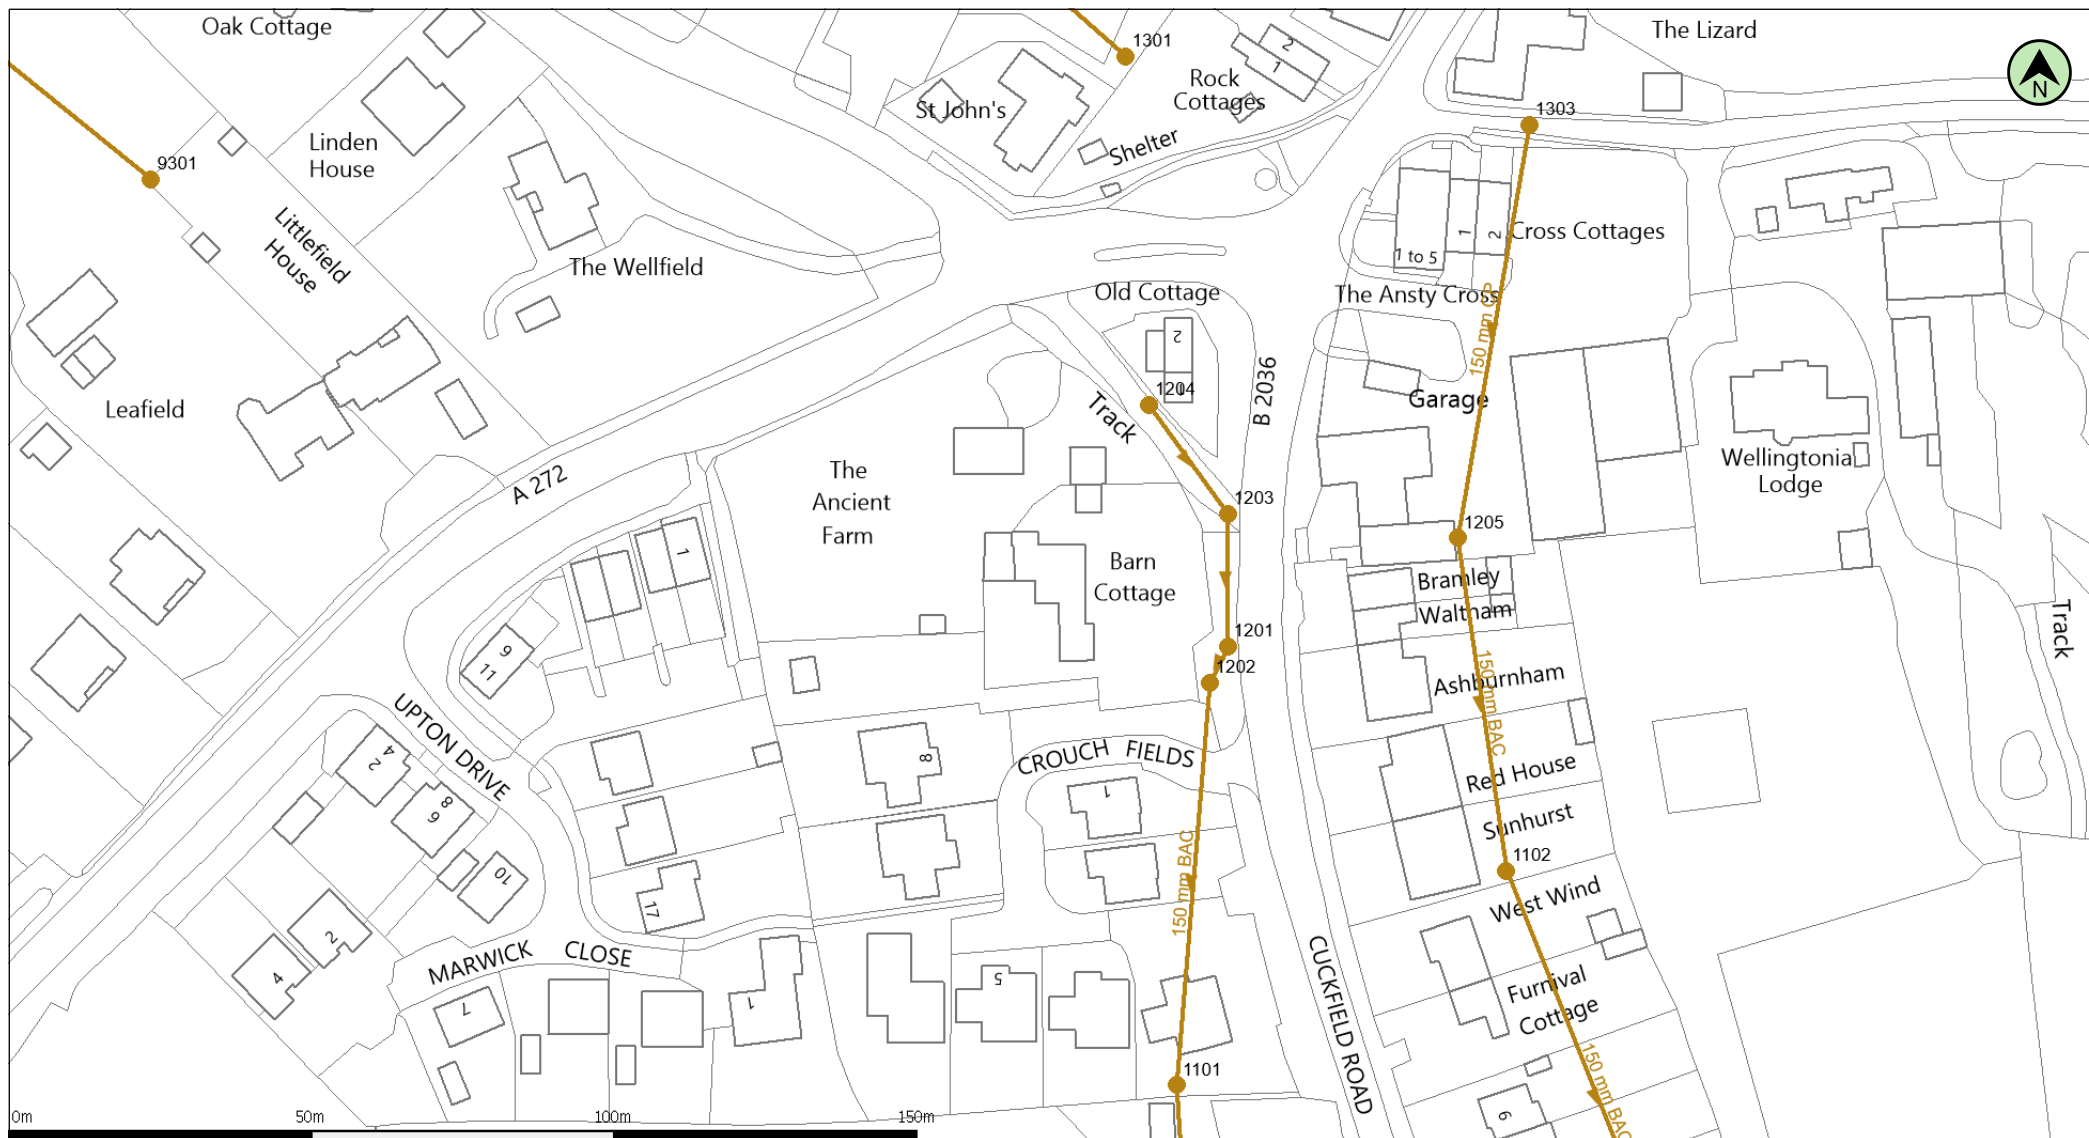
Wastewater Plan A4  
Powered by digdat

- 2.6 Public sewers: Southern Water's records (see Appendix B) show a 150mm diameter foul sewer flowing north-south on the west side of Cuckfield Road, with two manholes (1201 and 1202) located directly at the site entrance.

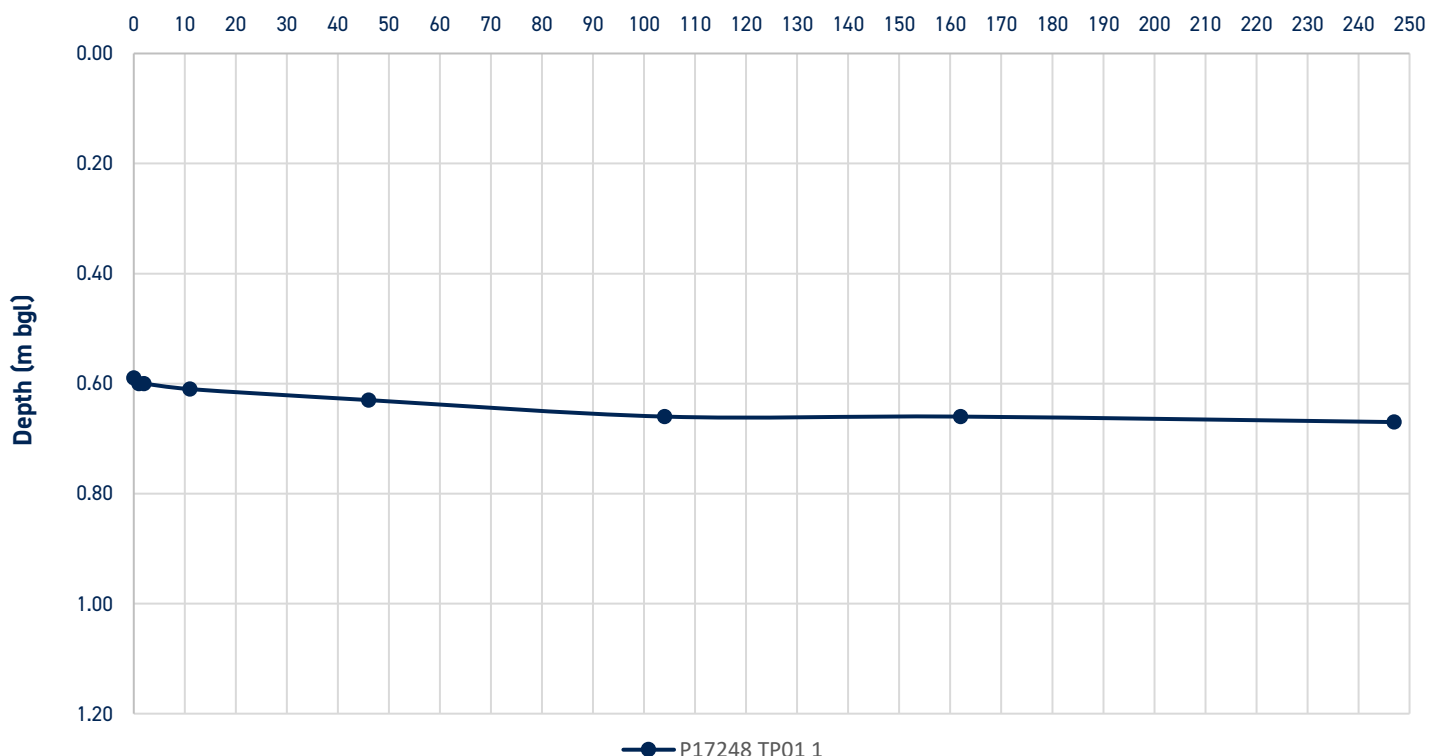
Elapsed Time (min)

## Infiltration rate

**9.45E-07 m/sec f**

Calculation method: The water level did not fall below 25% of the effective storage depth. 'f' has been calculated by dividing the volume of water lost during the test by the product of the average surface area in contact with water during the test and the test duration.

- 2.5 Soakage testing was carried out at the site location in June 2025 within a trial pit located central to the site. The investigation found a 200mm layer of topsoil directly over Upper Tunbridge Wells sand (slightly gravelly silty clay). A marginal infiltration rate of  $9.45 \times 10^{-7}$  m/s was calculated.

During the test performed within trial pit TP01 the water level within the test pit only fell to 87% of the initial test depth, and as such the calculation of the soil infiltration rates in accordance with the BRE digest was not possible. The soil infiltration rate has therefore been calculated by dividing the volume of water lost during the test by the product of the average surface area of the trial pit in contact with water during the test period and the test duration in seconds.
