## Bat Scoping Report

Stonehurst – Main House

Ian Adam Smith  
Architects

**Project No: 6718**

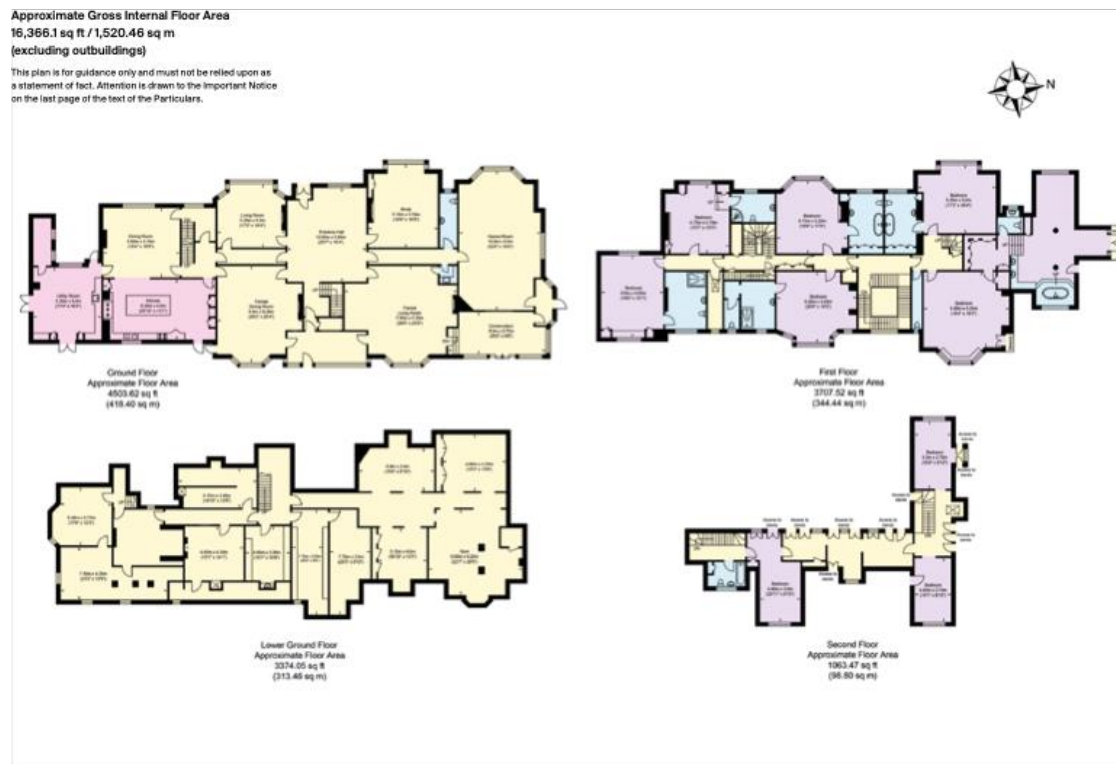
**Figure 2.** Existing floor plan of Stonehurst Main house. Image produced courtesy of Ian Adam Smith Architects

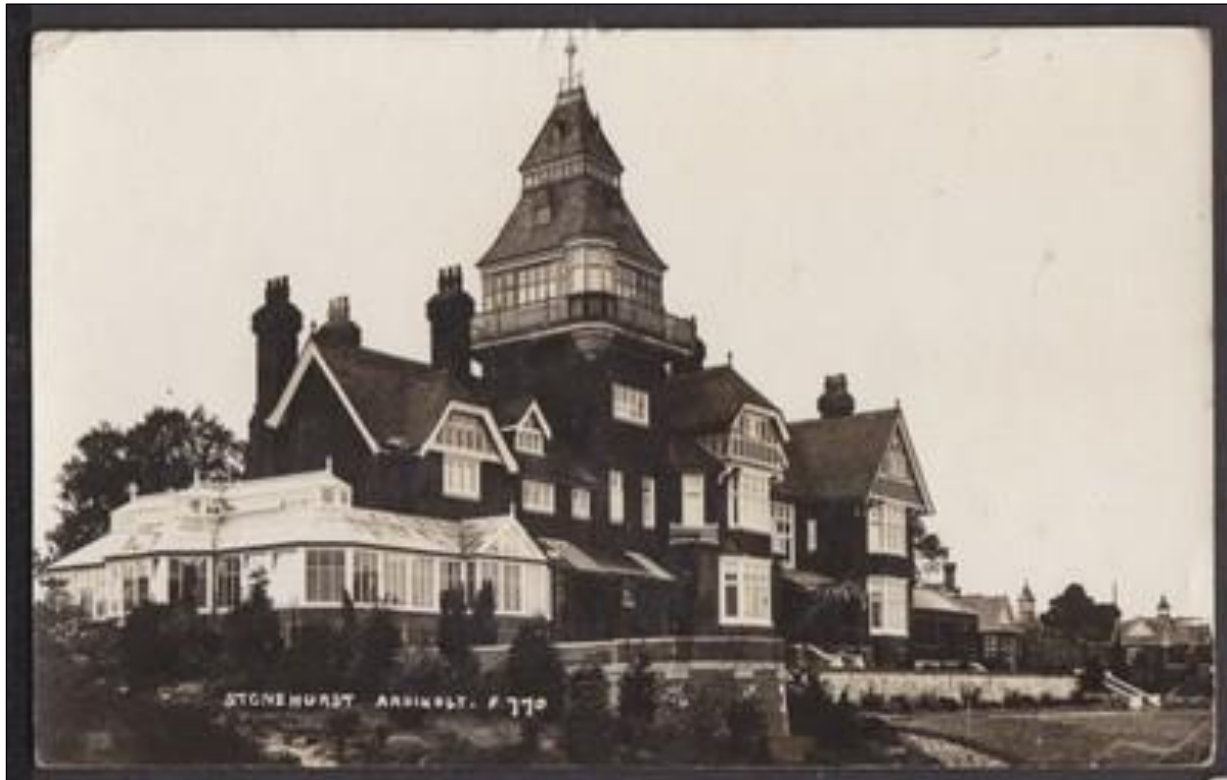
**Figure 3.** Historic view of Stonehurst Main house with view of the tower. Image produced courtesy of Ian Adam Smith Architects.

The proposed development/project seeks to re-instate the main house's iconic tower and renovate sections of the building to restore the overall building to match its historic features and renovate and repair sections. A view of the building with its former tower block is shown in Figure 3 and sections proposed for works in Figure 4.

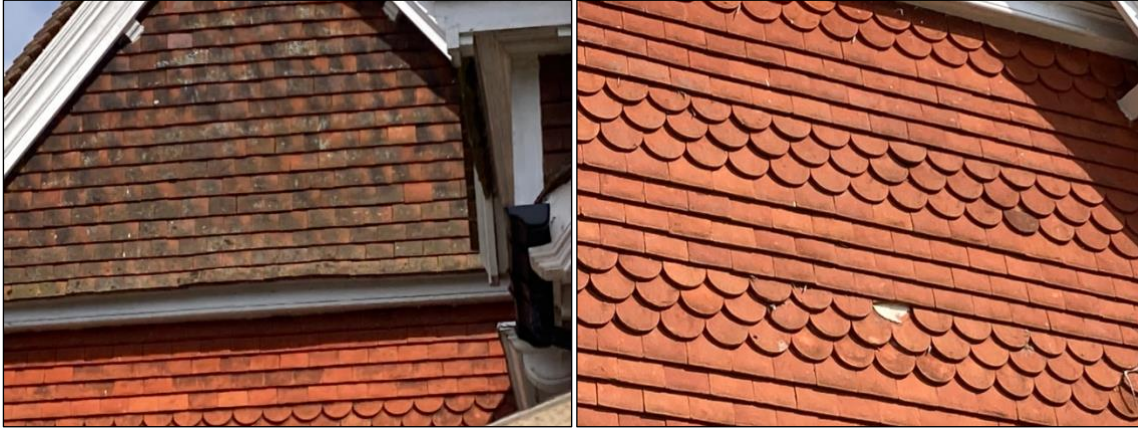
| Building section | Description of features | Assessment of suitability <sup>5</sup> |
|---|---|---|
| Exterior | The exterior of the property has several areas of lifted and damaged hanging tiles to all aspects, the large size and height of the building as such offers a large number of areas that can act as suitable bat roosts or access into void areas internally. Areas of lifted roof slate tiles are also noted through the roof with the varied roofing/pitch styles noted not all areas of the roof tiles were able to be seen so additional areas of suitable roosting features may be present. | High bat roost suitability |

**Photographs 2a (left) and 2b (right).** 2a) View of hanging tiles located to the southern aspect of the property with some signs of lifted and damaged tiles visible. 2b) View of hanging tiles located on the property with clear signs of damage, lifting and missing tiles.

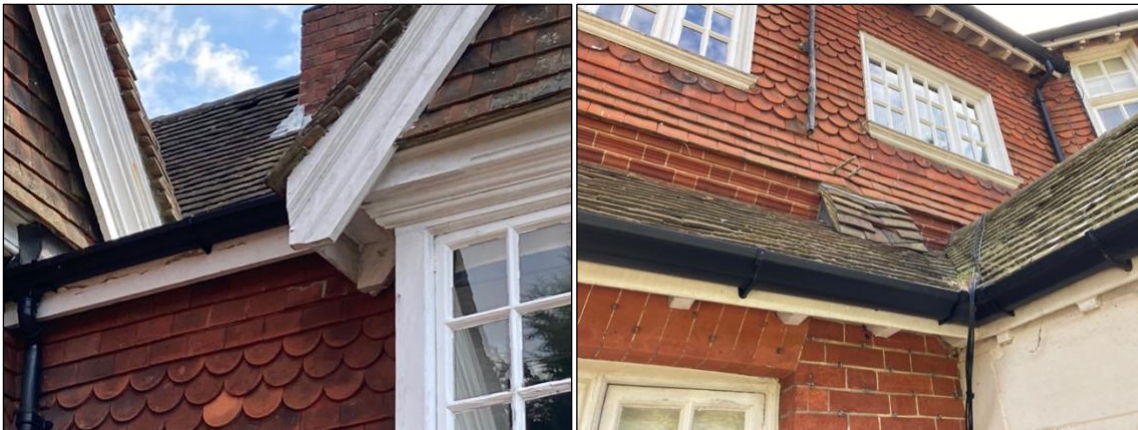
**Photographs 3a (left) and 3b (right).** 3a) View of lifted lead flashing and roof tiles noted to the western aspect of the property. 3b) View of lifted hanging and roof tiles noted to the northwestern aspect of the property.

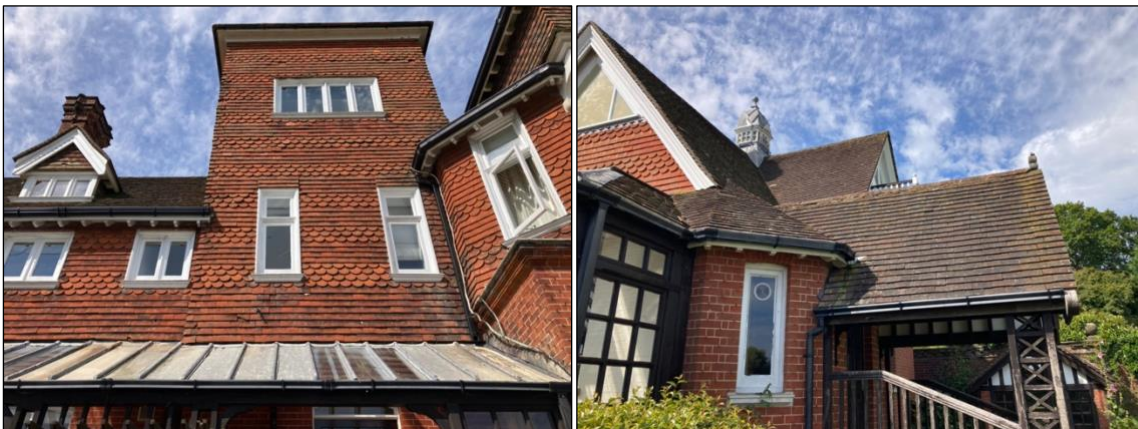
**Photographs 4a (left) and 4b (right).** 4a) View of the former tower block located to the centre left of the image, image taken from the eastern aspect of the property, clear signs of damage to hanging tiles noted included lifted and missing tiles throughout image. 4b) View of the northern aspect of the property with the image taken from the eastern aspect, some signs of damaged roofing tiles noted to these aspects.

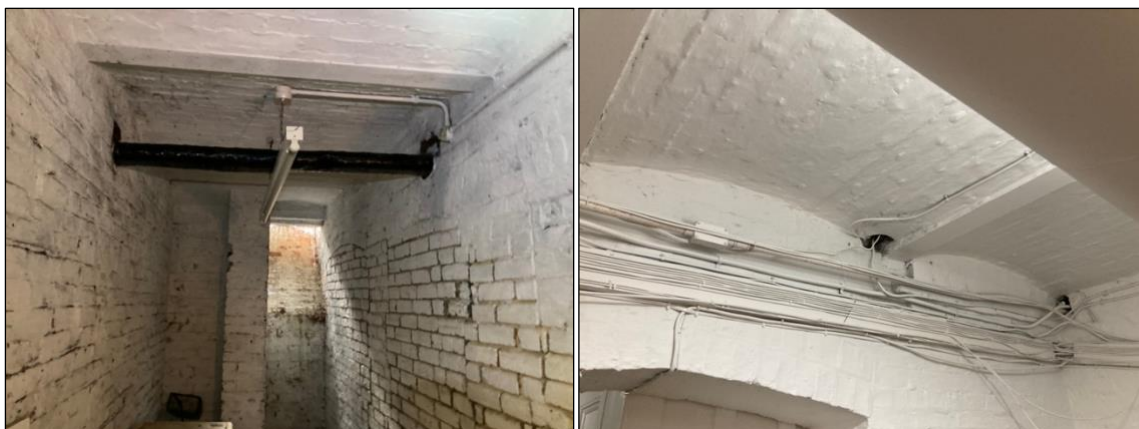
**Photographs 6a (left) and 6b (right).** 6a) View of a corridor space within the cellar/basement level with view of the access adjacent to the external ground floor gully that may act as possible access/egress to this area. 6b) view of hole with cables running through the first cellar room shown in photograph 5a.

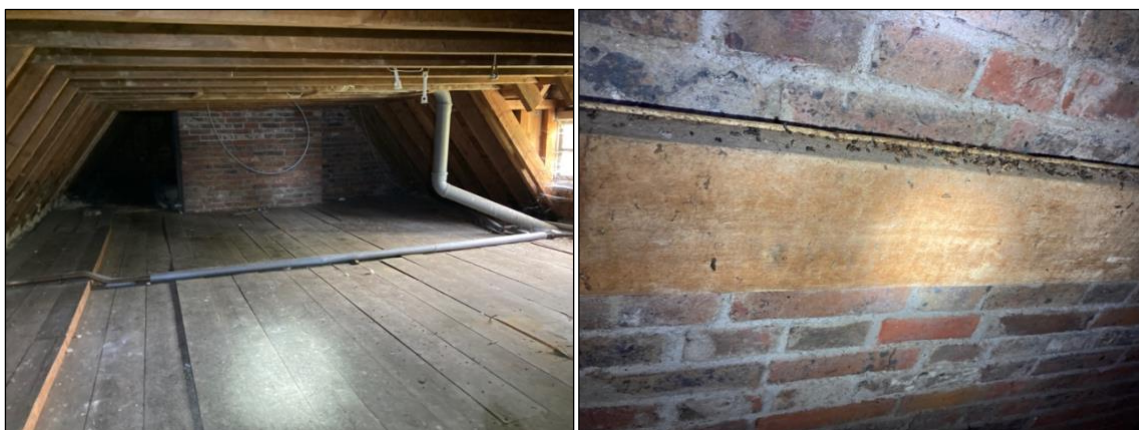
| Building section | Description of features | Assessment of suitability <sup>5</sup> |
|---|---|---|
| Interior/ loft space | <p>A single loft space was found during the internal inspection, the space was large measuring ~15m in length, 5m in width and 2.5m in height, though the loft space was divided with beams running across the width at ~ 1m slightly restricting the openness of the void but not enough to restrict open flying bat species but did reduce the effectiveness of the internal survey as access was restricted.</p> <p>The void is long with two separate chimneys noted within, a large number of droppings were noted scattered throughout the void space in small clusters with approximately 10-15 droppings resembling long eared bats (<i>Plecotus</i> sp.) identified per beam. In addition, larger clusters of droppings were noted to the base of the chimneys which formed larger piles as such it is impossible to estimate numbers here, though may act as potentially access/egress points for bat species. A single dropping resembling a pipistrelle species (<i>Pipistrellus</i>) was noted (it was not possible to collect this for DNA analysis). The droppings found on the beams were largely fresh. Droppings were analysed and return confirmed to be brown long eared bats and results can be seen in appendix 3.</p> | <p>High bat roost suitability</p> <p>Confirmed bat roost</p> |

**Photographs 7a (left) and 7b (right).** 7a) View of the loft space access, view of the beams located to the top of the image. Image taken from the north facing south. 7b) View of a beam located to the rear wall (south of loft space) with several bat droppings identified.

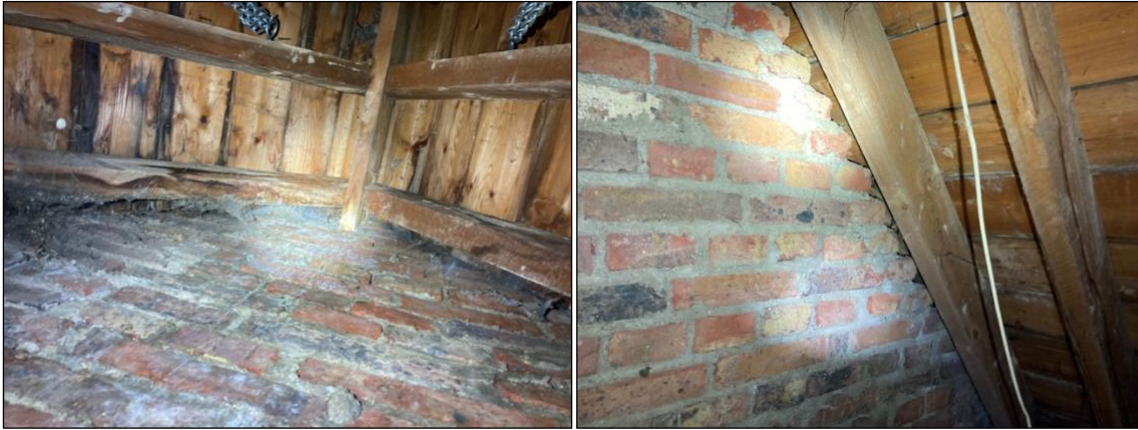
**Photographs 8a (left) and 8b (right).** 8a) View of the rear wall with gaps to the exterior/roof lining noted to the top of image. The image also illustrates the ridge beam and rafters that are typical throughout the loft space that can act as roosting opportunities for cavity dwelling bat species. 8b) View of the gaps to lining as shown in photograph 8a from approximately 0.5m away.

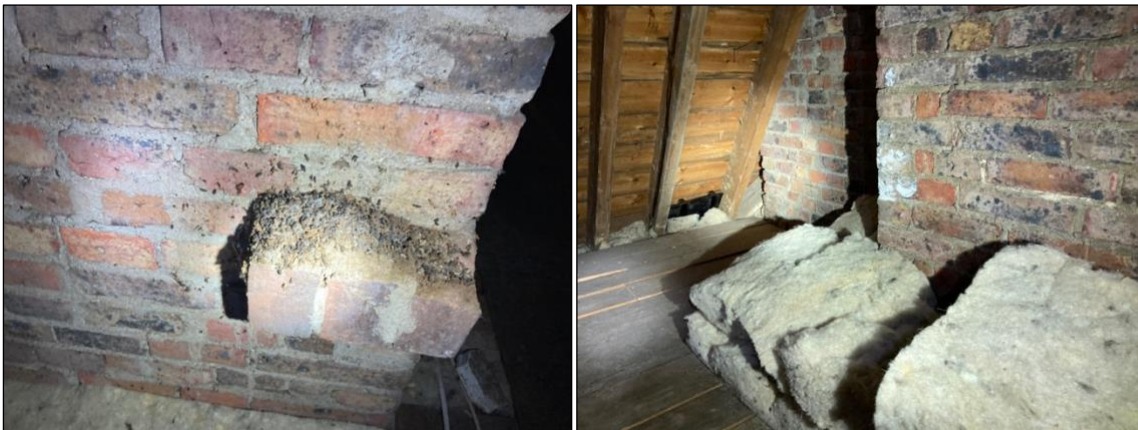
**Photographs 9a (left) and 9b (right).** 9a) View of a large number of bat droppings located to the southern aspect of the northern most chimney within this loft space, the photograph illustrates a large pile up on droppings on top of the exposed brick feature indicating more long-term use of this loft space. 9b) View of a chimney to the right of the image, and rafters and cladding located to the left of the image, the condition of the cladding and rafters is consistent to this throughout the void space.

An EPS licence will be required for any actions that would directly disturb, modify or destroy a bat roost. This would include measures to replace the existing roosting habitat such as designing integral bat roosting opportunities into the building fabric such as bat tiles and internal voids/access points for bats, depending on the scale of impact.
