## AGRICULTURAL BUILDINGS AT SPICER'S FARMHOUSE, WHITETHROAT LANE, BALCOMBE, WEST SUSSEX, RH17 6JN

### HISTORIC BUILDING ASSESSMENT, HERITAGE STATEMENT & IMPACT ASSESSMENT

Report No. 2025642/2  
Prepared by Maggie Henderson Ma  
March 2025

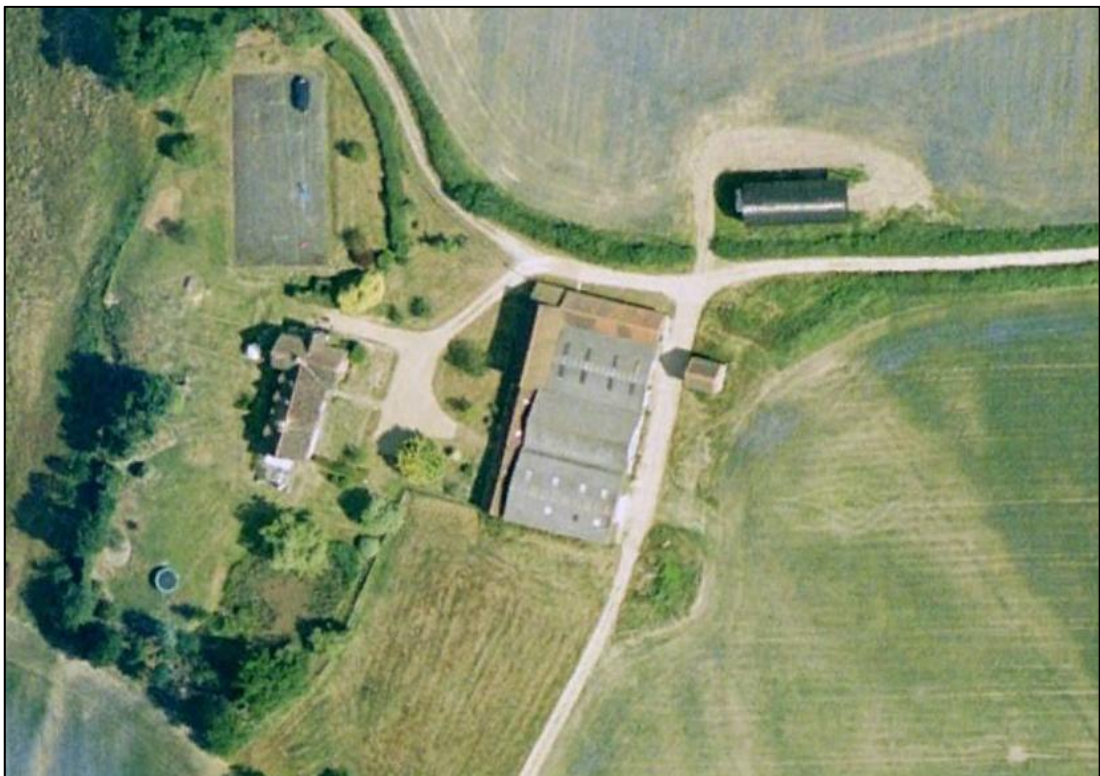
- 6.2.16 By 2001, the enclosures that had flanked the central courtyard group of the farmstead had been removed. A series of covered yards were created within the former courtyards, leaving only buildings B1, B2 and B3 extant. To the east, building B8 (added between 1895 and 1909) was retained, and building B9, a Dutch barn, added to the north side of the lane between 1909 and 1956 remained *in situ* (Plate 7).

Plate 7: 2001 Google Earth Image (© 2025 Infottera Ltd & Bluesky)

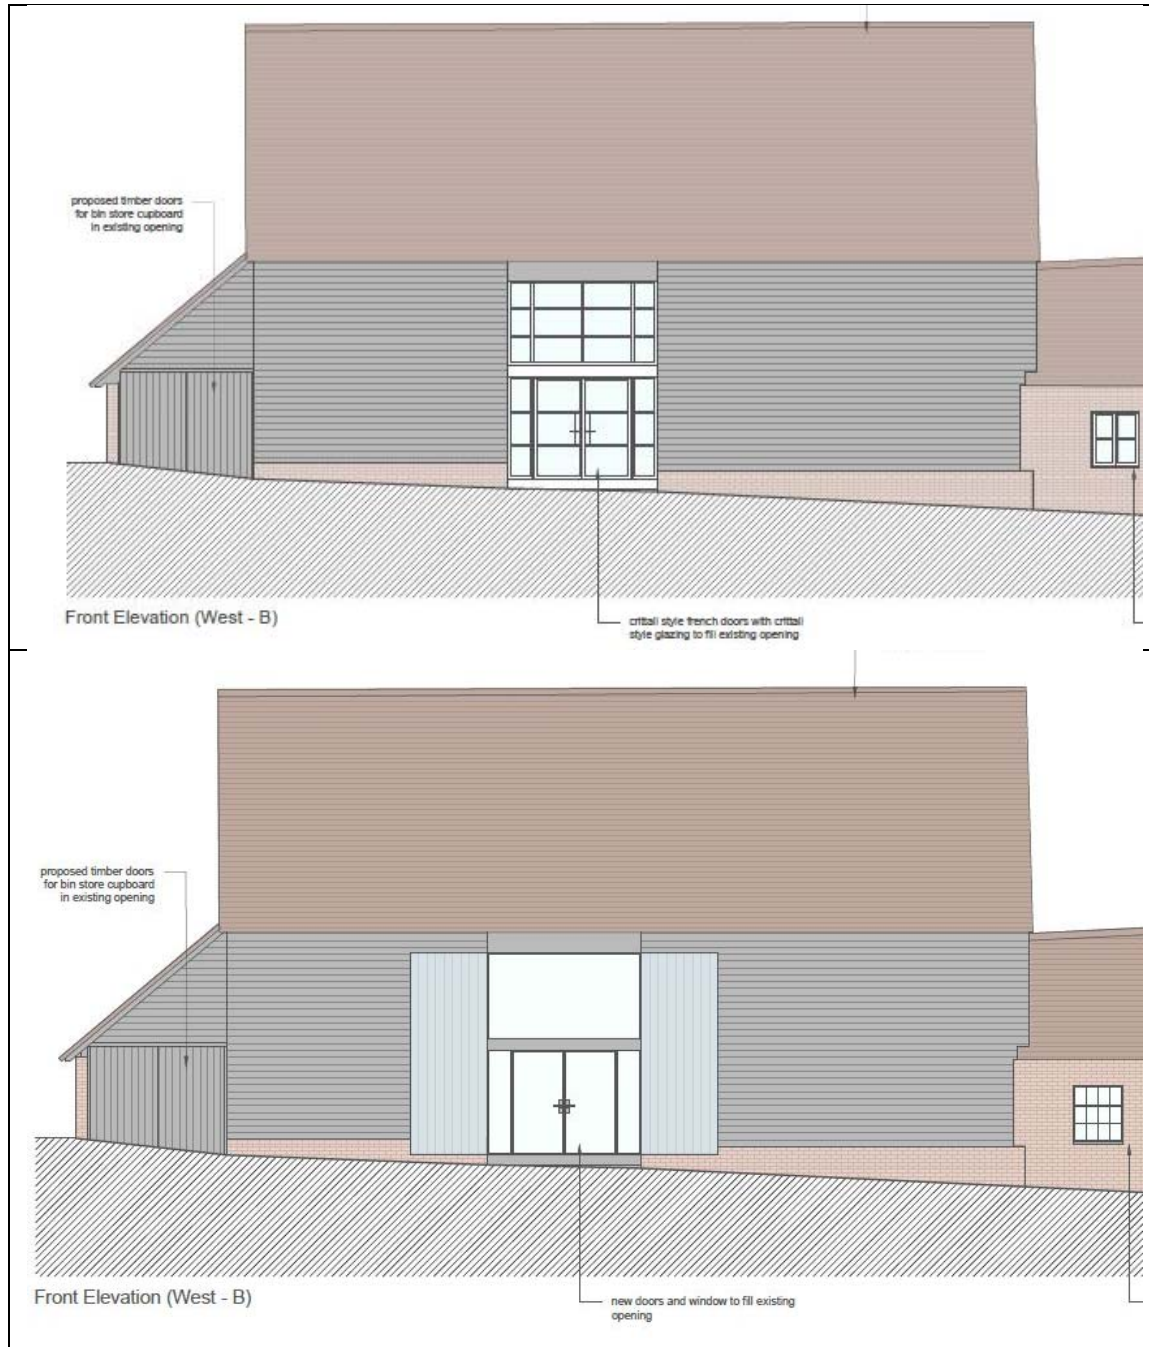
- 9.3.3 The scheme has been revised to address the concerns raised by the local authority (Plate 8).

Plate 8: The original glazing scheme (top) and the revised scheme (bottom)

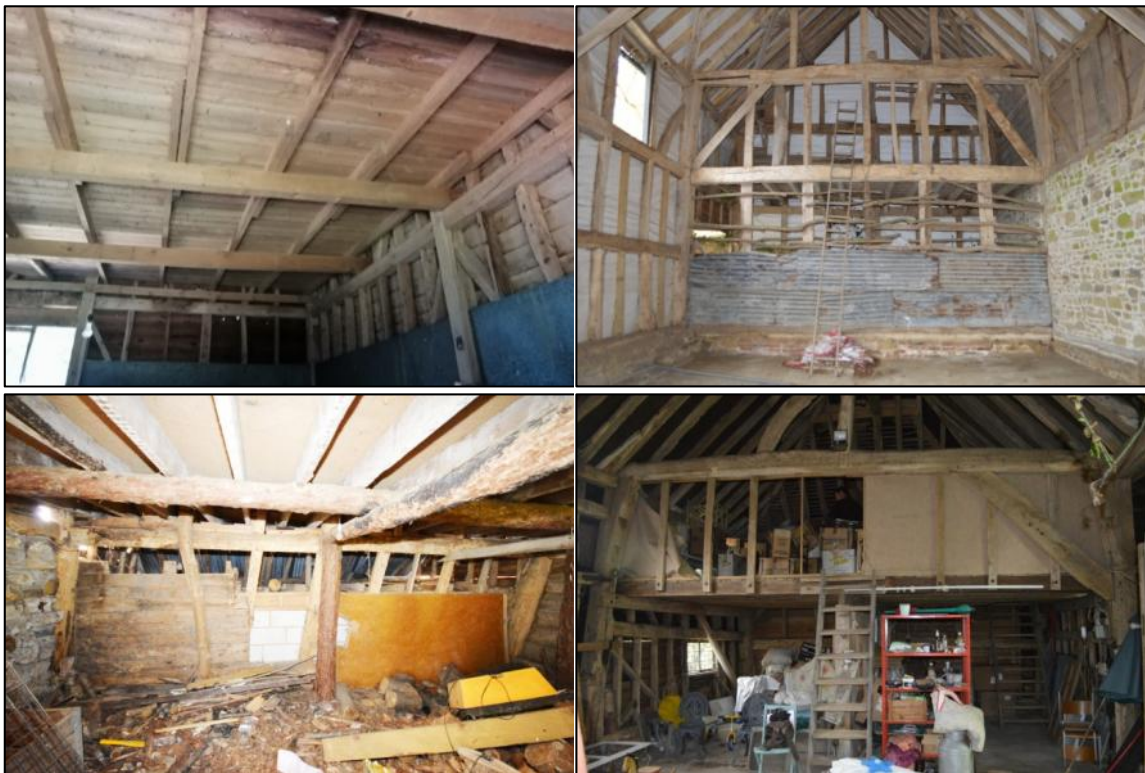
- 9.3.7 Whilst there is no evidence for an original upper floor within the barn, there are numerous examples in Sussex in general of their addition over the course of the life of the barn in response to changing needs, as hay-lofts or granaries (Plate 9). The remainder of the barn will remain open-plan and open to the roof, a welcome element of the proposal scheme for this important building.

Plate 9: A selection of Sussex barns with inserted mezzanine floors added in response to changing agricultural needs within the farmstead

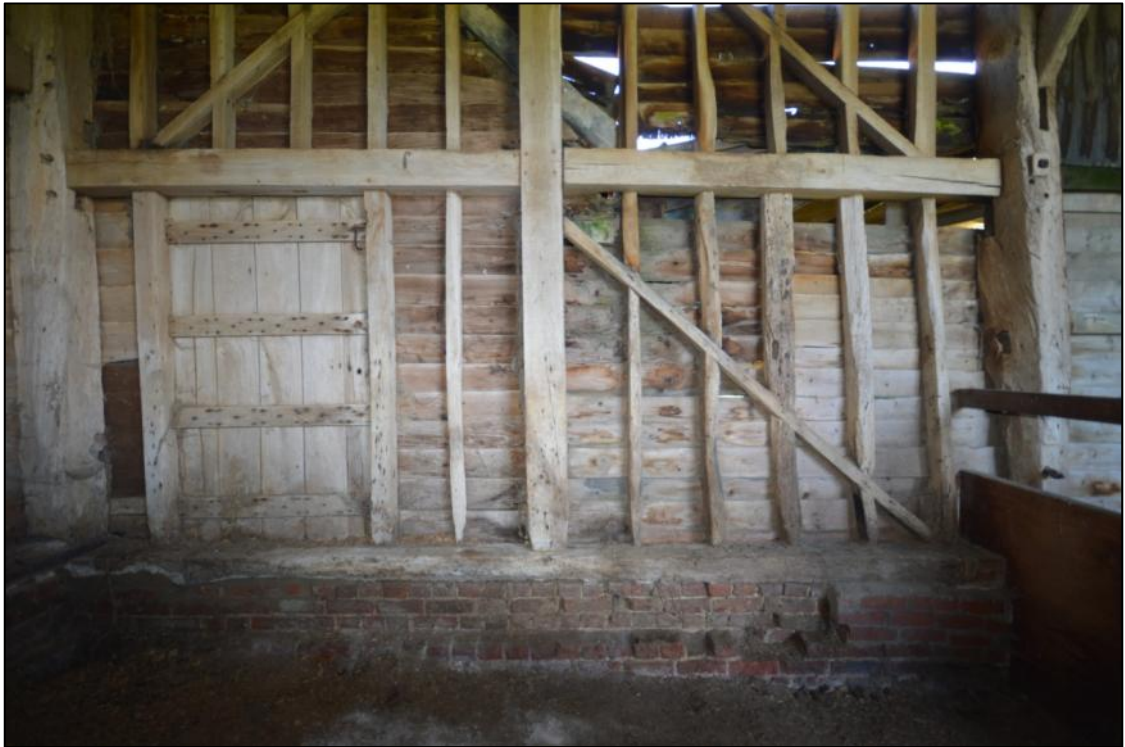
- 9.3.10 The installation of a doorway can therefore be achieved in the same manner as the doorway inserted into the 19<sup>th</sup> century fabric in bay 1 on its eastern side (Plate 12).

Plate 12: The doorway inserted into the rebuilt eastern elevation of bay 1 after the 19<sup>th</sup> century rebuild

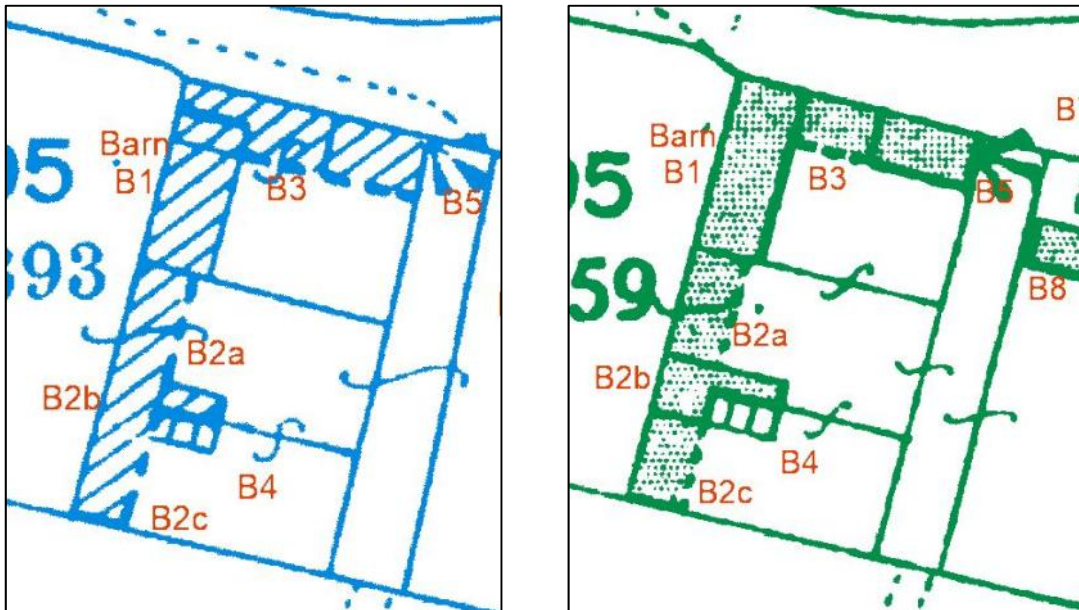
- 9.3.12 The north outshot had been subject to a series of alterations since it was first built, replacing an earlier structure in the same site. The first revision Ordnance Survey map shows compartmentalisation of the outshot to create two areas (stalls?), through the insertion of an east-west oriented partition; by 1909 the partition had been removed and the east wall with integral doorway added (Plate 14).

Plate 14: The farmstead in 1895 (blue) and 1909 (green) showing the changes to the north end of the barn

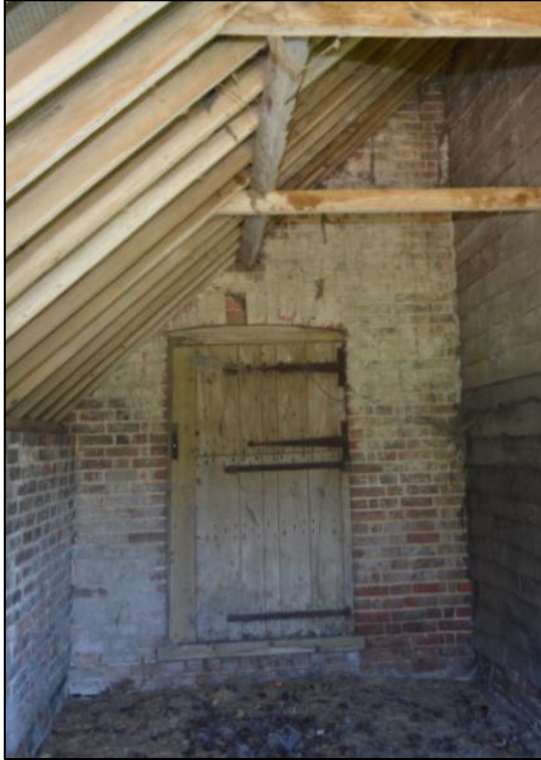
- 9.3.15 The brick partition with its integral doorway surmounted by a segmental arched soffit of brick is part of the late 19<sup>th</sup> or early 20<sup>th</sup> alterations to the group, illustrating the later adaptation of the building: concealment of the doorway will impact on the character and significance of this part of the farmstead (Plate 15).

Plate 15: The doorway in the east elevation of the north outshot (B3)

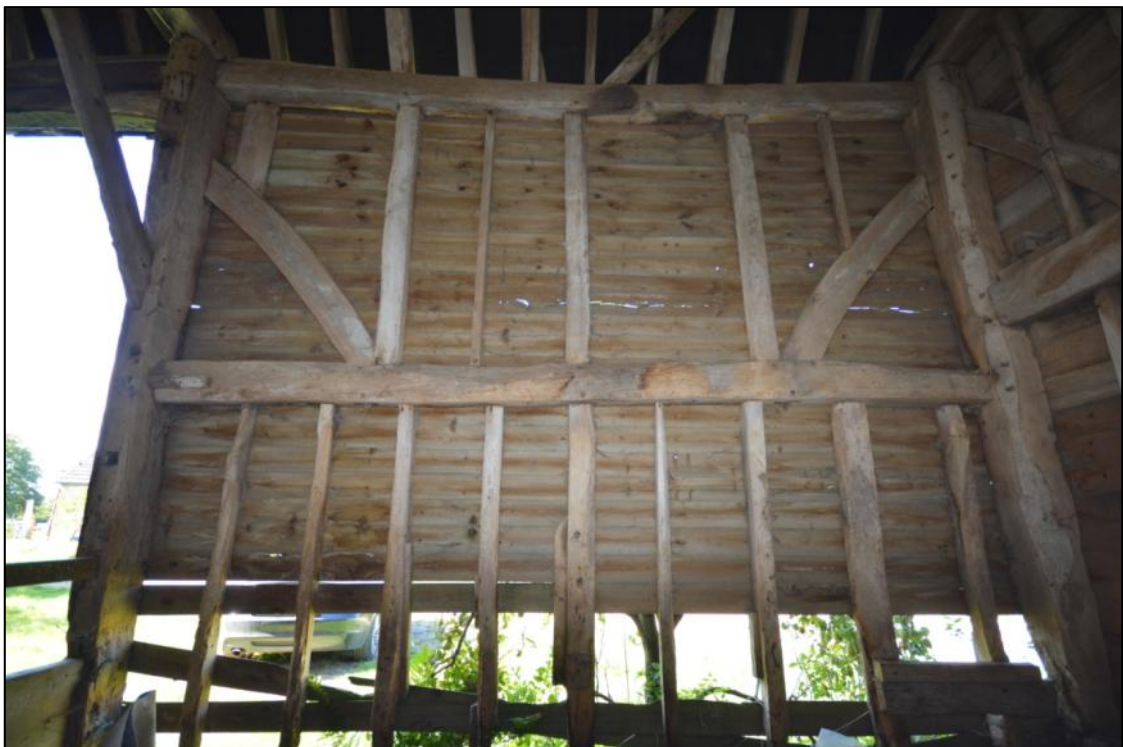
- 10.1.1 The barn was built to a three-bay layout comprising a central wagon entrance or midstrey, flanked by two storage bays of equal length. The building measured c. 12.50 metres north – south by c. 6.20 metres east – west, standing to a height of at least 8.00 metres measured from the current ground floor level to the base of the principal rafters (Figure 3).

Plate 20: The wall construction of the west elevation (bay 1), without intermediate full-height posts

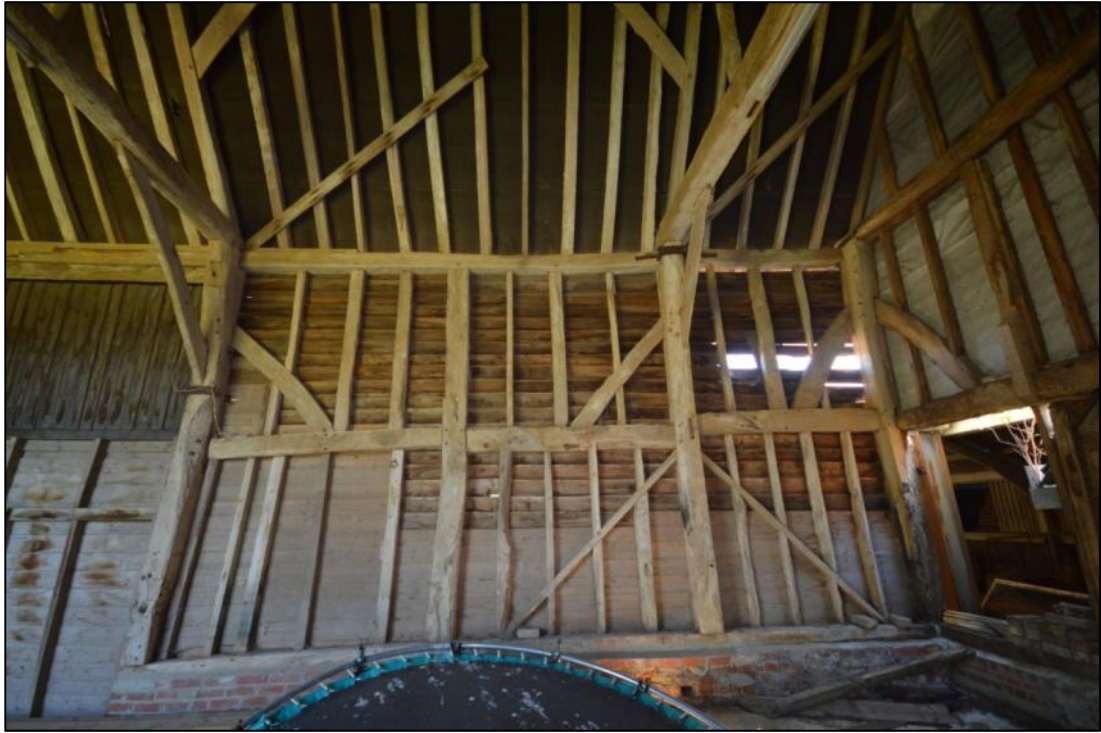
- 10.1.2 The frame comprises principal posts at 230 x 200 mm section with swelling jowls. The walls on the west side of the building comprise three regularly-spaced studs each to the panels above and below the side girts: these are set at 1.15 metre centres on average, intended to accommodate weatherboard cladding on the exterior from the outset (Figure 3). Arched foot-braces at 70 mm thick are situated above the side-and-end-girts extending between the principal posts and the girts (Figure 3; Plate 20).
- 10.1.3 The rear (east) elevation differs: each end bay includes a full height central post creating with the interrupted side girts, four panels to each bay. A central stud is situated within each of the four panels and foot-bracing is included in the same location as that described above for the west elevation (Figure 3; Plate 21).

Plate 21: The east elevation, south end showing the wall construction with intermediate full-height post (bay 4)

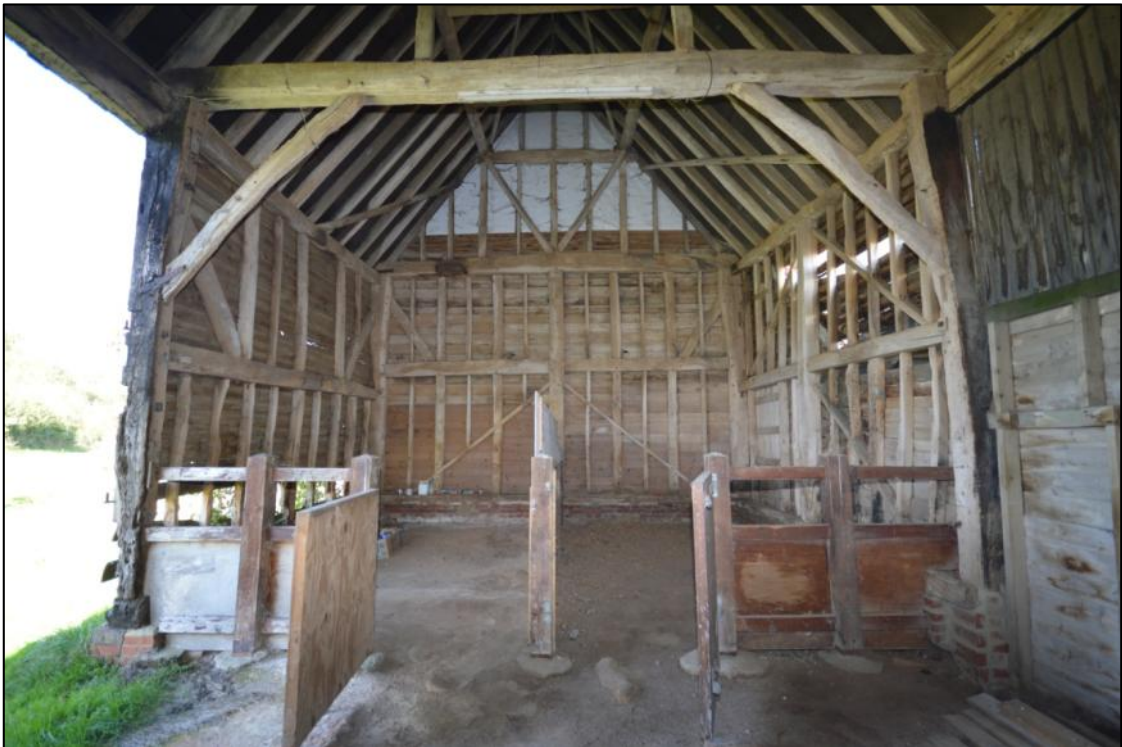
Plate 22: The north end elevation

- 10.1.4 The end elevations include a full height central post that interrupted the end girt. The four panels created by the central post and the girts are subdivided by two regular studs set at 920 mm centres on average. Foot-bracing, as before, extends between the principal posts and the end girts (Figure 3; Plate 22).

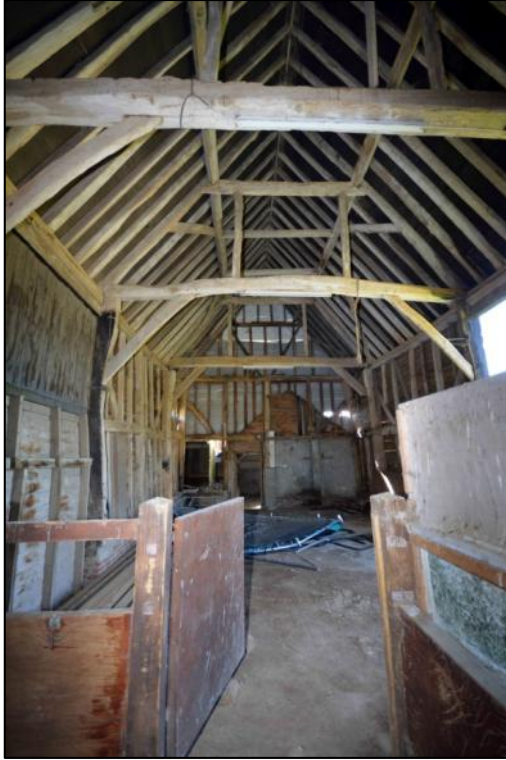
- 10.1.5 The two end trusses include stub gables subdivided by three regularly spaced studs that rise from tie-beam to collar. The two open trusses that flank the wagon entrance are of queen stud type, with arched head-braces (Plate 23). The braces have since been replaced, utilising their original locations as evidenced by mortises and pegged joints.

Plate 23: View towards the south end of the barn showing the open trusses flanking the wagon entrance

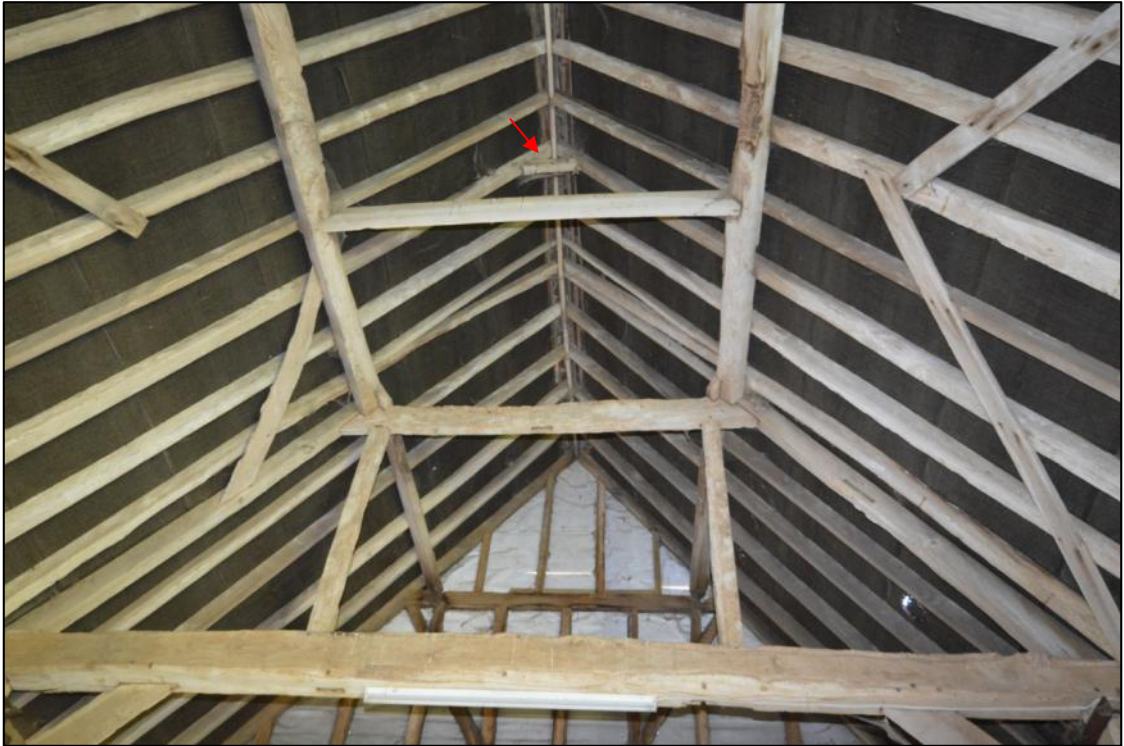
Plate 24: The north end of the barn showing the high-set collar (arrow) that had supported the half-hipped roof terminal at that end of the building prior to the addition of bay 5 in the 17<sup>th</sup> century

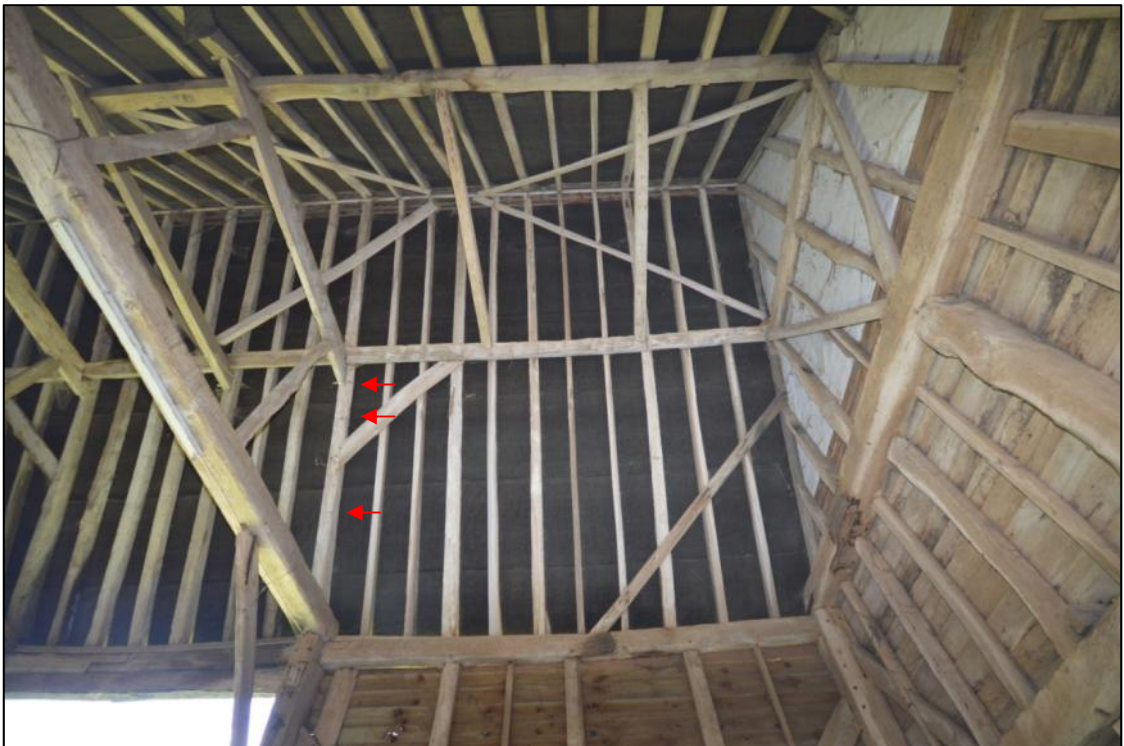
Plate 25: The west slope of the roof over bay 1 showing the lash marks on the principal rafter of the T2 truss, left from the original thatched roof cover (indicated by arrow)

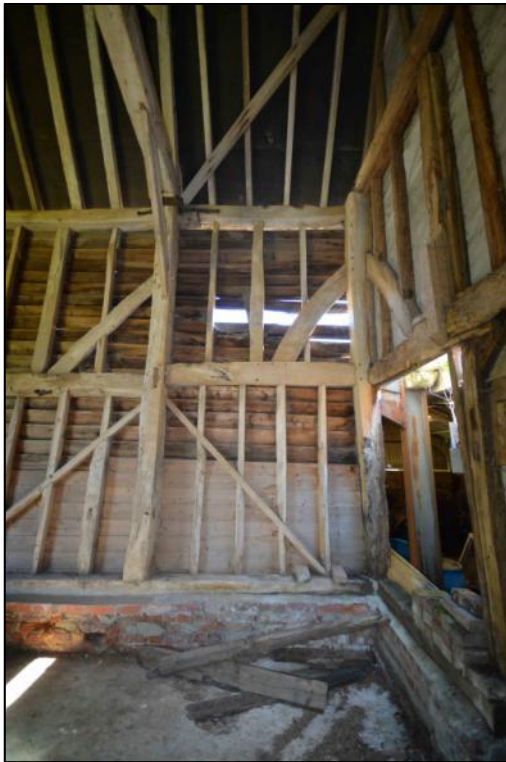
10.2.1 The barn was extended by a single bay at its southern end during the 17<sup>th</sup> century. The new bay (bay 5) added a further 2.15 metres to the length of the barn, a total of 14.70 metres on its north – south axis (Figure 4).

Plate 26: The east elevation of bay 4, added to the south end of the barn during the 17<sup>th</sup> century

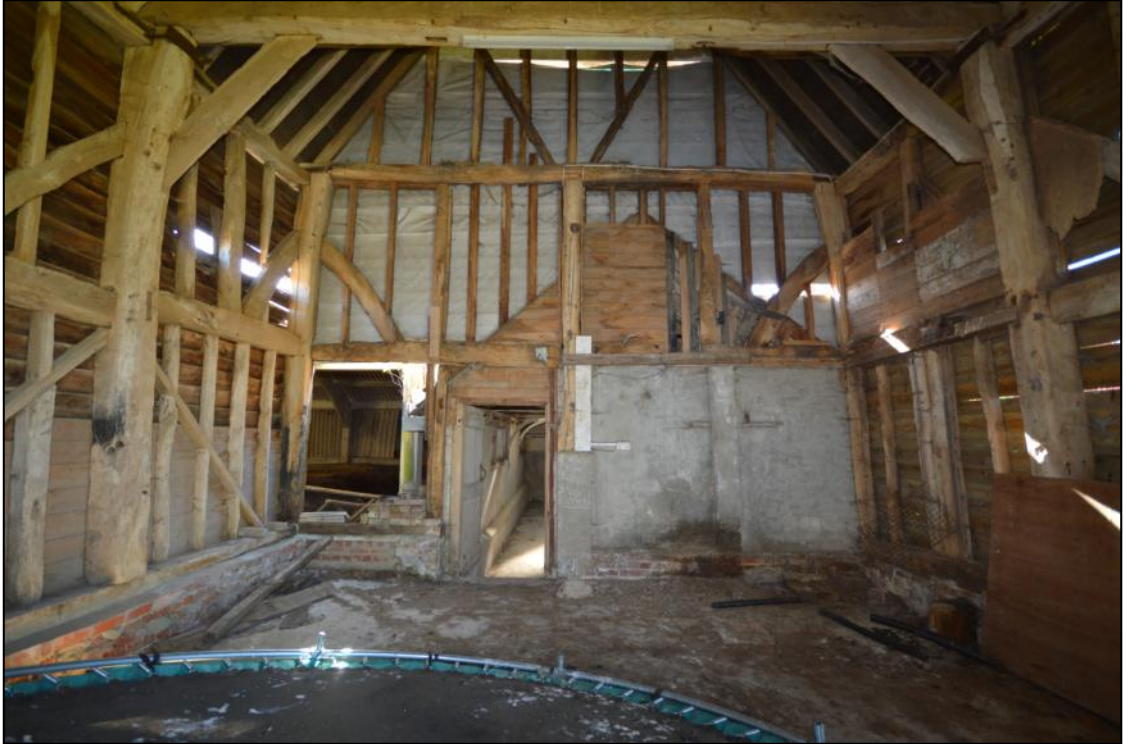
10.2.3 The studs, central post and infill of the original end wall of the barn was removed to increase the storage capacity within the extended building (Figure 4).

Plate 27: The much altered south end of the barn, retaining the interrupted girt, upper central studs, foot-braces and central full height stud of the original 17<sup>th</sup> century extension

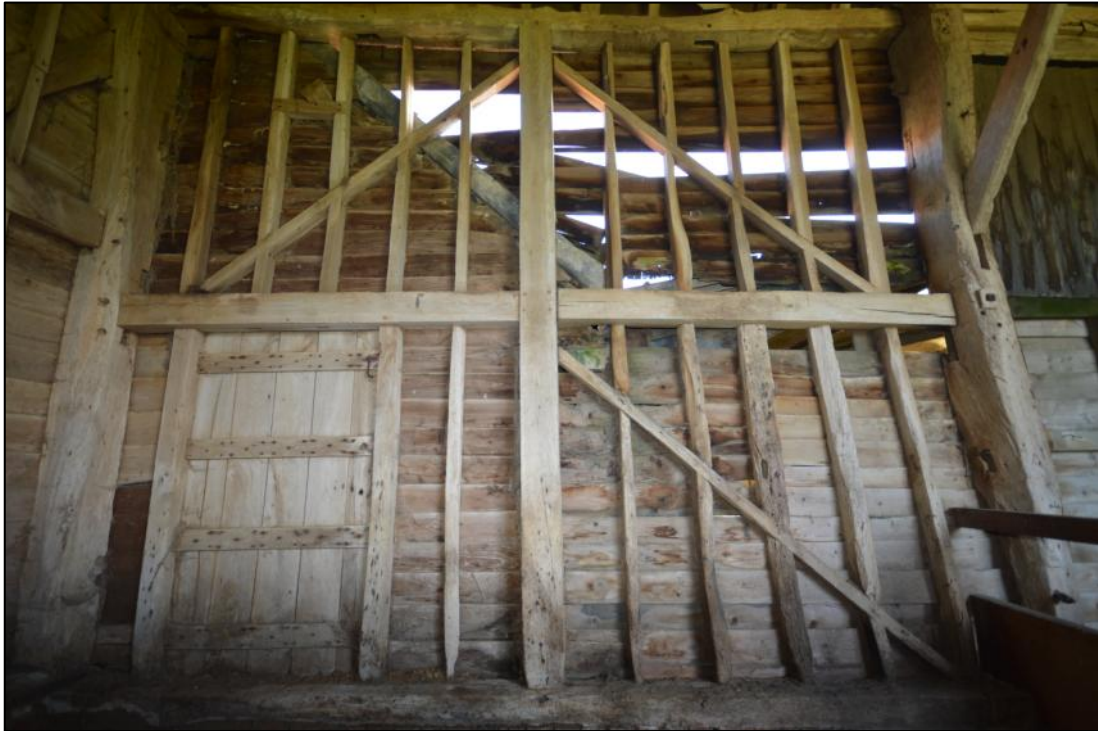
Plate 28: The much rebuilt eastern elevation of bay 1 (the door is a later insertion removing two of the 19<sup>th</sup> century studs to accommodate it)

- 7.4.1 20<sup>th</sup> century alterations are minimal and localised, comprising patch repairs to areas of weatherboarding and the brickwork to the plinths. A doorway was inserted into the east elevation of bay 1, retaining the sole-plate and plinth *in situ*.

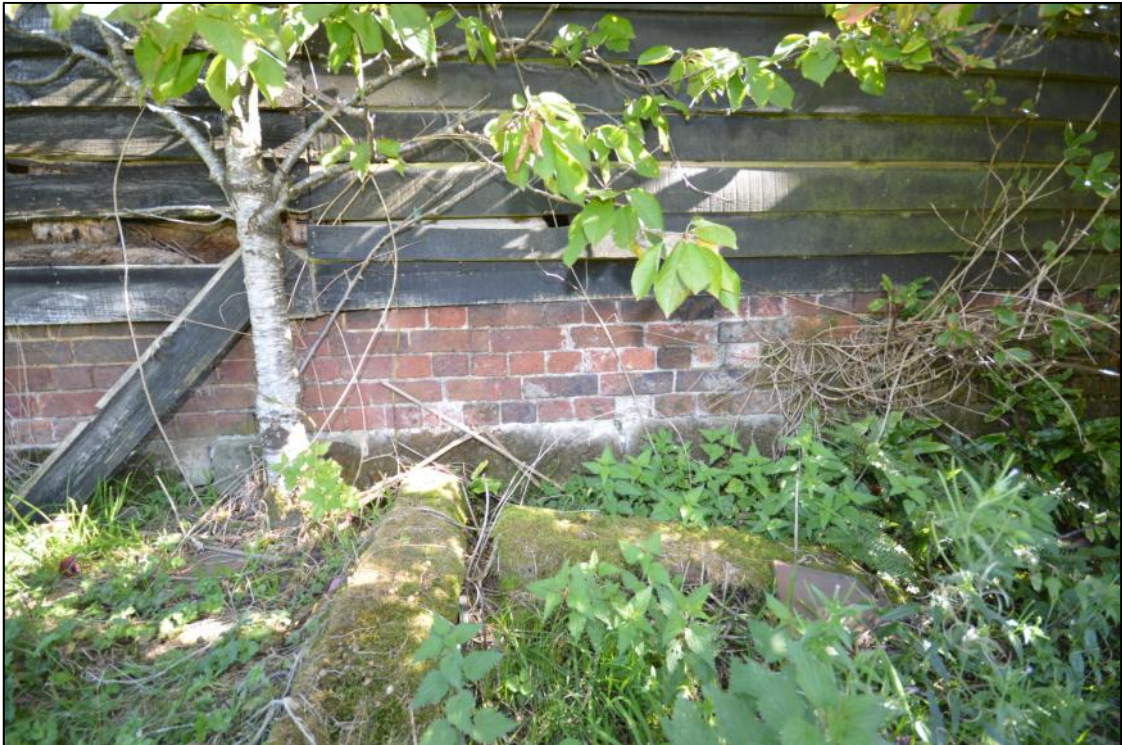
- 10.3.4 The timber frame is raised over a brick plinth: this is in English bond, the bricks measuring 65 mm thick. The brickwork to the western side of the barn surmounts a masonry base (Plate 29). The brick fabric is commensurate with a late 18<sup>th</sup> or a 19<sup>th</sup> century origin.

Plate 29: Detail of the brick plinth surmounting the masonry base on the western side of the barn (bays 3 and 4)

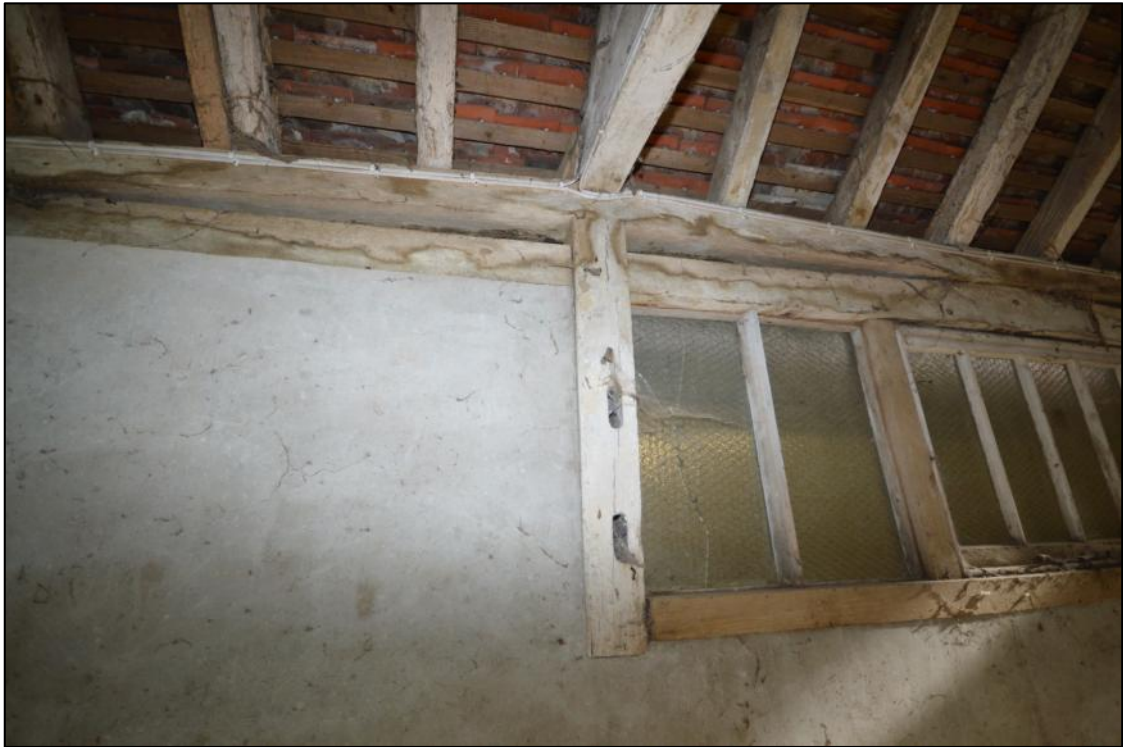
Plate 30: Detail of the mortises on the post between bays 1 and 2 of B2a, indicative of a partition

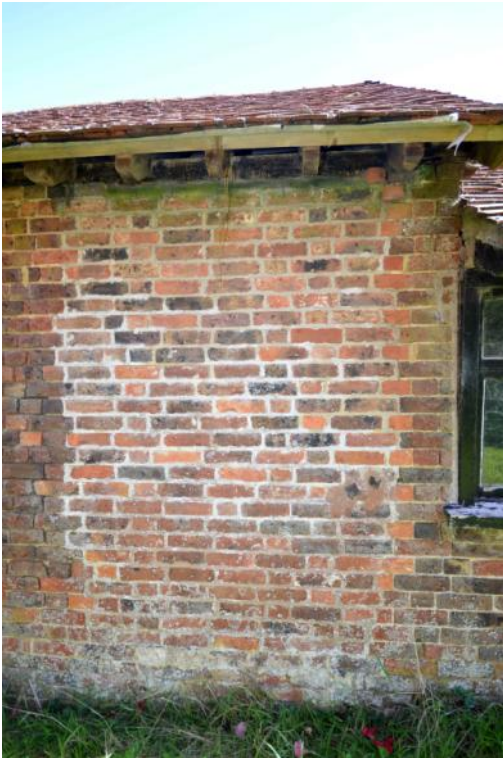
Plate 31: The evidence of a blocked doorway in the west elevation of bay 4 (B2a)

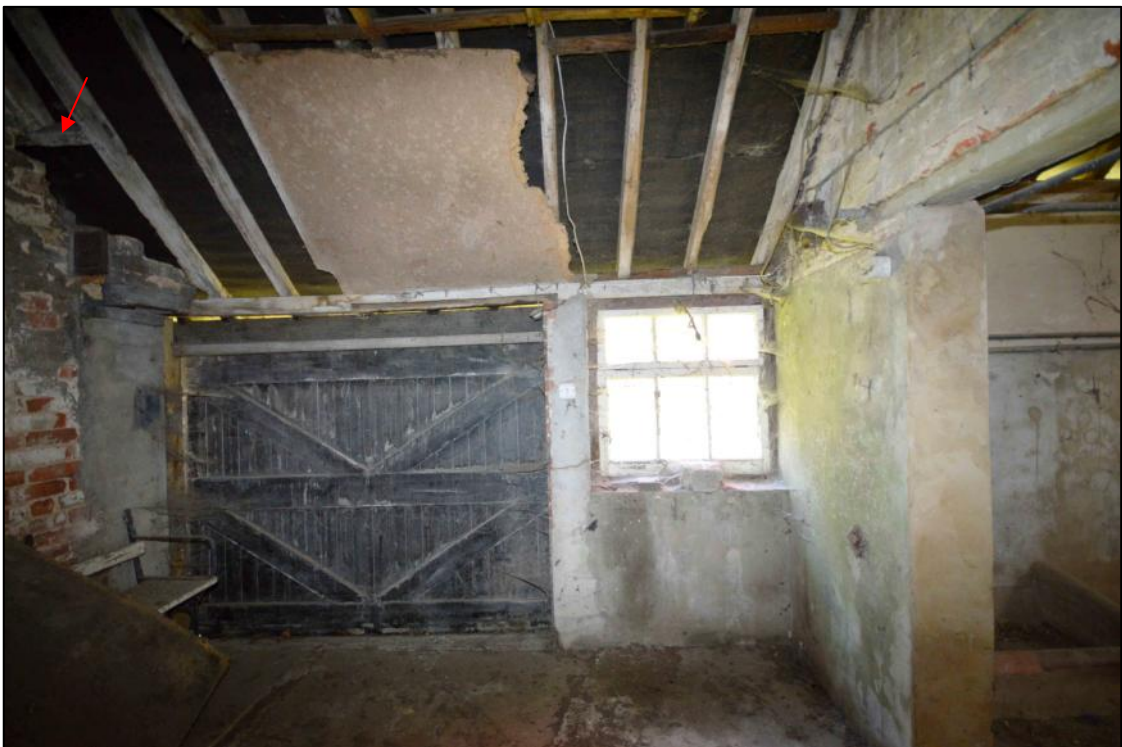
the inclusion of a jointed-in trimmer to the rafters overhead, allowing any chimney stack to pass through the roof (Plate 32).

Plate 32: The interior of bay 5 (B2b) showing the scars for a flue and the jointed-in trimmer in the rafters (arrow)

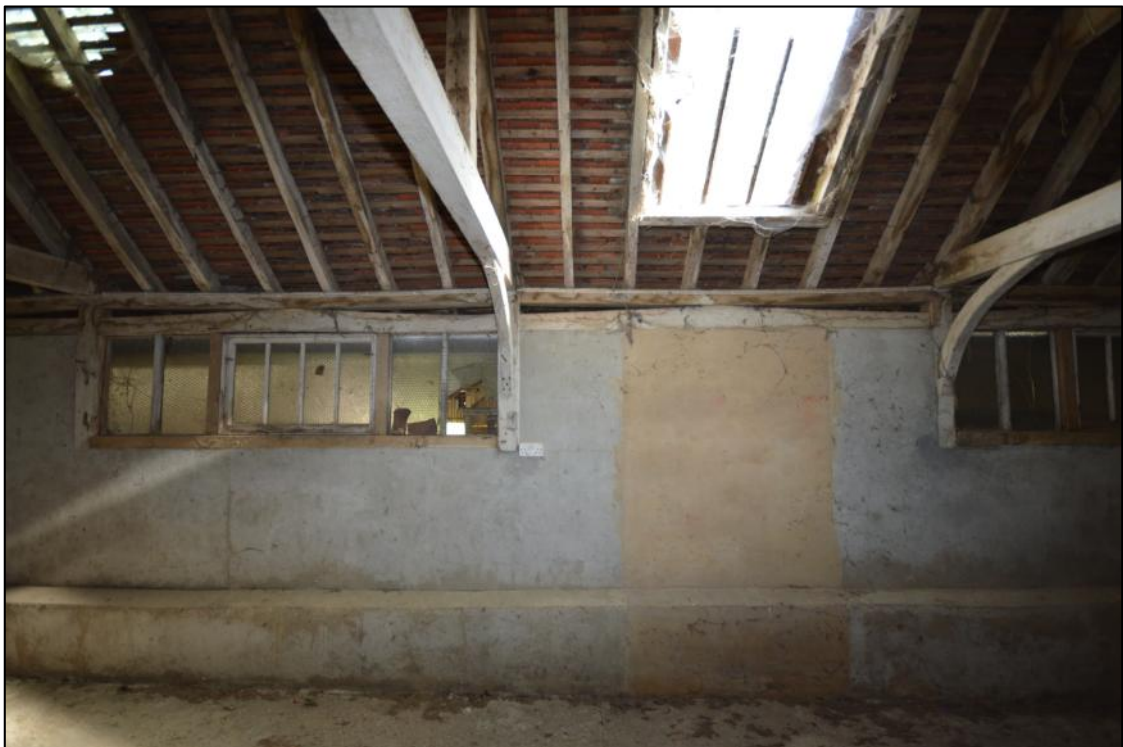
- 10.4.7 The west and south end elevations of the building were built in brick laid in Sussex bond. The north end was formed by the south end of the adjacent barn. All eight bays had originally been open-fronted on their eastern side: this is evidenced by the available Ordnance Survey maps as discussed above, and from the fabric of the building, in particular, the survival of posts, albeit truncated, on the eastern side of the building, head-bracing between the posts and the tie-beams, and within bay 3, by a retained, curved, head-plate situated just below the wall-plate, a particular characteristic of buildings of this type and date in the area (Plate 33).

Plate 33: The west side of B2a showing the former open front evidence: the head-plate below the bressumer/flying plate, the posts between the bays, and the nailed-on head-braces

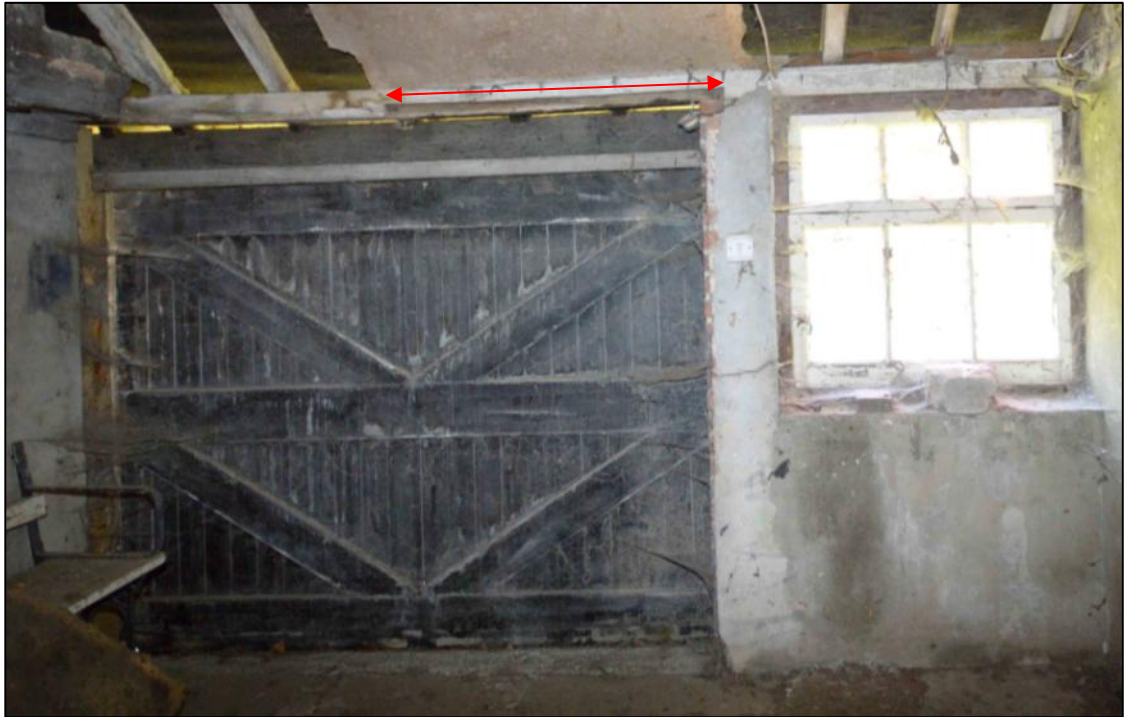
- 10.4.9 A second entrance is indicated at the centre of the west elevation within B2b (bay 5; Figure 6). The current entrance in the suggested location has been widened to its original form (Plate 34). Due to the compact single-bay layout of B2b, it is possible that an entrance had been included on the west side of the building at the outset, although this is by no means certain.

Plate 34: Bay 5 (B2b) showing evidence of the widening of the doorway (arrow)

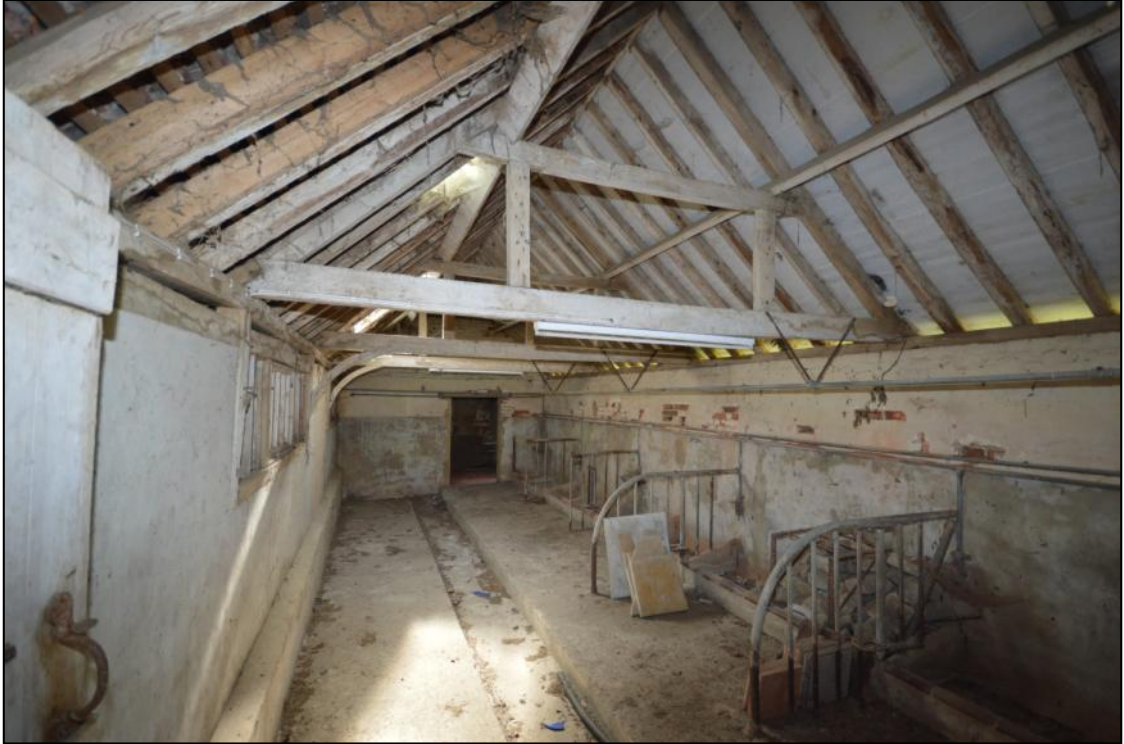
Plate 35: Roof structure and typical roof truss

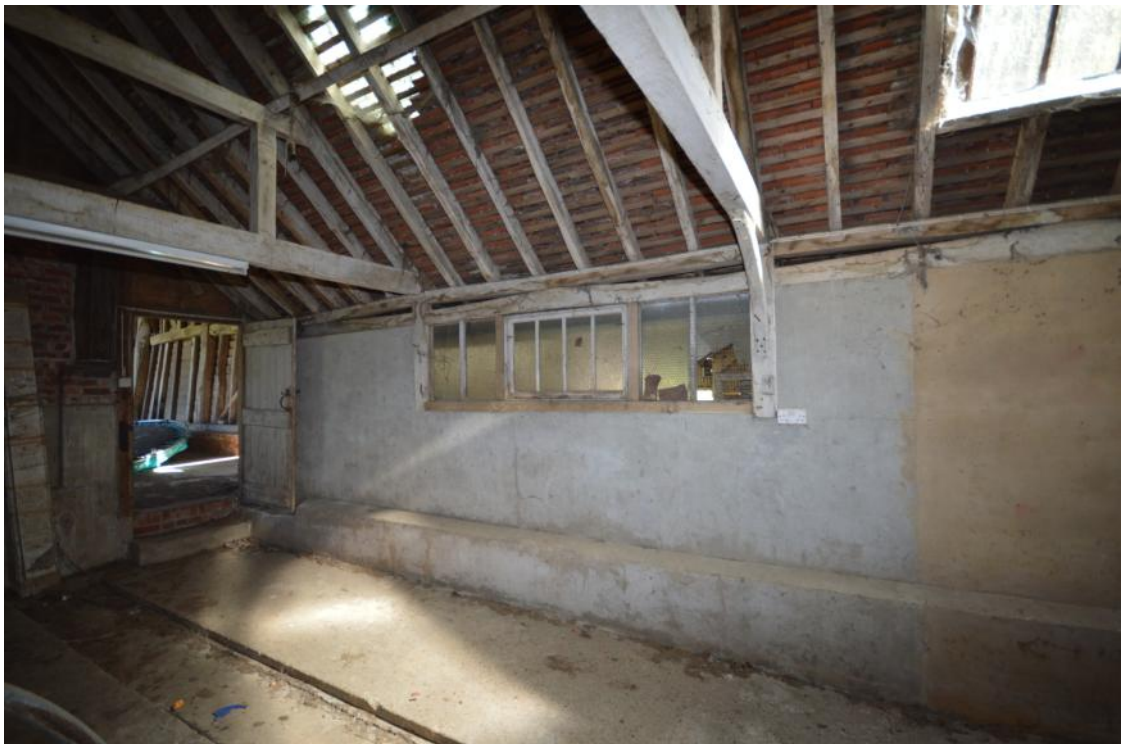
Plate 36: The east front of building B2a showing the truncated posts, head-braces, bressumers and head-plates

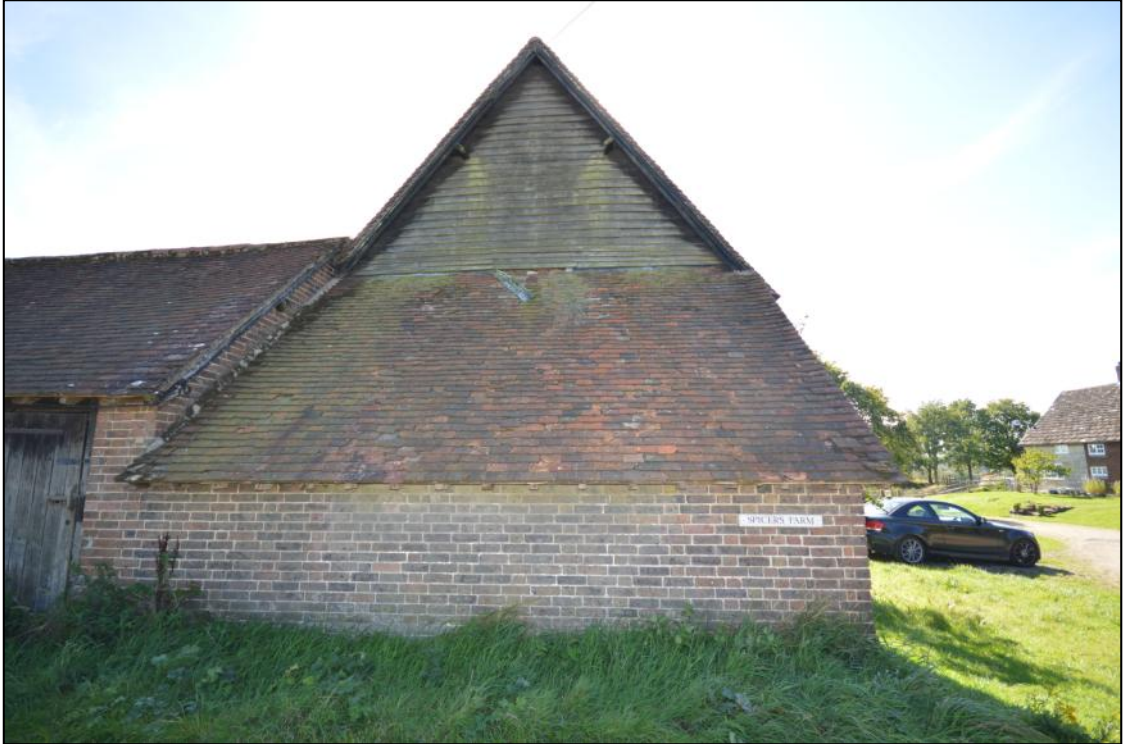
10.5.1 A building had been situated at the north end of the barn by 1840: this extended westwards to form a long linear range as depicted on the tithe map (Plate 1). Between 1840 and 1874 the northern range was removed and replaced with a new one, this time extending out to the east (Plate 2). The building that currently occupies a position at the north end of the barn is the result of the 1840-1874 era rebuilding event, creating a new range built in brick laid in Sussex bond (Plate 37).

Plate 37: The north end of the barn and building B3

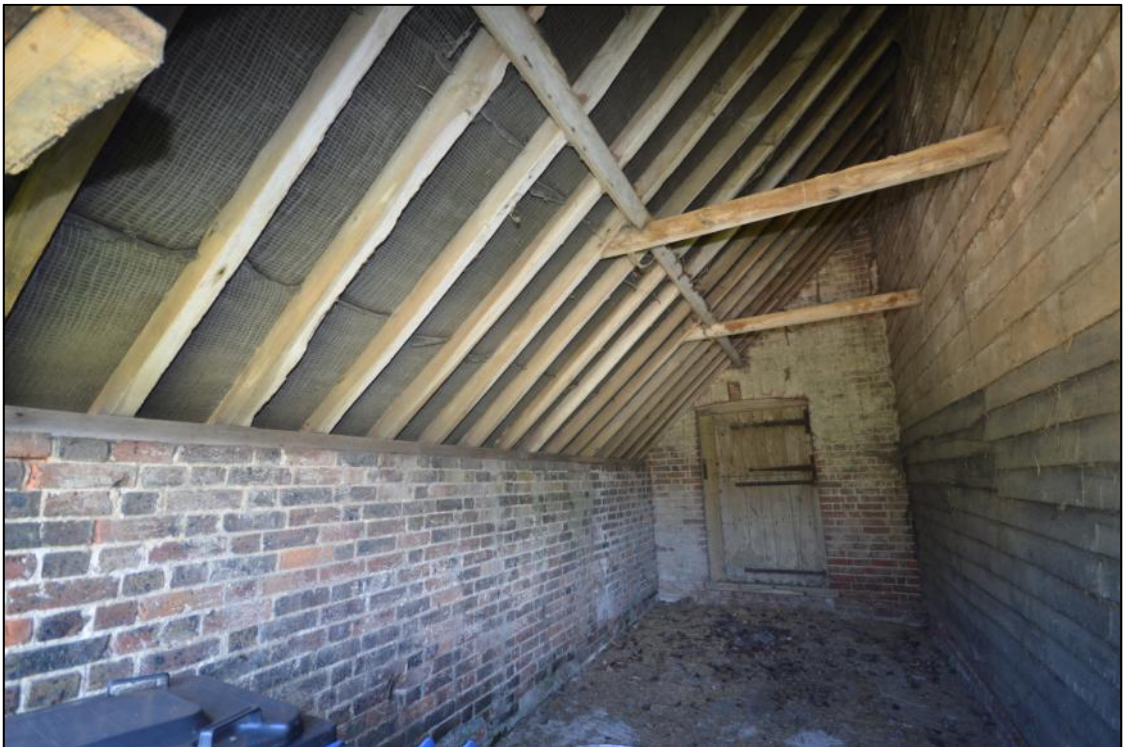
Plate 38: The interior of B3 as it abuts the barn, looking towards the inserted brick partition with its integral doorway
