## Bat Emergence and Re-Entry Surveys (BERS)

12 & 14 Eastern Road, Haywards Heath, West Sussex, RH16 3NN

This report is prepared to inform a planning application for the proposal described as a proposed demolition of existing lean to stores at the rear of each house and erection of two storey rear and side extensions with recessed balconies in order to enlarge the existing four flats. Loft conversions and roof extensions that include front dormers and rooflights. New dropped kerb and parking for five cars to the front.

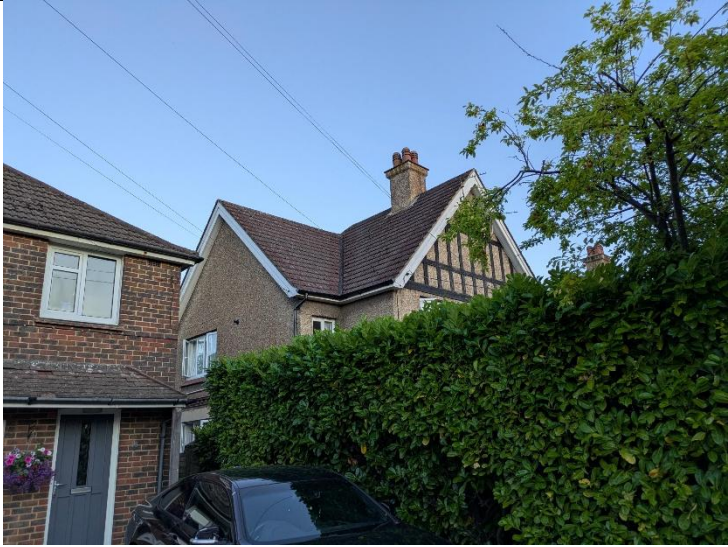
| Results | | | | | | |
|---|---|---|---|---|---|---|
| Surveyor 1 - SM | | <b>No emergencies observed.</b><br>There were low levels of bat activity during the survey. There were five occurrences of common pipistrelles that were heard but not seen at 22:02, 22:06, 22:09, 22:37 and 22:46.<br><br>These species were confirmed on site using an Echo Meter Touch 2 bat detector.<br><br>No further bat activity was detected throughout the remainder of the survey. | | | <p>Photo 1: elevation photo showing the view from position 1.</p> | |

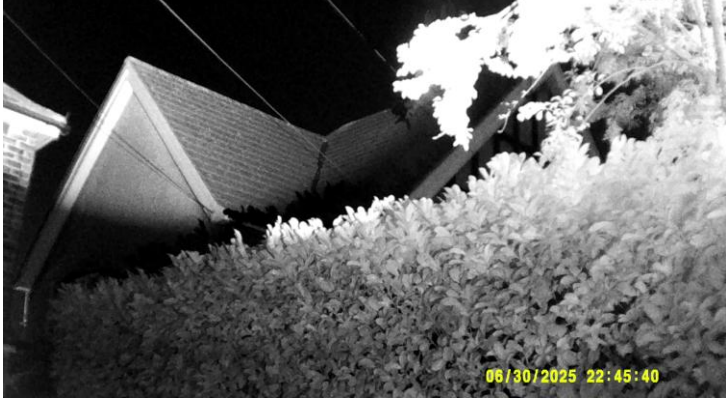
| <p><i>IR position 1</i><br/> <i>1 x Nightfox Whisker +</i><br/> <i>1 x Nightfox XB5 PRO</i></p> <p><i>Recording the north and west elevations and manned by surveyor 1.</i></p> | <p><b>No emergencies recorded.</b></p> <p>IR analysis reflects the surveyor's observations and no additional bat activity was recorded or observed upon full footage review.</p> | <p>Photo 2: darkest point photo from the IR camera at position 1.</p> |

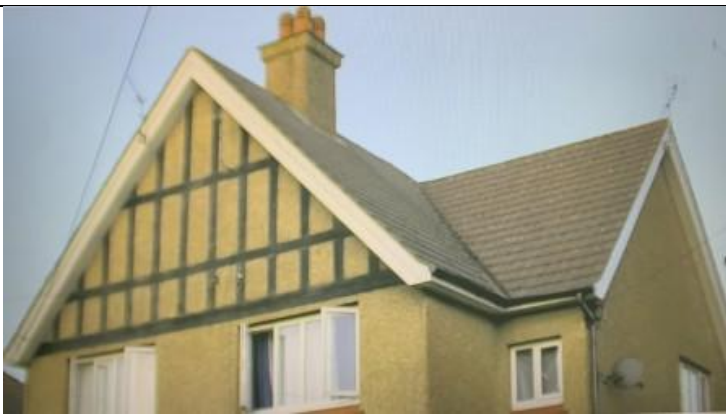
| <p><i>Surveyor 2 - LH</i></p> | <p><b>No emergencies observed.</b></p> <p>Bat activity was very low. Only one common pipistrelle was heard but not seen at 22:37.</p> <p>This species was confirmed on site using an Echo Meter Touch 2 bat detector.</p> <p>No further bat activity was detected throughout the remainder of the survey.</p> | <p>Photo 3: elevation photo showing the view from position 2.</p> |

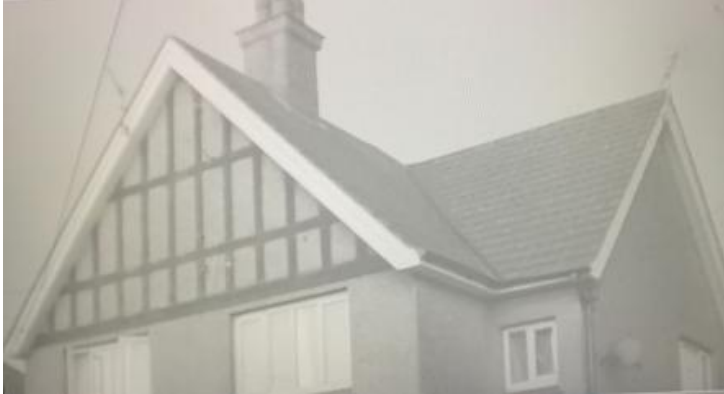
| <p><i>IR position 2</i></p> <p><i>1 x Nightfox Whisker +</i><br/> <i>1 x Nightfox XB5 PRO</i></p> | <p><b>No emergencies recorded.</b></p> <p>IR analysis reflects the surveyor's observations and no additional bat activity was recorded or observed upon full footage review.</p> | |

| <i>Recording the north and east elevations and manned by surveyor 2.</i> | | <p>Photo 4: darkest point photo from the IR camera at position 2.</p> |

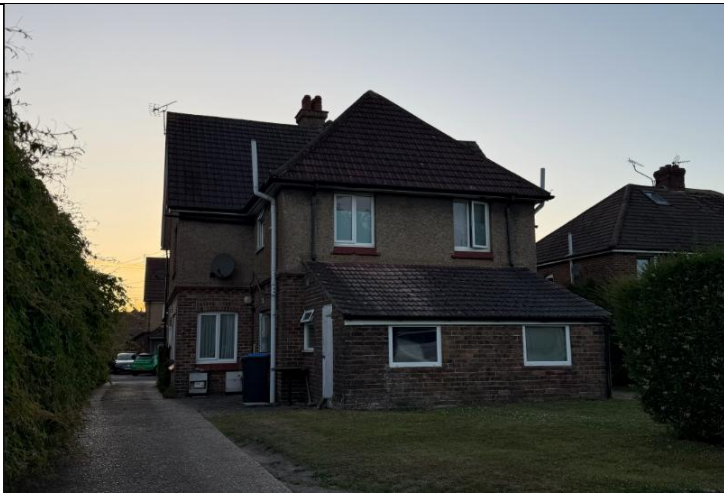
| Surveyor 3 - SG | <p><b>No emergencies observed.</b></p> <p>The first bat activity was a common pipistrelle that was seen passing from southeast to northwest towards B1 and B2 then turning in front of the building before flying southeast towards the back of the garden. Between 21:58 and 22:28 there were five instances where common pipistrelles were seen foraging at the back of the garden towards the southeast boundary of the site. Between 22:29 and 22:46 there were four occurrences of the common pipistrelles that were heard but not seen.</p> <p>This species was confirmed on site using an Echo Meter Touch 2 bat detector.</p> | <p>Photo 5: elevation photo showing the view from position 3.</p> |

| | No further bat activity was detected throughout the remainder of the survey. | |

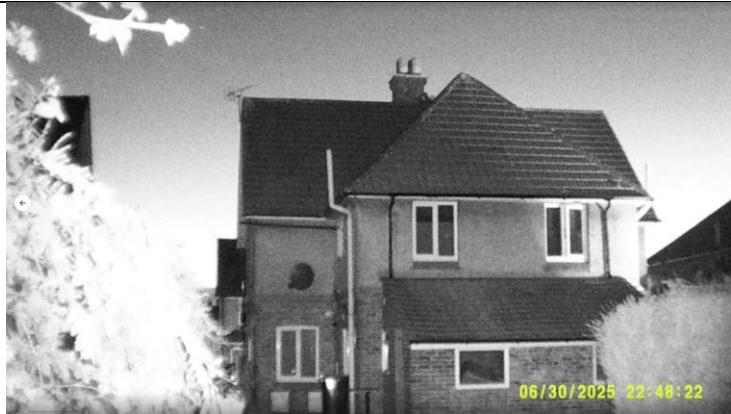
| <i>IR position 3</i><br><br><i>1 x Nightfox Whisker +<br/>1 x Nightfox XB5 PRO</i><br><br><i>Recording the north<br/>and east elevations<br/>and manned by<br/>surveyor 3.</i> | <b>No emergences recorded.</b><br><br>IR analysis reflects the surveyor's observations and no additional bat activity was recorded or observed upon full footage review. | <br>Photo 6: darkest point photo from the IR camera at position 3. |

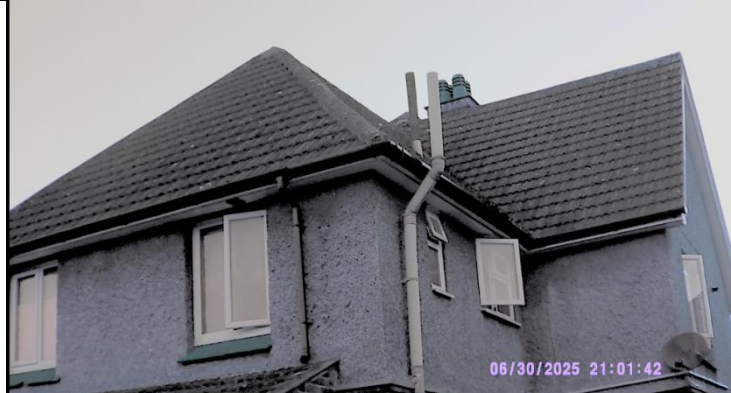
| <i>IR position 4</i><br><br><i>1 x Nightfox Whisker +<br/>1 x Nightfox XB5 PRO</i><br><br><i>Unmanned camera<br/>recording the north<br/>elevation and regularly<br/>checked by surveyor 3.</i> | <b>No emergences recorded.</b><br><br>No additional bat activity was recorded or observed upon full footage review. | <br>Photo 7: darkest point photo from the IR camera at position 4. |

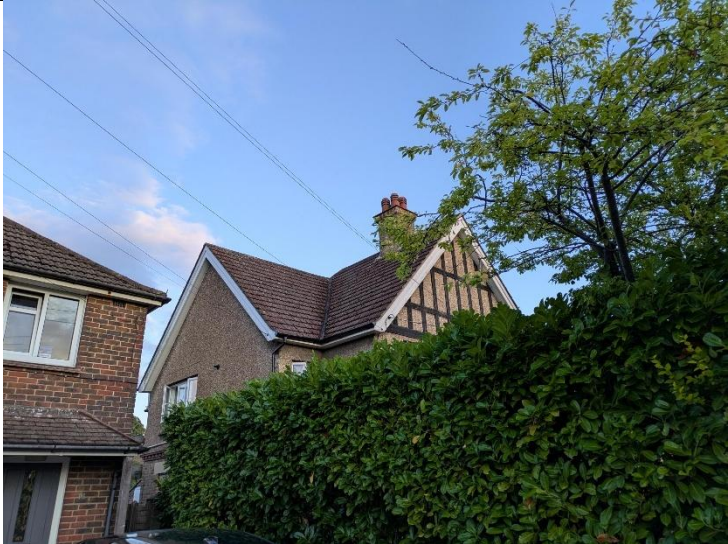
| Results | | | | | | |
|---|---|---|---|---|---|---|
| Surveyor 1 - SM | | <b>No emergences observed.</b><br><br>There were low levels of bat activity during the survey. At 21:39 one common pipistrelle was seen passing from southeast to northwest to the northeast of B1, also seen by surveyor 3. At 21:48 a second common pipistrelle was seen passing from the same direction, southeast to northwest.<br><br>These species were confirmed on site using an Echo Meter Touch 2 bat detector.<br><br>No further bat activity was detected throughout the remainder of the survey. | | <p>Photo 8: elevation photo showing the view from position 1.</p> | | |

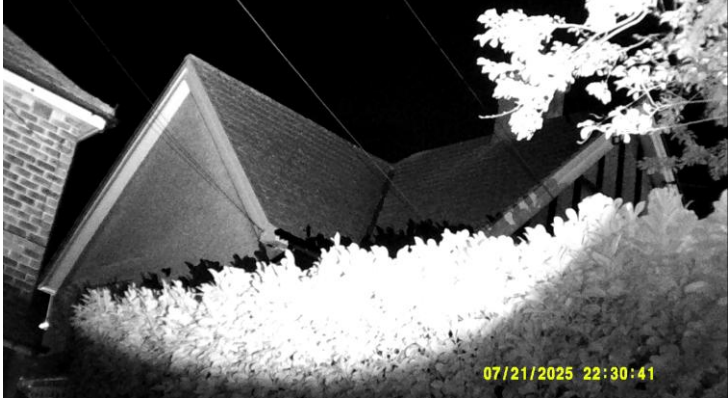
| <p><i>IR position 1</i><br/> 1 x Nightfox Whisker +<br/> 1 x Nightfox XB5 PRO</p> <p><i>Recording the north and west elevations and manned by surveyor 1.</i></p> | <p><b>No emergencies recorded.</b></p> <p>IR analysis reflects the surveyor's observations and no additional bat activity was recorded or observed upon full footage review.</p> | <p>Photo 9: darkest point photo from the IR camera at position 1.</p> |

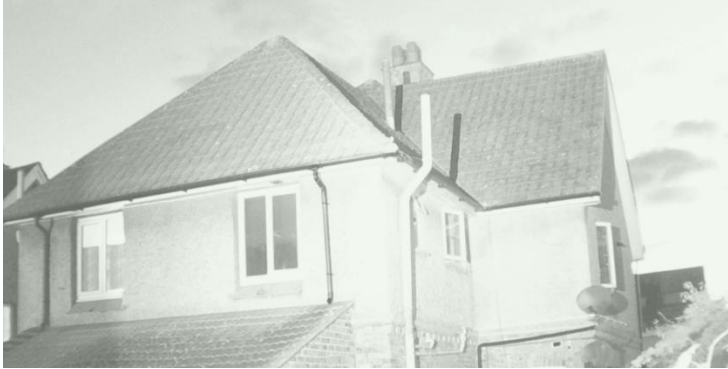
| <p><i>IR position 2</i></p> <p>1 x Nightfox Whisker +<br/> 1 x Nightfox XB5 PRO</p> | <p><b>No emergencies recorded.</b></p> <p>IR analysis reflects the surveyor's observations and no additional bat activity was recorded or observed upon full footage review.</p> | |

| <p><i>Recording the north and east elevations and manned by surveyor 2.</i></p> | | <p>Photo 11: darkest point photo from the IR camera at position 2.</p> |

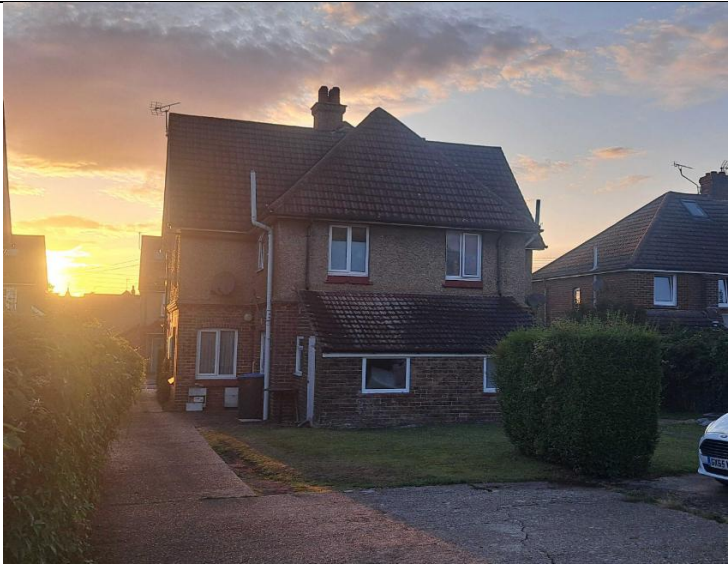
| <p><i>Surveyor 3 - ALD</i></p> | <p><b>No emergencies observed.</b></p> <p>First bat activity was a noctule that was heard but not seen at 21:11 and then again at 22:06. A common pipistrelle was heard and seen at 21:36 foraging from the east, directly over surveyor position and then began foraging around northern neighbours rear garden. Common pipistrelle foraging activity was heard and seen foraging both over northern neighbours rear garden and rear garden of surveyed dwelling from 21:36 until 21:48. A brown long-eared bat was very faintly heard but not seen at 22:09. A serotine was heard but not seen at 22:26 and a myotis species was heard and not seen at 22:29.</p> <p>This species was confirmed on site using an Echo Meter Touch 2 bat detector.</p> | <p>Photo 12: elevation photo showing the view from position 3.</p> |

| | No further bat activity was detected throughout the remainder of the survey. | |

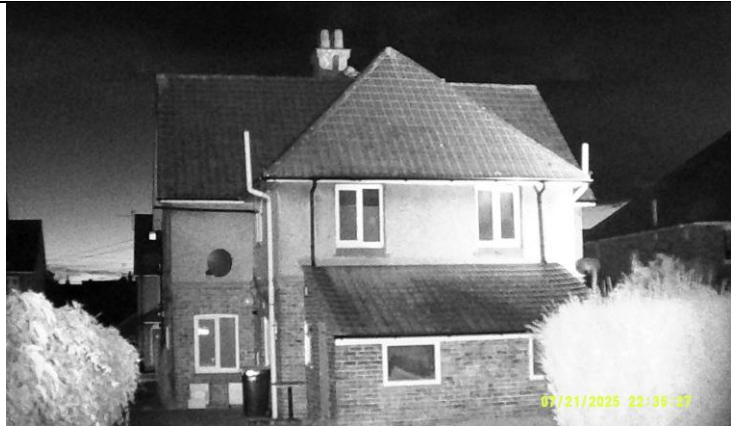
| <p><i>IR position 3</i></p> <p><i>1 x Nightfox Whisker +<br/>1 x Nightfox XB5 PRO</i></p> <p><i>Recording the north and east elevations and manned by surveyor 3.</i></p> | <p><b>No emergences recorded.</b></p> <p>IR analysis reflects the surveyor's observations and no additional bat activity was recorded or observed upon full footage review.</p> | <p>Photo 13: darkest point photo from the IR camera at position 3.</p> |

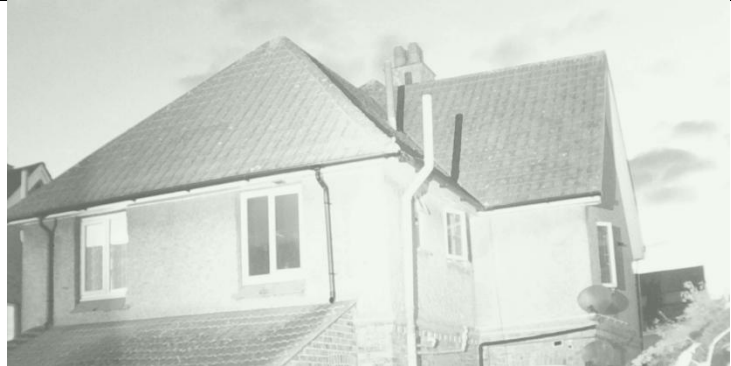
| <p><i>IR position 4</i></p> <p><i>1 x Nightfox Whisker +<br/>1 x Nightfox XB5 PRO +<br/>Magenta bat detector</i></p> <p><i>Unmanned camera recording the north elevation and regularly checked by surveyor 2.</i></p> | <p><b>No emergences recorded.</b></p> <p>There was common pipistrelle activity noted around B1 at 21:48 passing from east to north west between B1 and the neighbouring property – this was also seen and heard by surveyor 1.</p> | <p>Photo 14: darkest point photo from the IR camera at position 4.</p> |

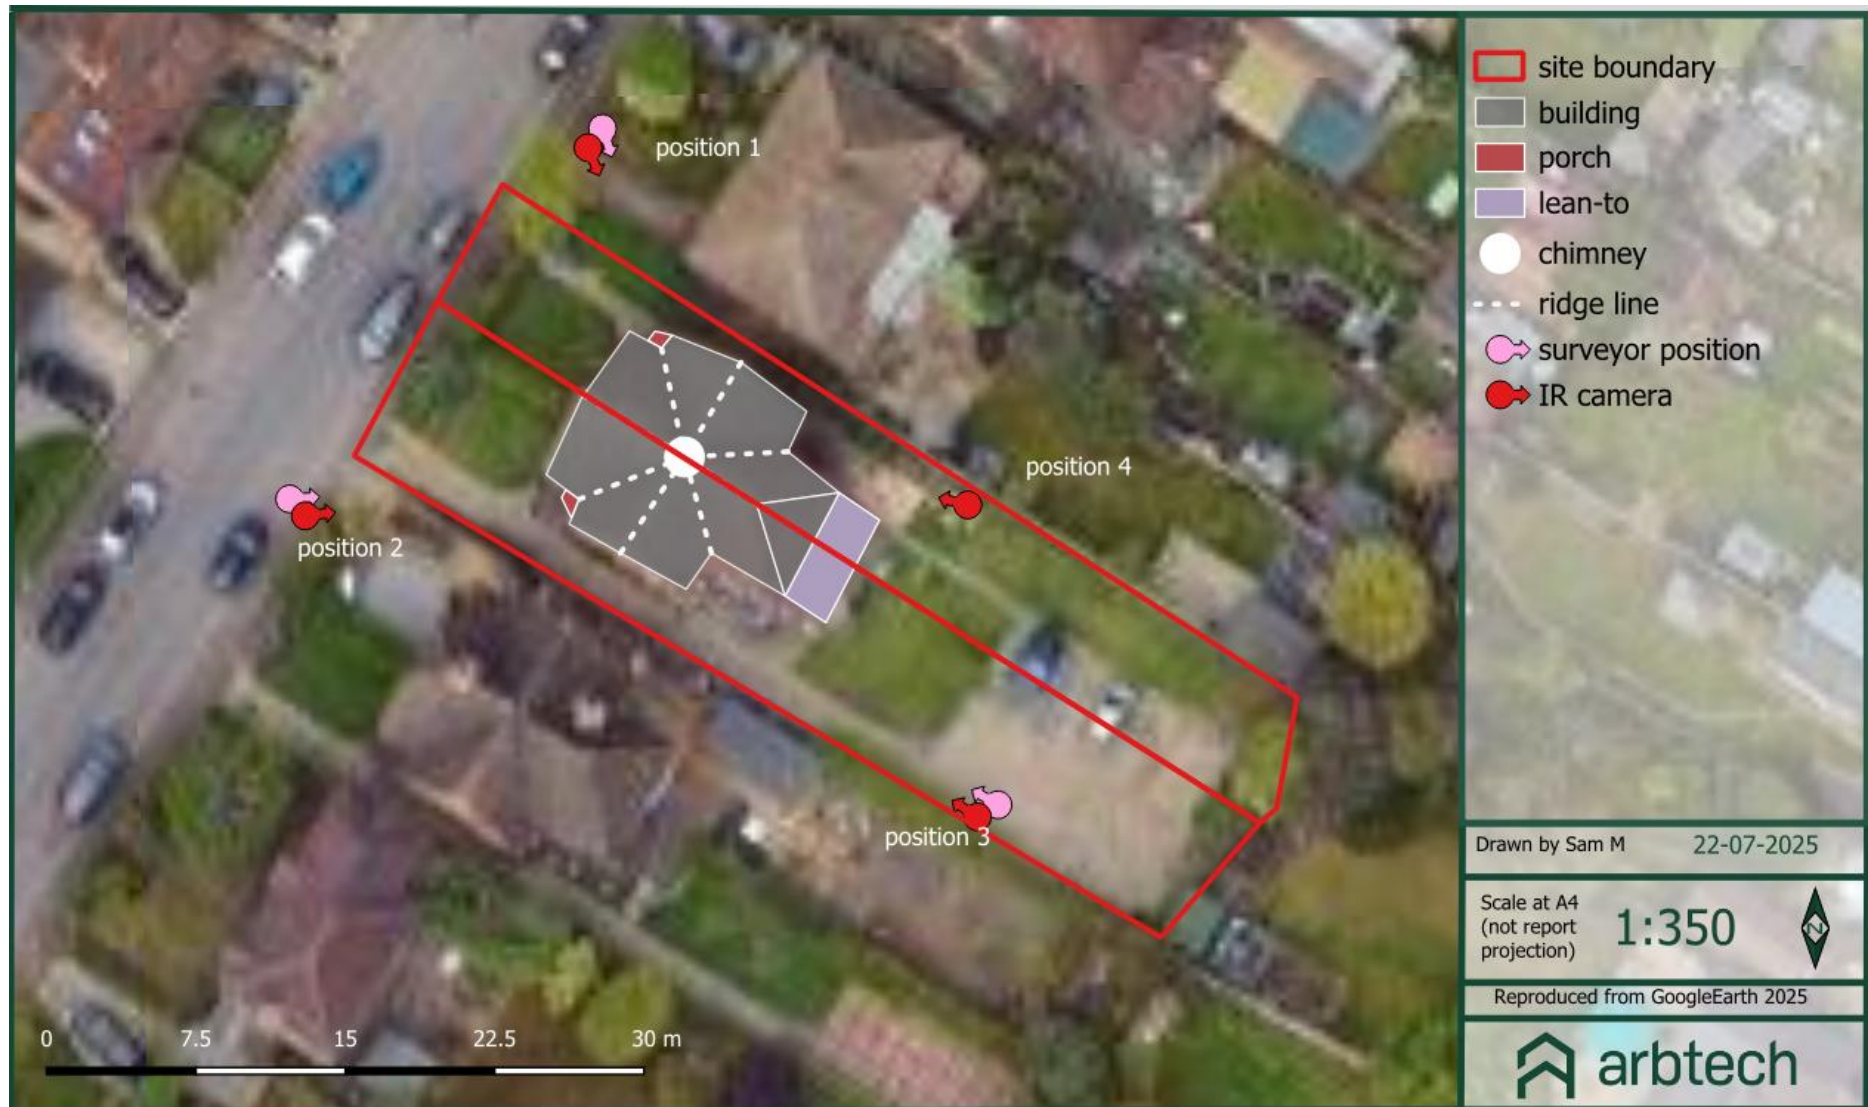
## Appendix 1: BERS plan

| <b>See surveyor locations in the</b> BERS plan in Appendix 1, proposed development plans in Appendix 2. | |
