# Preliminary Ecological Appraisal and Roost Assessment

Wickenden Manor, Chilling Street, East Grinstead, RH19 4JB

Netherhall Educational Association

This report is prepared to inform a planning application with the Mid Sussex District Council. The proposal is described as: *The renovation and extension of the Manor house, the Lodge and the Stables.*

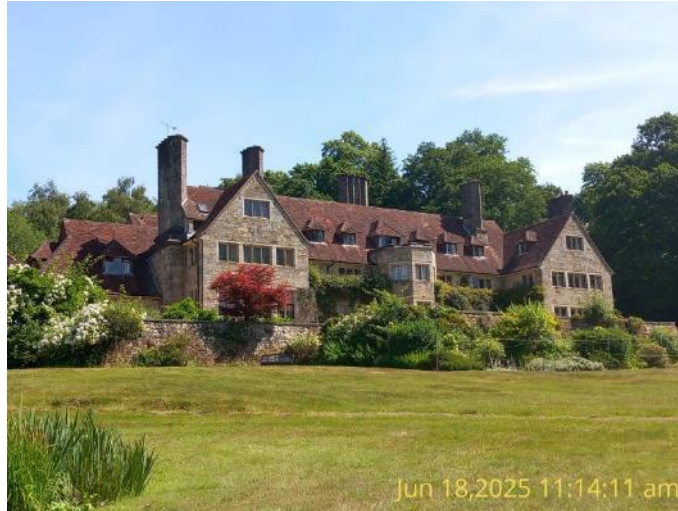
Figure 1: B1 (the Manor House) – southwest elevation.

B1 (the Manor House) is a three-storey, brick and stone built building (Figure 1). The brickwork around the building appears in excellent condition with no gaps or cracks in which bats can roost. The building has a multi pitched roof, clad in clay tiles.

Given the number of features identified on the property and the presence of excellent bat habitat around the site (i.e. trees and woodland), it is assessed that B1 provides **high** habitat value for roosting bats. Furthermore, previous surveys have revealed that the buildings comprise numerous confirmed roosts. Please refer to Appendix 4 for additional photos and descriptions of the building's construction.

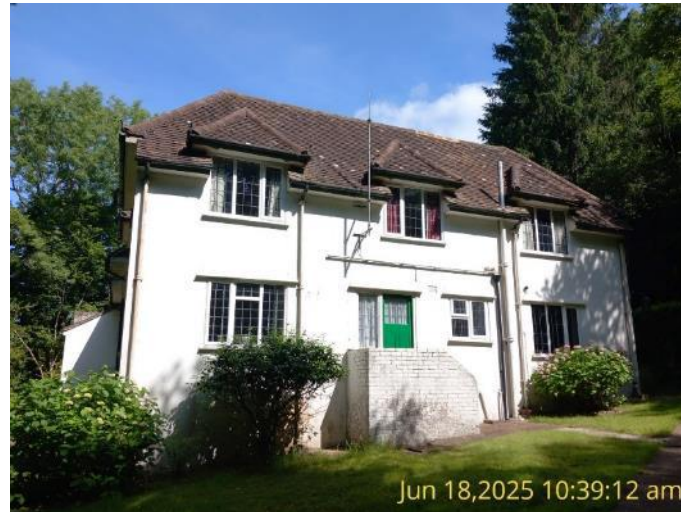
Figure 2: B2 (the Lodge) – south elevation.

B2 is a two-storey, brick-built building which is rendered (Figure 2). The brickwork around the building appears in excellent condition with no gaps or cracks in which bats can roost. The roof of B2 is pitched and hipped and clad in clay tiles.

Given the number of features identified on the property and the presence of excellent bat habitat around the site (i.e. trees and woodland), it is assessed that B2 provides **high** habitat value for roosting bats. Furthermore, previous surveys have revealed that the buildings comprise numerous confirmed roosts. Please refer to Appendix 4 for additional photos and descriptions of the building's construction.

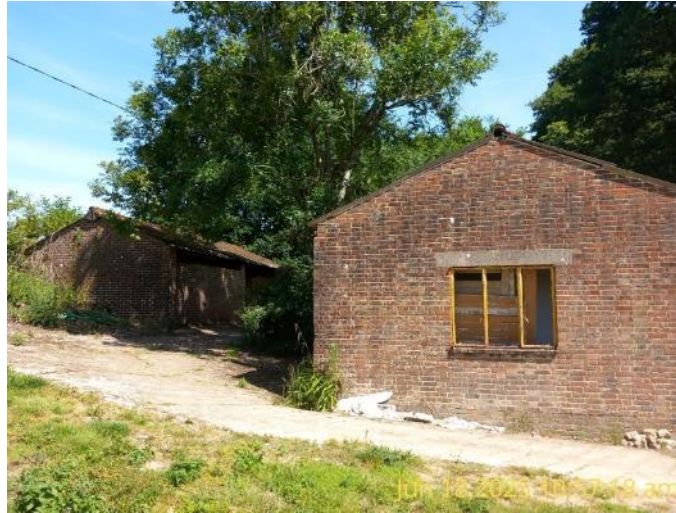
Figure 3: B3a (left) & B3b (right) – south elevation.

B3 comprises two rectangular derelict stable blocks. They are single-storey, brick-built buildings (Figure 3). The brickwork around the building appears in poor condition with no gaps or cracks in which bats can roost.

Given the absence of features identified on the property, it is assessed that B3 provides **negligible** habitat value for roosting bats. Please refer to Appendix 4 for additional photos and descriptions of the building's construction.

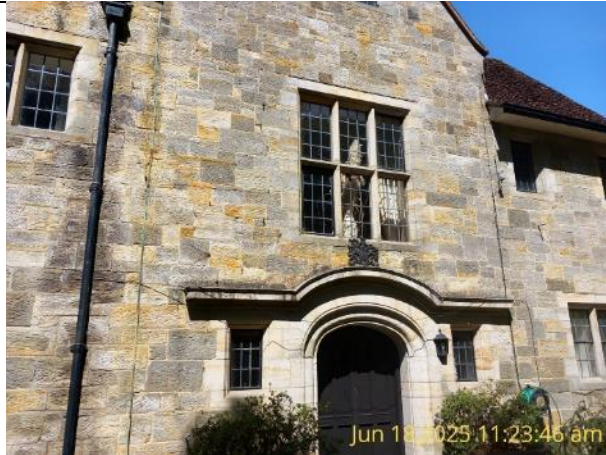
Figure 4: B1 – east elevation. Doors and window frames are of timber construction and are tight-fitting to the brickwork.

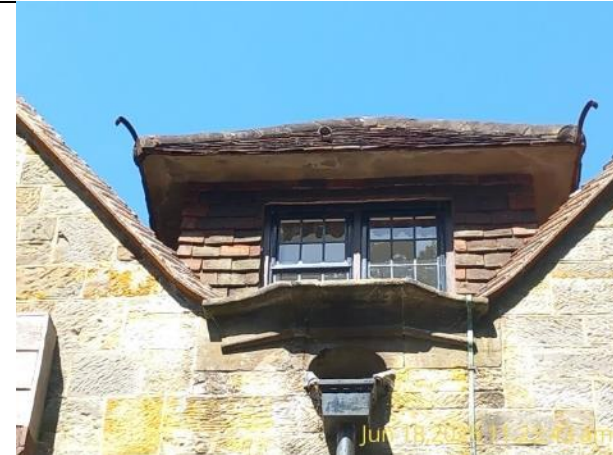
Figure 5: B1 – south elevation. There are hanging tiles on the dormer windows on all elevations of B1 which possess suitable roosting features in the form of gaps.

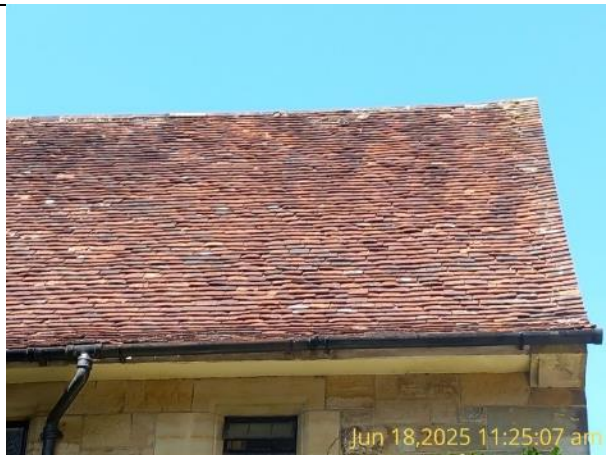
Figure 6: B1 – east elevation. The entire main roof of B1 has clay tiles which are raised in areas. These raised areas provide roosting features for crevice dwelling bats.

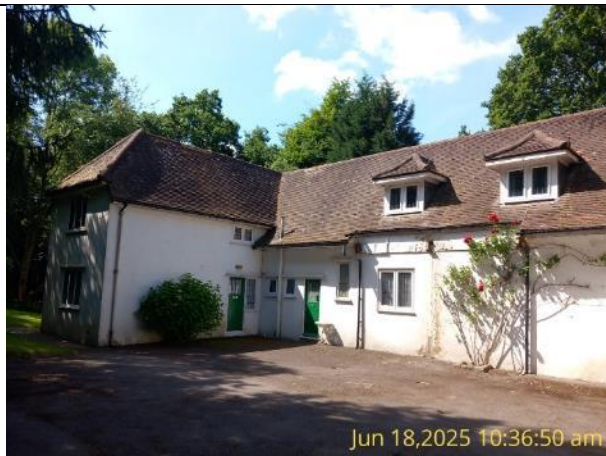
Figure 10: B2 – north elevation. There are numerous dormer windows on all elevations of B2. The main roof of B2 provides abundant roosting opportunities for crevice dwelling bats in the form of raised and or broken clay roof tiles.

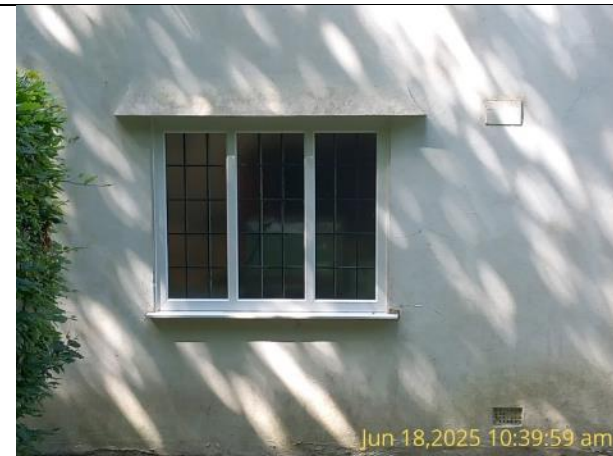
Figure 11: B2 – close-up. The rendered brickwork appears in good condition throughout.

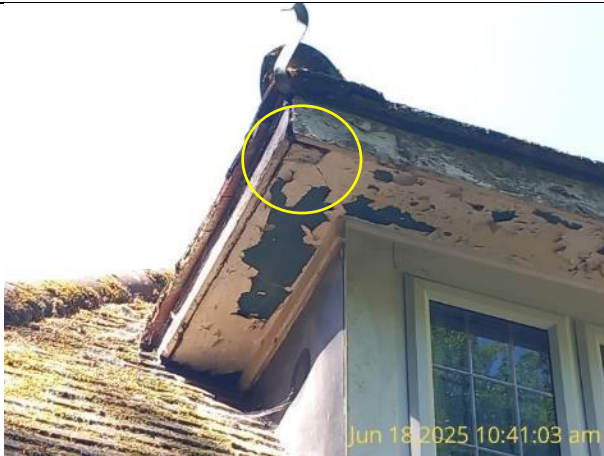
Figure 12: B2 – dormer window. There are gaps in the timbers of the dormers. These gaps provide suitable roosting features for bats.

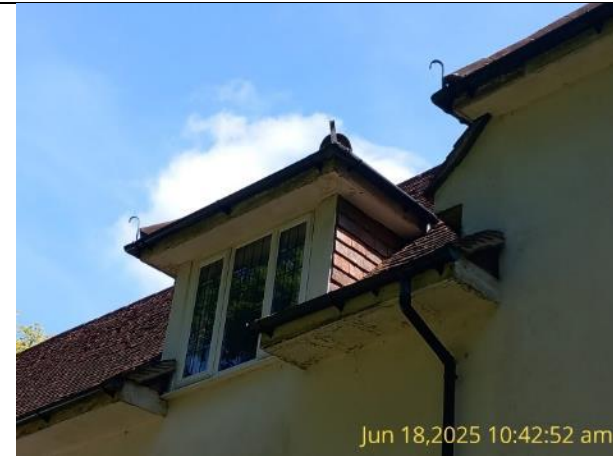
Figure 13: B2 – dormer window close-up. Only one dormer window on B2 is clad in hanging tiles.

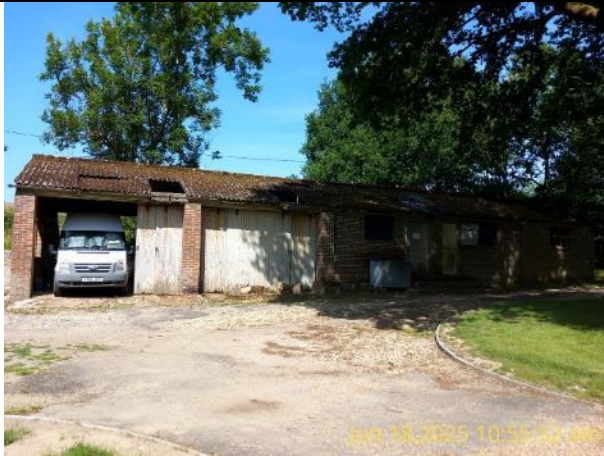
Figure 14: B3b – east elevation. The roof is single skinned and of corrugated asbestos construction. The building is open due to large doors and missing roof panels.

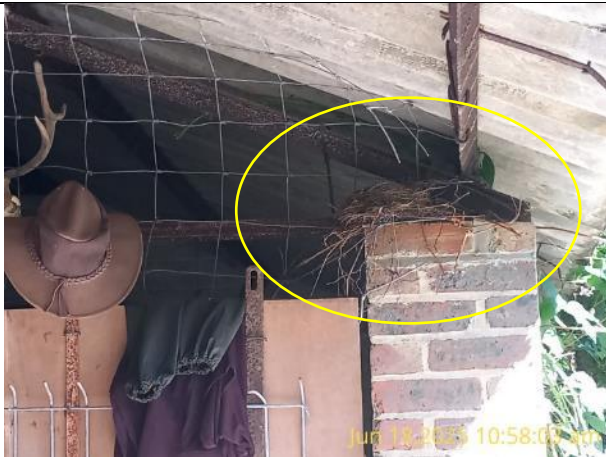
Figure 24: Birds nest within the interior of B3a.

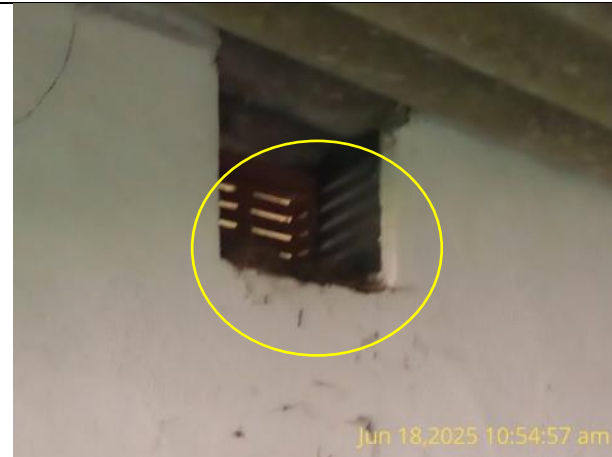
Figure 25: Birds nest within the interior of B4.
