ANCILLARY BUILDING TO THE REAR OF THE OLD BAKERY,  
65-65A HIGH STREET,  
LINDFIELD, WEST SUSSEX, RH16 2HN

## HERITAGE STATEMENT & IMPACT ASSESSMENT

January 2025  
Report No. 2025621

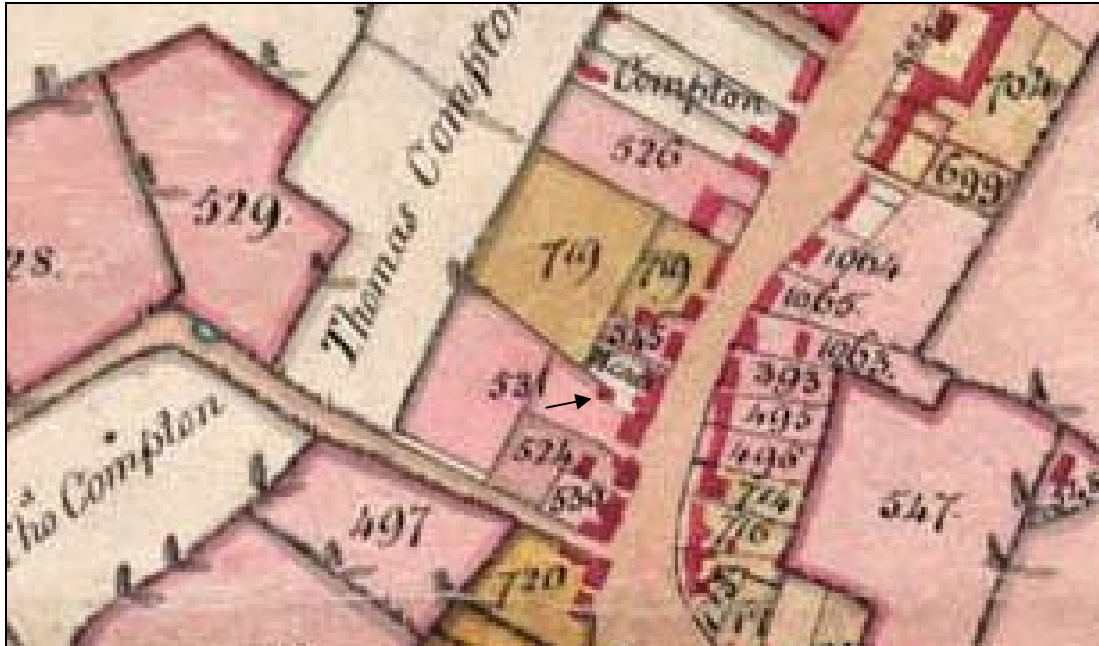
Plate 1: Extract of William Figg's draft for his map of the manor of South Malling Lindfield, 1824. The arrow indicates the location of the current ancillary building within the yard marked Meads

- 4.2.1 The clearest cartographic description of the building is also the earliest – William Figg's draft for his map of the manor of South Malling Lindfield, datable to 1824 (Plate 1).
- 4.2.2 The 1824 map shows a long, relatively narrow building with a cross-wing at the north end of the house, a projecting rear range (or possibly the rear part of a second cross-wing) towards the southern end and an outbuilding on the southern boundary of a small curtilage (Plate 1).

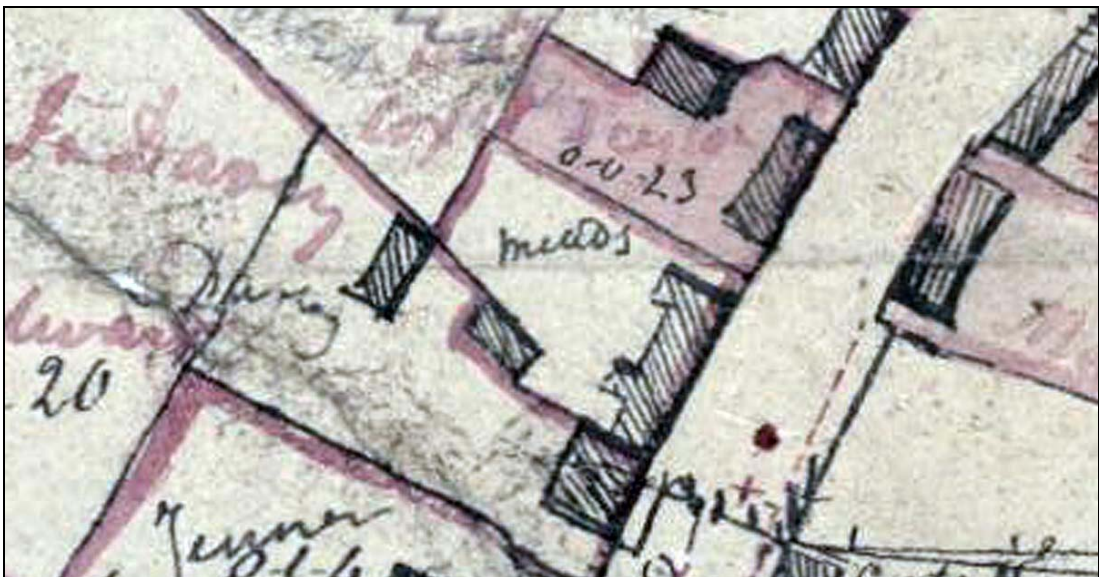
Plate 2: Extract of the 1845 edition tithe map showing the property in greater detail including the ancillary range that occupies a dog-leg on the south boundary of the curtilage

- 4.2.3 The features identified on the early map were depicted unchanged on the tithe map of 1845 (Plate 2). It is worth noting that the tithe map was intended as a resource for calculating the size of a holding for taxation purposes, as such, whilst buildings are represented on the maps they are not always a true and accurate depiction of the structures present on site at the date the survey was undertaken. The first edition Ordnance Survey map of 1874 shows the property in greater detail (Plate 3).

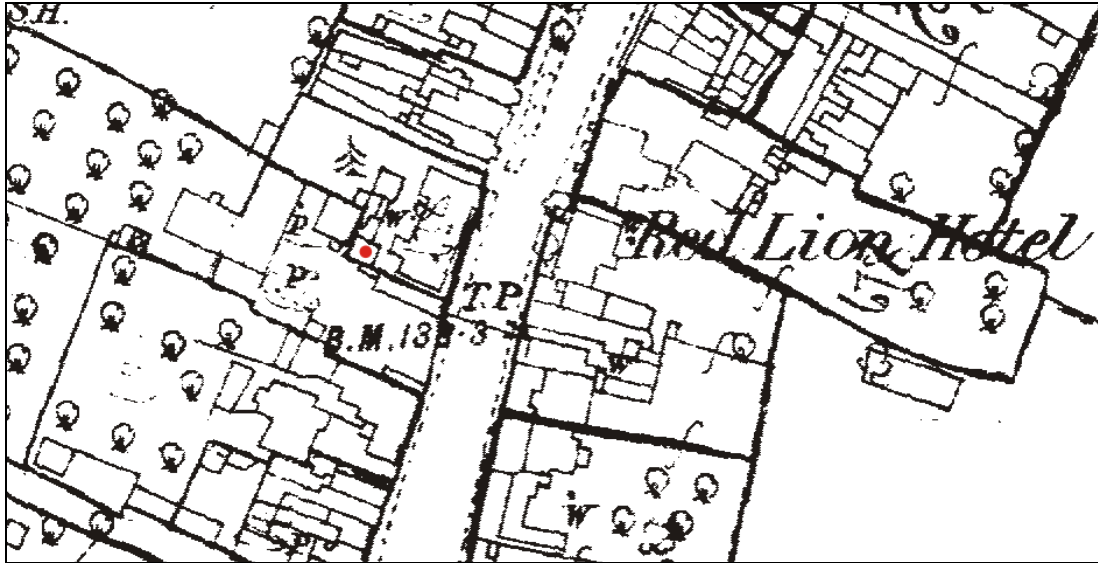
Plate 3: Extract of the 1874 first edition Ordnance Survey map showing the property with a series of ancillary buildings within the curtilage including the surviving building proposed for alteration

- 4.2.4 A series of ancillary buildings and yards or enclosures are shown to the rear of the main building, the southwestern rectangular-plan building occupies the same site as the current ancillary range.

- 4.2.5 No external changes are shown to the group of ancillary buildings and yards to the rear of the main range, the only extant alteration was the addition of a new long linear range in the northwest corner of the property (compare Plates 3 and 4).

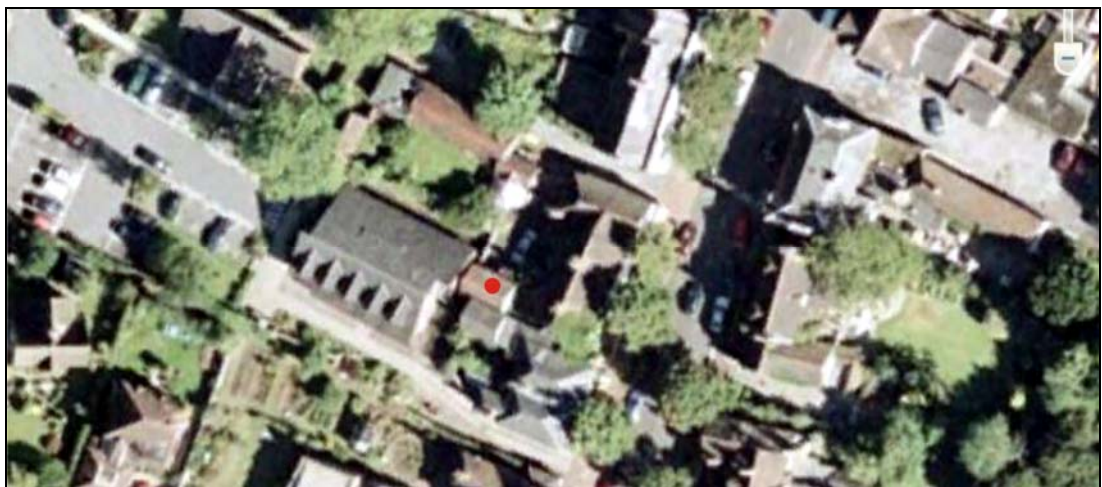
Plate 9: The property and its environs by 2001 (Google Earth Image)

- 4.2.11 Google Earth images show that the property remained to much the same external layout by 2001. The main changes comprise the addition of new buildings to the southwest corner of the group in the neighbouring building plots, in addition to new buildings along the north boundary terminating in very close proximity to the west side of the surviving ancillary range (compare Plates 8 and 9).

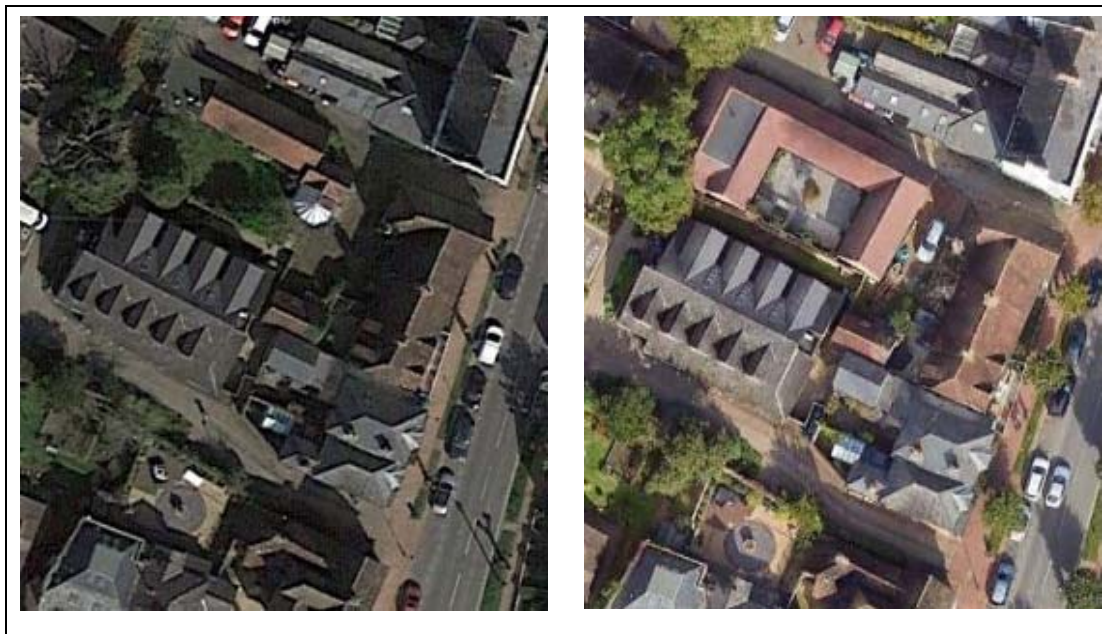
Plate 10: A comparison of the property in March 2022 and September 2023, the northern ancillary ranges had been removed and replaced with a large inverted U-plan commercial group

- 4.2.12 Between 2022 and 2023 the two northern ancillary ranges had been removed and replaced by a large purpose-built commercial building accessed at its eastern end from the courtyard to the rear of the Old Bakery (Plate 10).

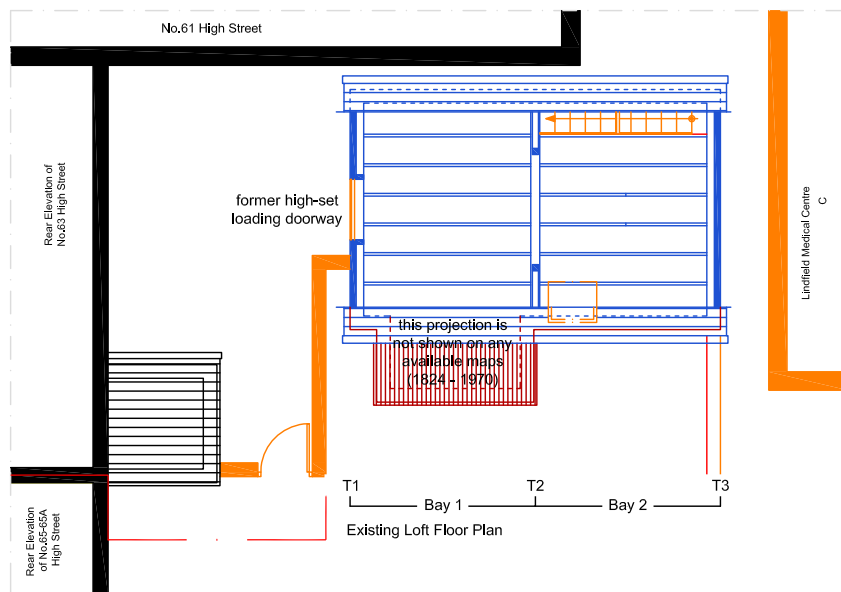
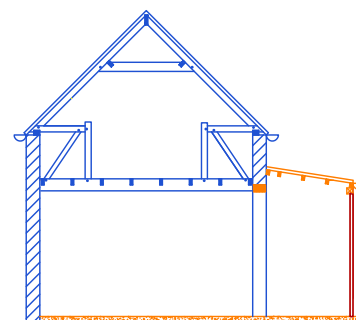
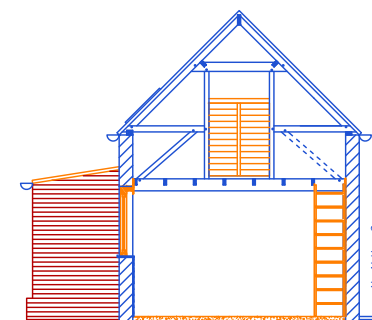
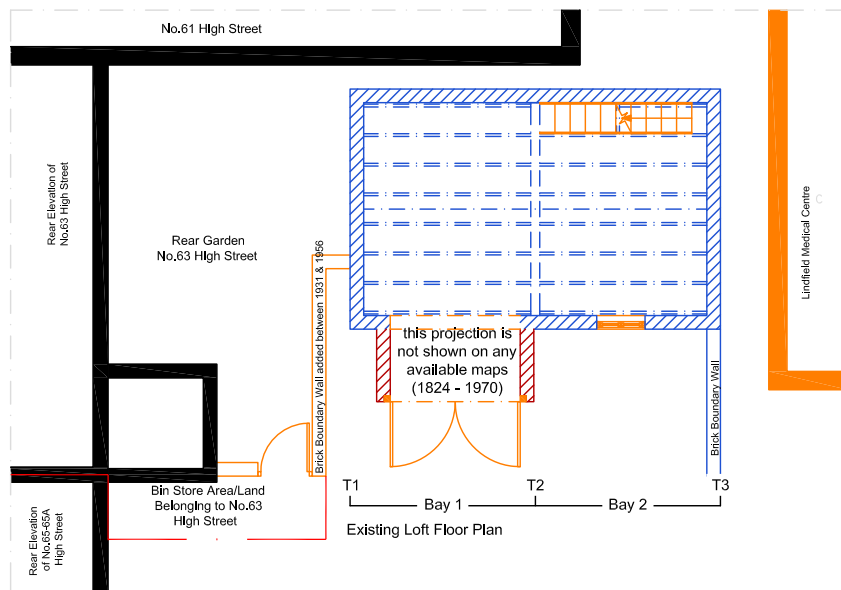
Figure 2:        Phased plans and sections of the ancillary building based on the originals prepared by  
LYL Architectural Designs Ltd

T2 Truss

T1 Truss

- Phase 1: Early 19th century, by 1824
- Phase 2: 20th C alterations
- Uncertain - added after 1970?
- Evidenced
- ..... Conjectural
- Overhead

- 5.1.2 The building includes a short projection on its northern side (Figure 2): that measures 2.60 metres east – west by 1.20 metres north – south and appears to be integral to the fabric of the main part of the range. The historic maps show no projections for this building from 1824 to 1970. The brickwork of the two parts of the range does seem to be bonded together and is certainly of a fabric and type that is consistent with the main body of the building. If the fabric does not represent the remains of an enclosure, then it is possible that it was added to extend the width of the building to accommodate a modern car using salvaged historic bricks and integrated particularly well with the earlier range.

- 5.1.3 The interior layout of the building now comprises a single large room surmounted by the floor of the former loft. The open-plan layout may be the original, with any partitioning required added as a second-fit to form stalls or loose-boxes after the outer envelope was constructed. No clear evidence for former stall partitions was observed.
- 5.1.4 The loft was similarly open across the entire length of the building with a central truss (T2) specifically designed to facilitate through access (Figure 2).

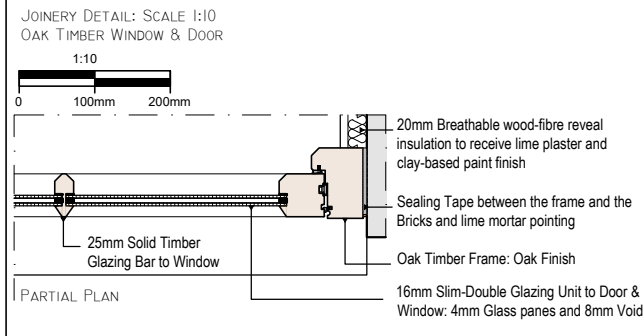
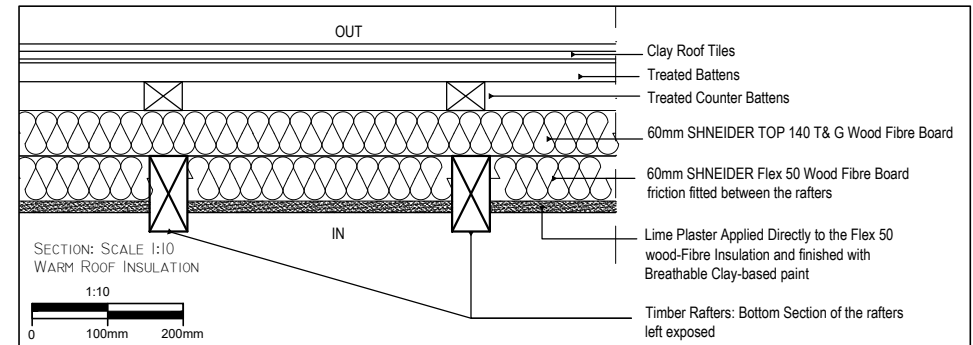
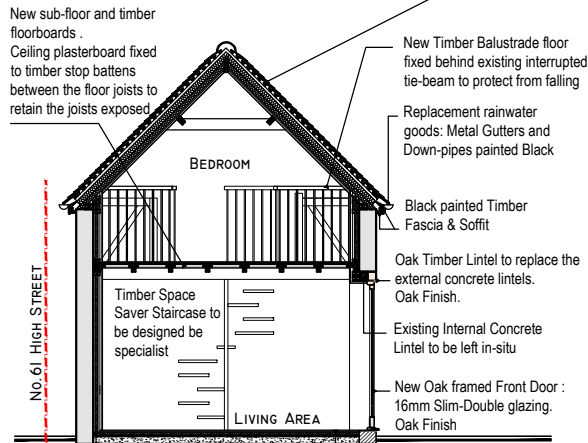
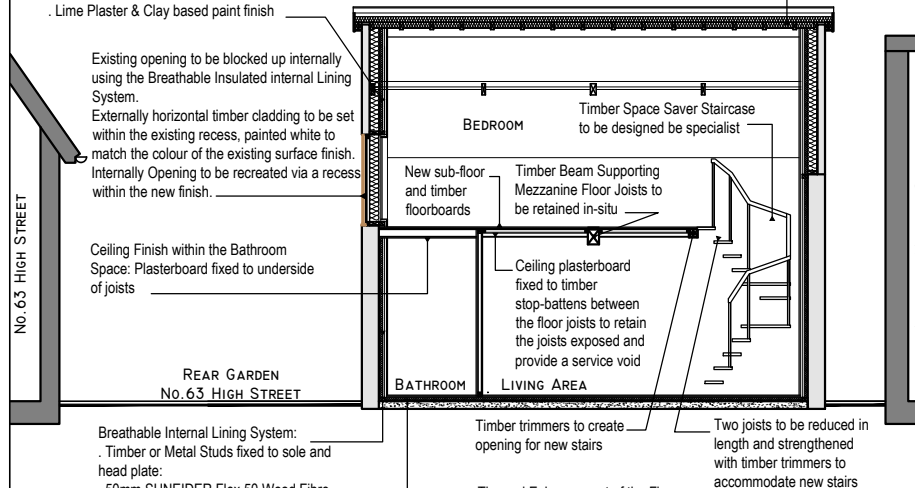
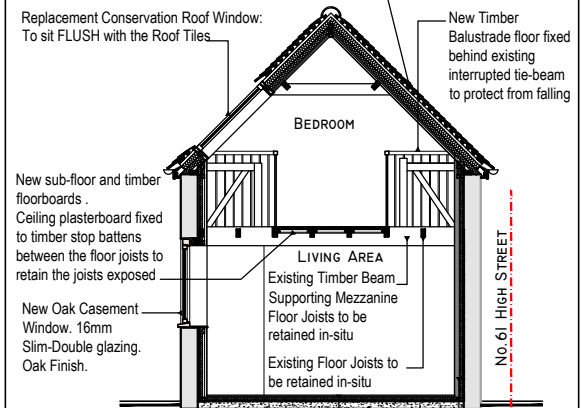
Re-roofing using Clay Roof Tiles and allowing for the thermal enhancement of the roof fabric.  
Breathable Insulation fitted between and above the rafters.  
. 60mm SHNEIDER TOP 140 T & G Wood Fibre Board  
. 60mm SHNEIDER Flex 50 Wood Fibre Board friction fitted between the rafters to receive lime plaster and breathable finish, leaving part of the rafters exposed internally.  
Black painted Timber Fascia, Soffit and Barge Boards

Breathable Internal Lining System:  
. Timber or Metal Studs fixed to sole and head plate:  
. 50mm SHNEIDER Flex 50 friction fitted between the stud,  
. 25mm Wood Wool Board fixed to stud,  
. Lime Plaster & Clay based paint finish

Thermal Enhancement of the Floor Structure: Insulated Floating Floor with Polished concrete floor finish.

Breathable Internal Lining System:  
. Timber or Metal Studs fixed to sole and head plate:  
. 125mm + 50mm SHNEIDER Flex 50 friction fitted between the stud,  
. 25mm Wood Wool Board fixed to stud,  
. Lime Plaster & Clay based paint finish

Breathable Internal Lining System:  
. Timber or Metal Studs fixed to sole and head plate:  
. 50mm SHNEIDER Flex 50 Wood Fibre Board friction fitted between the stud,  
. 25mm Wood Wool Board fixed to stud,  
. Lime Plaster & Clay based paint finish

8.2.9 The internal lining system is a vapour-permeable one, intended to improve conditions within the building whilst also safeguarding the future of the fabric of the building itself. It is acknowledged that the brickwork will no longer be exposed; however, the details extant on the interior of the building had already been substantially concealed behind plaster and paint. The internal lining system has the advantage over a plaster or painted finish in that it is fully and easily reversed without harm to the historic fabric, preventing the loss of any features that are extant within the brickwork.

- 8.3.6 The insulation to the roof has been revised in line with recommendations made by Mid Sussex District Council to allow the rafters to remain exposed. The rafters and indeed the roof as a whole are near intact and a particular feature of this building. The revision to introduce vapour-permeable insulation between and above the rafters, leaving the rafters exposed is a particularly welcome one that will ensure the roof continues to contribute to the special character and significance of the building.
