## Preliminary Ecological Appraisal and Roost Assessment

75 Station Road, Burgess Hill, West Sussex RH15 9DY

Burgess Hill Dental Practice – Dickon Adams

Demolition of garage, construction of 2 storey rear extension and 1 storey side extension

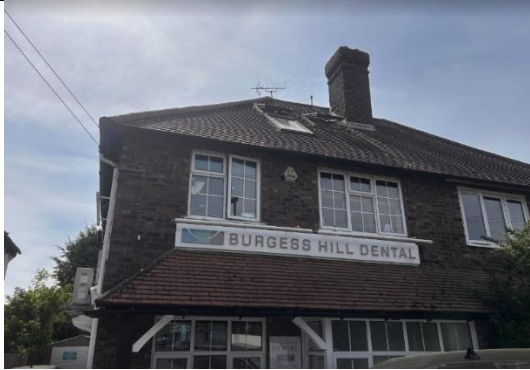
| B1 Building description | | | Photographs |
|---|---|---|---|
| <p><i>Summary</i></p> <p>B1 is a dental practice with a loft that has mostly been converted into usable space, with vaulted ceilings. One portion of the loft remain a separate void, however, this was no accessible. This was not considered to be a significant limitation, as the <b>development will not impact the roof of this building</b>. Nevertheless, the building was assessed to provide context of the site and the development.</p> <p>The roof is clay tiled and walls are rendered with pebbledash. The structure presenting suitable bat roosting and access features under the eaves. The building has <b>low habitat value</b>.</p> | | | |

| <i>Recommendations</i> | <p><b>Roosting habitat [Buildings]</b></p> <p><b>One bat emergence survey</b> is required on <b>B1</b> during the active bat season (May – September) to confirm presence/likely-absence of bats roosting in or on the building. This survey visit should be completed during the optimal survey period mid-May to August inclusive. The survey visits should be at least three weeks apart. Sub-optimal timings (early May and September) would require greater justification of timing e.g., weather conditions, known local bat activity.</p> <p><b>Two surveyors</b> are required to provide full coverage of the building's elevations to look for emerging/re-entering bats. An infrared camera should also be employed as part of the survey to see where any specific roost locations are located.</p> <p>If any bat roosts are confirmed from this survey schedule, a bat licence would be required to alter the buildings as it would involve the destruction/ disturbance of roosts. This is applied for with the help of a class 2 licensed bat ecologist after planning permission is granted, but before commencement of works.</p> <p>Lighting mitigation may be required based on the outcome of the night bat survey(s).</p> |

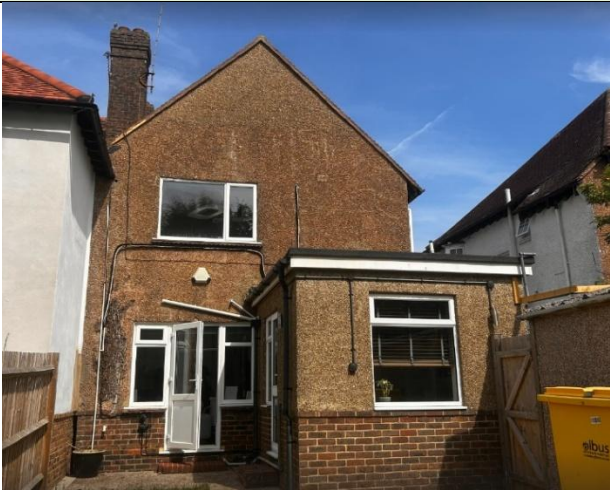
| B1 Building description | | | Photographs |
|---|---|---|---|
| Walls | Pebble dash | <p><b>Condition/description</b><br/>Rendered, in good condition.</p> <p><b>Suitability/access/evidence of bats</b><br/>None</p> | |

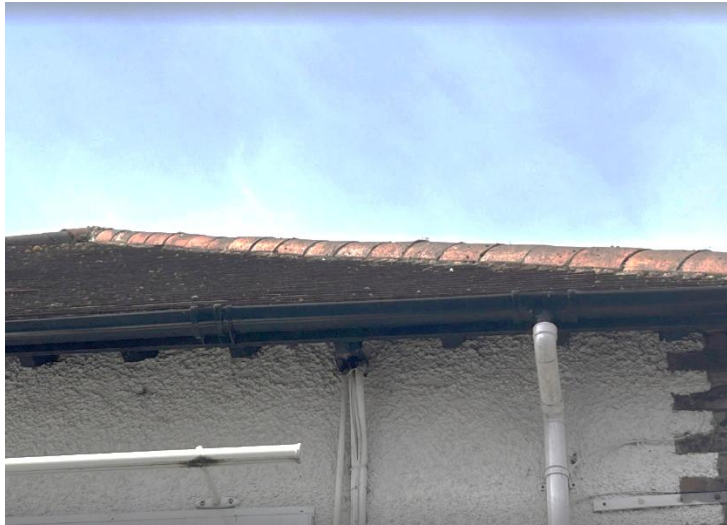
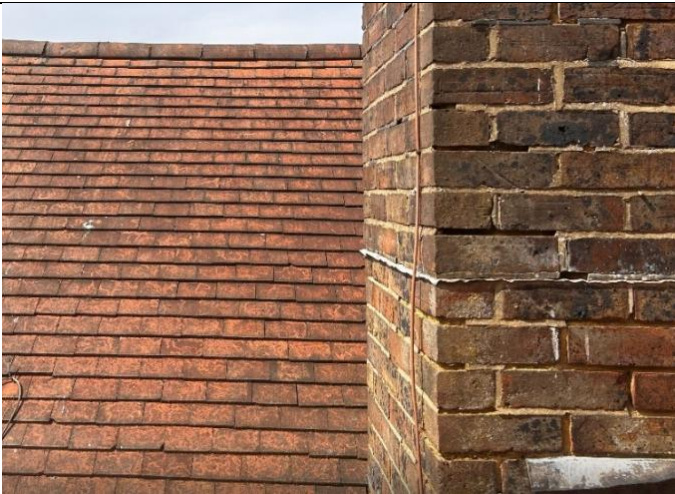
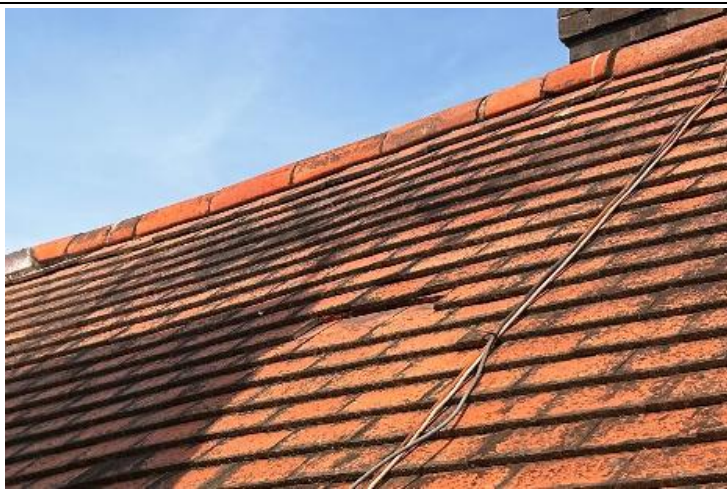
| Roof | Clay | <p><b>Condition/description</b></p> <p>Hipped, clay tiled roof with a gable on the southern elevation. Tiles lie flat and the ridge tiles are intact. One broken tile was observed on the southern elevation, however this breakage did not appear to create any gapping.</p> <p>Mortar on the chimney is in poor condition, however the crevices created were superficial and did not appear to lead to deeper holes that would be considered suitable for roosting.</p> <p>Mortar on the southern gable verge is in good condition, with no cracks or crevices noted.</p> <p><b>Suitability/access/evidence of bats</b></p> <p>None.</p> | |

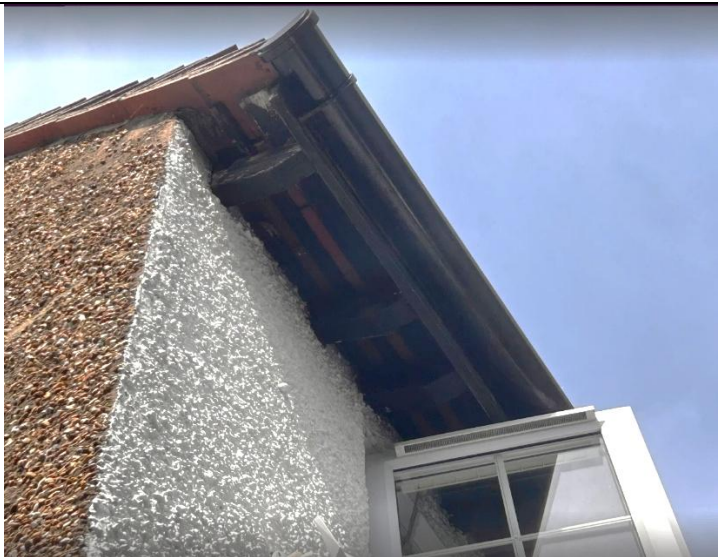
| Eaves | Overhanging | <p><b>Condition/description</b></p> <p>No soffit boxes, tiles underneath exposed. Visibility was impaired by bright backlighting, but a sparrow nest was present under the eaves during the survey. Implying that there are crevices available within the eaves.</p> <p><b>Suitability/access/evidence of bats</b></p> <p>Provides possible bat roosting for individual or a small group of crevices dwelling species. No evidence found but recent and current rain would wash this away externally.</p> | |

| <i>Summary of Survey Findings</i> | <p><b>Buildings</b><br/>An active house sparrow nest was identified with the eaves of B1. This building is considered suitable for nesting for species such as this, as well as other birds that may roost with eaves, such as swallows. No evidence of nesting birds was identified within B2, however gaps under the corrugated roof material provide possible access to smaller species such as robins, that may use the internal space to nest.</p> <p><b>Trees and vegetation</b><br/>No bird nests were identified within the hedgerow, bramble scrub and trees on-site, however, a fledging robin was noted within the bramble scrub, therefore a nest is likely present within that area, highlighting the gardens potential for nesting birds.</p> <p><b>Barn owls</b><br/>The site does not appear to provide any suitable nesting sites for barn owls.</p> <p><b>Overwintering birds</b><br/>Due to the small size of the site and the extent and type of the habitats recorded, the site not considered suitable to support a significant assemblage of protected and/or notable birds.</p> |

| <i>Recommendations</i> | <p><b>Buildings/trees</b><br/>Any building removal should be undertaken outside the period 1st March to 31st August. If this timeframe cannot be avoided, a close inspection of the vegetation should be undertaken immediately, by a qualified ecologist, prior to the commencement of work. All active nests will need to be retained until the young have fledged.<br/>Precautions should be taken with machinery and noise levels when working close to any retained nests so as not to disturb any nearby nesting birds during construction works. At least a 3-5m buffer should be created between any machinery and active nests until the young have fledged.</p> <p><b>Barn owls</b><br/>None required.</p> <p><b>Overwintering birds</b><br/>None required.</p> <p><b>Suggested biodiversity enhancements</b><br/>The installation of a minimum of two bird boxes within the fabric of the new building or on the retained trees will provide additional nesting habitat for birds e.g.<br/>Schwegler No 17 Swift Nest Box (buildings)<br/>Schwegler 1SP Sparrow Terrace (buildings)<br/>Schwegler 1B Nest Boxes (trees)<br/>Schwegler 2H Robin Boxes (trees)<br/>Woodstone Nest Box (buildings or trees)<br/>Or a similar alternative brand.</p> <p>Tree boxes should be positioned approximately 3m above ground level where they will be sheltered from prevailing wind, rain and strong sunlight. Small-hole boxes are best placed approximately 1-3m above ground on an area of the tree trunk where foliage will not obscure the entrance hole.</p> |

| | Swift and sparrow boxes should be positioned at the eaves of a building and can be incorporated into the fabric of the building during construction. |

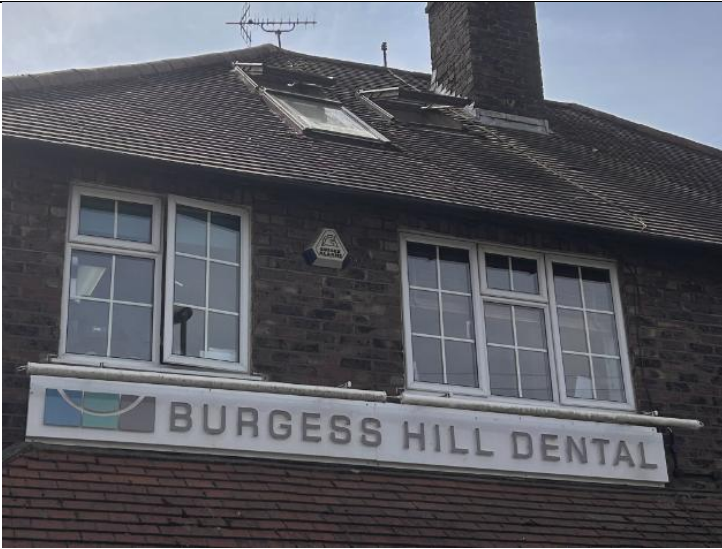
| Window/doors frames and lintels | Timber | <p><b>Condition/description</b></p> <p>Tight fitting</p> <p><b>Suitability/access/evidence of bats</b></p> <p>None</p> | |

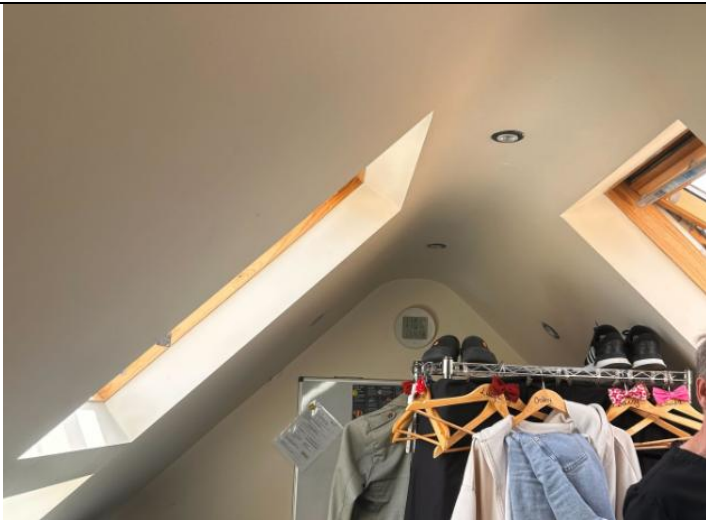
| Internal voids | Vaulted ceilings | <p><b>Condition/description</b><br/>N/A</p> <p><b>Suitability/access/evidence of bats</b><br/>None</p> | |

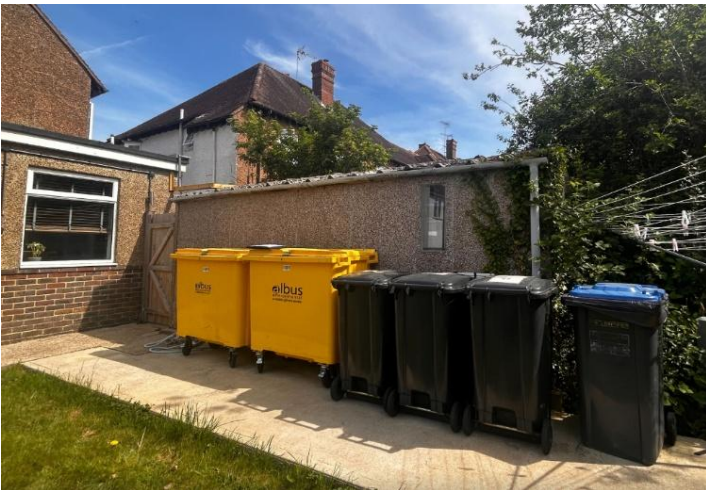
| <p><i>Summary</i></p> <p>B2 is a rendered garage with an asbestos sheet roof. There is a high level of clutter and light ingress within the building, making it suboptimal for crevice and void dwelling species. Gaps present at the periphery of the roof are considered unsuitable as the crevices they create are subject to this light ingress and are low enough that the constant usage of the building would like to disturb any roosting bats.</p> <p>B2 is <b>negligible value</b> for roosting bats.</p> | | | |

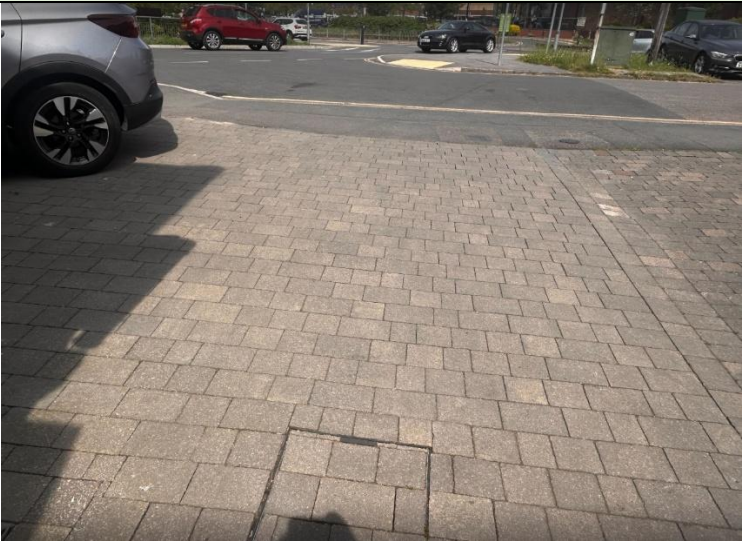
| Sealed surface | |
|---|---|
| | Figure 1: Driveway |

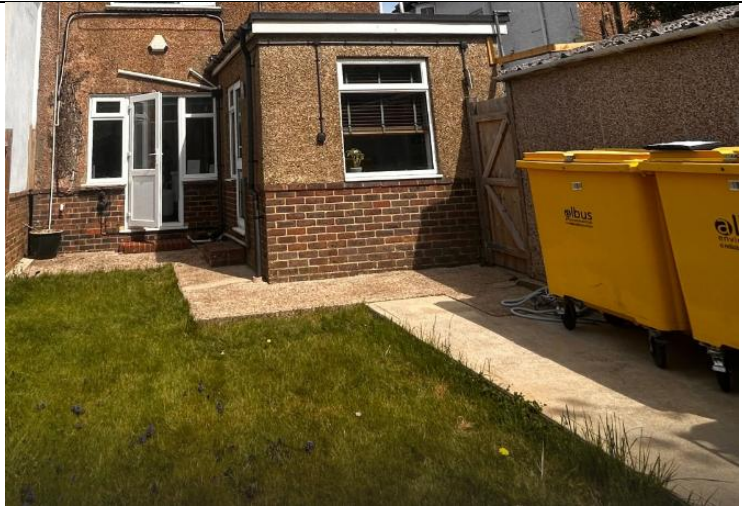
| Sealed surface | |
|---|---|
| | Figure 2: Hardstanding within garden area. |

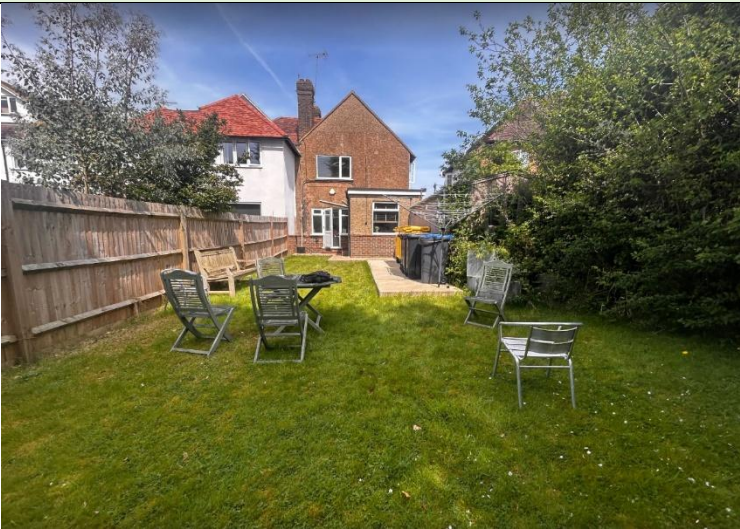
| Modified grassland | |
|---|---|
| | Figure 3: Amenity grass lawn on site (to rear of B1) |

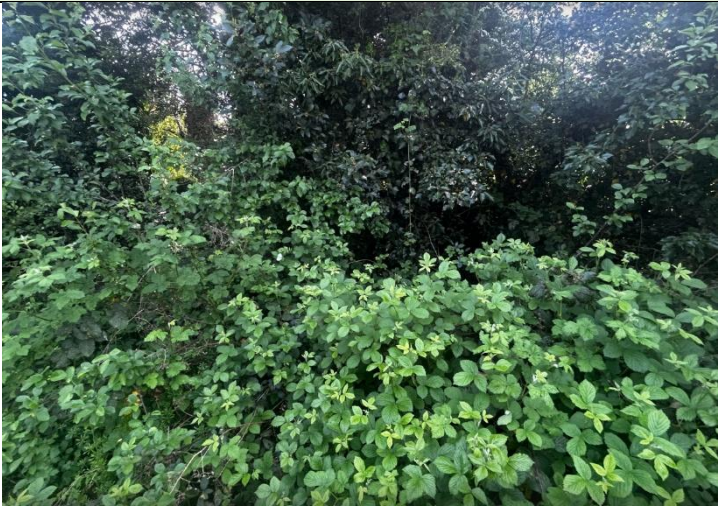
| Modified grassland | |
|---|---|
| | Figure 4: Southern boundary dominated by bramble |

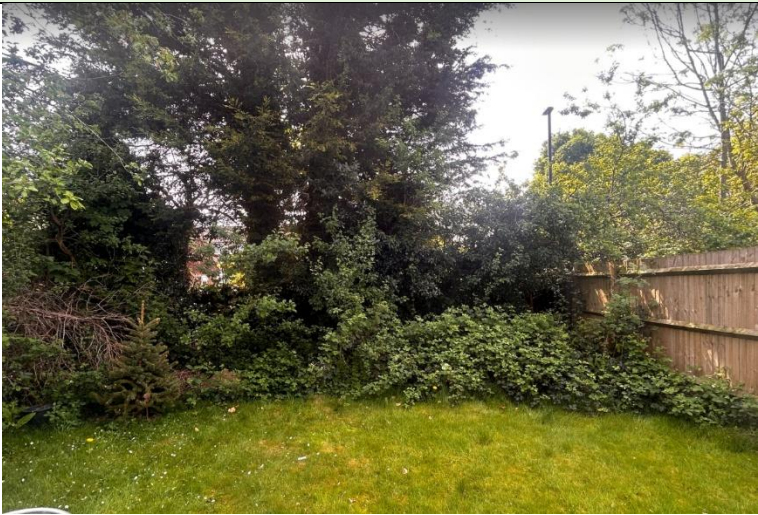
| | <p>Three trees are located in the southernmost portion of the garden. T01 and T02 are both mature Leyland cypress (<i>Cupressus x leylandii</i>) trees, and T03 is a cultivated plum. No ecological niches appropriate for bats were noted on any of the trees.</p>

| Scattered trees | |
|---|---|
| | Figure 5: Scattered trees present on site (along southern site boundary) |

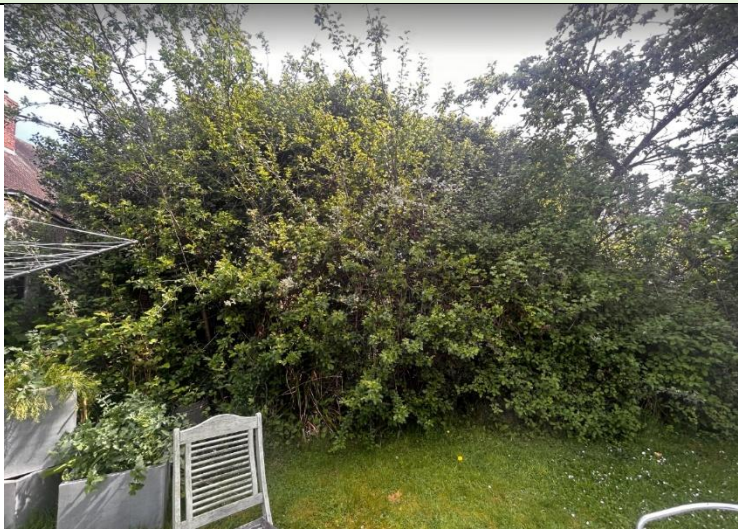
| | Habitats on site are assessed to provide commuting, and nest building opportunities for dormice in the form of ornamental hedgerow. However, the value of this hedgerow is limited and the site is enclosed by urban infrastructure including roads and significant residential development. These landscape features fragment suitable dormice habitat in the wider landscape and are likely to limit dispersal opportunities to the site. |

| Scattered trees | |
|---|---|
| | Figure 6: Mixed ornamental; hedgerow along eastern site boundary |
