## Bat Scoping Report

Stonehurst – North Lodge

31st March 2025

**Project No: 10344**

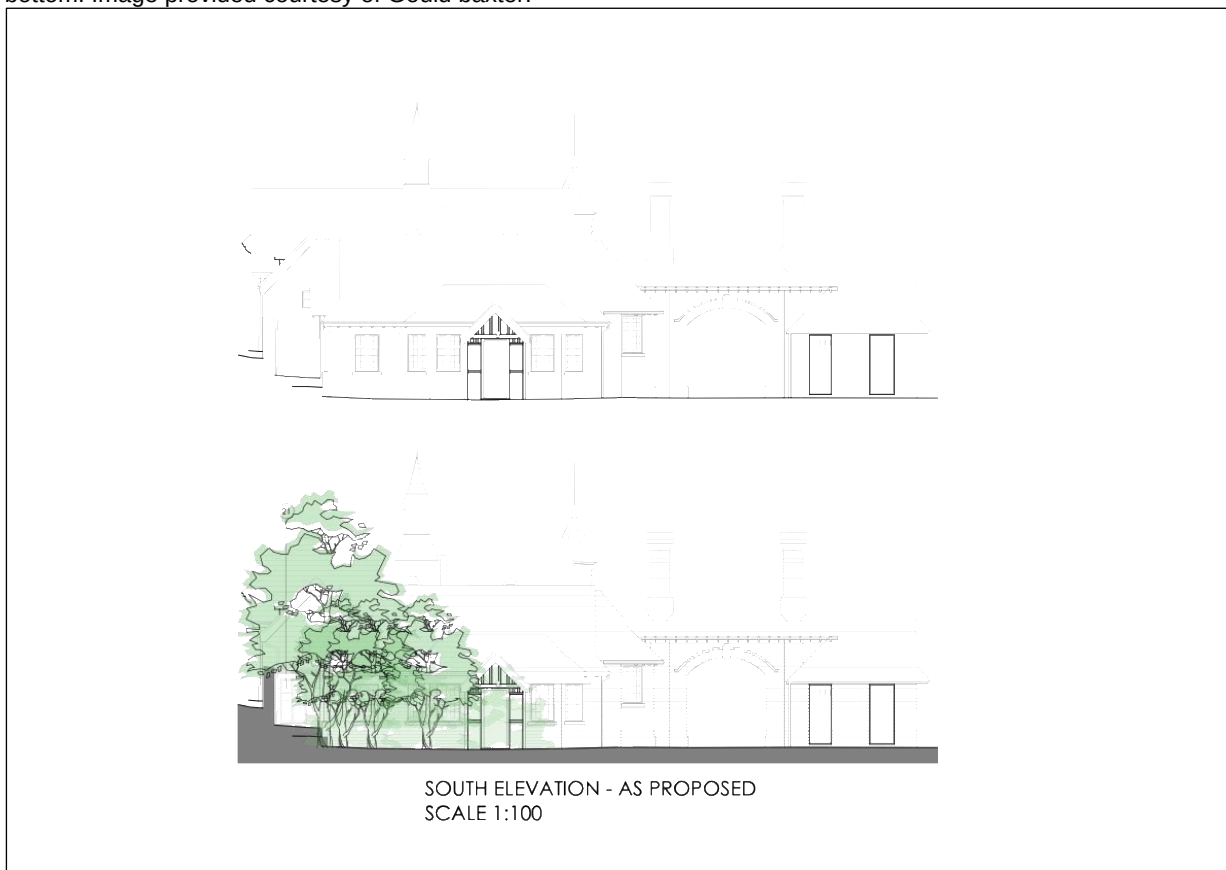
**Figure 5.** View of the southern elevation with the existing layout illustrated in the top layout and the proposed to the bottom. Image provided courtesy of Gould baxter.

The proposed development/project comprises the redevelopment of the existing property to serve additional residential units through the conversion of loft spaces and garage plots whilst also seeking to amend aspects of the property such as skylights and additional windows in line with the buildings original concept (see Figure 4, Figure 5, Figure 6 and Figure 7).

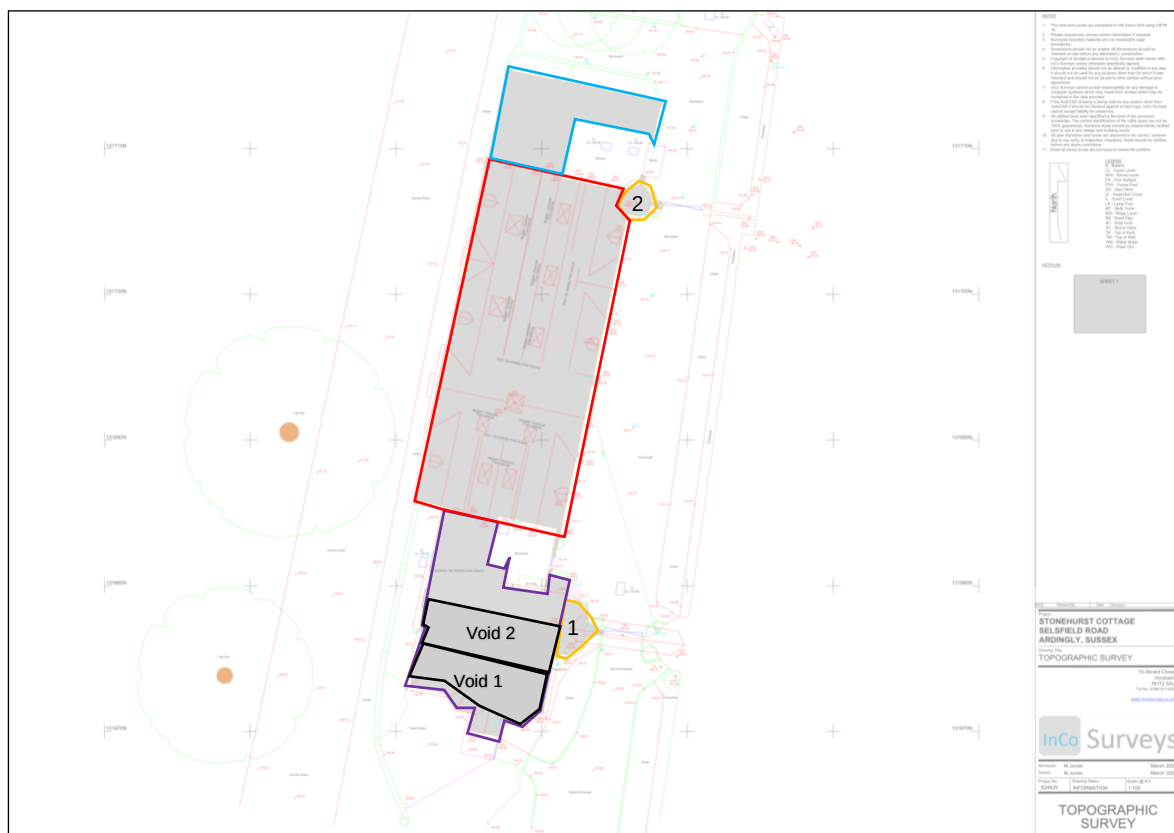
The building is comprised of a single storey residential unit located to the southern aspect of the property with a tower connecting to archway and corresponding tower (the archway and second tower are out of scope of the proposed development). The building then connects further north to a number of garage plots (approximately five entrances existing), the building then extends further north towards a store room. All aspects of the property are considered to be single storey with no cellar or second floors noted to any areas accessed. For the purposes of the bat scoping assessment the property has been divided and named as; the cottage, garages 1 to,5, store room, tower 1 and tower 2 (as per Figure 10 below).

**Figure 10.** View of approximate property divisions and void locations (purple boundary = the cottage, red boundary = the garages, yellow boundary's = the towers, blue boundary = the store).

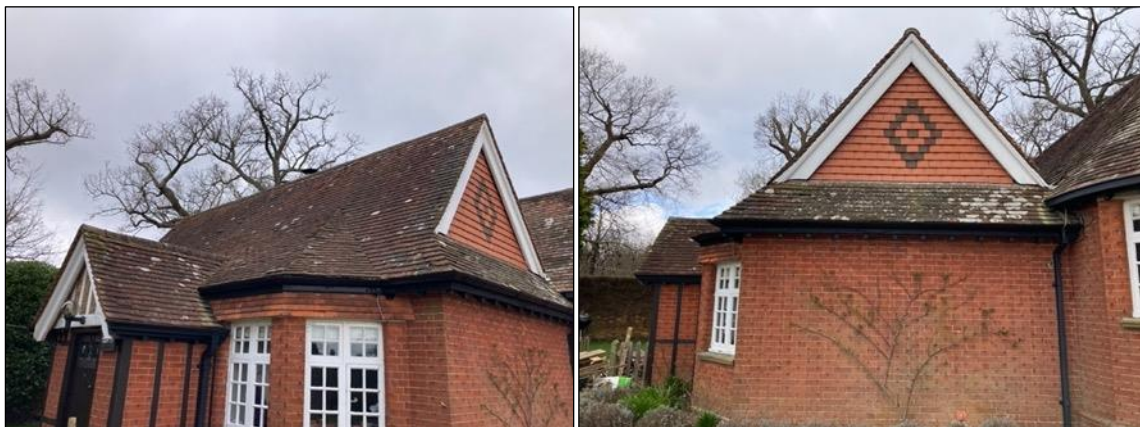
**Photographs 1a (left) and 1b (right).** 1a) View of the cottage from the south-eastern aspect of the site with view of the hanging tiles and roof tiles. 1b) View of the cottage from the eastern aspect of the site with view of the hanging tiles that form the eastern aspect of void 1. Tower 1 is visible from the far right of the image.

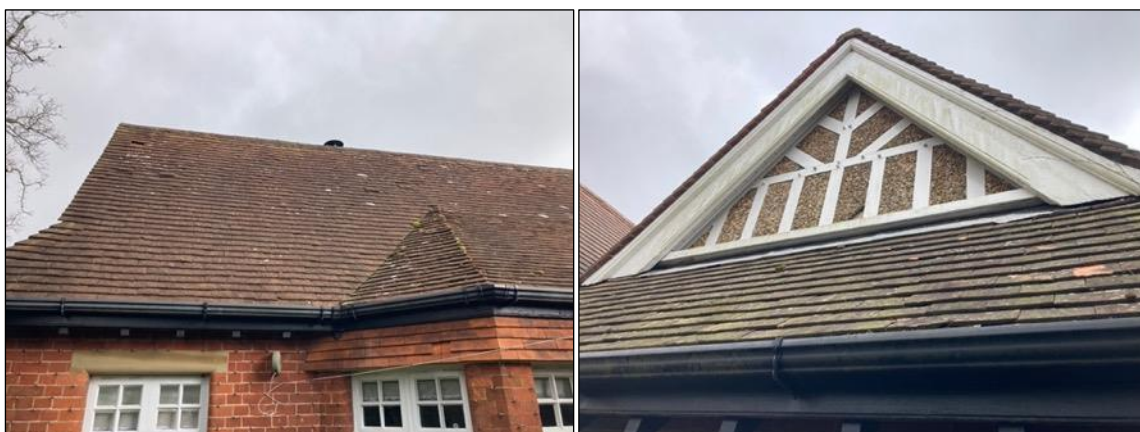
**Photographs 2a (left) and 2b (right).** 2a) View of the cottage from the southern aspect of the site with view of the front door entrance visible in photograph 1a shown in the bottom right of the image. 2b) View of the western aspect of the cottages southern roof pitch.

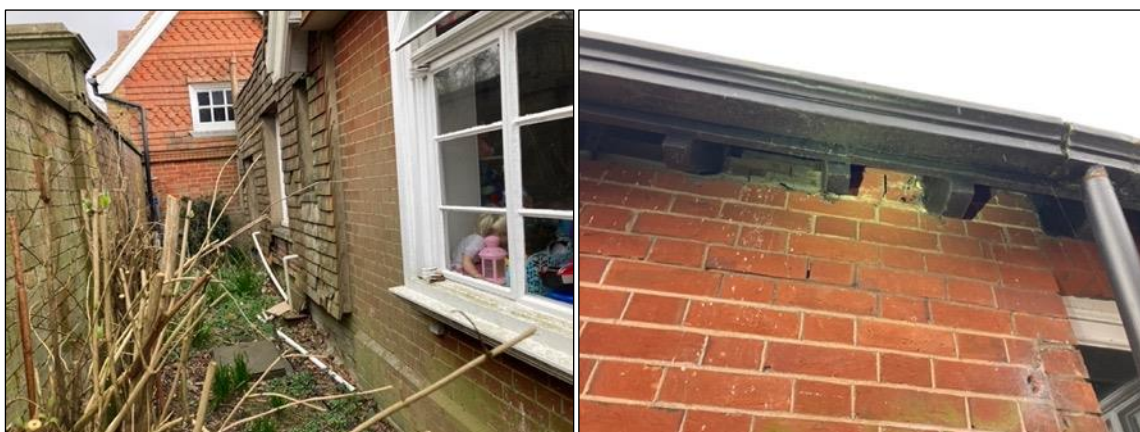
**Photographs 3a (left) and 3b (right).** 3a) View of the western aspect of the cottage with view of the close proximity of the building and the adjacent boundary wall. View of the garage aspect is noted to the top of the image. 3b) View of the gaps noted to gables on the western aspect of the cottage.

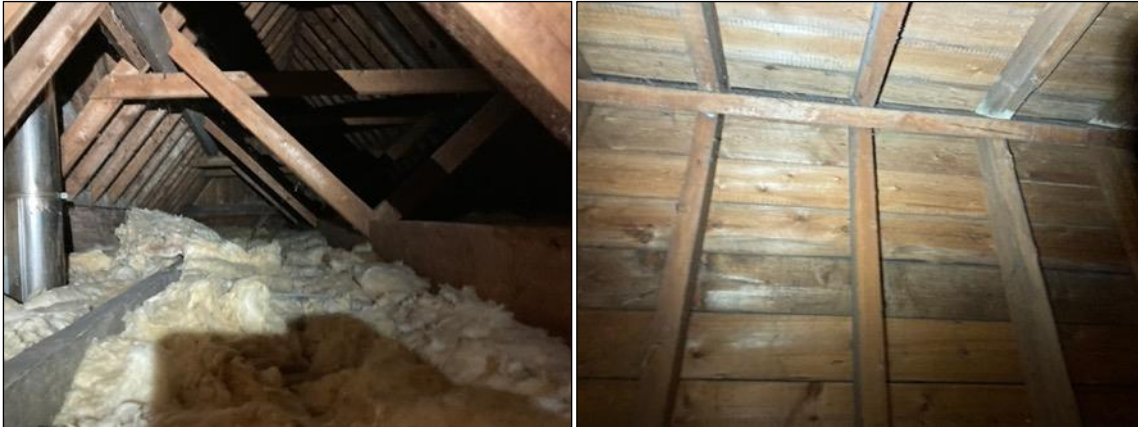
| Building section | Description of features | Assessment of suitability <sup>1</sup> |
|---|---|---|
| | <p>The void was narrow measuring approximately 2.2m wide, 8m long and 2m tall, with collar ties noted at approximately 1.3m height. There was limited light noted in this void with no roof lining noted and well-kept wooden boards forming the interior of the roof, limited access/egress was noted to this area.</p> <p>A small number of bat droppings (approximately 20) were identified within void 1, these droppings were isolated around the collar ties to the centre of the void with a peak count of seven droppings on a single collar tie. These droppings morphologically resembled long eared bats. A large number of other mammal droppings were also noted throughout the void space.</p> <p>The floor space was comprised of old insulation foam.</p> <p><b><u>Void 2</u></b></p> <p>This void was located adjacent (just north) to void 1, the voids are connected via a central chimney feature though this has little gaps around making access between the two spaces difficult with no clear or obvious flight lines noted.</p> <p>The void measures the same length as void 1 (approximately 2.2m wide, 8m long and 2m tall) though further connects to the interior void space of tower 1 through a small (~45cm*60cm) opening at the base of the brick wall.</p> <p>The floor space was comprised of wooden boards overlaid upon insulation foam.</p> | |

**Photographs 4a (left) and 4b (right).** 4a) View of loft void 1 from the void entrance with the image taken at the base with of the collar ties noted to the centre of image. 4b) View of void 1's apex with view of the wooden board's tight seals and limited gaps which is consistent across the length of the void.

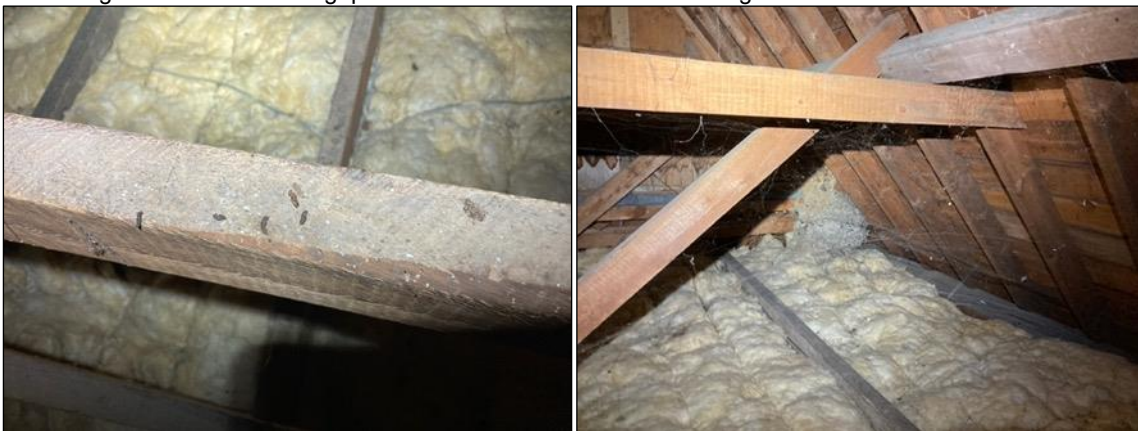
| <b>Key findings</b> | The building was assessed as having moderate suitability to support roosting bats, with bat droppings confirming a roost in void 1. Due to survey limitations resulting in areas of the proposal not being accessed or fully assessed this has been elevated to 'high' on a precautionary basis. It is worth noting that the current development proposals do not seek to damage or destroy all aspects of the site. Habitats within the zone of influence of the proposals were considered to be of potential value to bats for foraging/commuting/dispersal purposes. |

**Photographs 5a (left) and 5b (right).** 5a) View of bat droppings located along one of the collar ties within void 1. 5b) View of the collar tie within void 1 with a large disused wasps nest located to the far right of the image.

| <b>Further survey requirements</b> | <p>A minimum of three bat emergence/re-entry surveys are required to determine the importance of this building to bats as without further surveys the level of impact upon bats cannot be fully assessed.</p> <p>To ensure adequate coverage of all potential roost features, it is estimated that to cover the entirety of the main house building a minimum of seven observers will be required for each survey visit to observe all suitable roost features. To ensure that the survey effort conforms with interim guidance on the use of night vision aids, produced by the Bat Conservation Trust, a minimum of nine night vision cameras (NVA's) with infra-red lighting to support surveyors will be required.</p> <p>As proposed works may not impact the entirety of the dwelling and the segmented sections and aspects of the property it may be appropriate to reduce the surveyor and NVA requirements and focus upon specific areas to be impacted though this will be based upon more detailed information on proposed works in combination with a suitably qualified ecologists' best judgement.</p> |

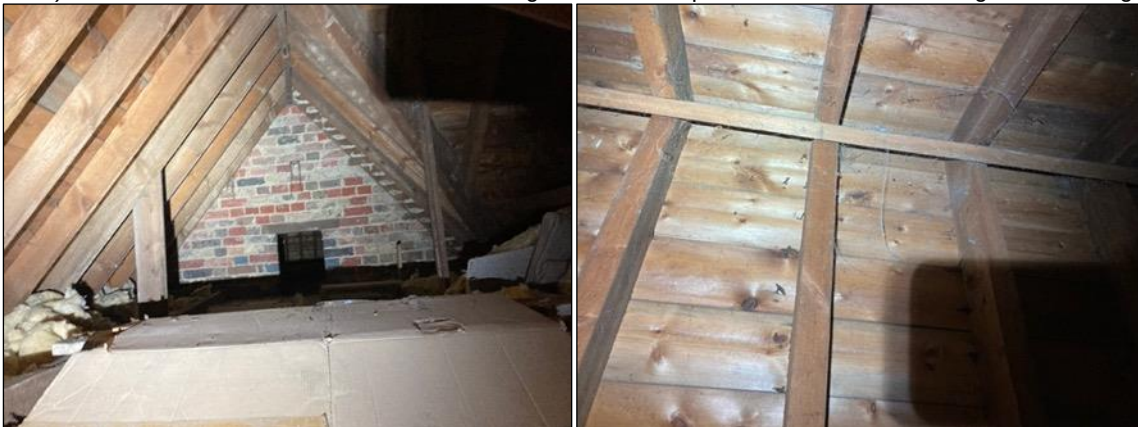
**Photographs 6a (left) and 6b (right).** 6a) View of the interior of void 2, facing east with view of the brick wall and the small opening into tower 1's void space. 6b) View of void 2's apex with view of the wooden board's tight seals and limited gaps which is consistent across the length of the void.

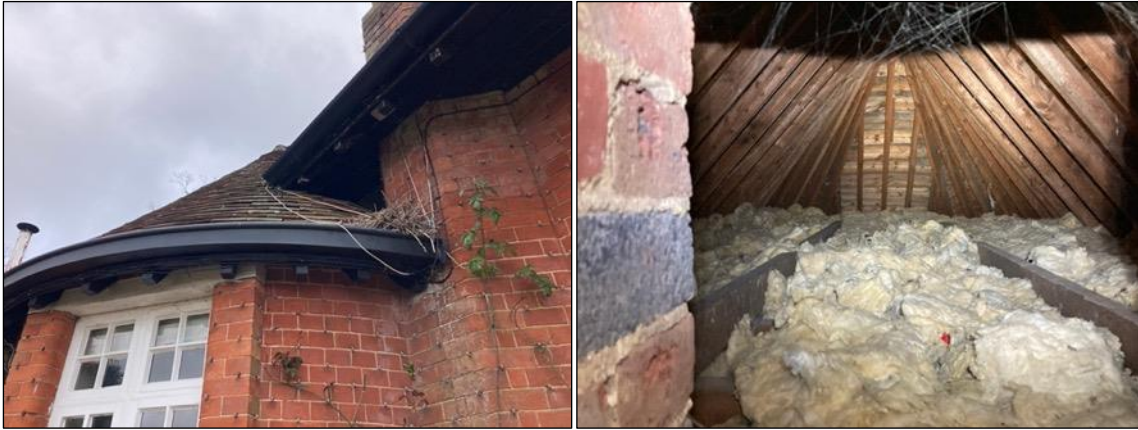
| Building section | Description of features | Assessment of suitability <sup>1</sup> |
|---|---|---|
| Tower 1<br>Exterior | A number of lifted tiles are noted across the tower block and a number of these features may have potential to support roosting bat species though no internal inspection was possible with only a small view of the interior space visible from the entrance of Void 2 within the cottage which indicated closed board wooden interior with no obvious access/egress points noted. A bird's nest was noted to the exterior of the tower. | low bat roost suitability. |

**Photographs 7a (left) and 7b (right).** 7a) View of the exterior of tower 1 as taken from the eastern aspect with view of lifted tiles noted to the center of the image and bird nesting material to bottom right of the towers roof. 7b) Interior view of the towers void as taken from the hole noted in void 2 (photograph 6a).

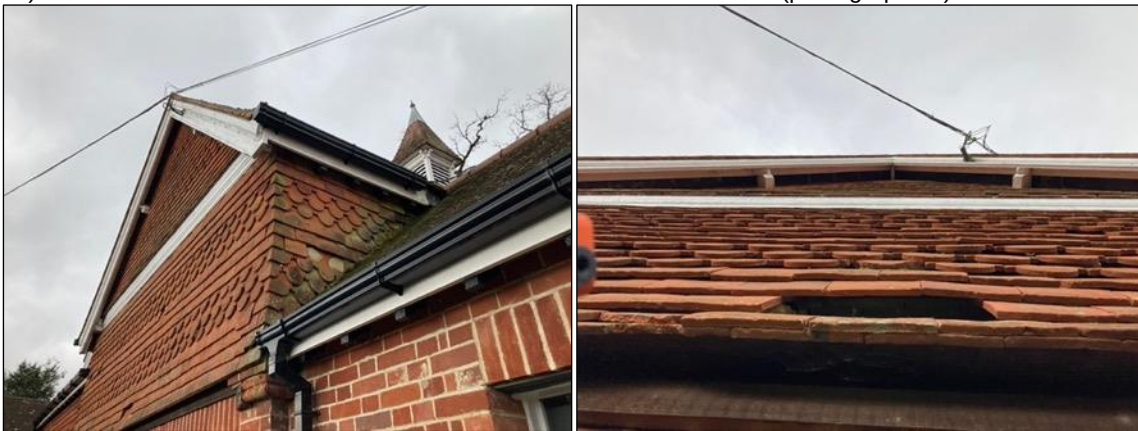
| Building section | Description of features | Assessment of suitability <sup>1</sup> |
|---|---|---|
| Garage block 1 to 5<br>Exterior | The garage block was noted to have several clay tiled pitched roofs running north to south making visibility of these pitches difficult. They also had several sections of hanging tile located to the eastern aspect. The visible roof areas and hanging tiles had a large number that were slipped or missing potentially forming suitable access/egress points for bats or acting as crevice roosts themselves. Only the eastern aspect of this block was able to be assessed. | Moderate bat roost suitability |

**Photographs 8a (left) and 8b (right).** 8a) exterior view of the garage block with the image taken from the eastern aspect, large sections of hanging tiles noted to this feature with view of missing/lifted tiles noted. 8b) view of the missing tiles taken from the base of the southernmost garage block with the missing tiles noted to the centre of the image visible in photograph 8a.

It is recommended that prior to additional survey effort, if possible, an aerial survey (such as drone) is undertaken to assess the sections of roof that were not able to be assessed such as the roof pitches beyond the easternmost pitch. In addition, a loft inspection of the garage void space using an enhanced length ladder to ensure surveyor safety. The above assessments are not considered essential at this stage but may however be able to further assess the building reducing the required scope of assessment.

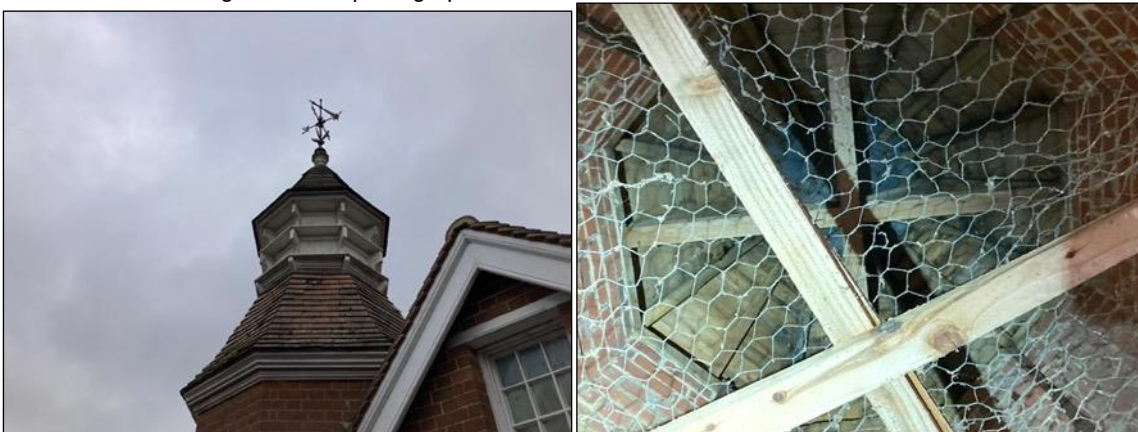
| Building section | Description of features | Assessment of suitability <sup>1</sup> |
|---|---|---|
| Tower 2<br>Exterior | The exterior of the tower was in good condition with limited slipped, missing or hanging tiles noted across the feature. | None |
| Tower 2 interior | The interior of this was accessible and the interior was formed of the same exterior tiles that were not lined, with no access or egress points noted from these features and the interior had been covered with a fire mesh net from ~2m height to prevent bird access. There were no features such as beams noted that could have potential to support roosting bats. | None |

**Photographs 9a(left) and 9b (right).** 9a) exterior view of tower 2 taken from the northern aspect with view of the well-kept tiles noted across the feature. 9b) interior view of the tower from the base with view of the well-kept boarded roof and the wire mesh to centre of the image.

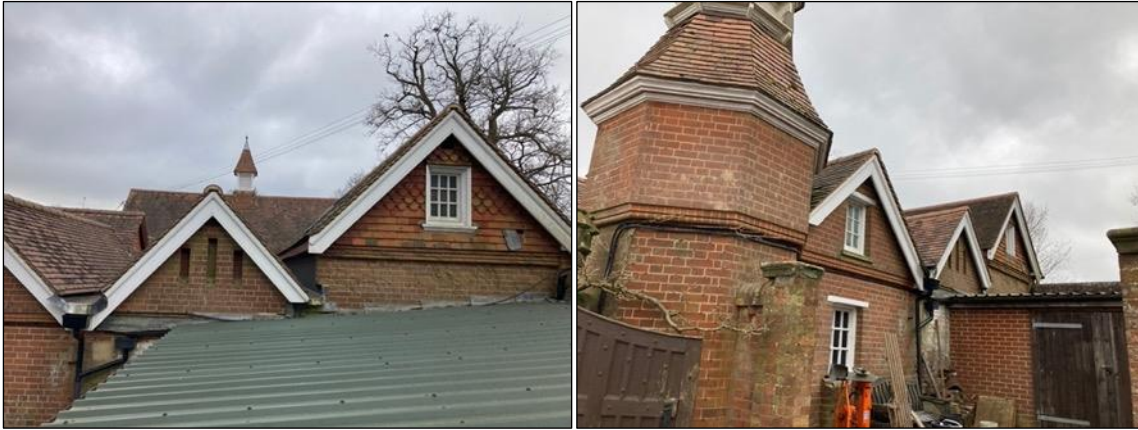
**Photographs 10a(left) and 10b (right).** 10a) View of the stores from the northern aspect with view of damaged hanging tiles to the right of the image and well-kept roof tiles across the image. 10b) view of the stores as taken from the eastern aspect of the site with a view of tower 2 located to the far right of the image.

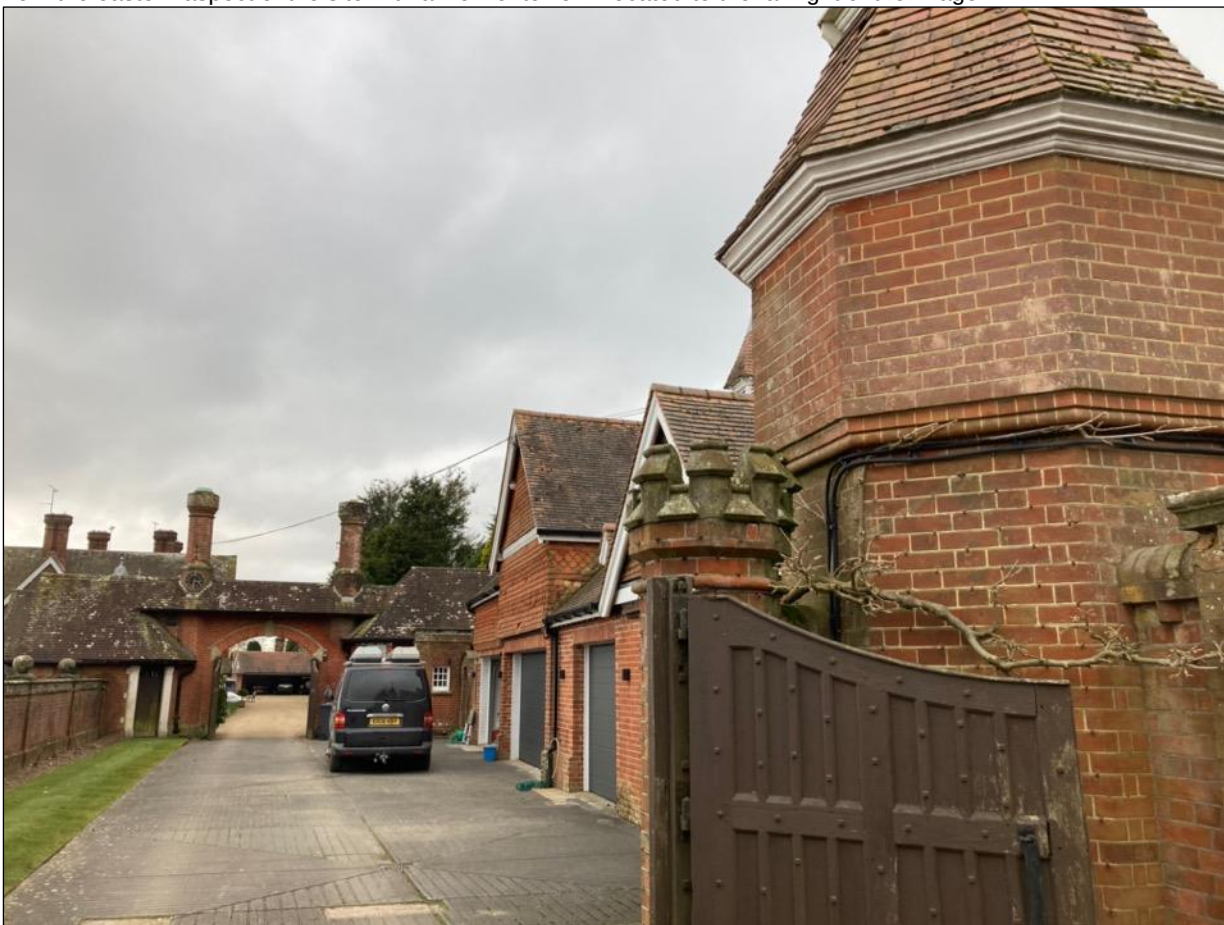
**Photograph 11.** View of the property from the northern aspect of the site facing south with view of the property to the right of the image.
