# Precautionary Working Method Statement to Safeguard Bats

The Granary - Gibbshaven Farm

| <i>Report Title</i> | Precautionary Working Method Statement to Safeguard Bats |
| <i>Report Reference</i> | Gibbshaven1/PWMS/24 |

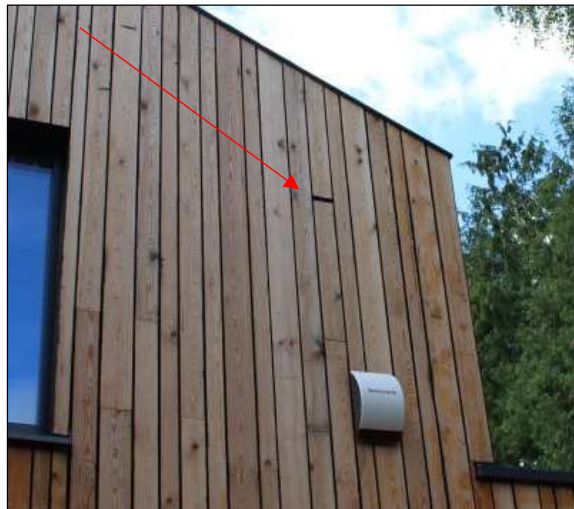
- 3.11. An example of how a building might look with permanent integrated bat box/tube fitted below timber cladding can be seen below;

- 3.10. Within the new development, integrated bat roost features offer the most preferable, suitable, permanent enhancement for roosting opportunities and are easy to integrate into the design of most buildings. These integrated features provide a more permanent integrated opportunity for an individual or small number of "crevice dweller" species that requires tight gaps to roost within. These can be selected to match the aesthetic of the building. The Integrated Eco Bat Box (see link below) is made from lightweight, long-lasting woodcrete and can be bolted to supporting timbers or brickwork beneath, with timber cladding fitted around it. An integrated box could be fitted at the highest point of the southwestern wall under the eaves. Alternatively, these boxes can be fixed externally. Further advice on location or specification can be sought at any time from the author.

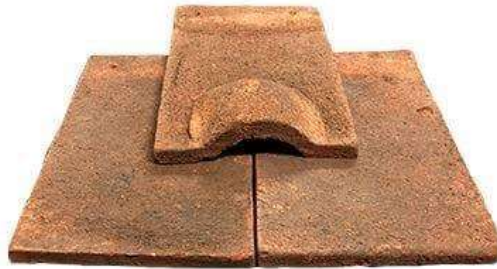
- 3.12. A further alternative to bat boxes would be to further enhance bat roosting opportunity on site, by replacing a roofing tile with a 'raised access tile' which can provide a more permanent integrated opportunity for an individual or small number of "crevice dweller" species that requires tight gaps to roost within. These can be chosen to match the aesthetic of the roofing material. A suitable location for this would be on the southwestern elevation at a height of at least 3-5m, with the tile replaced during the works. A small rectangular access hole the width of the tile should be cut in the roof lining to allow access to a roof cavity beneath. The tile should not be illuminated by nearby artificial lighting. Regular tiles can be flat or pegged (outwards) or alternatively a specialist tile can be purchased from retailers online such as the following. Further advice on location or specification can be sought at any time from the author. Advice set out within the PWMS will make the most suitable recommendation for provisional bat roosting opportunities on site, however further bat boxes in the form of either stand alone or preferably integrated bat boxes or bat tiles will also be required to enhance the site for use by bats.

<https://www.nhbs.com/search?q=bat+access+tiles> (photo shown below)

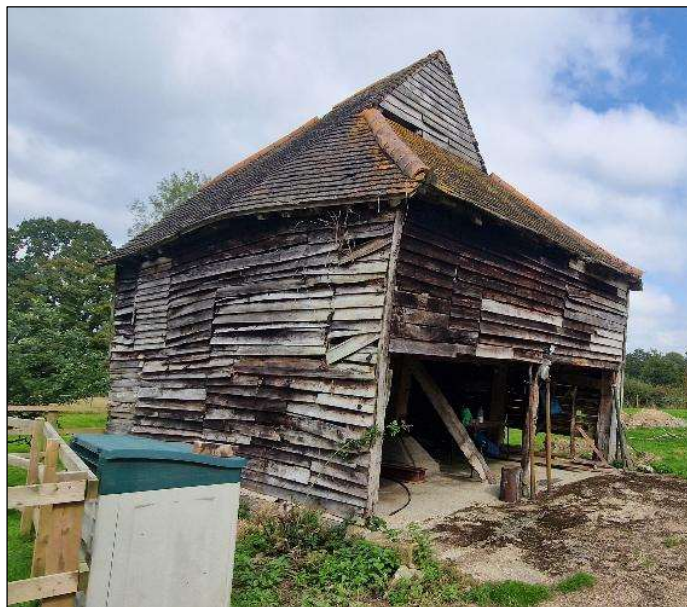
## Appendix 2: Image 1. View of the Granary building from the southwest.

Image 1. Photo of The Granary building from he from the southwest.

- 2.1. The Granary, a square two-story detached agricultural building constructed from timber and cladding, with a double-pitched, combination-style roof lined with clay tiles was assessed for its potential to support roosting bats. The majority of the building was recorded to be in derelict condition (internally and externally) with the integral structural timbers supported by steel props, and the entirety of the building tilting to the west. Some areas of the upper pitched roof, particularly on the eastern elevation offers opportunity for significant water ingress and there is evidence of this internally resulting in very damp, drafty conditions which are also exposed to high levels of natural light without sheltered areas. A total of six gaps (suitable potential roost features) for crevice-dwelling species are present externally within lifted and slipped roof and hip tiles and gaps under lifted lead flashing on the walls and roof. No bats or evidence of their presence was discovered within the areas of the building proposed for works. All areas of the building were accessed, and no other limitations were observed, or assumptions made during any part of the survey (desk or field study). It is considered that with the access gained and recording undertaken an accurate assessment of the site's ecological value has been made.
