# Surface Water Drainage Strategy for Planning

Danworth Farm Ltd

Danworth Farm

97486-Ventham-DanworthFarm

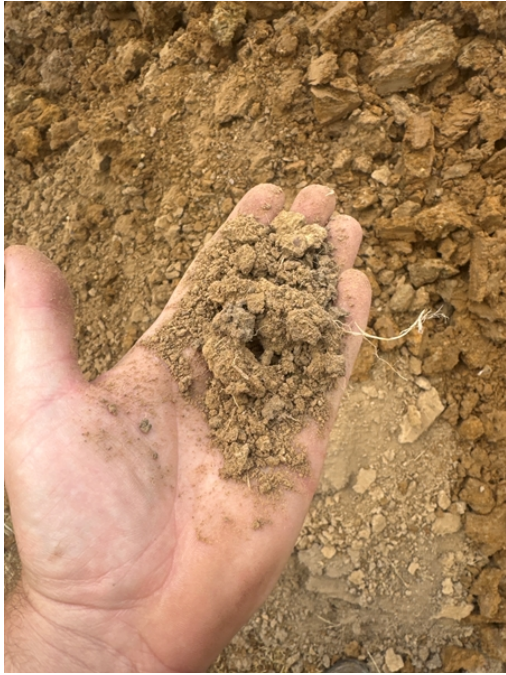
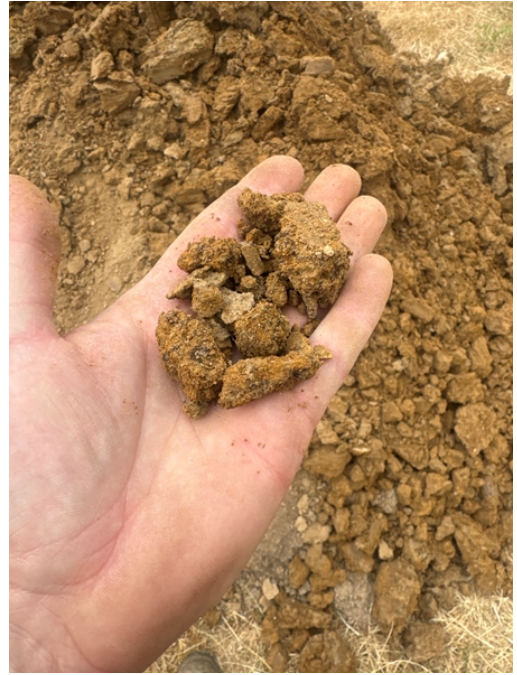
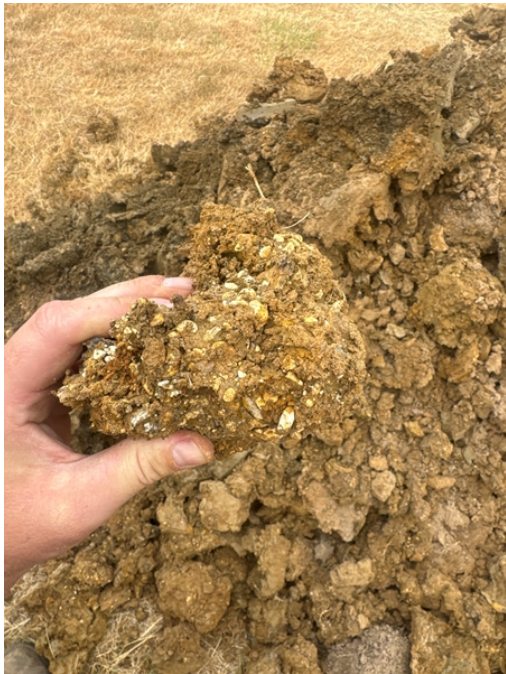
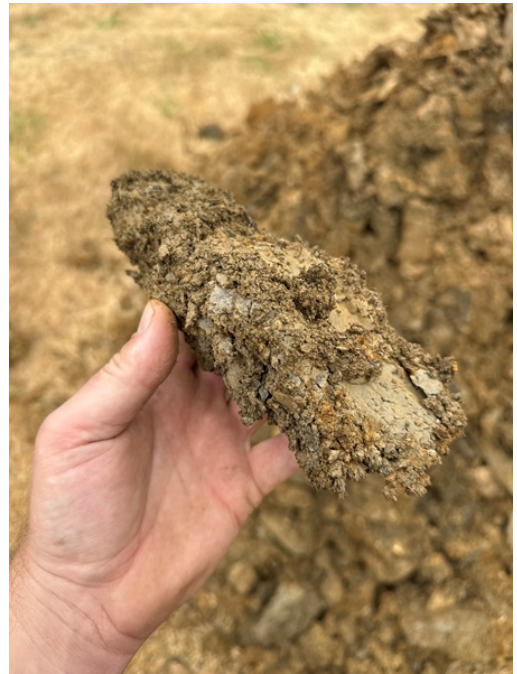
4 layers of substrate  
 First 600mm - dry sandy clay(hard)  
 From 900-1600mm wet sandy clay  
 1600-2200mm- gravel filled clay/sand band  
 2200-2600 - sandy gravel with blue clay present

| Ben Ford | Groundwater Test Hole 450 wide x 1.8 meter long x 2.6 meter deep | Depth 2.6m<br>First 600mm - dry sandy clay(hard)<br>From 900mm- wet sandy clay<br>1600-2200mm- gravel filled clay/sand band<br>2200 to 2600mm- sandy gravel with blue clay present<br>After 6 hours there was 100mm of water in the bottom of test hole<br>Ground water penetration observed at approximate depth of 2.0m |

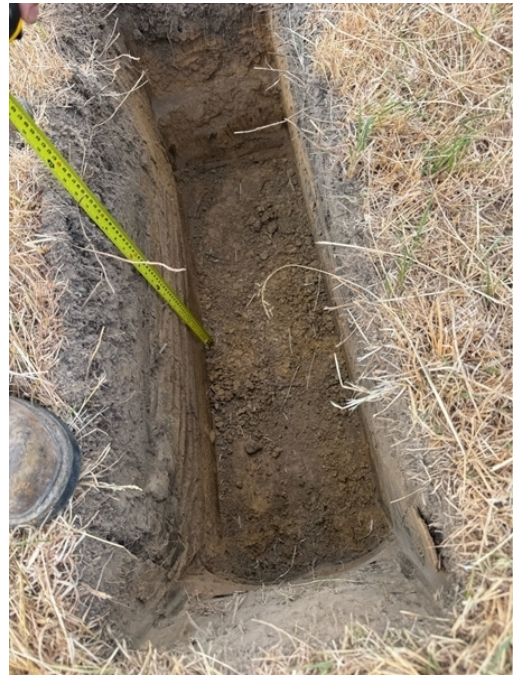
### Trial pit

Dimensions: 0.30 m (W) x 1.00 m (L), excavated depth 0.60 m bgl, effective test depth 0.45 m.  $V(75-25) = 0.068 \text{ m}^3$ ,  $a(p50) = 0.885 \text{ m}^2$  (sides to 50% depth plus base). Water per fill: 135 litres.

- 4.5. Infiltration testing was conducted on the site. Two trial pits were excavated to 1.6m below ground level (bgl) to test suitability of soakaways. One trial pit was excavated to 0.6m bgl to test suitability of permeable paving.

- 4.6. The 1.6m deep trial pits failed to drain down to the 25% marker within 24 hours. As such, soakaways are not considered suitable.
- 4.7. The 0.6m deep trial pit, located in the area of the proposed car park, returned a minimum infiltration rate of  $2.35 \times 10^{-6}$  m/s. As such, permeable paving can be considered suitable.
