# Method Statement

Opening up of Existing Bricked-up Fireplace

56 High St  
Lindfield  
West Sussex  
RH16 2HL

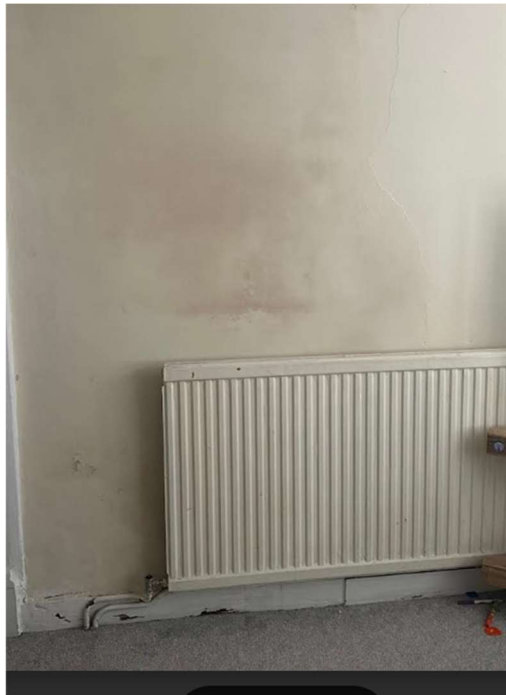
*Figure 2 – Image of Bricked-up Fireplace*

Current image of the fireplace:

Measure the internal cavity of the fireplace and mark on the wall the true fireplace opening.

Using hand tools, remove the bricks that have been used to block up the original fireplace, until the original opening is restored. Bricks to be cleaned and stored in a safe place for potential future use.

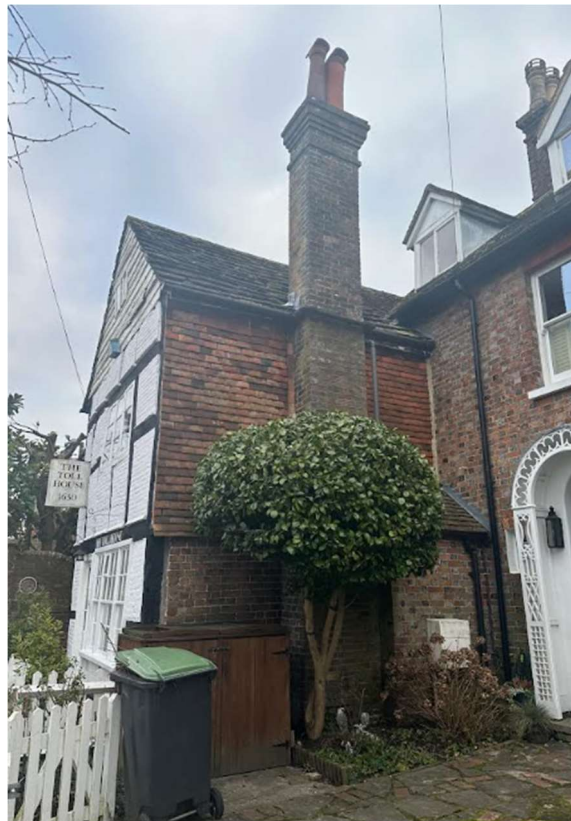
*Figure 3 – Image of Chimney*

Current image of the chimney:

Specialist team to clean and inspect the chimney and advise. If all is acceptable to the specialist team, installation of wood burner to be go ahead.

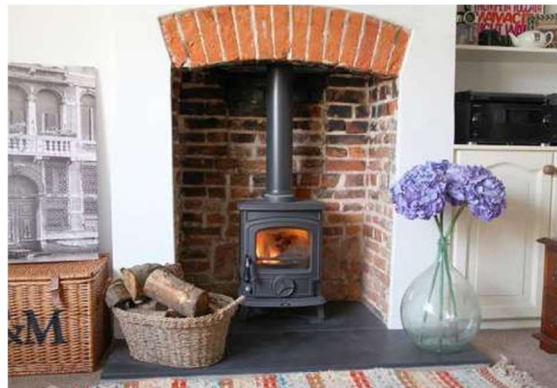
*Figure 4 – Example of Wood Burner and Mantel*

When opening the fireplace, the proposal is to be guided by the discovery. It is expected there is a brick segmental arch rather than a flat arch or if timber lintel, oak lintels in fireplaces were imbedded into the brickwork and flush with the brick jambs.

Below is an example of what is expected:

Replaster to edges.

The hearth will be traditional stone.
