## Preliminary Roost Assessment

Whitehouse Farm Cottage, Staplefield Lane, Staplefield, Haywards Heath, RH17 6AU

This report is prepared to inform a planning application. The proposal is described as: Works to the roof, the conversion of the existing north facing outhouse into a utility roof and internal alterations to suit a new layout. The proposed project is described further in the foreseen impact section of this report.

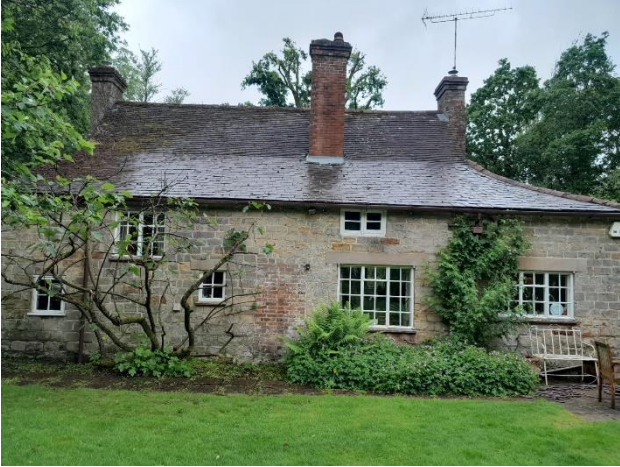
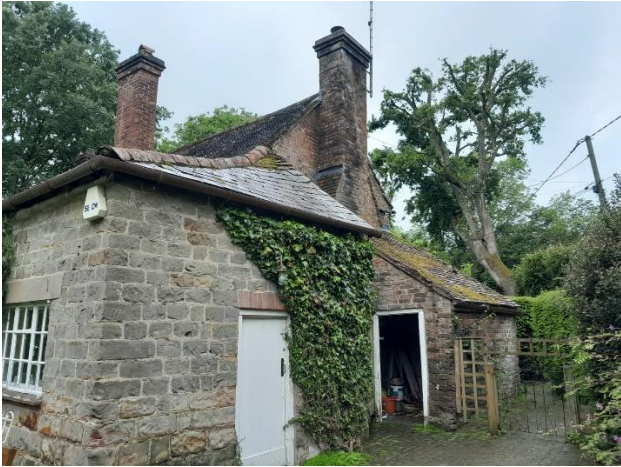
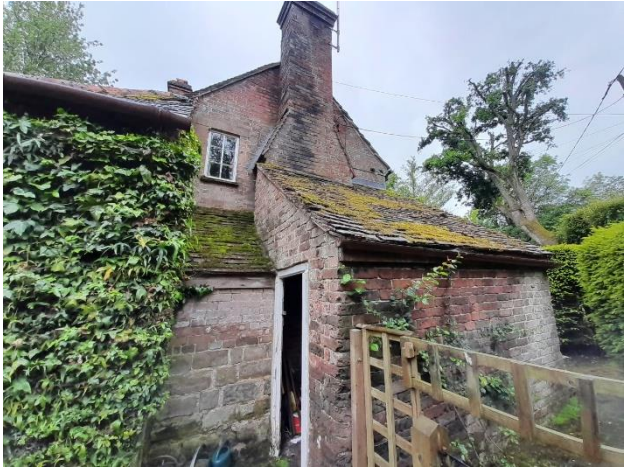
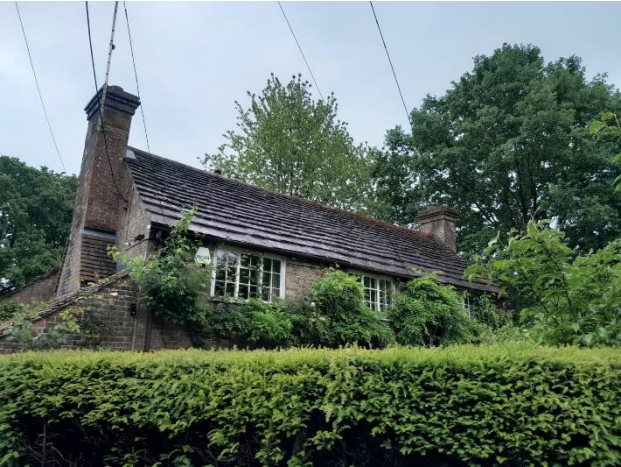
| Description | Photograph |
|---|---|
| Overview of the building exterior | <div>A wide-angle photograph of the front elevation of Whitehouse Farm Cottage. The building is constructed from light-colored stone with a dark, tiled roof. Two prominent brick chimneys are visible. The facade features several windows, some of which are partially covered by climbing ivy. A green lawn and some shrubbery are in the foreground.</div> <div>A photograph showing a corner of the cottage. The stone wall is heavily covered in ivy. A white door is visible, and a small window is partially seen. A large tree stands to the right of the building.</div> <div>A photograph of a side elevation of the cottage. The stone wall is covered in ivy. A small, dark doorway is visible, and a wooden fence runs along the side of the building.</div> <div>A photograph of the rear elevation of the cottage. The building is partially obscured by a dense, green hedge in the foreground. A brick chimney and a window are visible above the hedge.</div> |

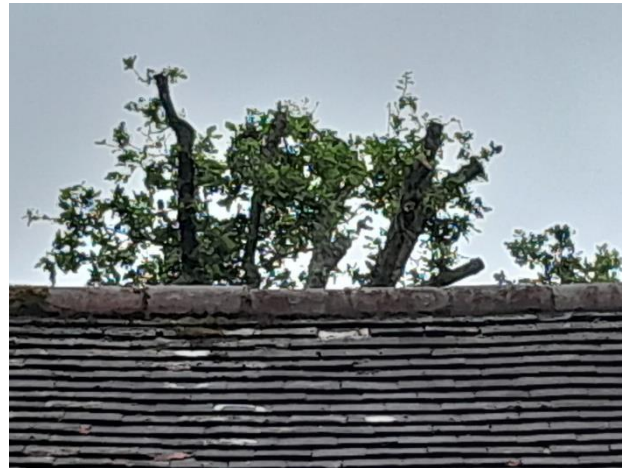
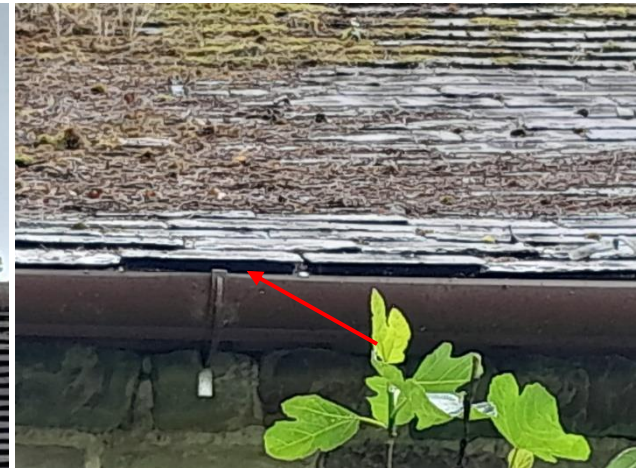
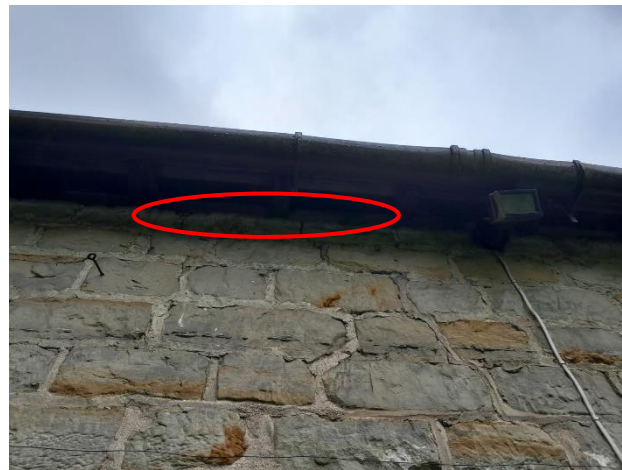
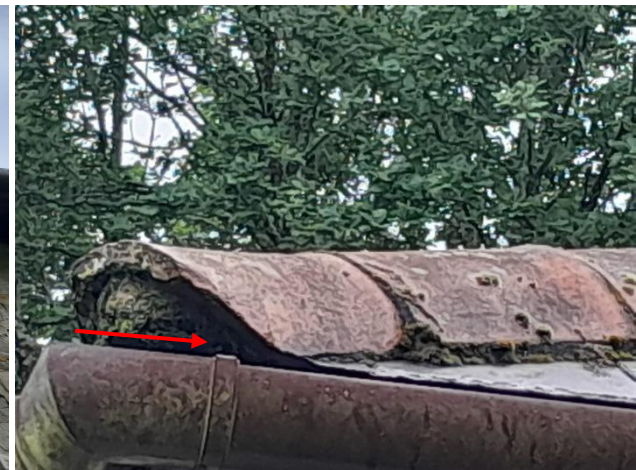
Suitable roosting features, such as gaps underneath roof tiles, gaps by the eaves and gaps where mortar has worn in brickwork.

| <i>Recommendations</i> | <p>B1 is assessed as <b>moderate value</b> to roosting bats.</p> <p>Two bat emergence surveys are required during the active bat season (optimal May to August, suboptimal September) to confirm the presence or likely-absence of a bat roost in the building.</p> <p>Infra-red cameras should be used as an aid. Four surveyors are required to provide full coverage of the building. Surveys should be a minimum of three weeks apart.</p> <p>If the absence of a bat roost cannot be determined during the first visit, then further surveys will be required.</p> <p>If bat roosts are confirmed in the building one additional surveys may be required to characterise the roost and to inform an EPSL application to Natural England. Surveys should be a minimum of two weeks apart. The EPSL application requires that surveys have been undertaken within the most recent active bat season and planning permission must have been granted and all relevant wildlife-related conditions have been discharged prior to submission.</p> |

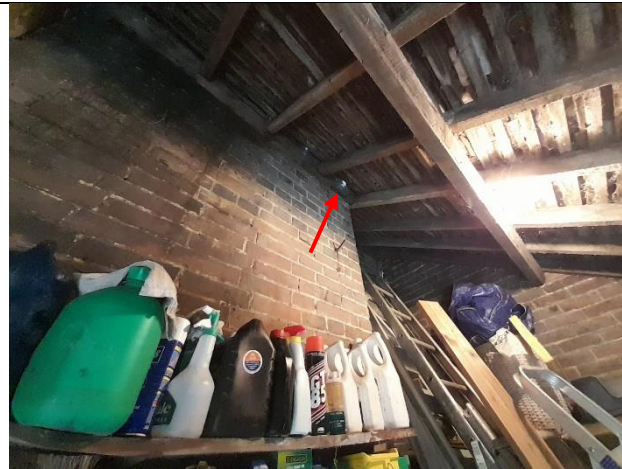
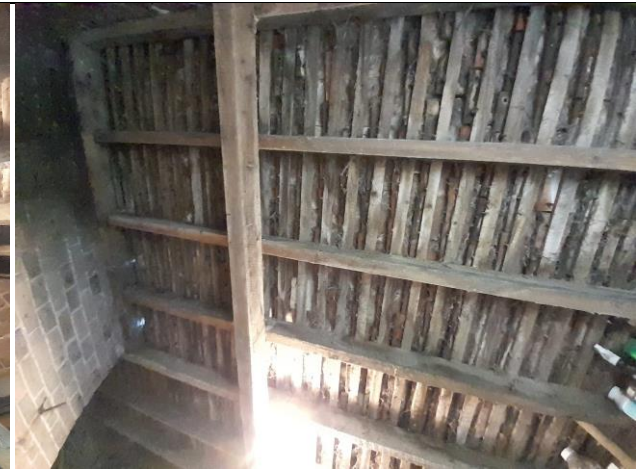
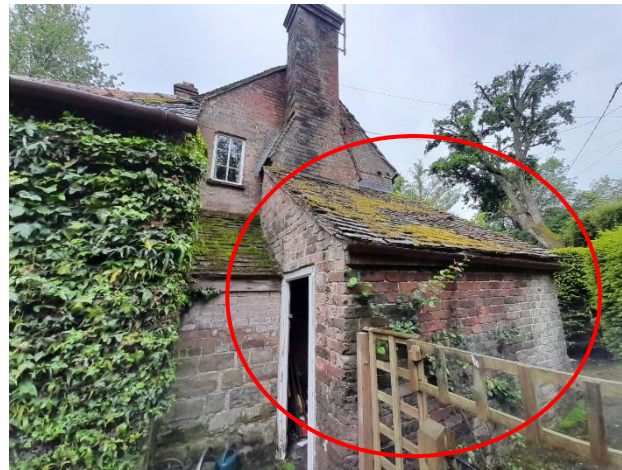
North-facing outhouse

Unlined clay roof tiles, currently used for storage. Gaps showing ingress of light.

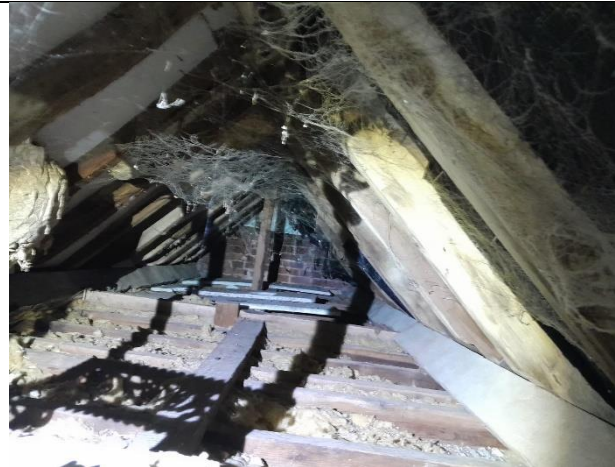
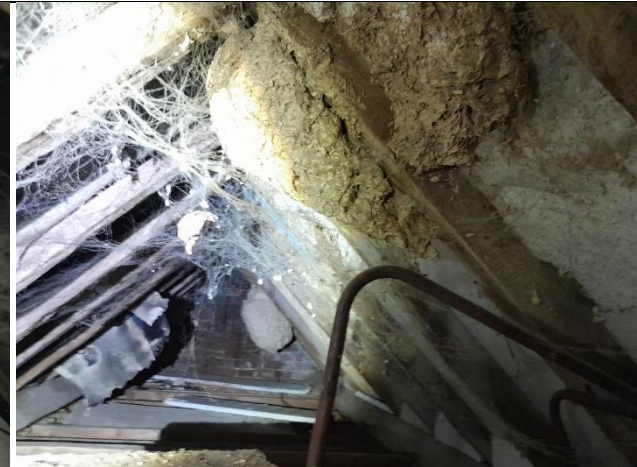
## Overview of the loft space

Photographs show felt lining with frequent tears, showing exposed roof tiles.

The presence of dense, old cobwebs suggest a lack of recent flight.

This roof space was inaccessible due to small size of loft hatch. Therefore, some evidence of bats (if present) may have been missed.
