# Beechy Bottom Parkland Reserve

Proposed Cycle Route (Woodland Section)

Document Title: Beechy Bottom Parkland Reserve, Proposed Cycle Route - Woodland Section

Document Reference: DLA/2131//CR/RPT/03/V1 - Proposed Cycle Route - Woodland Section

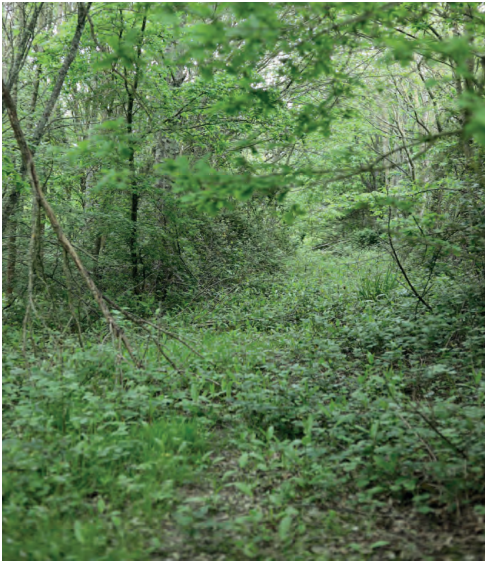
View looking north along existing informal track

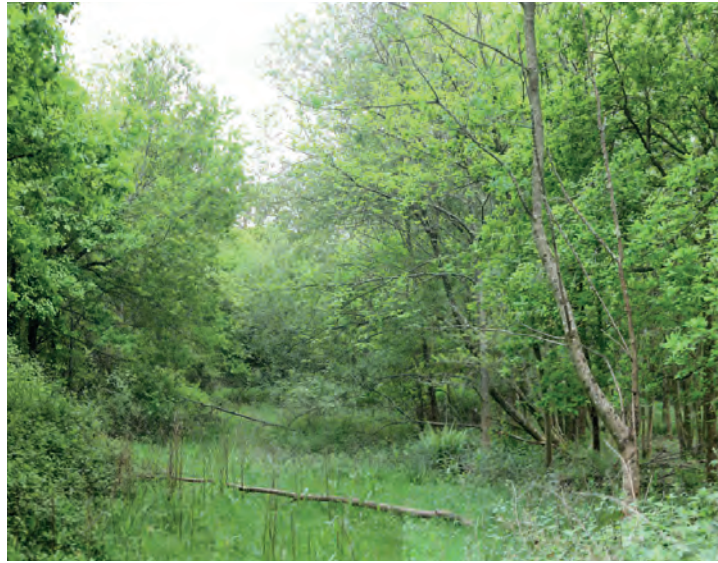
View looking east along the existing track

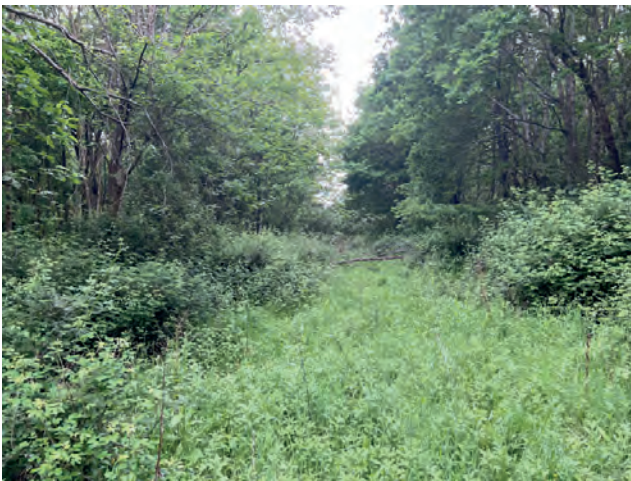
Woodland west of the existing track

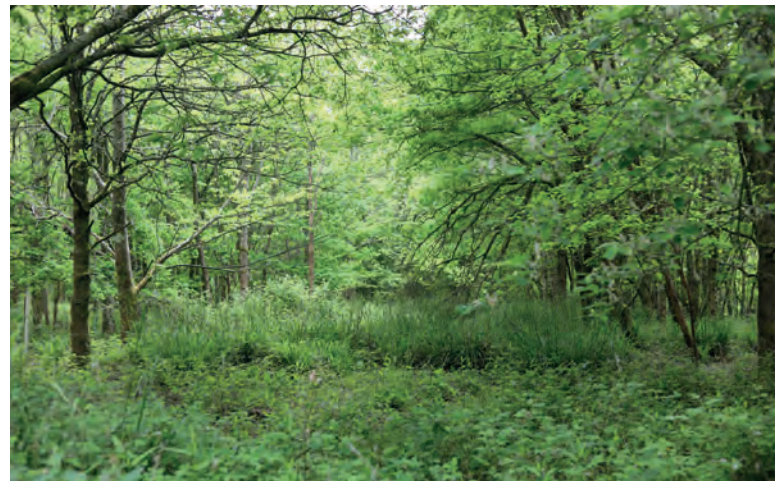
Typical character of woodland, view towards the south

Plantation, semi-mature, mixed deciduous native species woodland: predominantly pedunculate oak *Quercus robur*, sweet chestnut *Castanea sativa*, ash *Fraxinus excelsior*, silver birch *Betula pendula*, willow *Salix sp* and cherry *Prunus avium*. The ground flora was generally sparse, species-poor and denuded with ground ivy *Glechoma hederacea*, pendulous sedge, common nettle, male fern, light scattered bramble, occasional dog's mercury *Mercurialis perennis* and ground elder *Aegopodium podagraria* with large amounts of bare ground. Heavy deer pressure was evident. Land was formerly an open field.

Moderate.

The proposed route will run through the existing low quality plantation woodland, removing smaller sapling as part of the management and allowing larger trees to develop their canopies.

Where the route meets the east x west 'glade' there is an opportunity to develop the species diversity further.

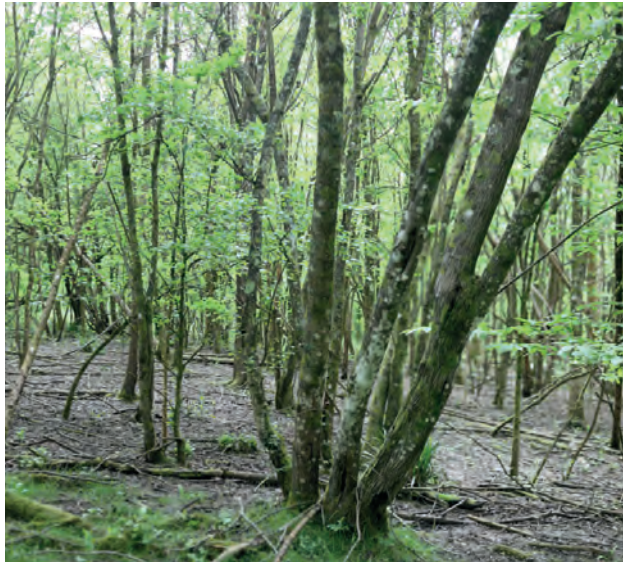
Footpath weaves through woodland

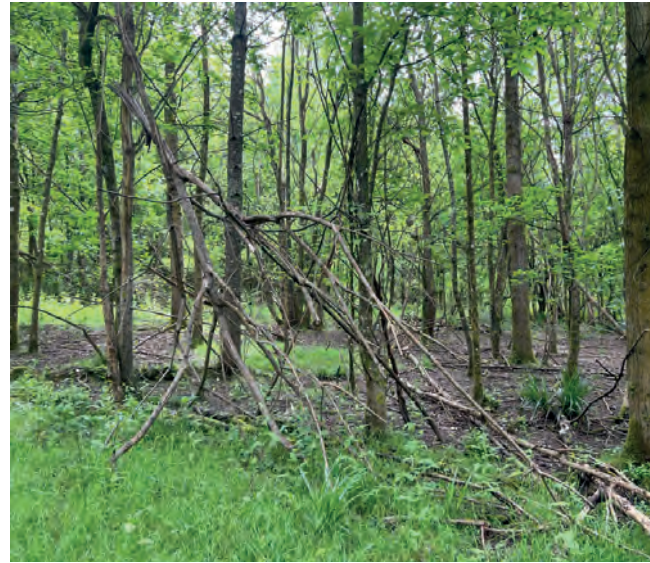
View southwards on the footpath, facing low quality woodland

Regenerated, semi-mature, mixed deciduous native species plantation woodland: predominantly birch, willow, oak & ash. Denser planting than photo location 1, with an impoverished herb/ground flora. Heavy pressure on vegetation from deer evident. Land was formerly an open field.

Moderate quality tree stock, impoverished herb/ground flora.

The proposed route will run through the existing low quality plantation woodland, removing smaller sapling as part of the management and allowing larger trees to develop their canopies.

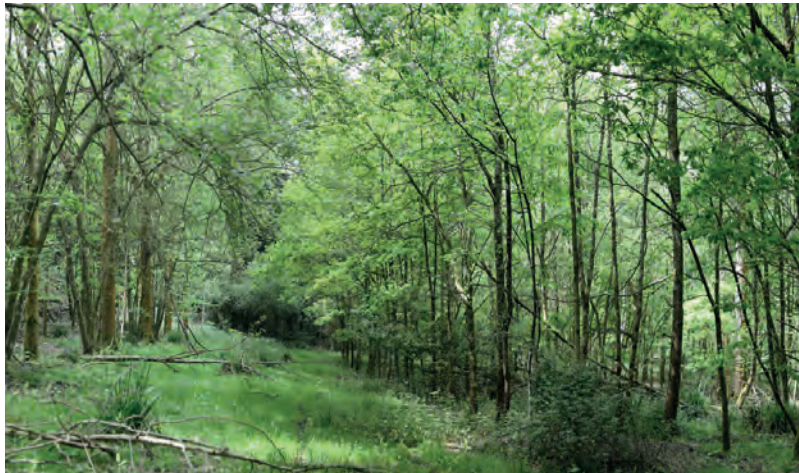
East x west track forms a notable 'glade' along the route

Where the route meets the east x west 'glade' there is an opportunity to develop the species diversity further.

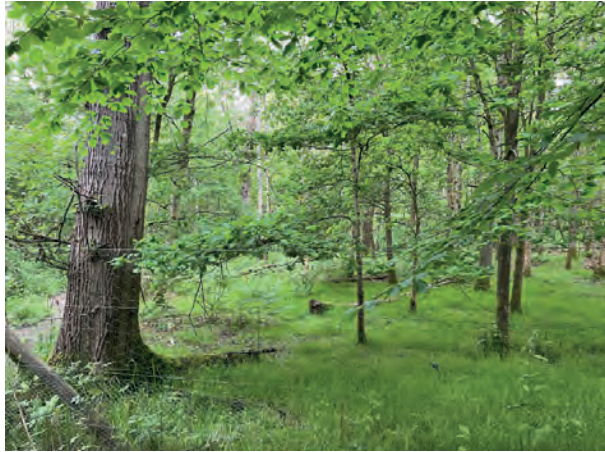
View north- plantation woodland character

Plantation of rows of poplar (*Populus spp*), ash, oak and birch, predominantly. Land was formerly an open field.

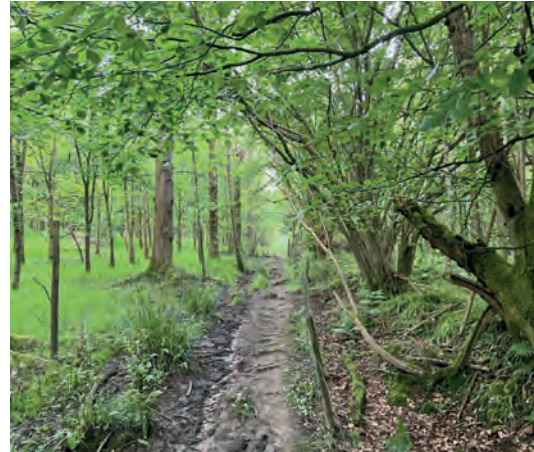
View east

Low quality tree stock: large majority of ash displaying symptoms of ash dieback disease. Impoverished ground flora, some orchids noted.

Removal of some of the smaller saplings/ developing trees will afford an easy route through. Ongoing management will include the removal of the rhododendron.

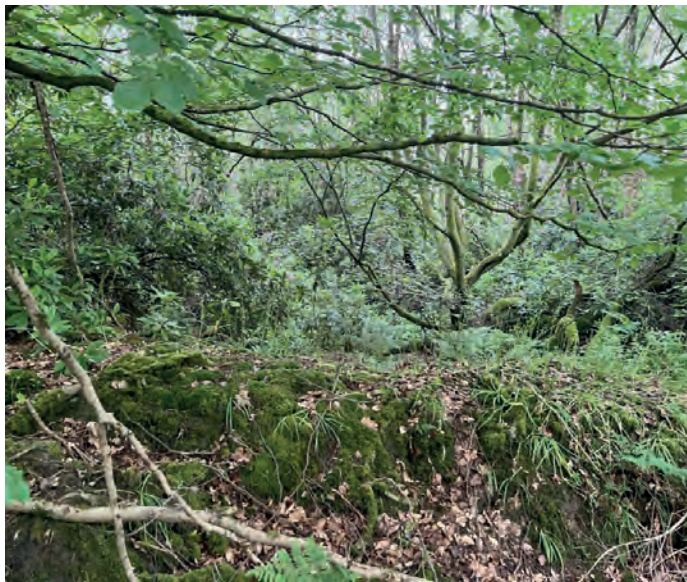
South- Footpath weaves through woodland - some maturing trees

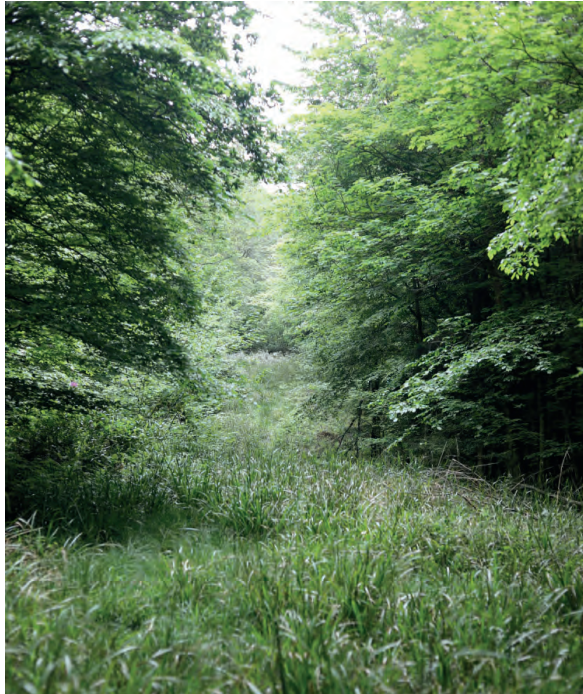
The route through is well defined by pendulous sedge

Ancient Semi-Natural Woodland (ASNW). South of the High Weald trail. Regenerated, semi-mature, mixed deciduous native species woodland: predominantly birch, willow, oak & ash. Ground flora present, but dominated by Rhododendron (*Rhododendron ponticum*) and Pendulous sedge (*Carex pendula*).

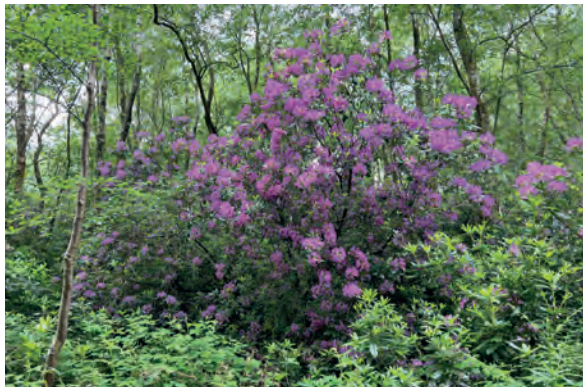
View west - Rhododendron is well established in areas

Moderate quality tree stock, dominated by birch. Ground/herb layer dominated by invasives. This area had been subject to some form of management over the previous 10-20 years. The woodland was subject to relatively high browsing and grazing pressure from deer, predominantly fallow *Dama dama*, which was recorded during the site visit

Removal of some of the smaller saplings/ developing trees will afford an easy route through. Ongoing management will include the removal of the rhododendron and

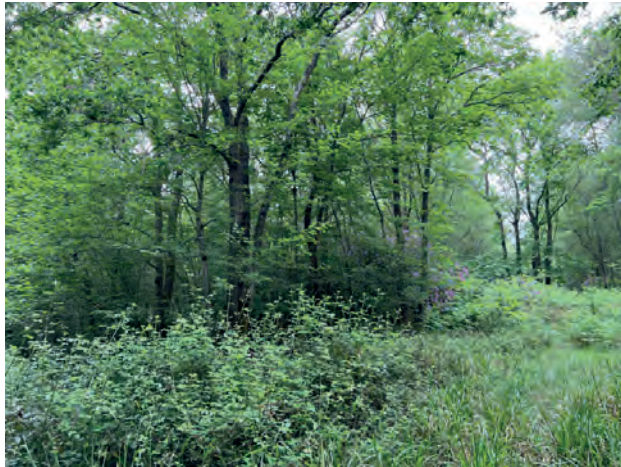
Route north defined by a linear clearings through the woodland

Ancient Semi-Natural Woodland (ASNW). Regenerated, semi-mature, mixed deciduous native species woodland of predominantly birch, willow, oak, and ash, with individual standards of beech (*Fagus sylvatica*), oak and sweet chestnut (*Castanea sativa*). Ground flora present, but dominated by Rhododendron and Pendulous sedge. Other species recorded included occasional hard fern *Blechnum spicant*, wood sorrel *Oxalis acetosella*, pendulous sedge *Carex pendula*, thin-spiked wood sedge *Carex strigosa*, stinging iris *Iris foetidissima*, betony *Betonica officinalis*, ivy *Hedera helix*, dog rose *Rosa canina*, sanicle *Sanicula europaea*, bramble *Rubus fruticosus* agg, bush vetch *Vicia sepium*, wood sage *Teucrium scorodonia*, hemp agrimony *Eupatorium cannabinum*, tormentil *Potentilla erecta*, water mint *Mentha aquatica*, tufted hairgrass *Deschampsia cespitosa* and bracken *Pteridium aquilinum*

Moderate quality tree stock. Ground/herb layer dominated by invasives, but heavily grazed and browsed by deer within woodland.

Removal of some of the smaller saplings/ developing trees will afford an easy route through. Ongoing management will include the removal of the rhododendron.

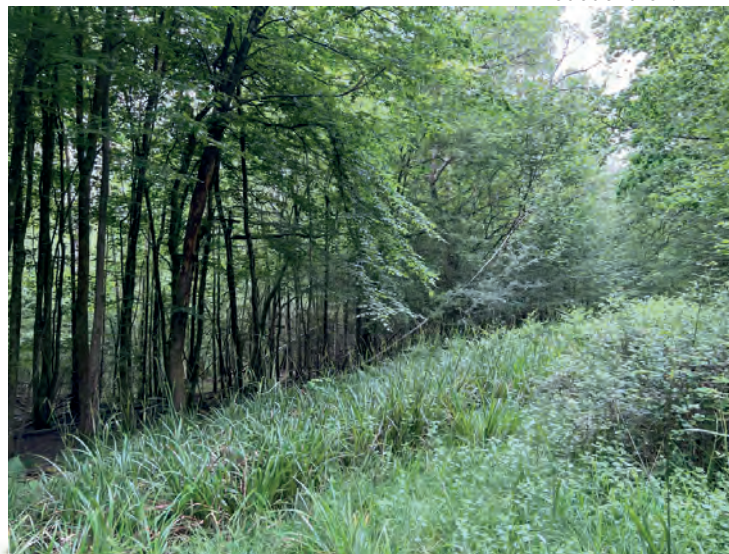
West- The current route affords access over several steep streams that traverse the woodland.

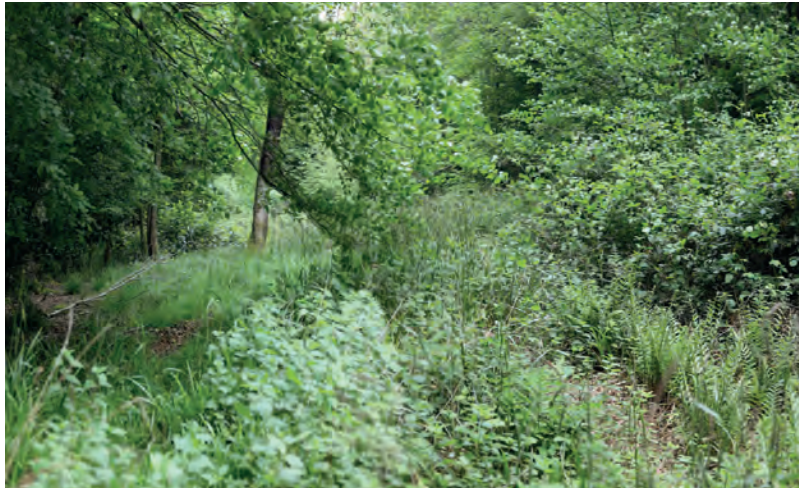
Route heading northwards - defined by a visibly clear swathe of ground flora

**Ancient Semi-Natural Woodland (ASNW).** Regenerated, semi-mature, mixed deciduous native species woodland of predominantly birch, willow, oak, and ash. Impoverished ground flora to south of glade, due to grazing and browsing by deer.

Moderate quality tree stock. Ground/herb layer heavily grazed by deer.

The route follows a clearly defined linear opening through the ancient woodland, noticeable by the extent of ground

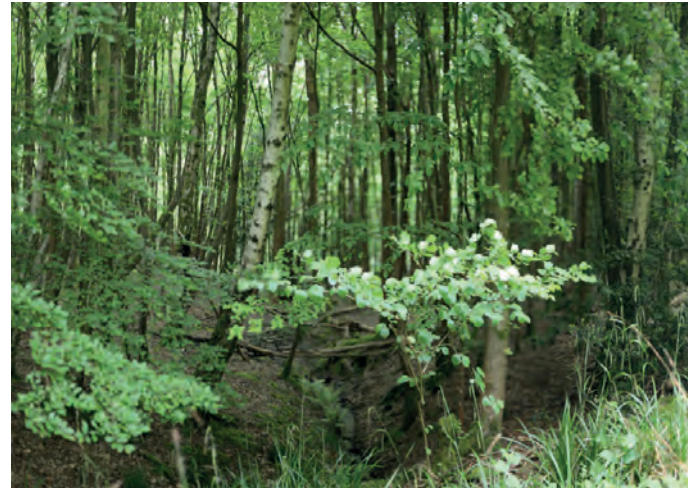
View west- Woodland either side of the swathe typically close planted and dense

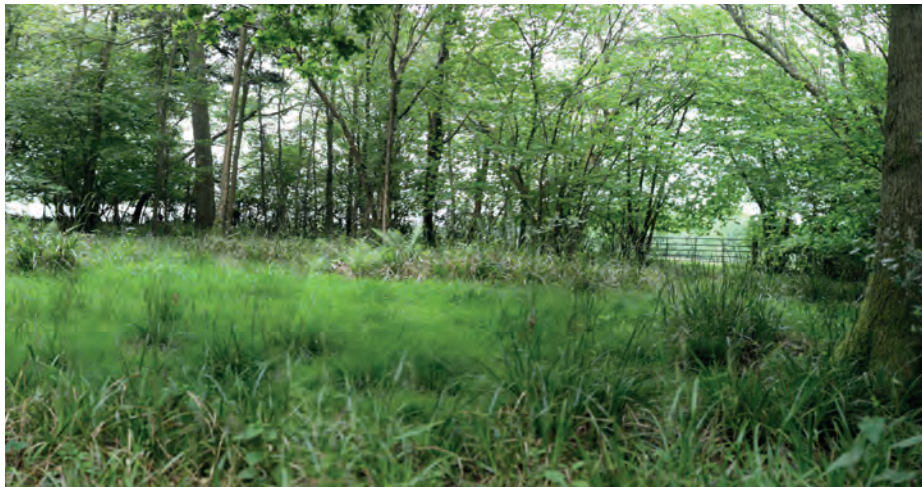
Route passes through clearing to the gate on the southern boundary of the wood

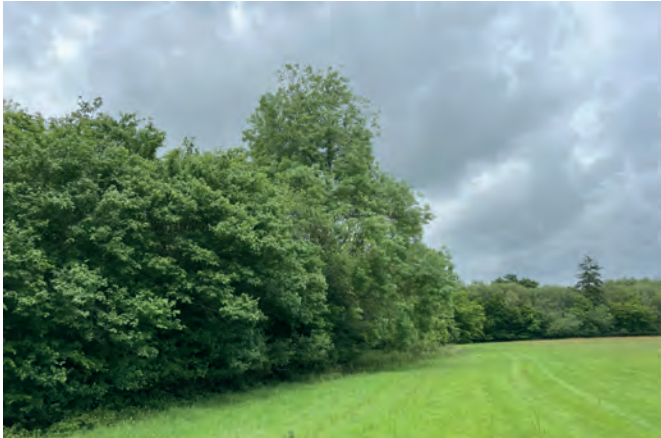
View looking north on the approach to the woodland edge

Ancient Semi-Natural Woodland (ASNW). Older tree stock at the southern end of the wood, with hornbeam (*Carpinus betulus*), ash and field maple (*Acer campestre*) present additionally to birch and oak. Impoverished ground flora due to grazing by deer.

Moderate quality tree stock. Ground/herb layer heavily grazed by deer.

The approach to woodland will be located within a fenced pathway with the field remaining open for grazing.

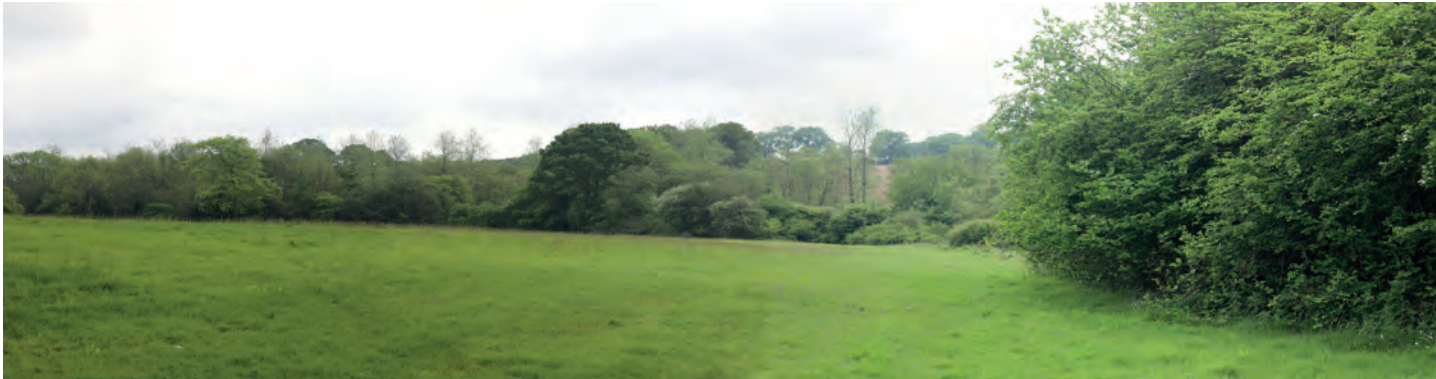
View looking south from the egress of the southern gate
