# HB Archaeology & Conservation Ltd

BARLANDS, THE STREET, WARNINGLID, WEST SUSSEX, RH17 5SZ  
(NGR: TQ 24636 25554)

## HERITAGE STATEMENT

REPORT NO. 2024582  
November 2024

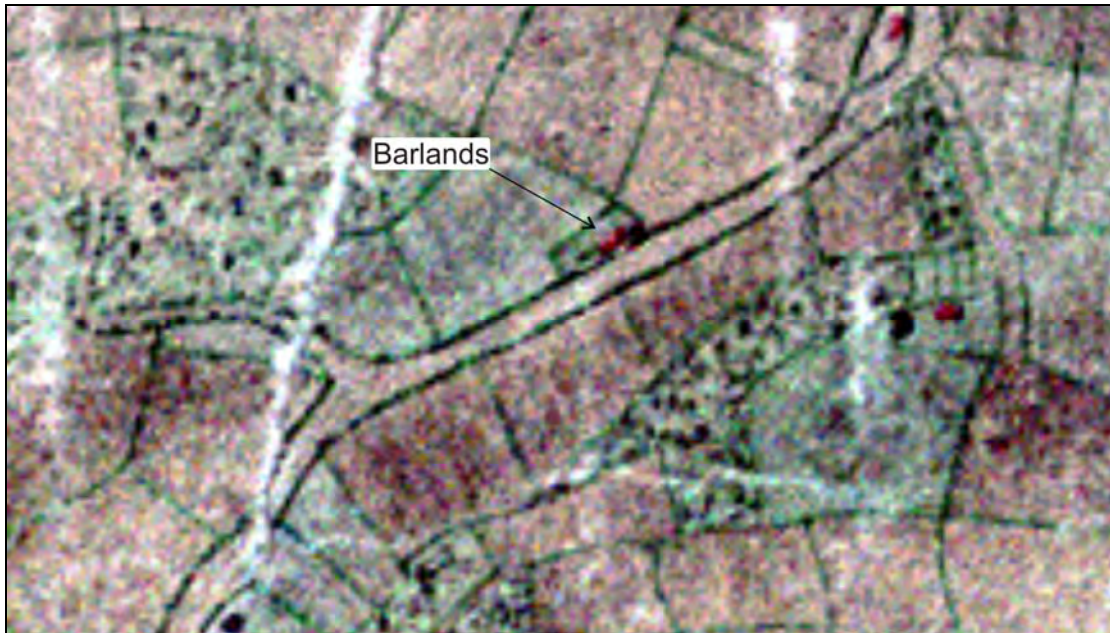
Figure 2: Ordnance Survey Surveyor's Draft c.1800

- 5.1.1 The surveyor's draft Ordnance Survey map shows the property comprising an east - west oriented domestic range (shaded pink). A pair of probable ancillary building are shown flanking the house (shaded grey). The scale is insufficient to determine any further detail at this stage (Figure 2).

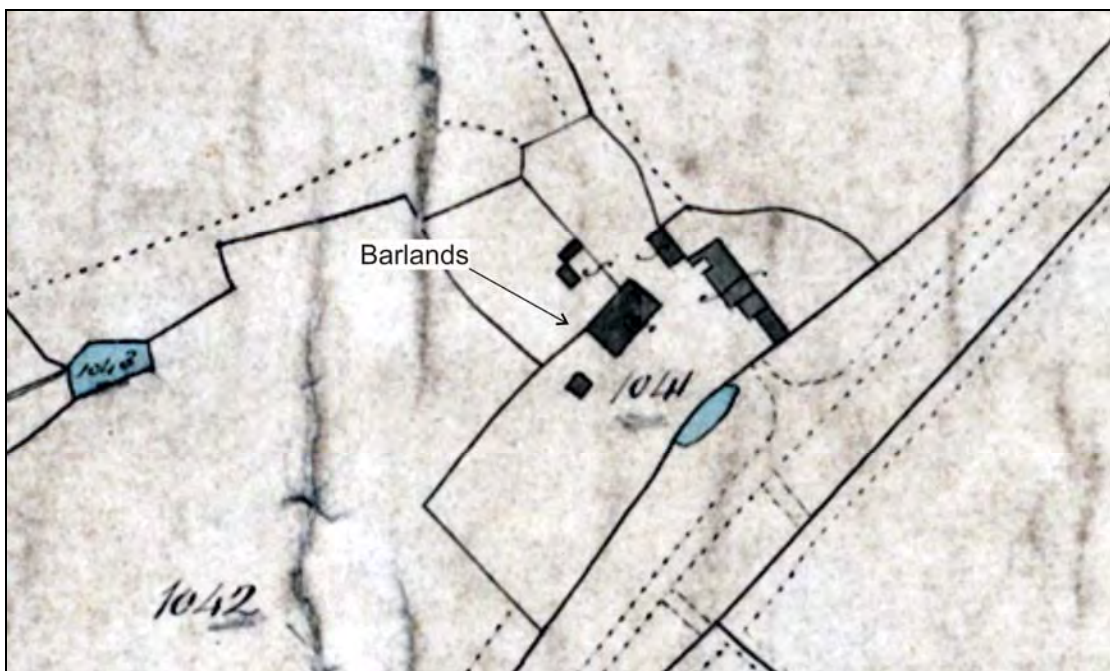
Figure 3: Extract of the Slaugham tithe map, c.1840

- 5.1.2 By the issue of the Slaugham tithe map in c.1840 the property had developed to include a series of farm buildings to the east laid out on a north – south axis, a pair of compact ancillary buildings to the north of the house set within their own enclosure and a small detached building to the west of the farmhouse (Figure 3). Two ponds are indicated, one to the south of the house, between the road and the property itself and another against the field boundary to the west of the house.

- 6.2.3 The remains may correspond to the eastern of the two buildings shown in the same location on the tithe map of 1839 (Figure 3).

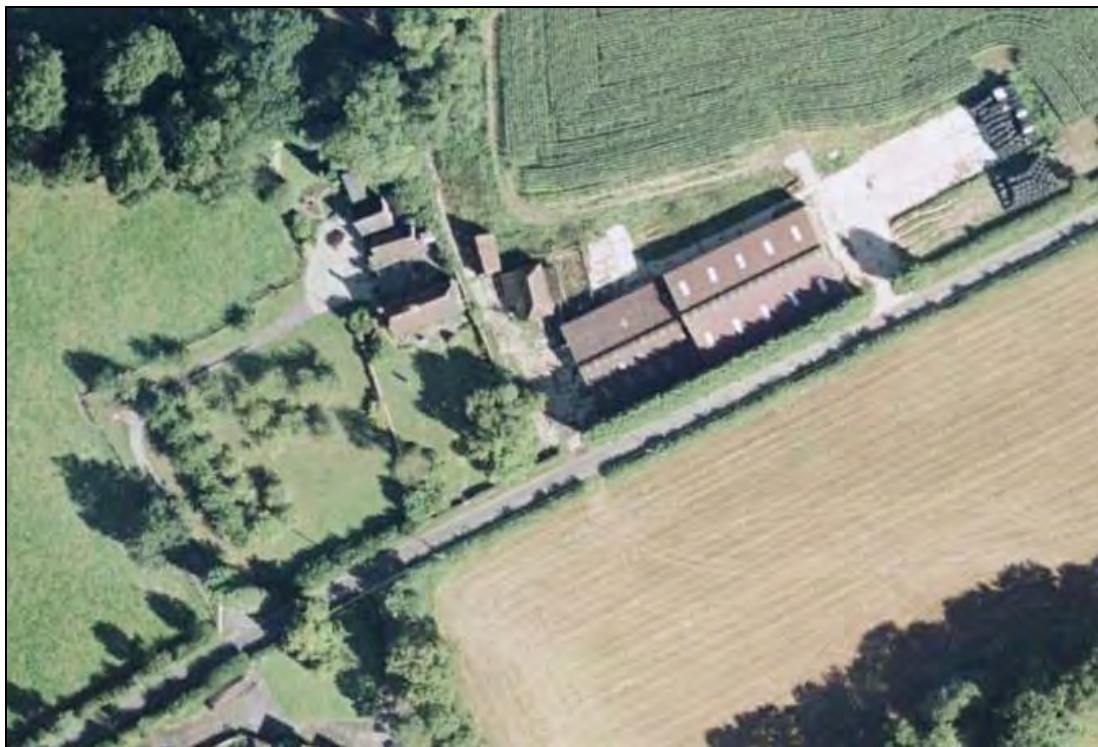
Figure 8: Google Earth image of the property taken in January 2001 showing the expansion of the modern farmstead to the east of Barlands and the additional buildings to the north of the domestic group

- 5.2.7 By 2001, the detached building to the northwest of the house had been removed and two new buildings had been added to the north of the existing north ancillary range (Figure 8). The farmstead to the east had gained a further substantial multi-purpose shed at its eastern side close to the highway (Figure 8). The southern of the two surviving historic farm buildings had been further truncated at its south end (Figure 8).

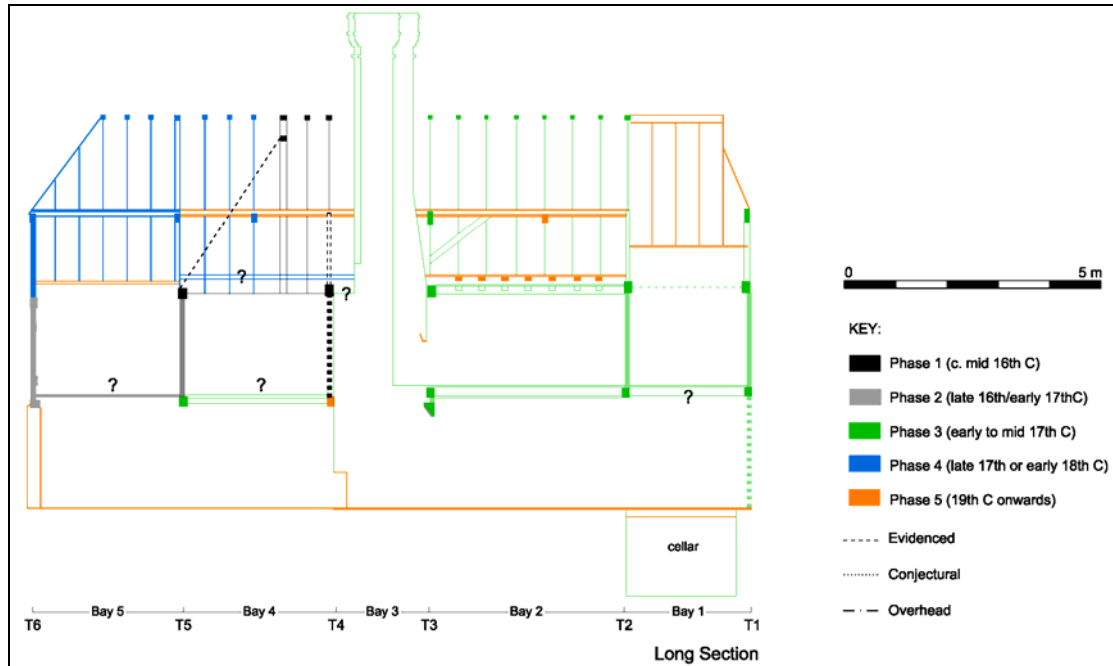
Figure 10: Phased long section through the building showing the location and extent of the fragmentary Phase 1 remains (in black)

***Phase 5: 19<sup>th</sup> century onwards (Figures 10 and 11)***

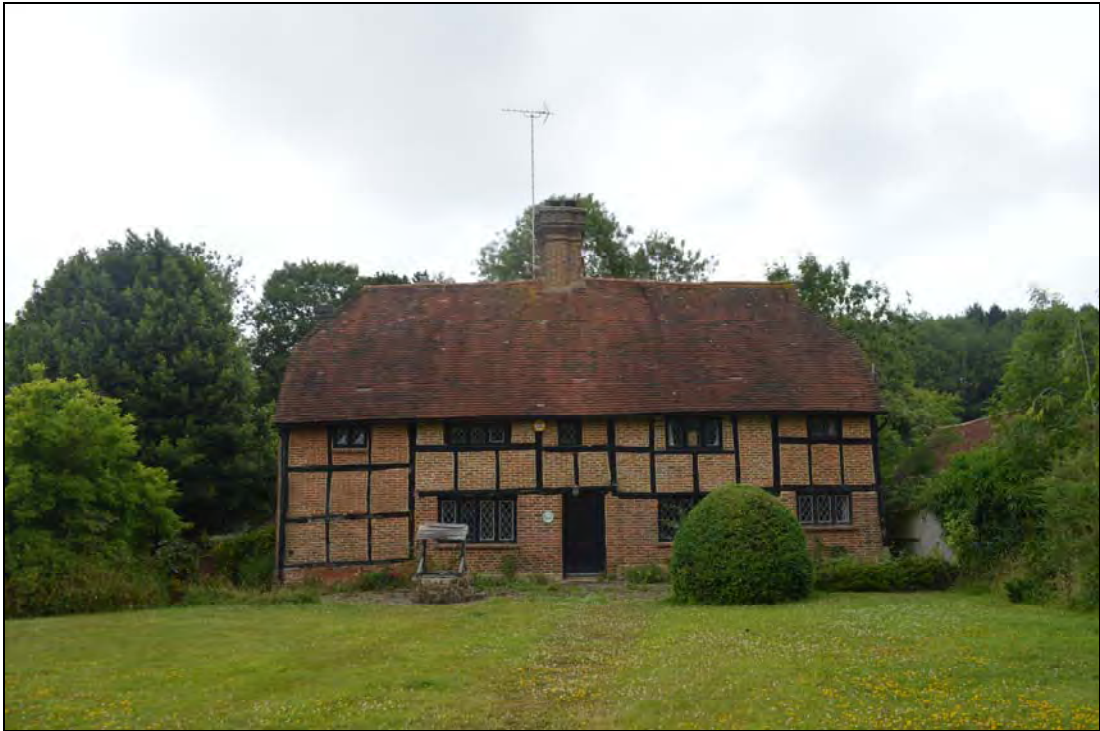
Plate 1: The south side of the house as arrived at by the 18<sup>th</sup> century showing the contrast in construction between the rebuilt western end and its predecessors to the east

- 6.1.8 The phase 2 work at the western end of the original mid-to-late 16<sup>th</sup> century remains was rebuilt at least in part and re-roofed in the 18<sup>th</sup> century. The roof terminal is half-hipped and the hipped part lacks both high-set collar and central jack-rafter indicating a date of construction no earlier than the second half of the 17<sup>th</sup> century, and in this instance more probably within the 18<sup>th</sup> century for the rebuilding campaign.

- 6.1.9 The wall framing at the western end of the house on its southern side lacks a side-girt that is included in all other areas of extant framing, suggesting that this part of the wall has been made to match aesthetically, perhaps to fit the remains of the earlier frame within the building (Plate 1). The rebuilt south elevation may relate to the Phase 4 building campaign, or indeed later phases of construction with the aim to make the fabric on the publicly visible southern side of the building broadly match.

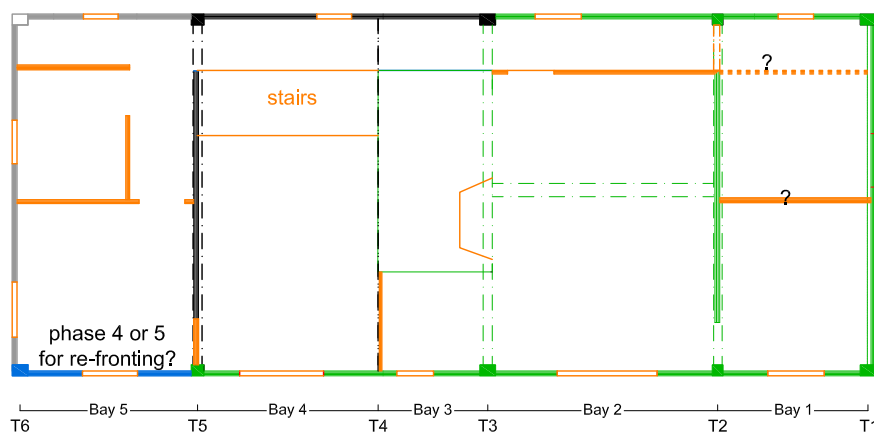
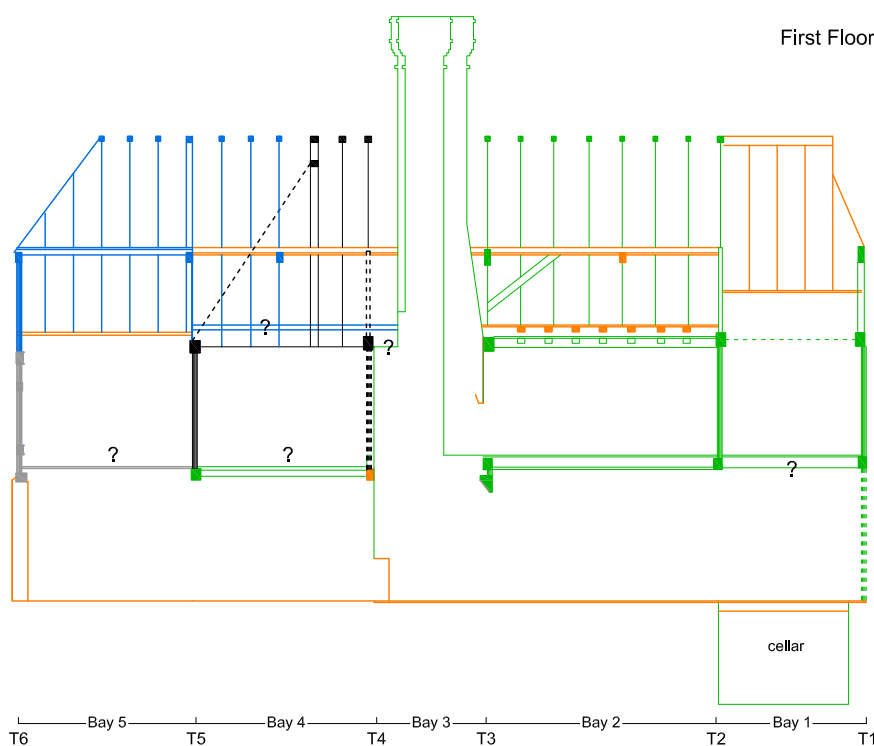
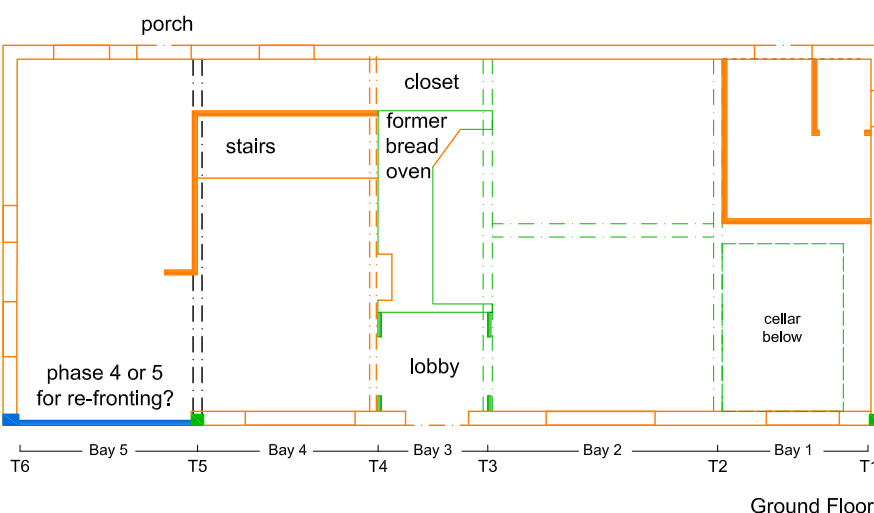
Figure 11

- Phase 1 (c. mid 16th C)
- Phase 2 (late 16th or early 17th C)
- Phase 3 (early to mid 17th C)
- Phase 4 (late 17th or early 18th C)
- Phase 5 (19th C onwards)

The Building as Existing - All Extant Phases (Surveyed July 2015)

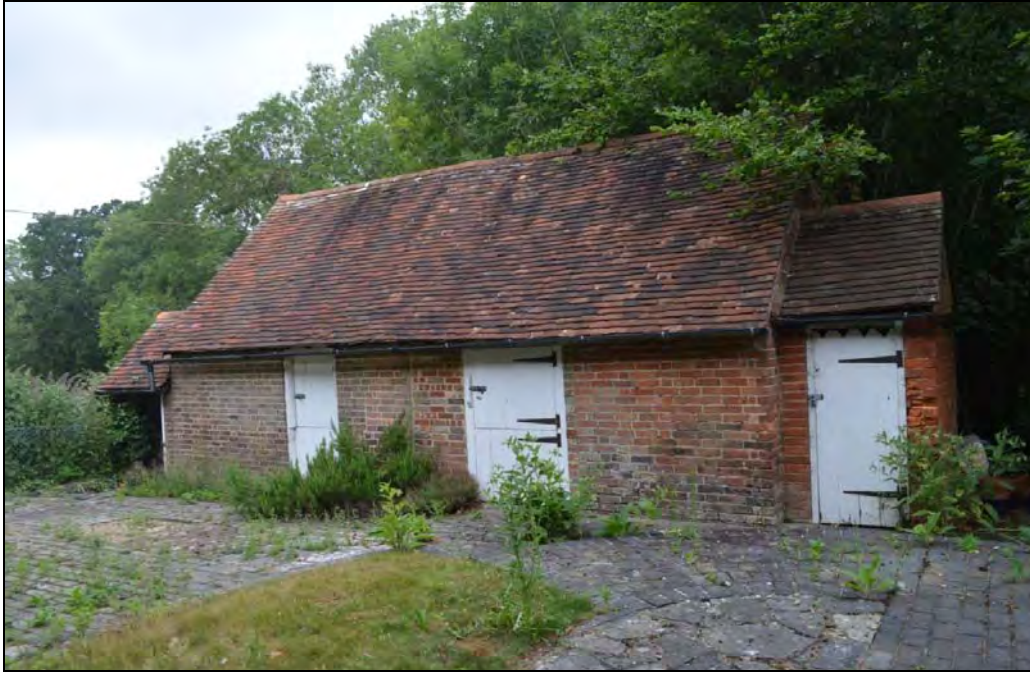
Plate 2: The south side of the north ancillary range

- 6.2.1 The ancillary building is situated to the north of the house on the same broadly east – west alignment, with the principal elevation facing south towards the house (Plate 2). The building is single storey in height, built predominantly of brick (with some sandstone rubble masonry visible to the north on the eastern end of the building (Plate 3)).

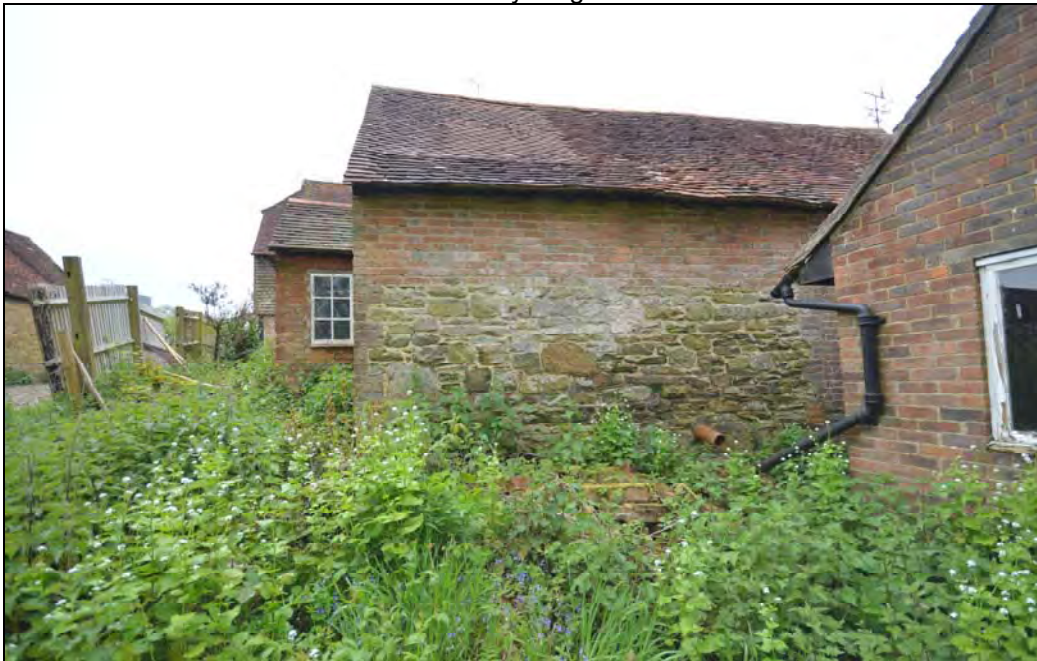
Plate 3: The north side of the north ancillary range, earlier masonry, later brick above

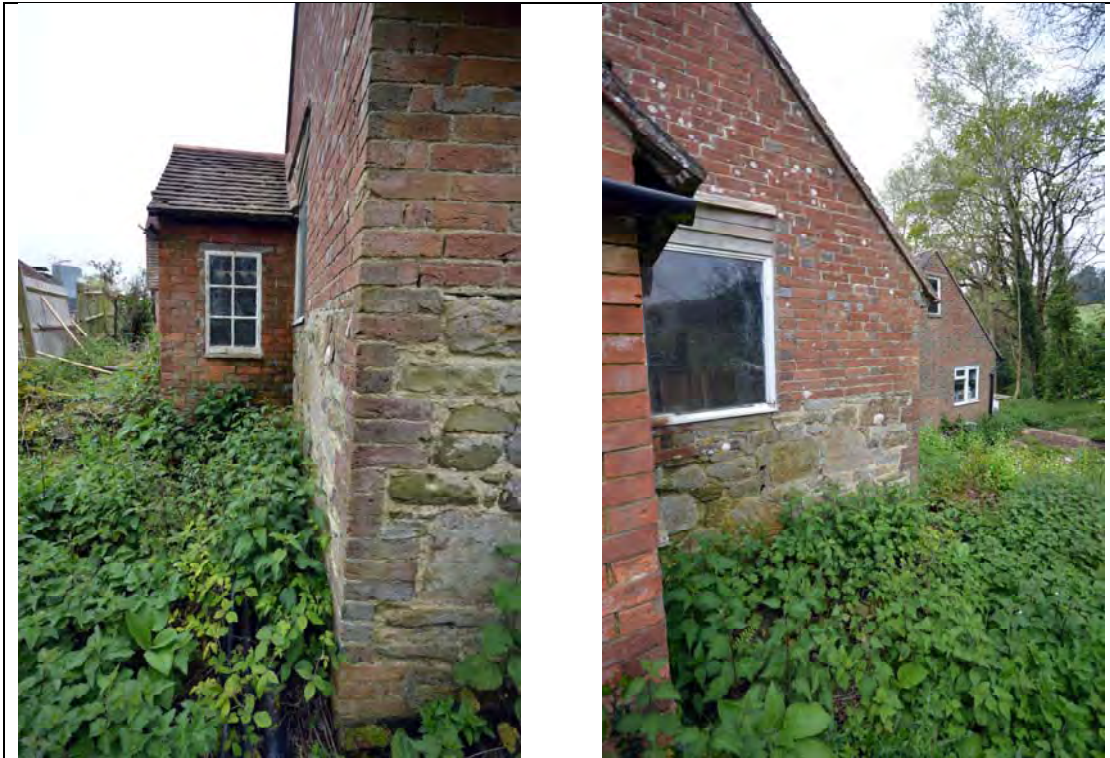
Plate 4: The masonry base at its northeast corner and east side

- 6.2.2 The earliest extant remains are those of a small masonry building constructed in random rubble with brick quoins. The remains are situated to the west side of the building on its northern and eastern sides, measuring c. 4.60 metres east – west, returning for c. 2.20 metres to the south to form the northern part of the east end elevation (Figure 12; Plate 4).

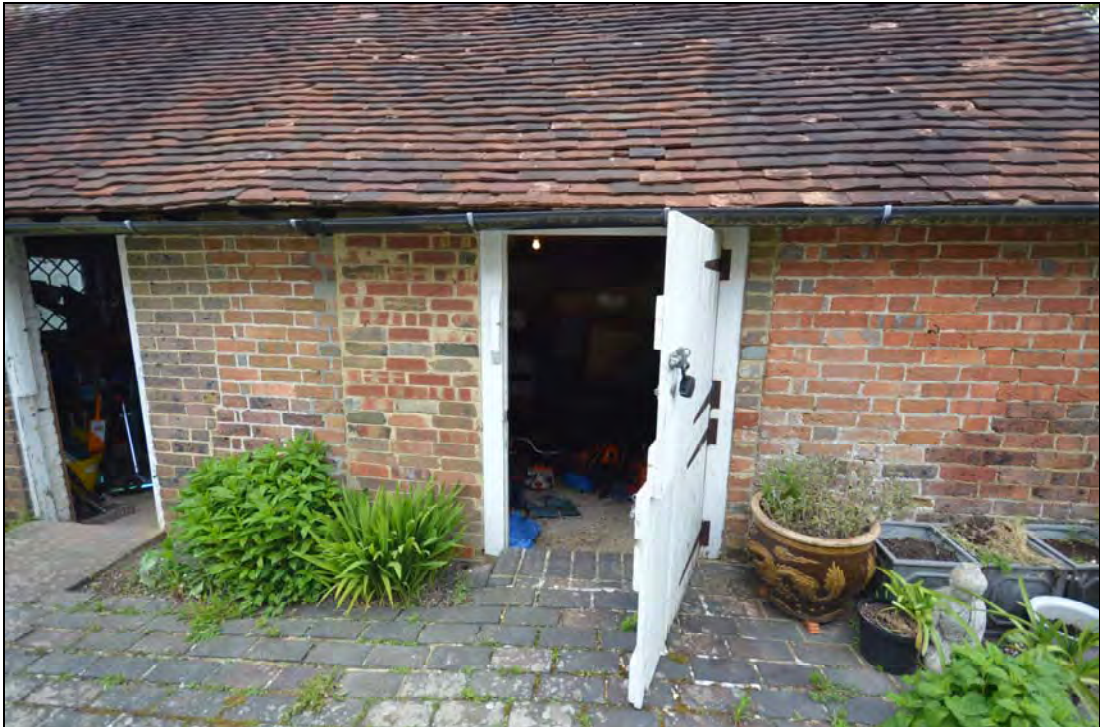
Plate 5: The south front showing Sussex bond brickwork to the east side of the current entrance

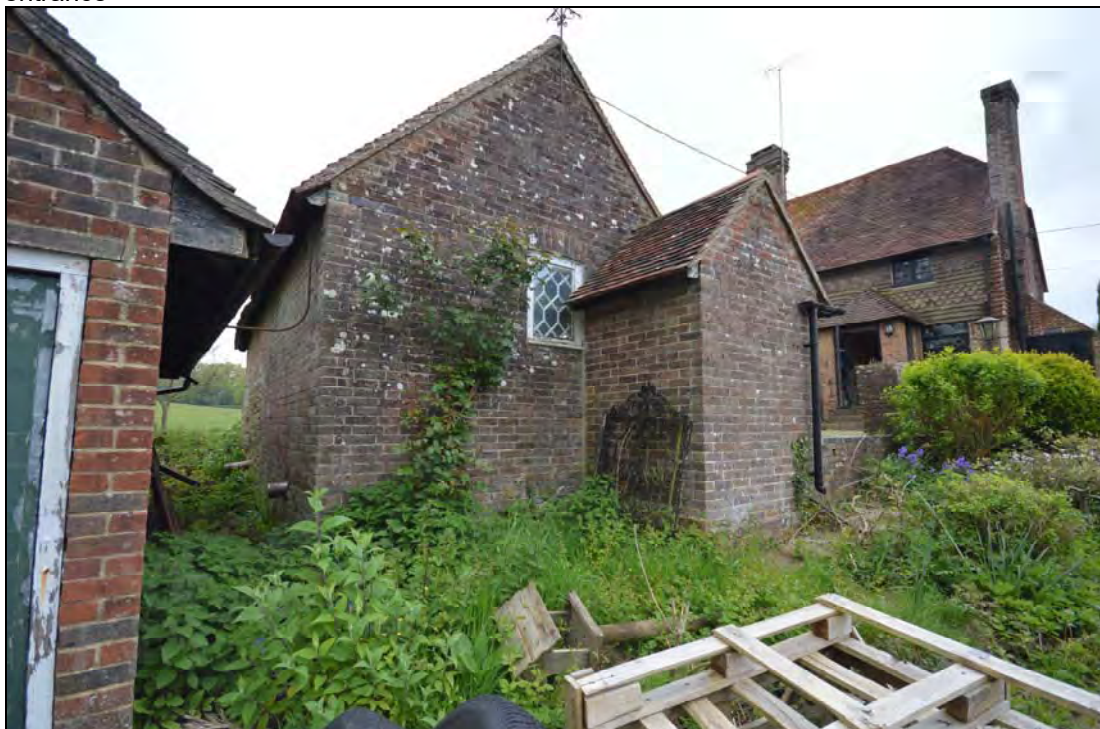
Plate 6: The new west end of the range in Sussex bond with integral single-light window

- 6.2.6 The next building campaign replaced the building to the west, an L-plan arrangement that had its north elevation set back from flush to that of the east end (Figure 5). The new west end matched the width and height of its eastern predecessor and was built in its entirety in brick laid in stretcher bond (Plate 6).

- 6.2.7 The new west end of the ancillary range included a single-width stable-type doorway on its southern side and a single-light metal framed window in its western end, the glazing embellished with lozenge-shaped quarrels, commensurate with the date of construction.
- 6.2.8 The two small extensions at the terminal ends of the building were also added between 1897 and 1911, the different fabrics utilised in the construction of the two

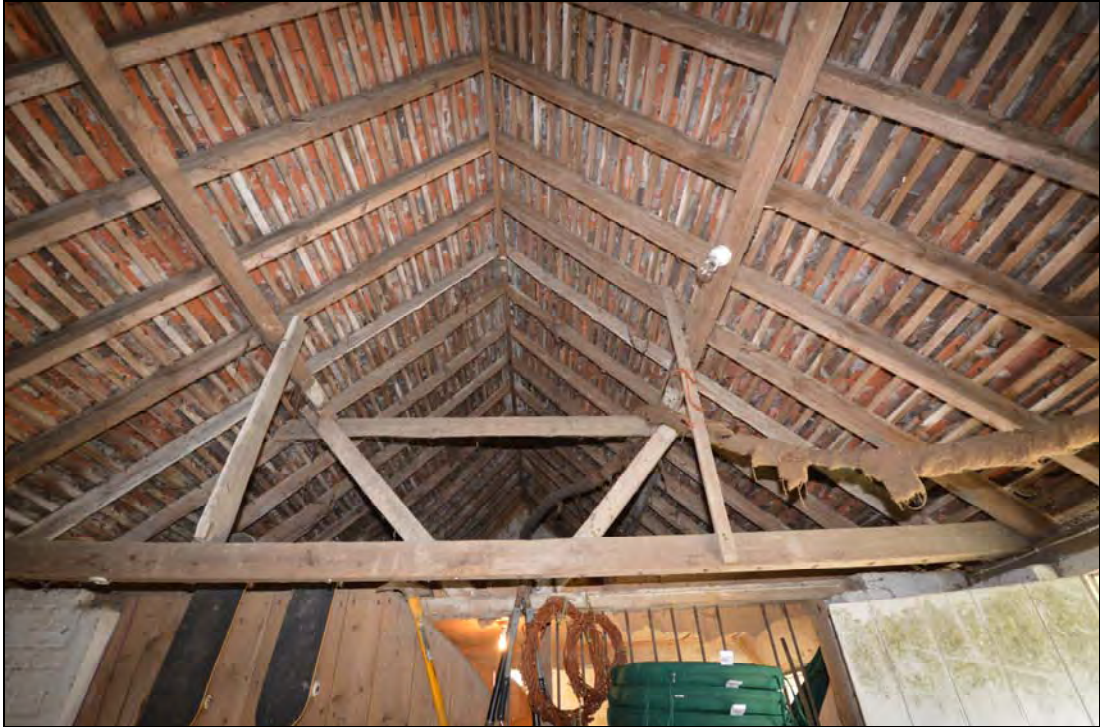
Plate 7: The consistent roof over the various parts of the main range looking east

- 6.2.9 The very late 19<sup>th</sup> or early 20<sup>th</sup> century alterations served to unite the various parts of the main range under a single roof structure: this comprises common rafter pairs terminating to each side of a central ridge board (Plate 7). The common rafters are supported over single tiers of purlins set at right angles to the roof, the latter strengthened by nailed on collars and struts.

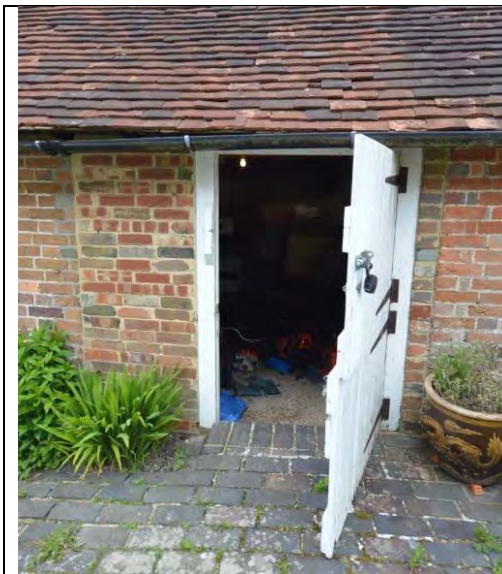
Plate 8: The modern infill on the south front

- Infill of the remaining open area on the south front, to the eastern end unit of the main range (Plate 8)
- Insertion of windows into the east end of the main range and the north side of the east extension
- The insertion of two timber stall partitions within the main range of the building
- The insertion of a loft at the east end of the range
- The insertion of a doorway between the east unit of the main range and its eastern extension
- Refinishing of the floor in concrete
- Repairs to the roof

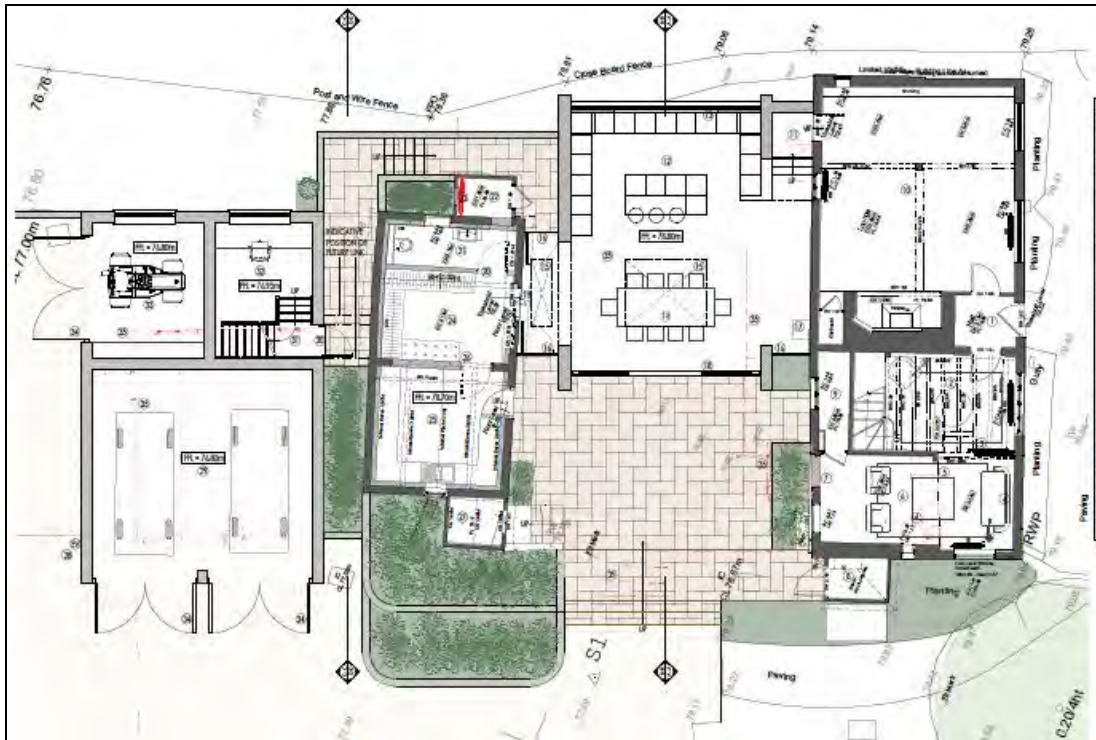
Plate 9: Detail of the proposal scheme (Gould Baxter Drawing No. GH553 PL.03)

8.3.6 The proposed single-storey extension to the rear of the house replacing part of the existing 20<sup>th</sup> century brick surface that extends from the house to the ancillary range. The extension measures 8.70 north – south by 7.40 metres east – west (external measurements). The addition is off-set from the eastern end of the house by 0.80 metres and 5.00 metres from the west end and is surmounted by a flat 'green' roof (Plate 9; Appendix 2). The extension encompasses a current well complete with pump that abuts the rear of the house.

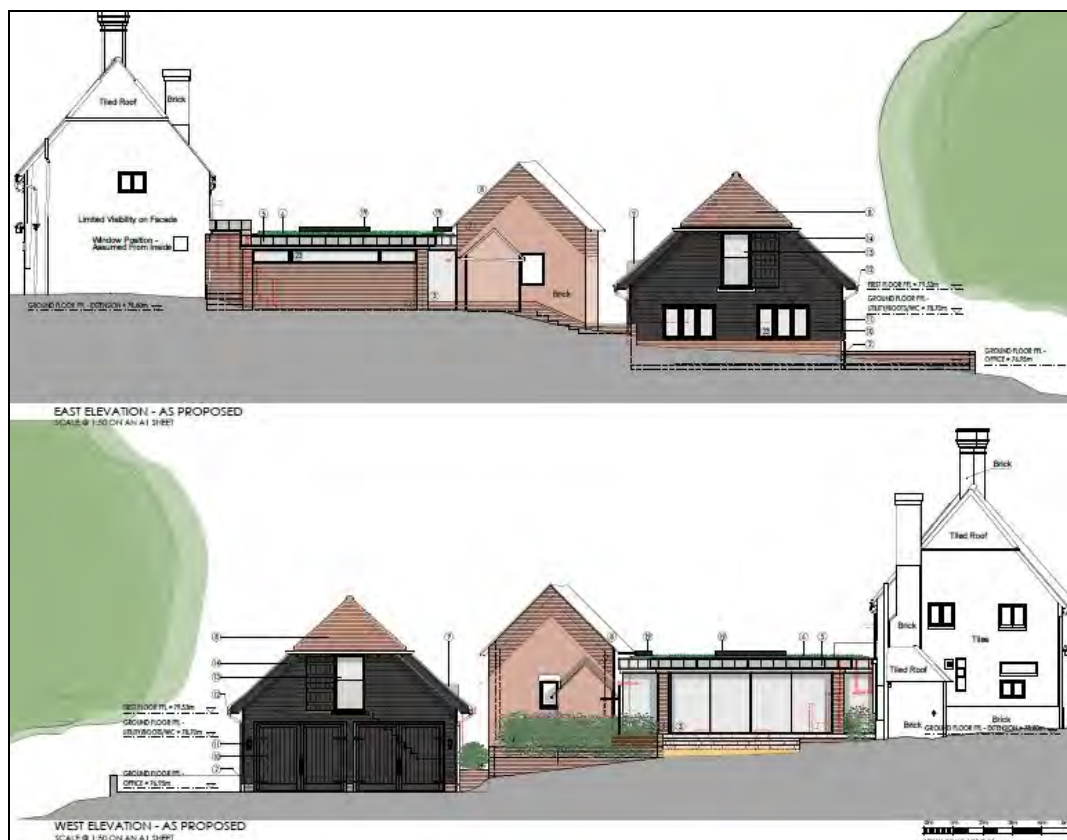
Plate 10: The materials and new roof-line proposed for the new work (Gould Baxter Drawing No. GH553 PL.05)

- 8.3.14 The metal border to the green roof is discrete and the green roof itself will enhance the views from the upper floor of the house through the replacement of the extensive hard brick surface that currently occupies that location.

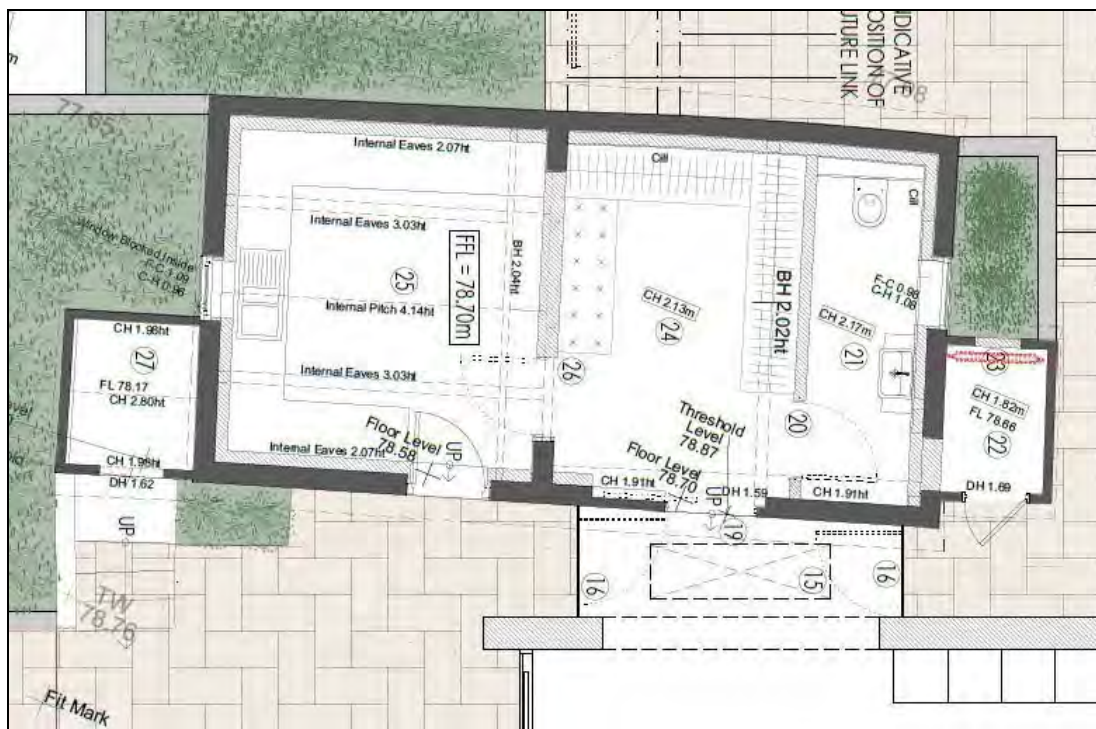
Plate 11: Interior alterations proposed for the north ancillary range (Gould Baxter Drawing No. GH553 PL.03)

**Interior – alterations to east doorway (Plate 11)**

- 8.3.24 It is proposed that the existing inserted doorway in the south elevation of the southeast unit is replaced with a sliding door. The changes are situated within the most recent infill to the south front of the ancillary range and can be achieved without harm to the special character and significance of this small curtilage-listed building.

*Remove inserted window in the north elevation of the east extension (Plate 11)*

- 8.3.26 The window is a later insertion, however, it is recommended that any blocking is offset to allow the evidence for the later evolution of this small ancillary building to remain legible.

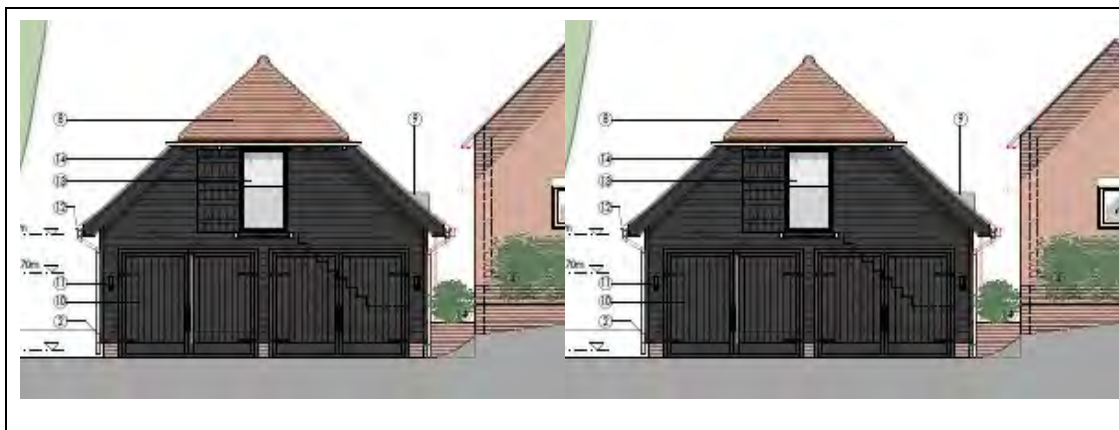
Plate 12: The proposed replacement garage (Gould Baxter Drawing No. GH553 PL.05)

5. Replace the existing garage (Plate 12)

- 8.3.29 A previously proposed link between the ancillary buildings (including partial demolition of that building) has been designed out of the proposal scheme. The replacement garage building occupies the same site as existing and extends no further towards

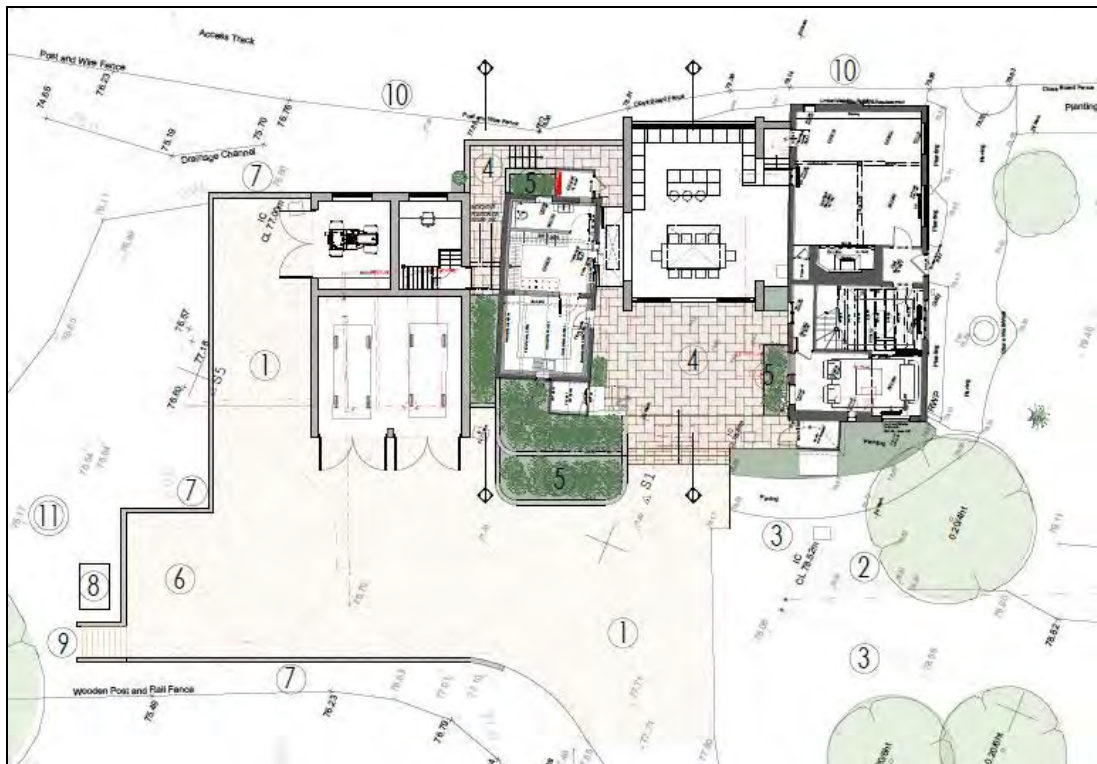
Plate 13: Proposed landscaping (Gould Baxter Drawing No. GH553 PL.02)

8.3.32 A programme of landscaping is proposed to improve access and parking provisions at the property (Plate 13). The remodelled driveway will be finished in a permeable crushed stone, stone paving is proposed for terracing and paths and low-level retaining walls are in brick (Plate 13). The palette of materials draws from those already present on the site: the masonry and brick extant in both historic buildings, in order to create a coherent and cohesive appearance to the property as it continues to evolve to meet new needs.

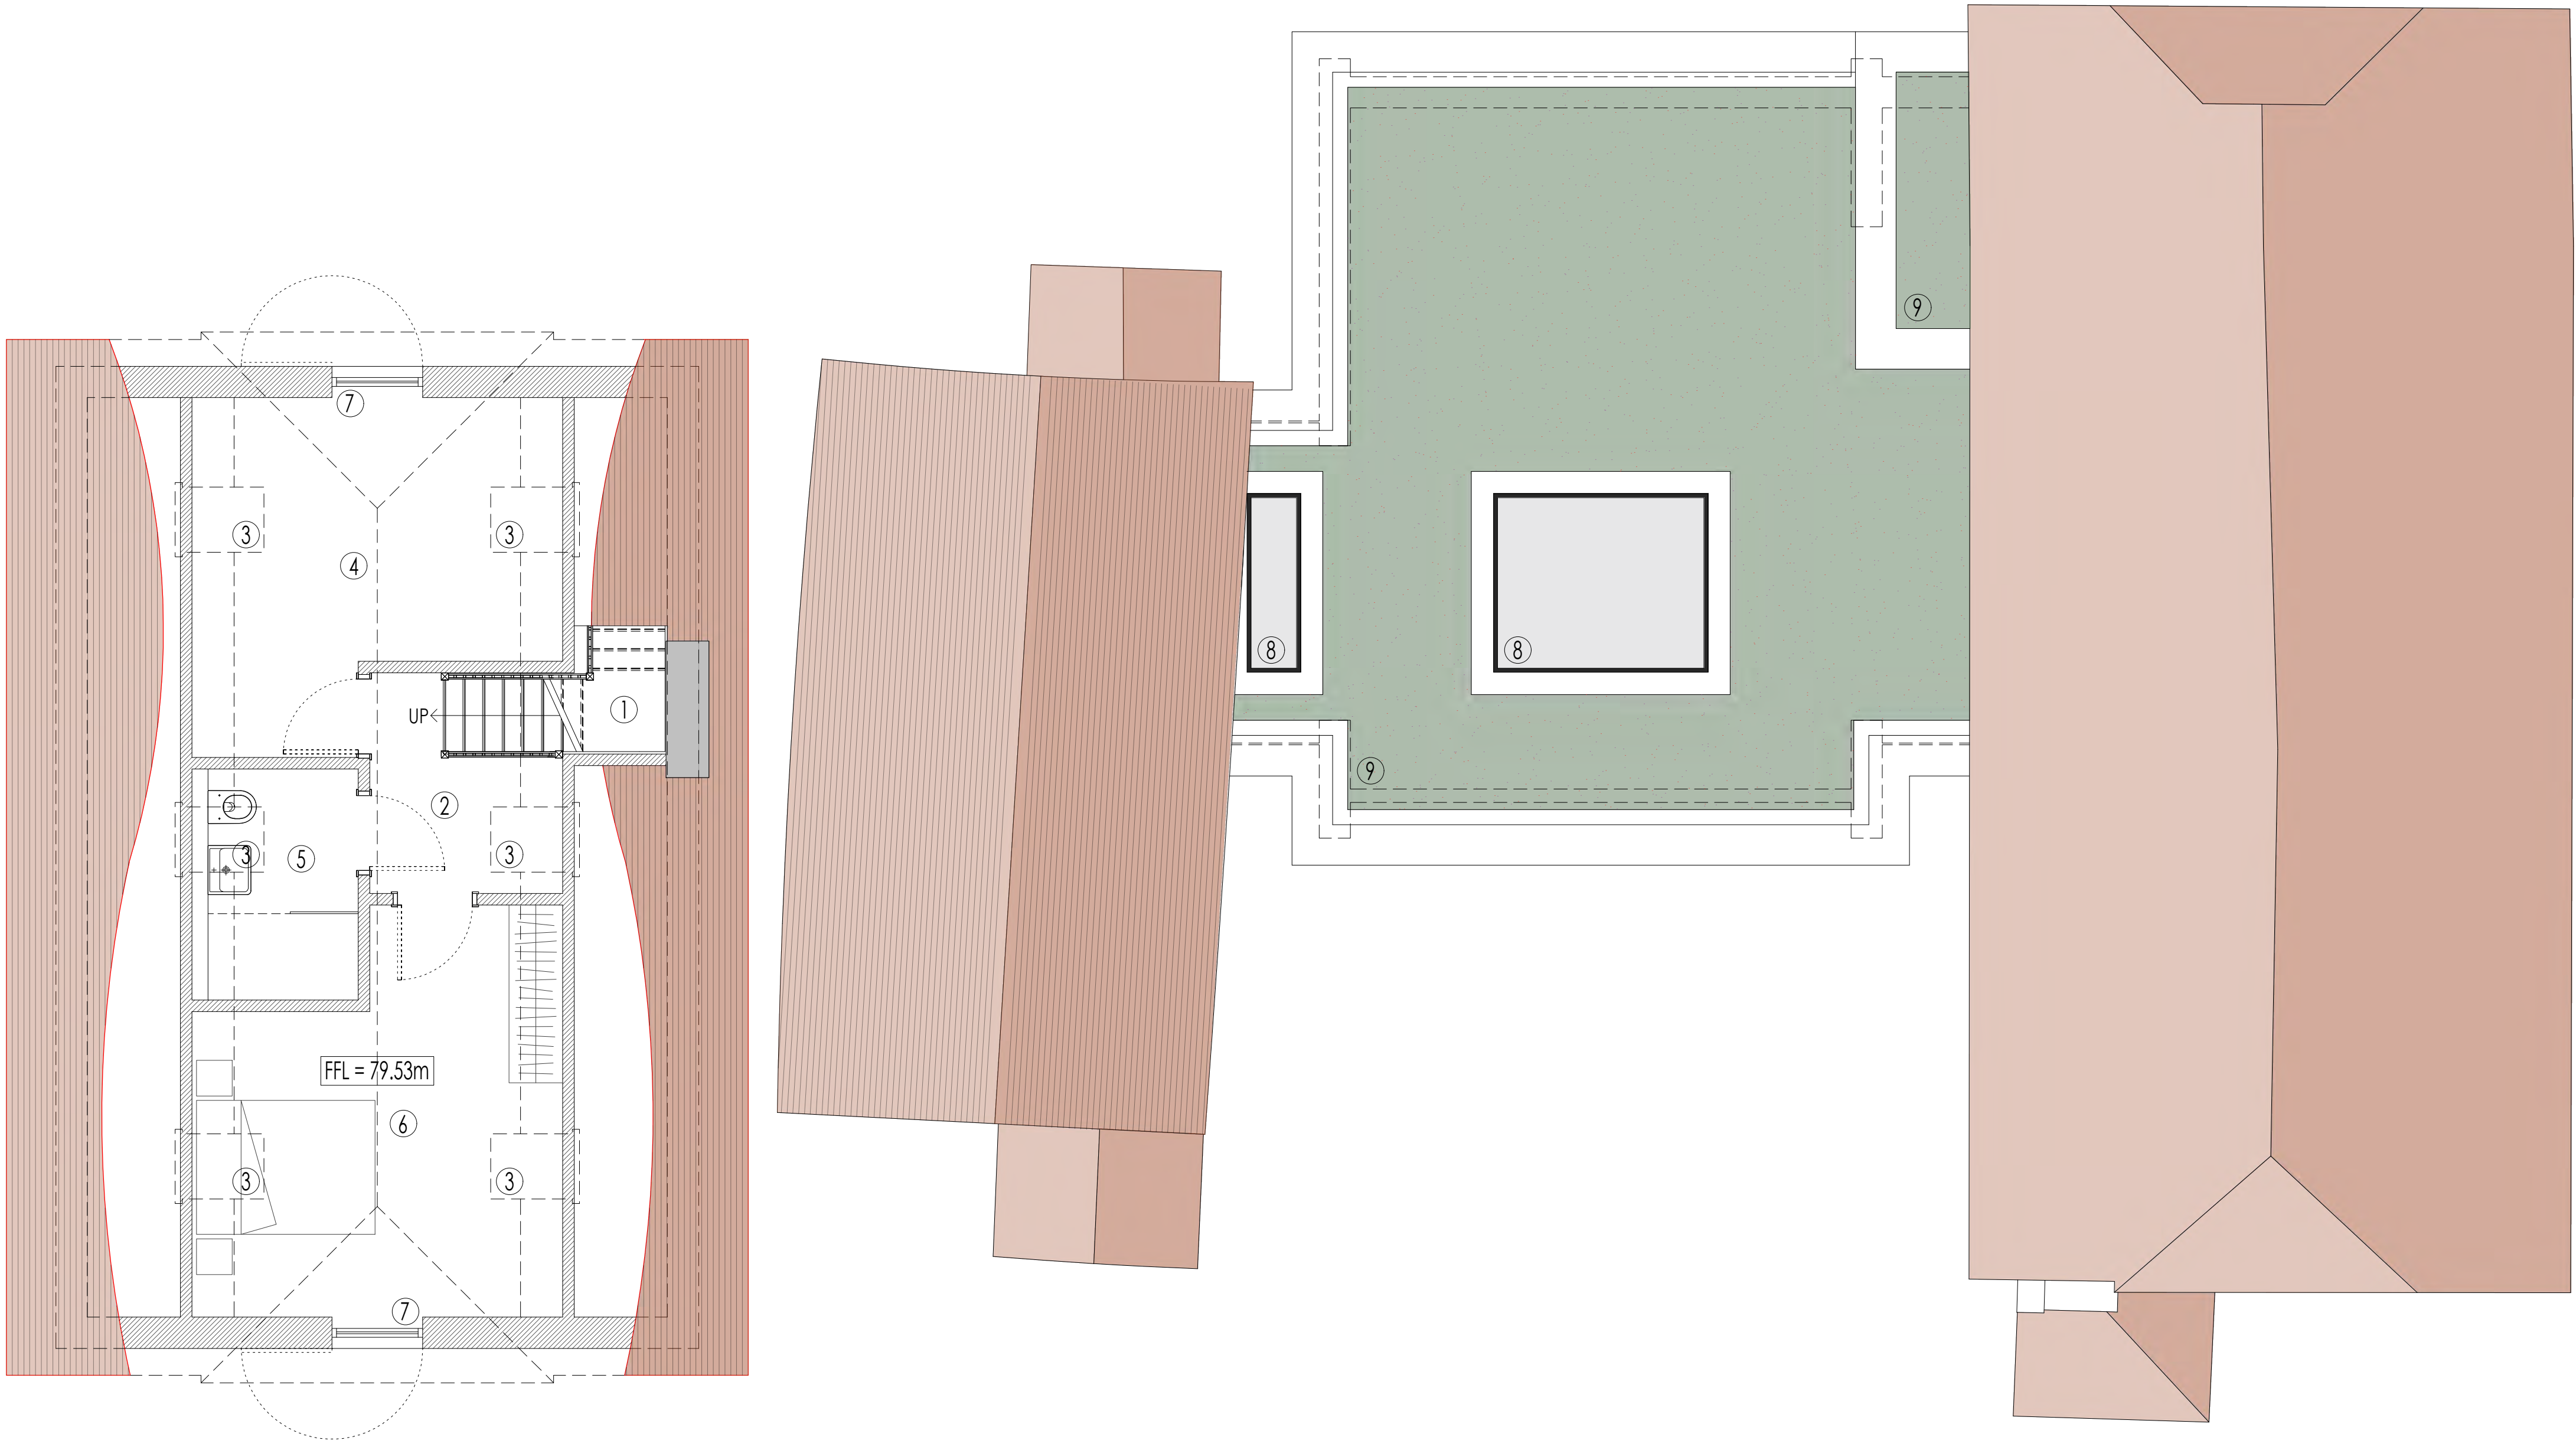
- First Floor Floor Plan Key:
- 1 - New Staircase
  - 2 - Landing
  - 3 - Conservation Roof Window
  - 4 - Store Room
  - 5 - Shower Room
  - 6 - Bedroom
  - 7 - Window set within stable door
  - 8 - Roof Lantern
  - 9 - Green Roof

FIRST FLOOR GENERAL ARRANGEMENT - AS PROPOSED  
SCALE @ 1:50 ON AN A1 SHEET

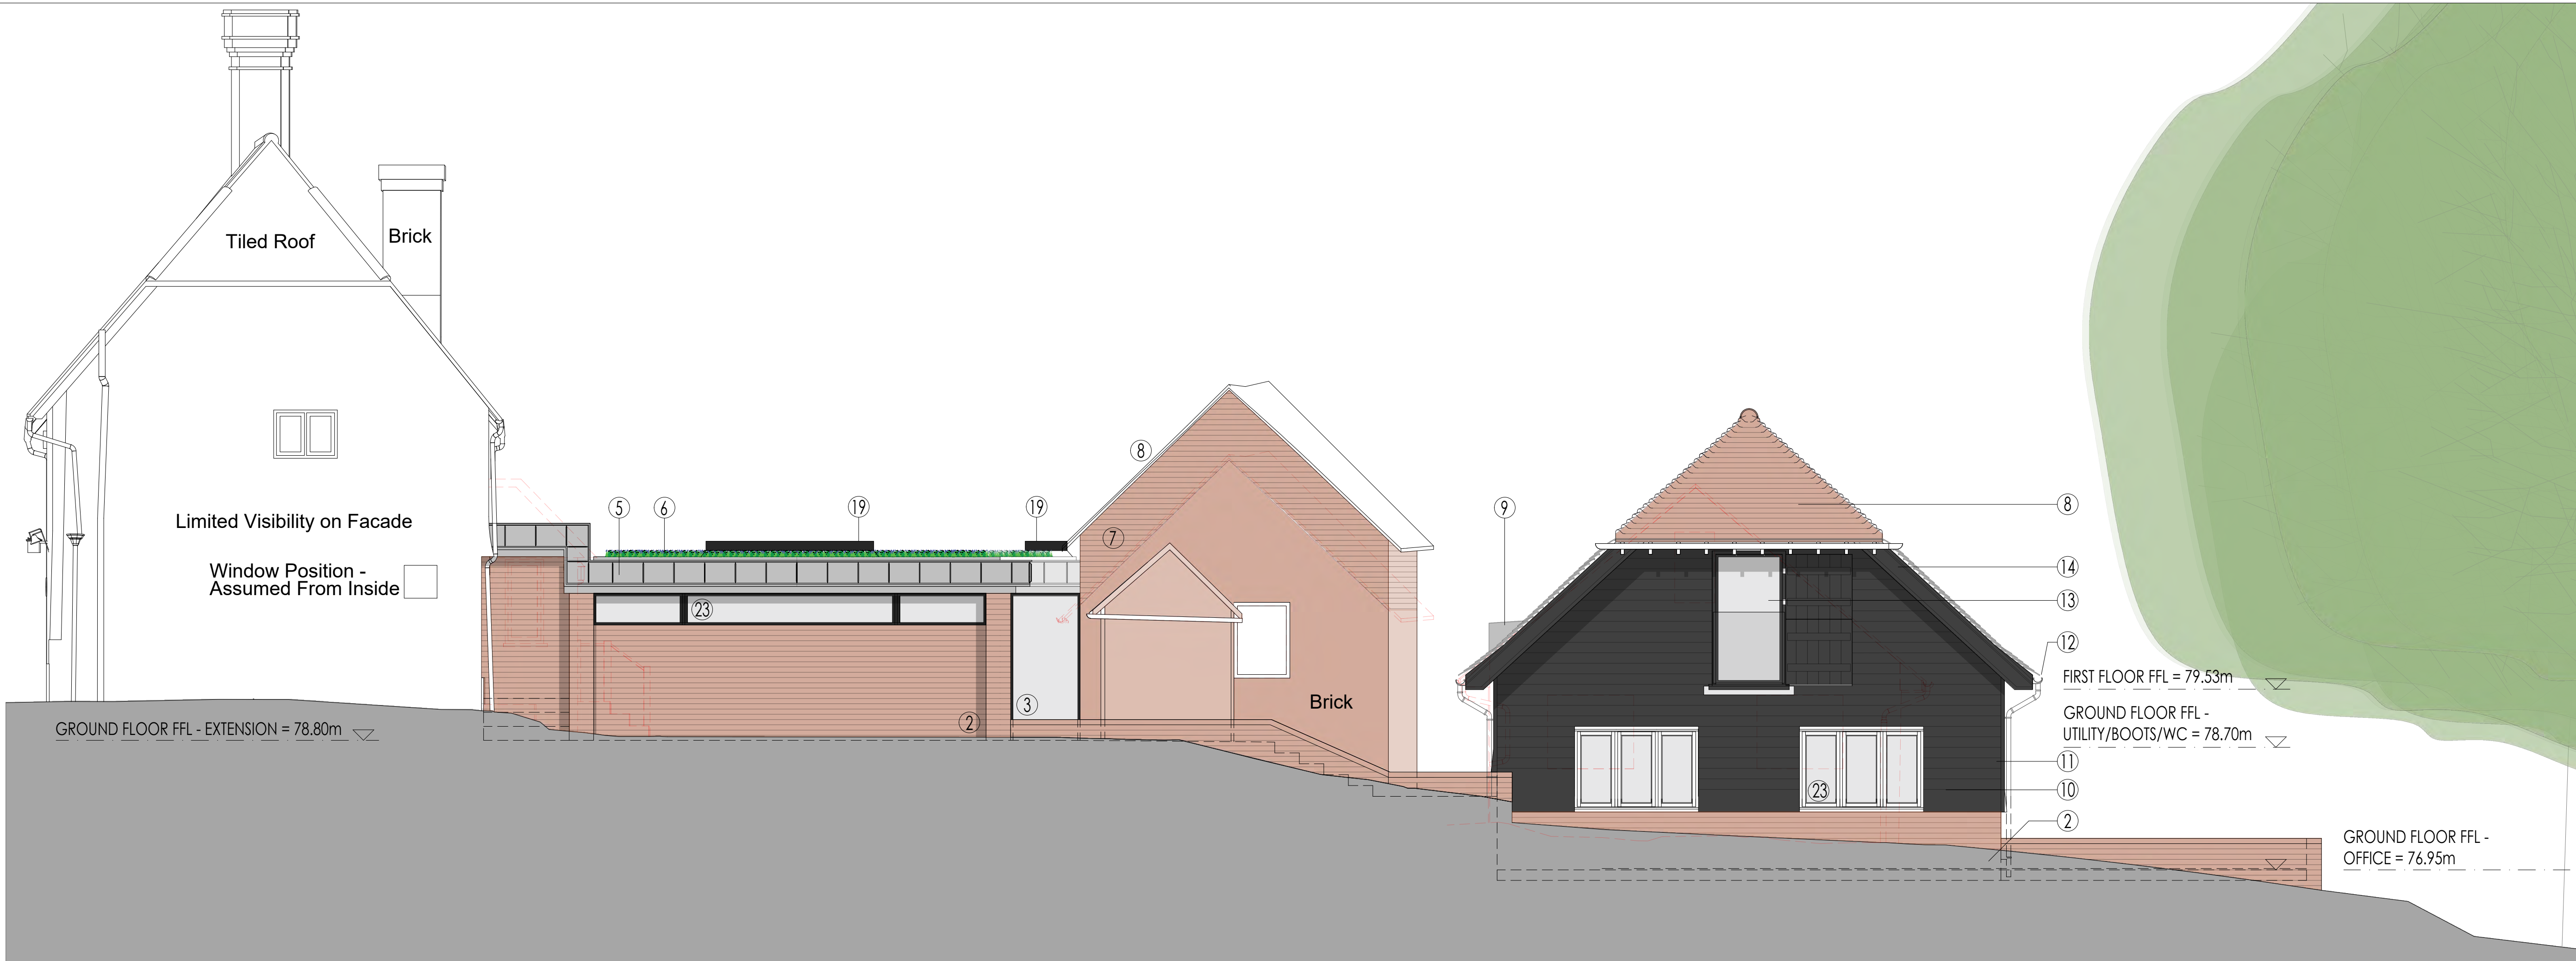
EAST ELEVATION - AS PROPOSED  
SCALE @ 1:50 ON AN A1 SHEET
