# HB Archaeology & Conservation Ltd

BARLANDS, THE STREET, WARNINGLID, WEST SUSSEX, RH17 5SZ  
(NGR: TQ 24636 25554)

## HERITAGE STATEMENT

REPORT NO. 2024582  
November 2024

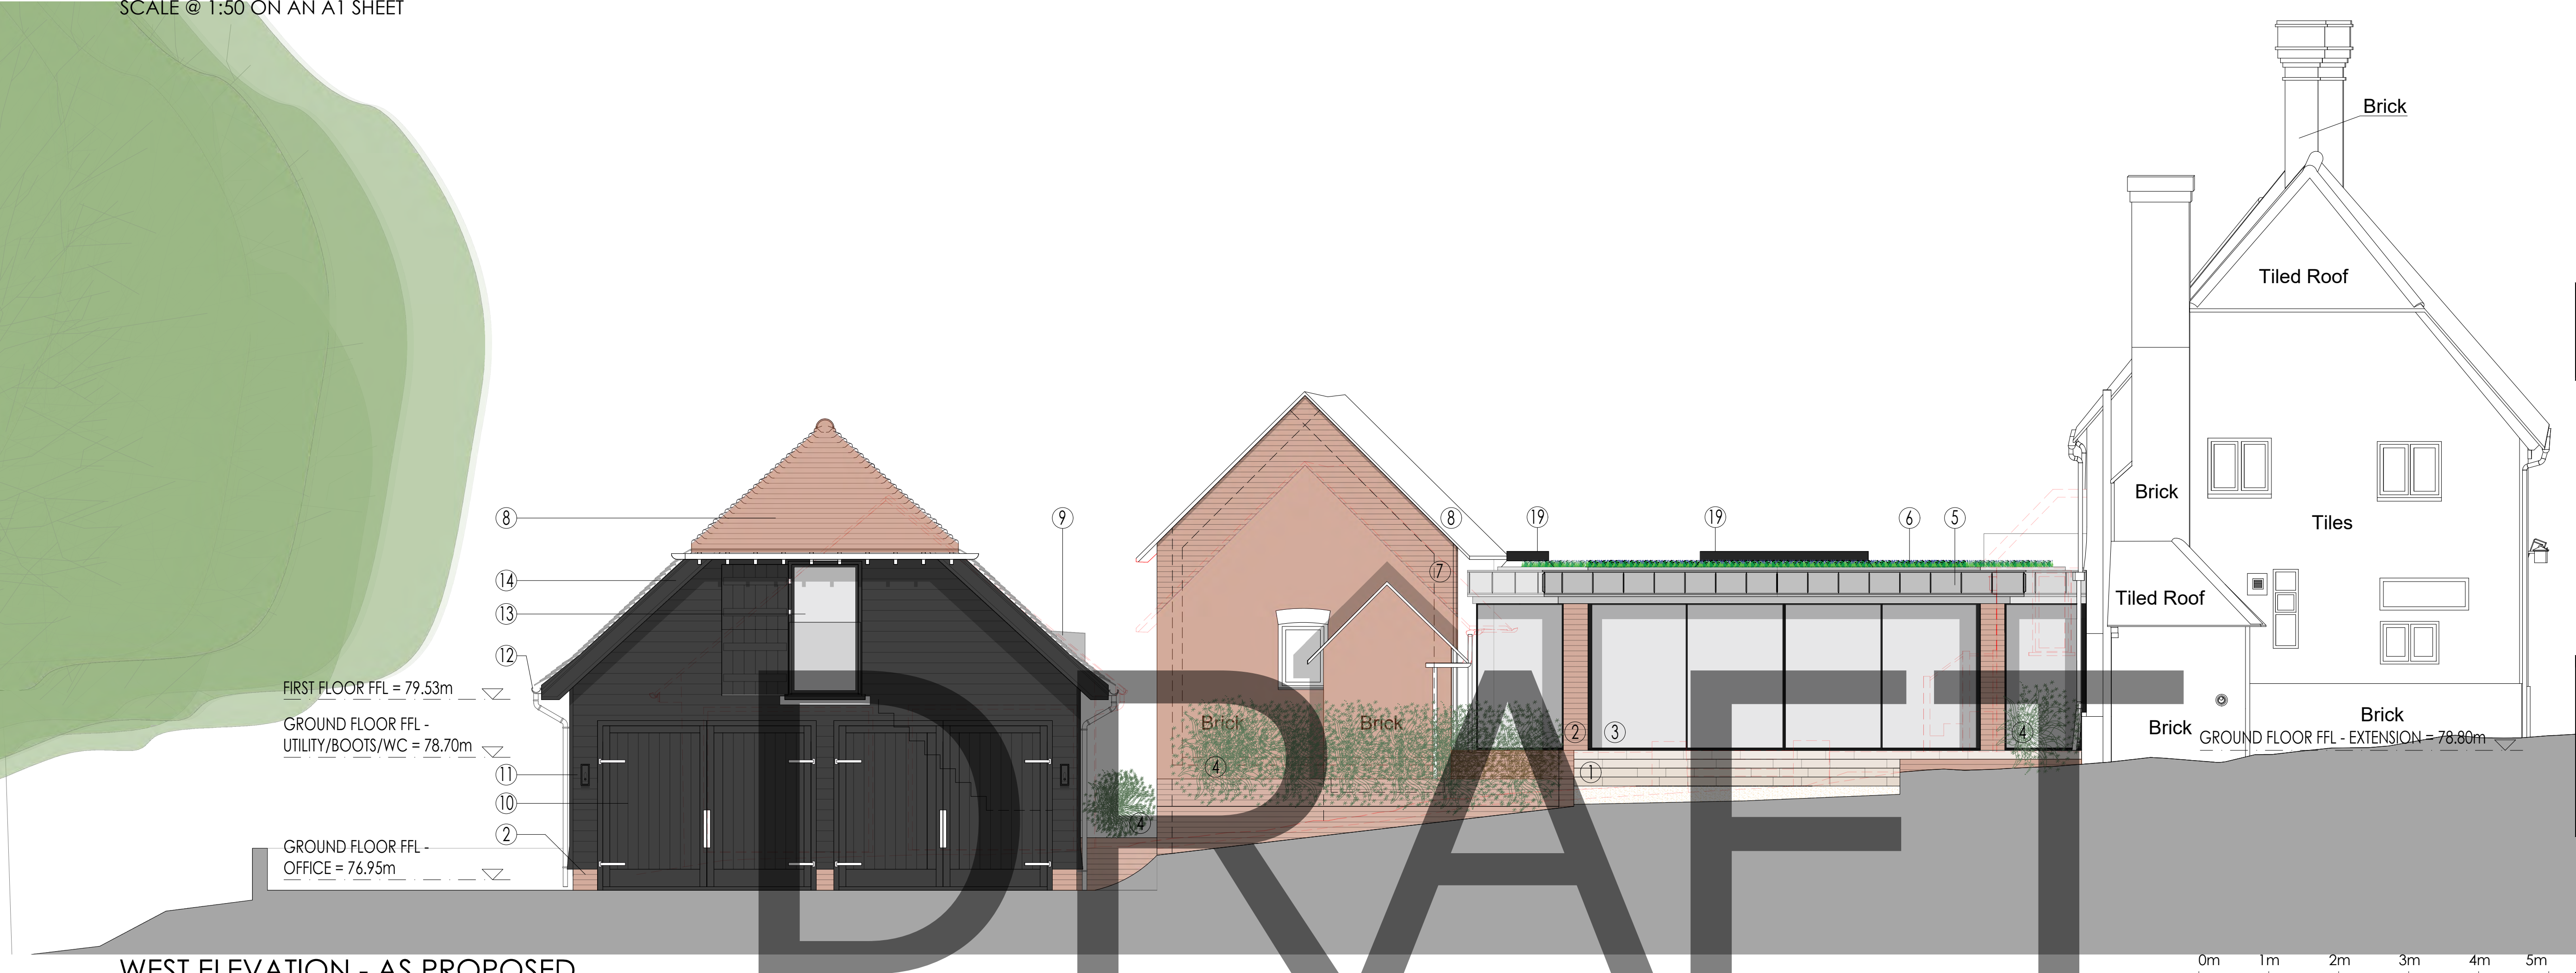
WEST ELEVATION - AS PROPOSED  
SCALE @ 1:50 ON AN A1 SHEET

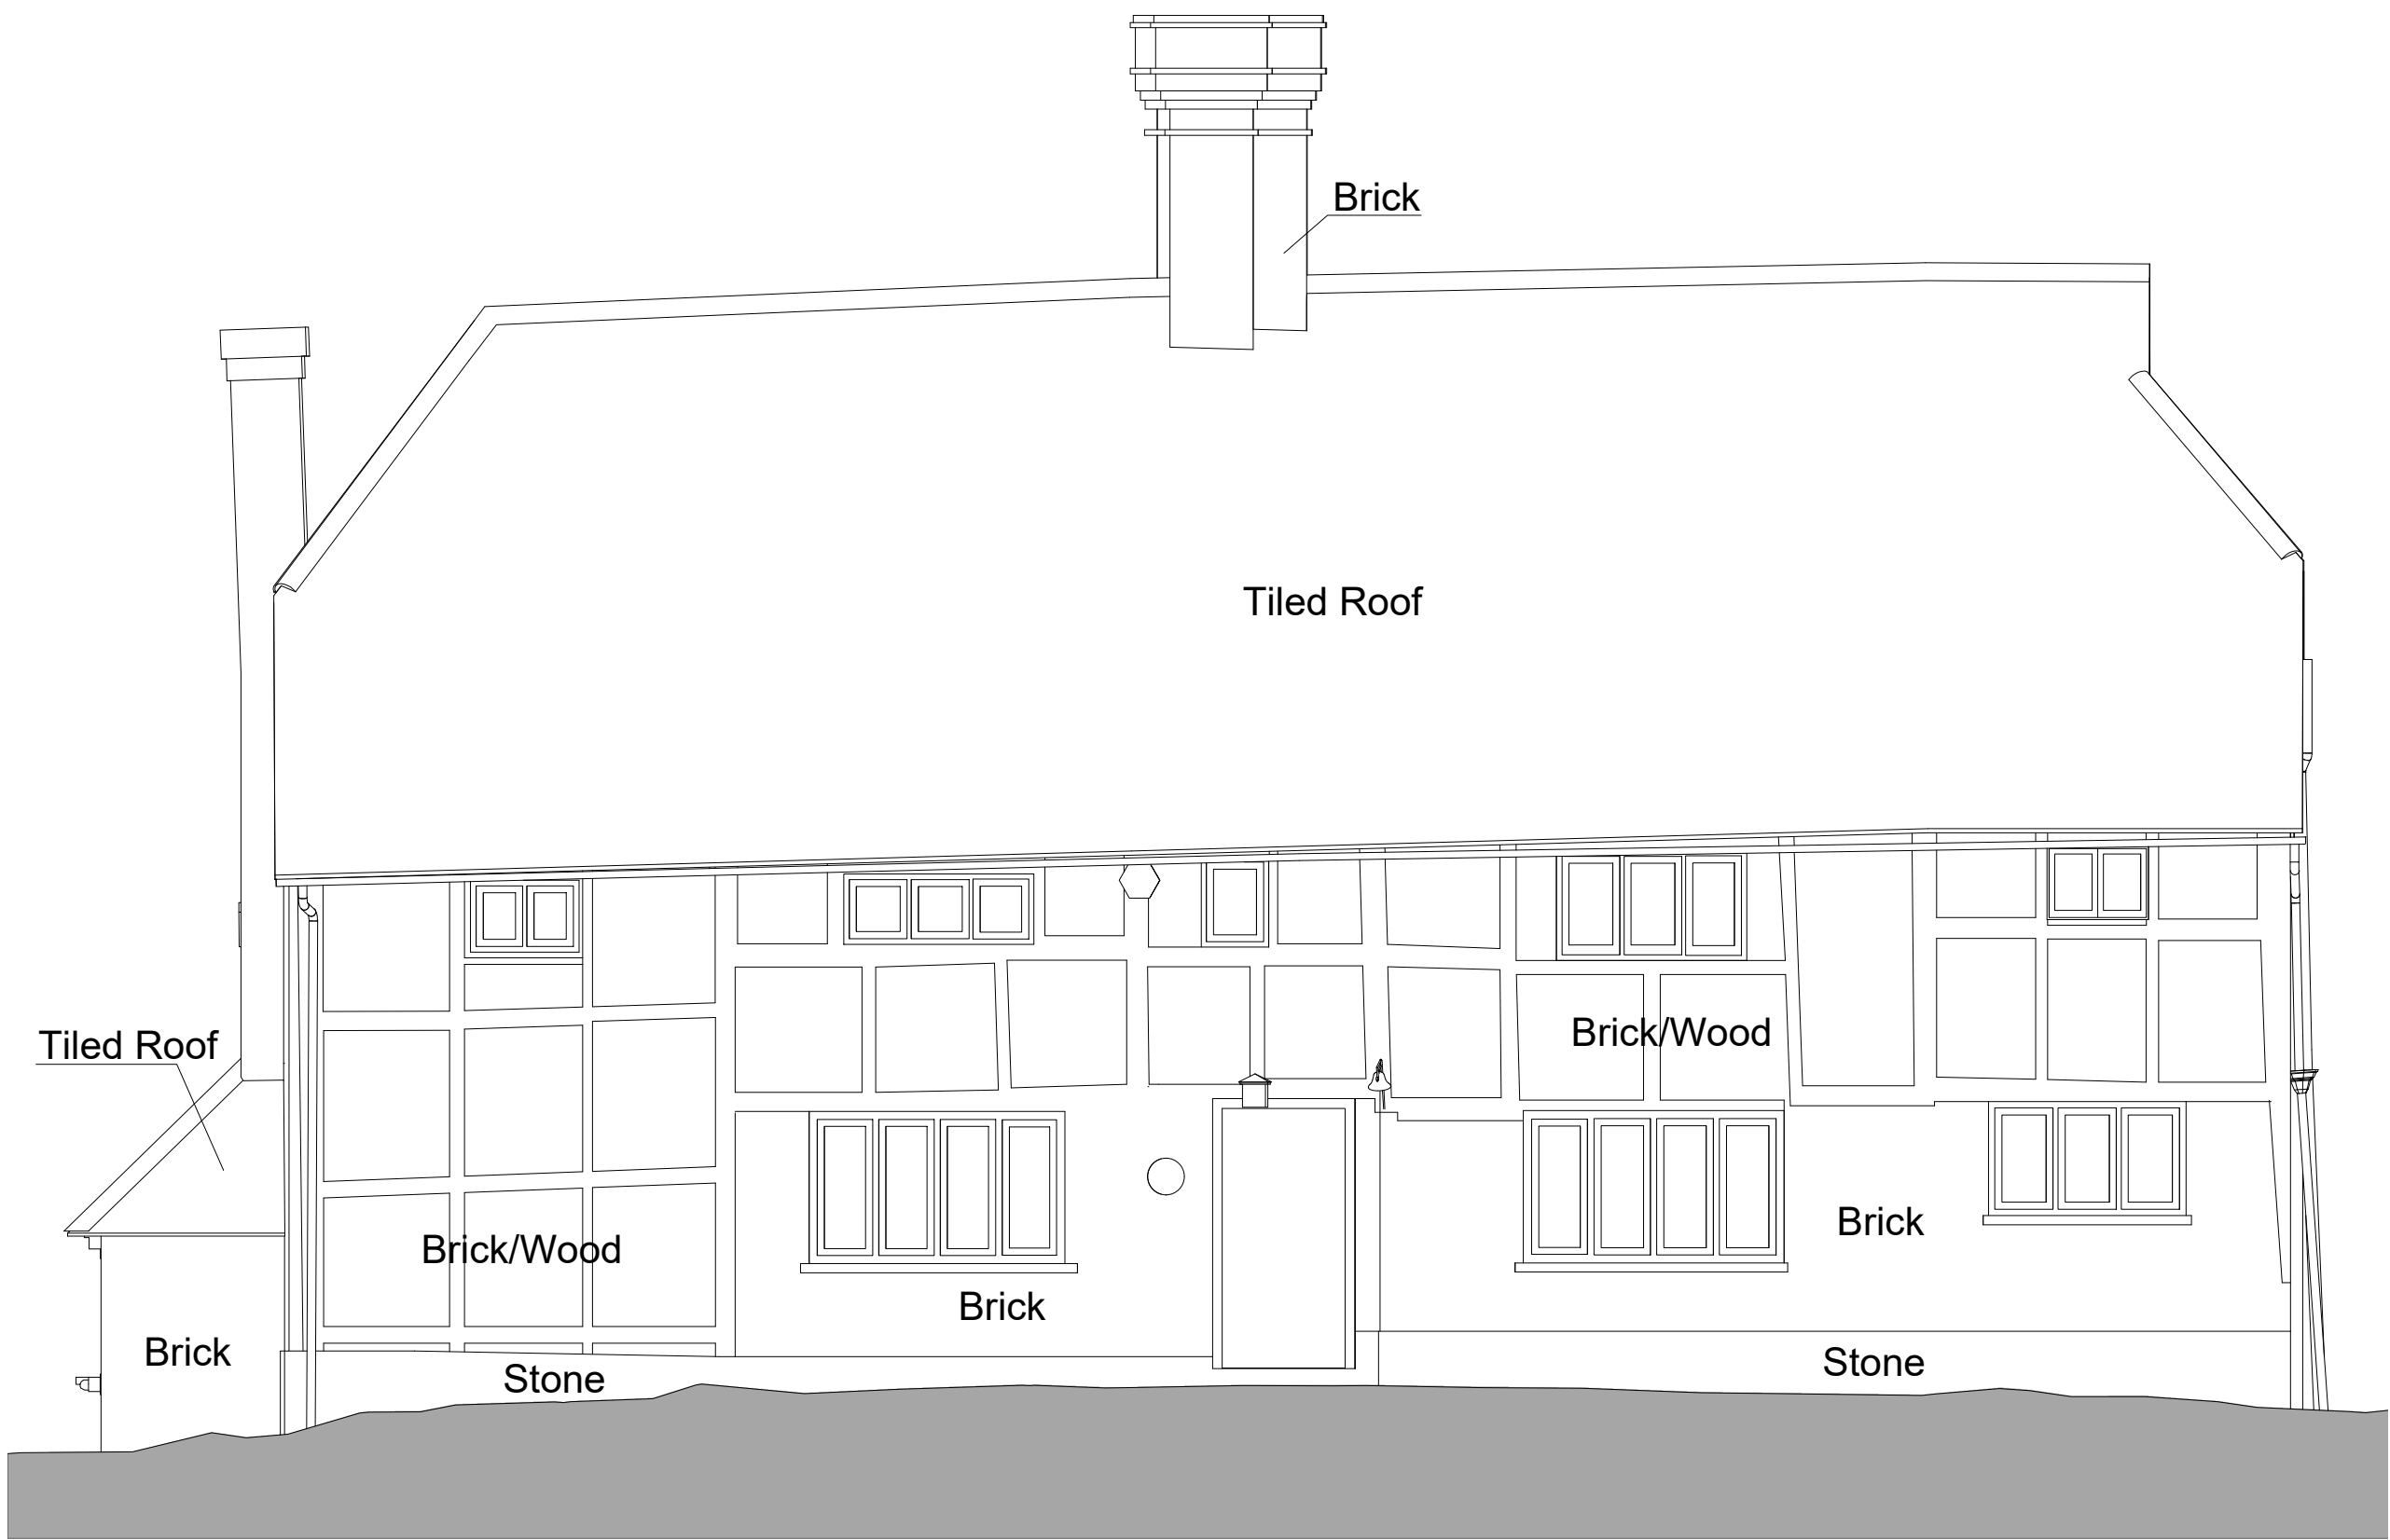
SOUTH ELEVATION - AS PROPOSED  
SCALE @ 1:50 ON AN A1 SHEET

- Elevation Key:
- 1 - Natural stone to steps
  - 2 - Facing brick to match existing
  - 3 - Narrow profile aluminium windows and sliding doors, anodised in black

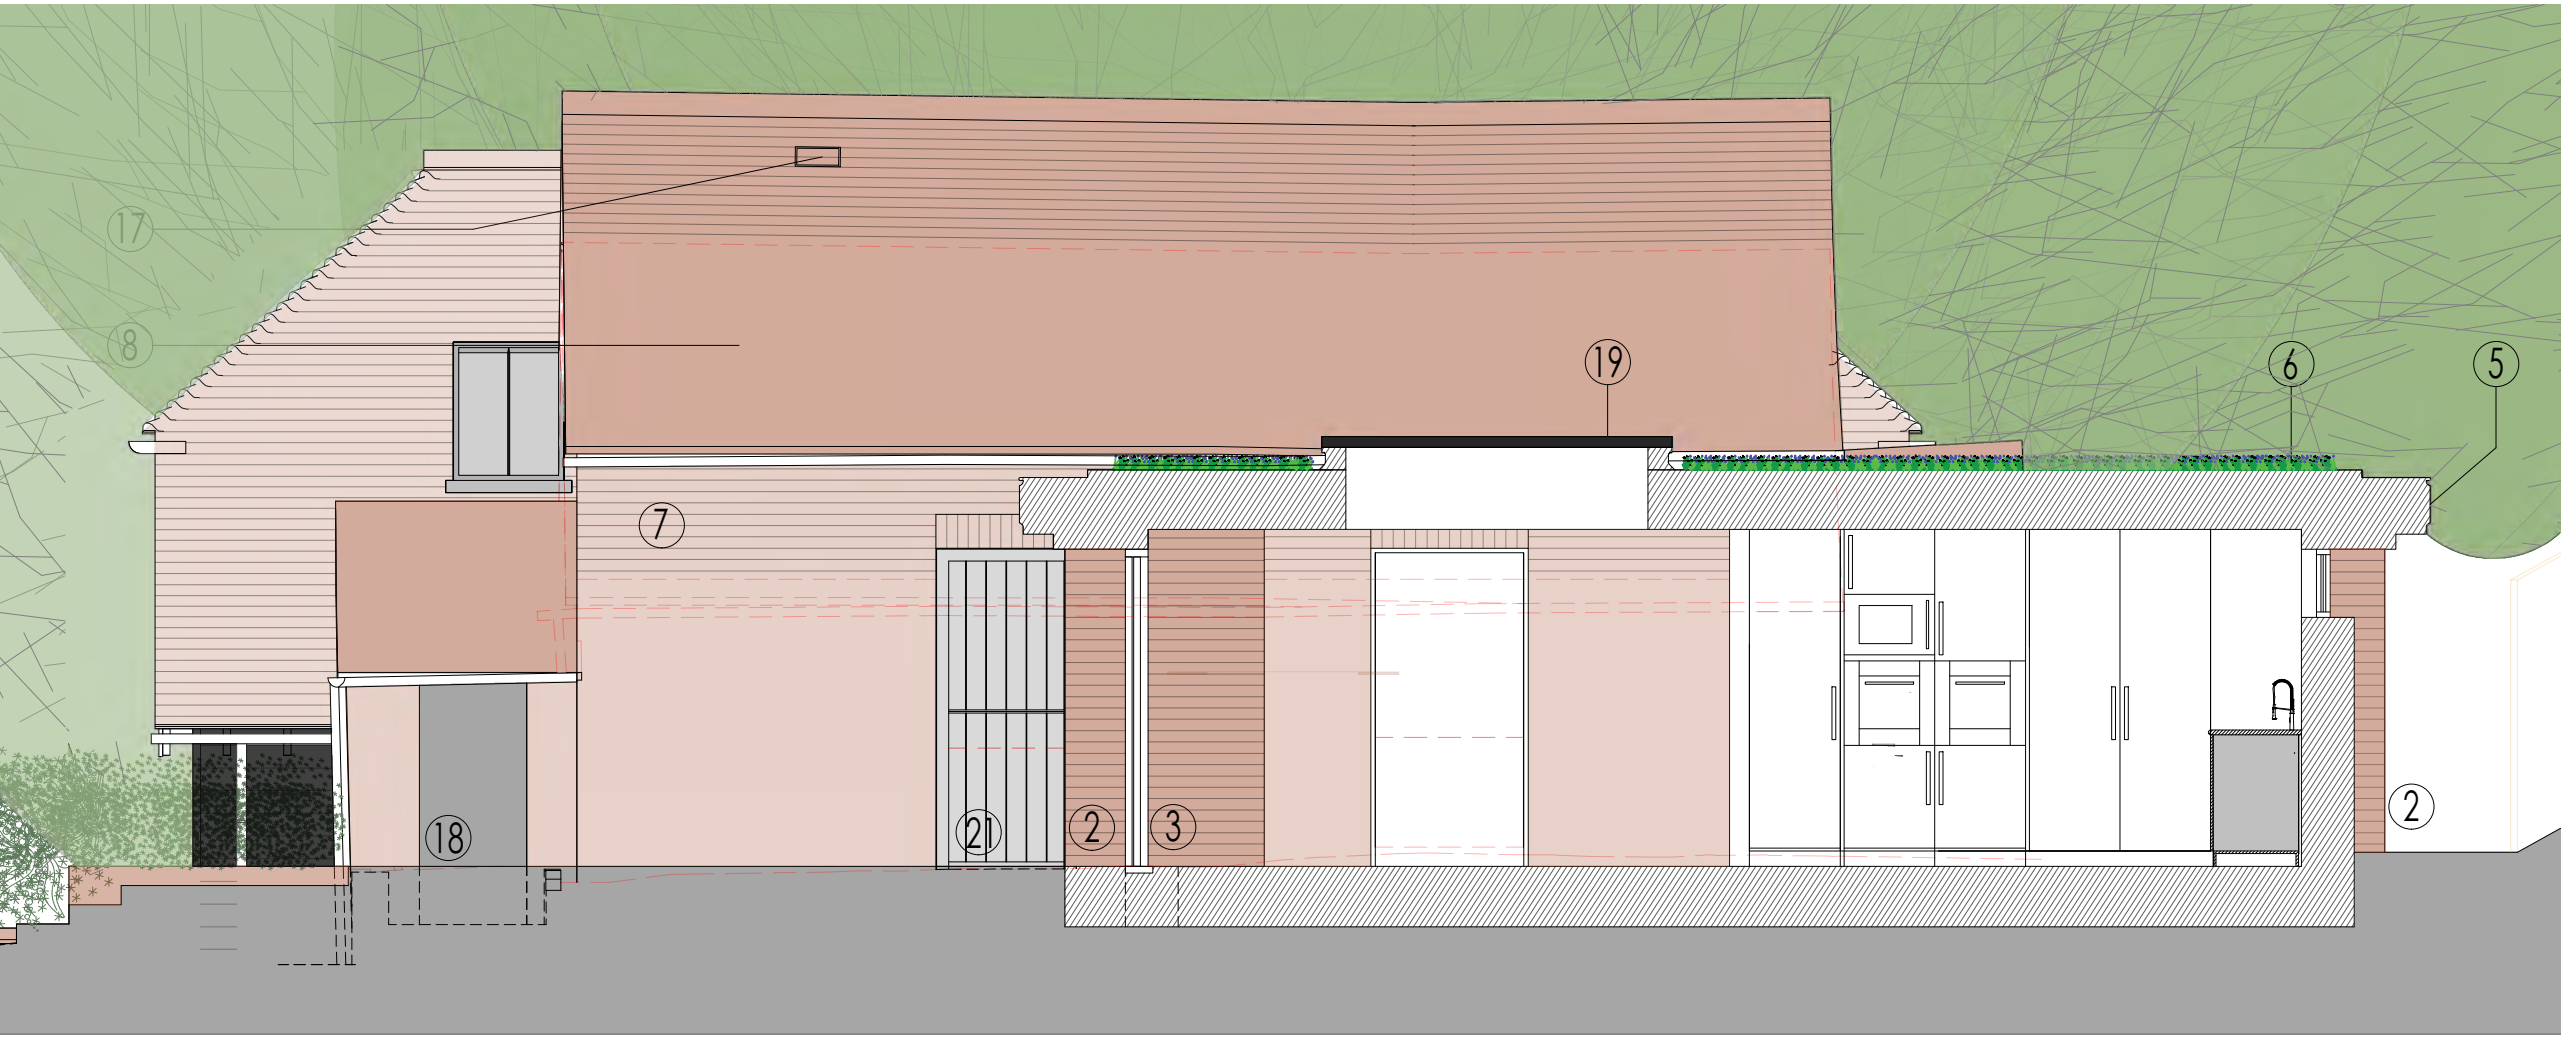
SECTIONAL ELEVATION B-B - AS PROPOSED  
SCALE @ 1:50 ON AN A1 SHEET

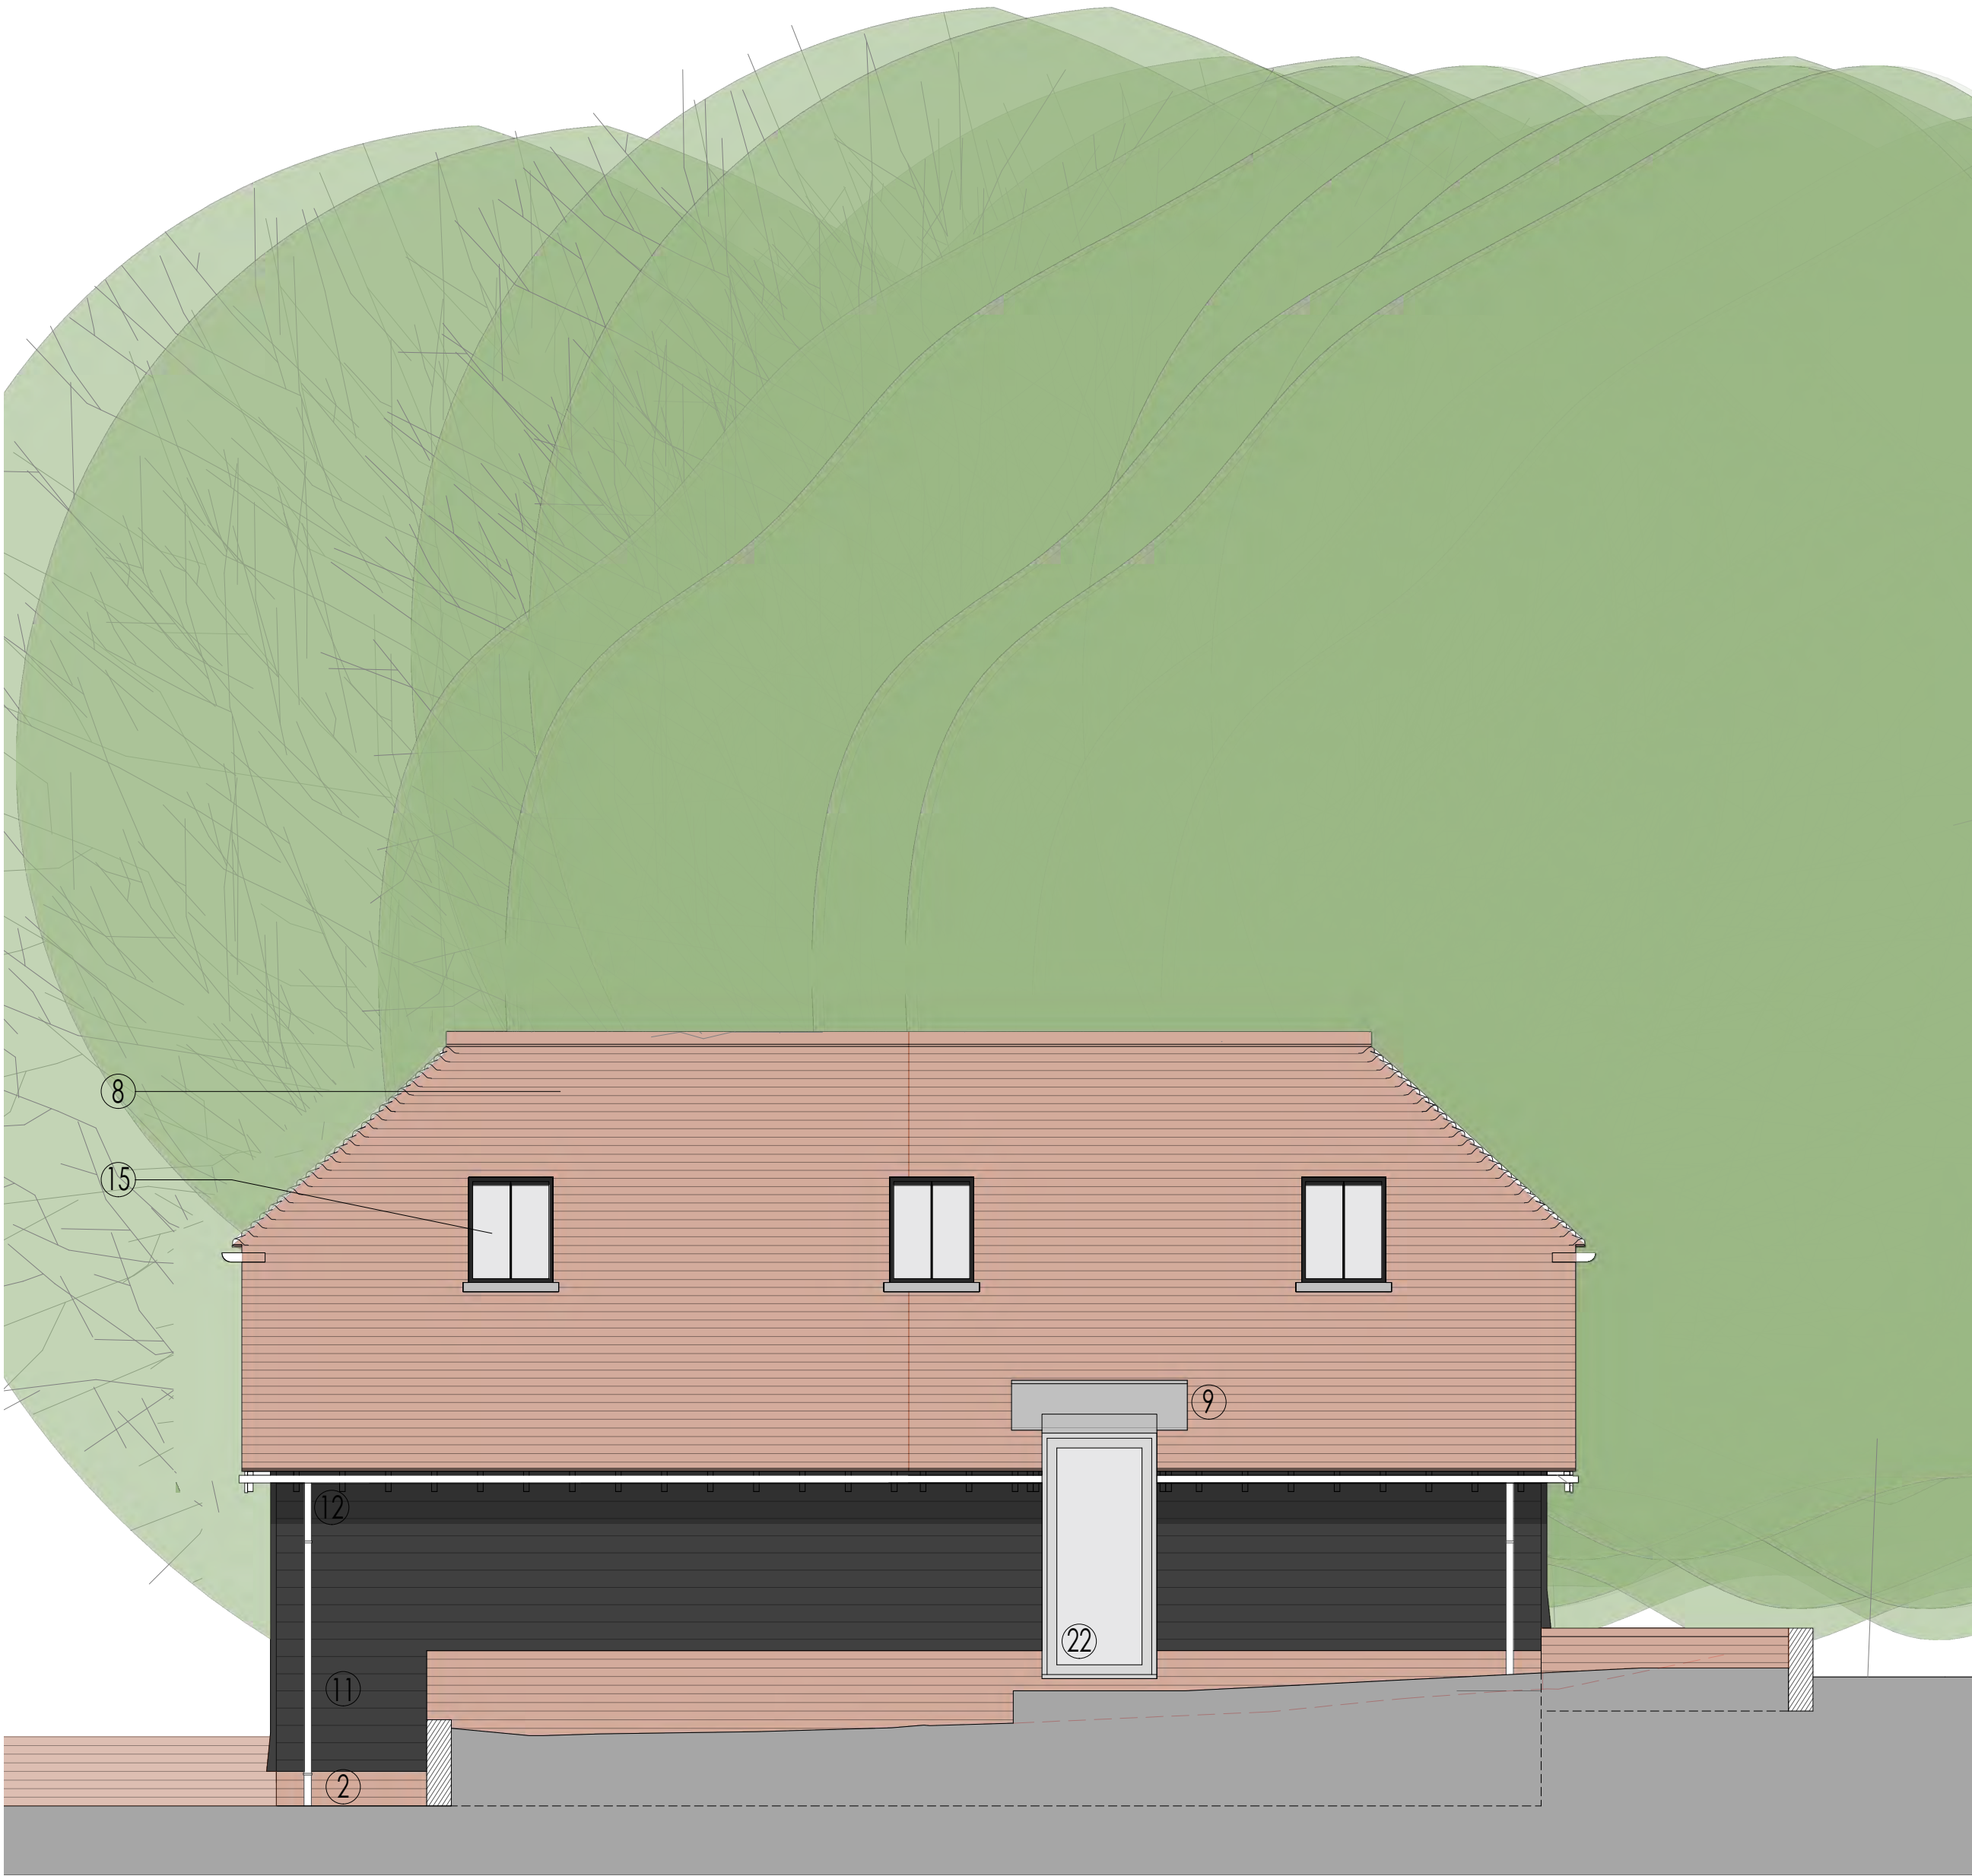
SECTIONAL ELEVATION C-C - AS PROPOSED  
SCALE @ 1:50 ON AN A1 SHEET

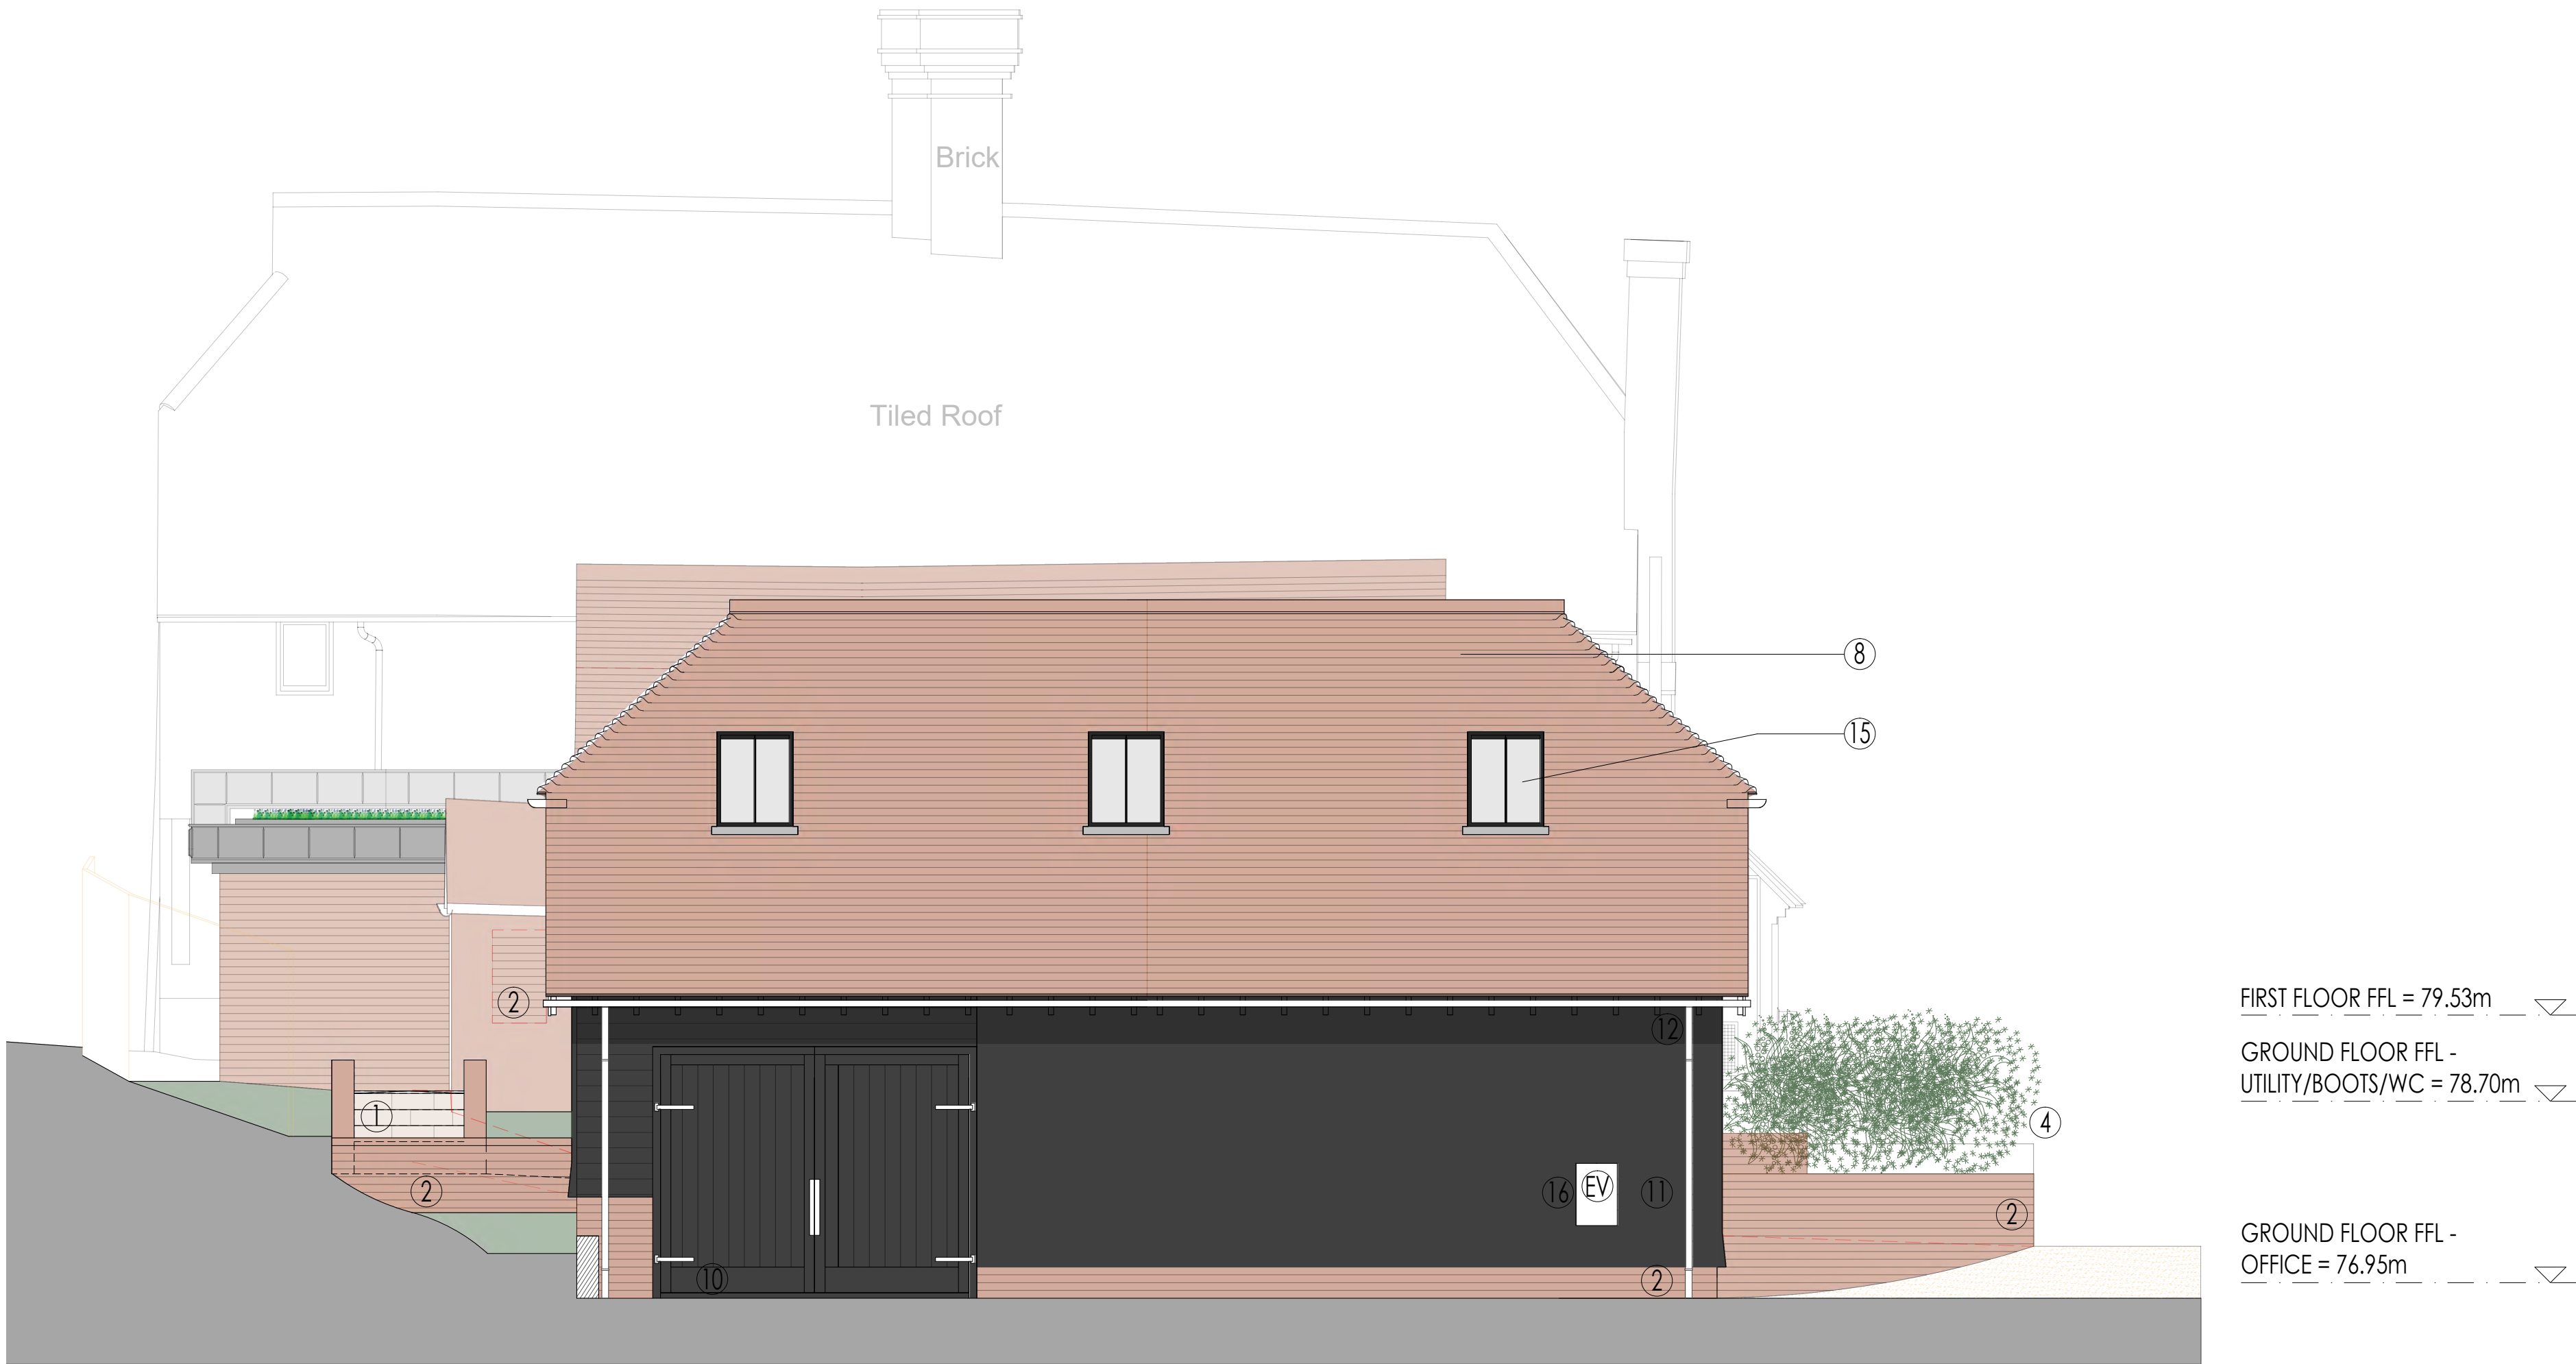
NORTH ELEVATION - AS PROPOSED  
SCALE @ 1:50 ON AN A1 SHEET
