# Gibbshaven Farm – East Grinstead

## Schedule of Works – Barn and Granary

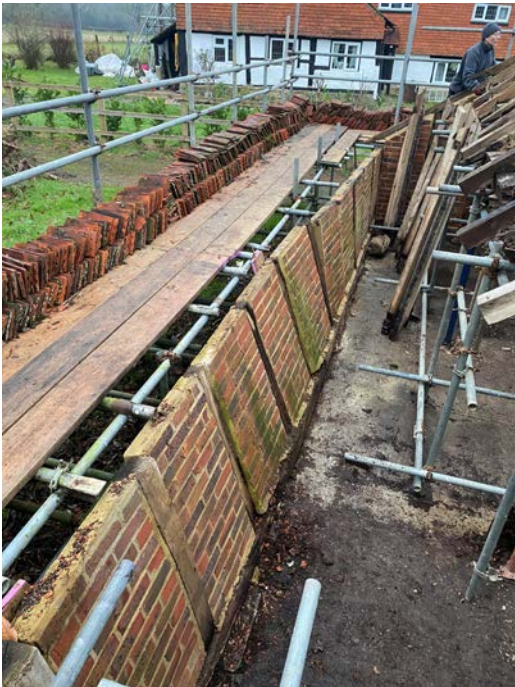
collapsed wall with roof removed

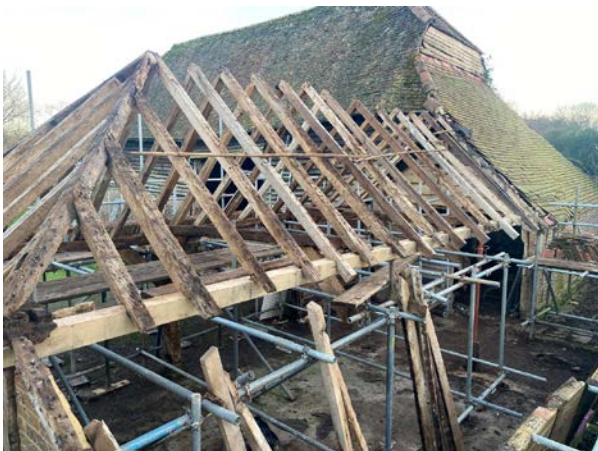
New purlin supporting existing rafters and ready for existing outshot rafters to be installed

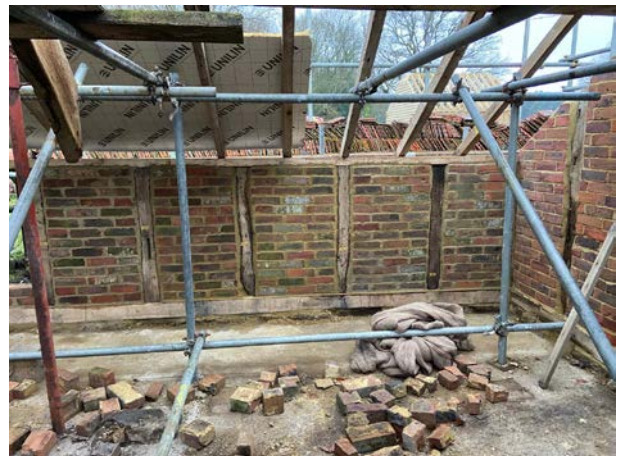
Rebuilt wall, with new sole, wall plates, and existing outshot rafters reinstalled
