Our ref. AT/25/3751022/Plots 3,4,5, 34-35

## Re: 3751022 Furze Field, Sayers Common – Verification Report

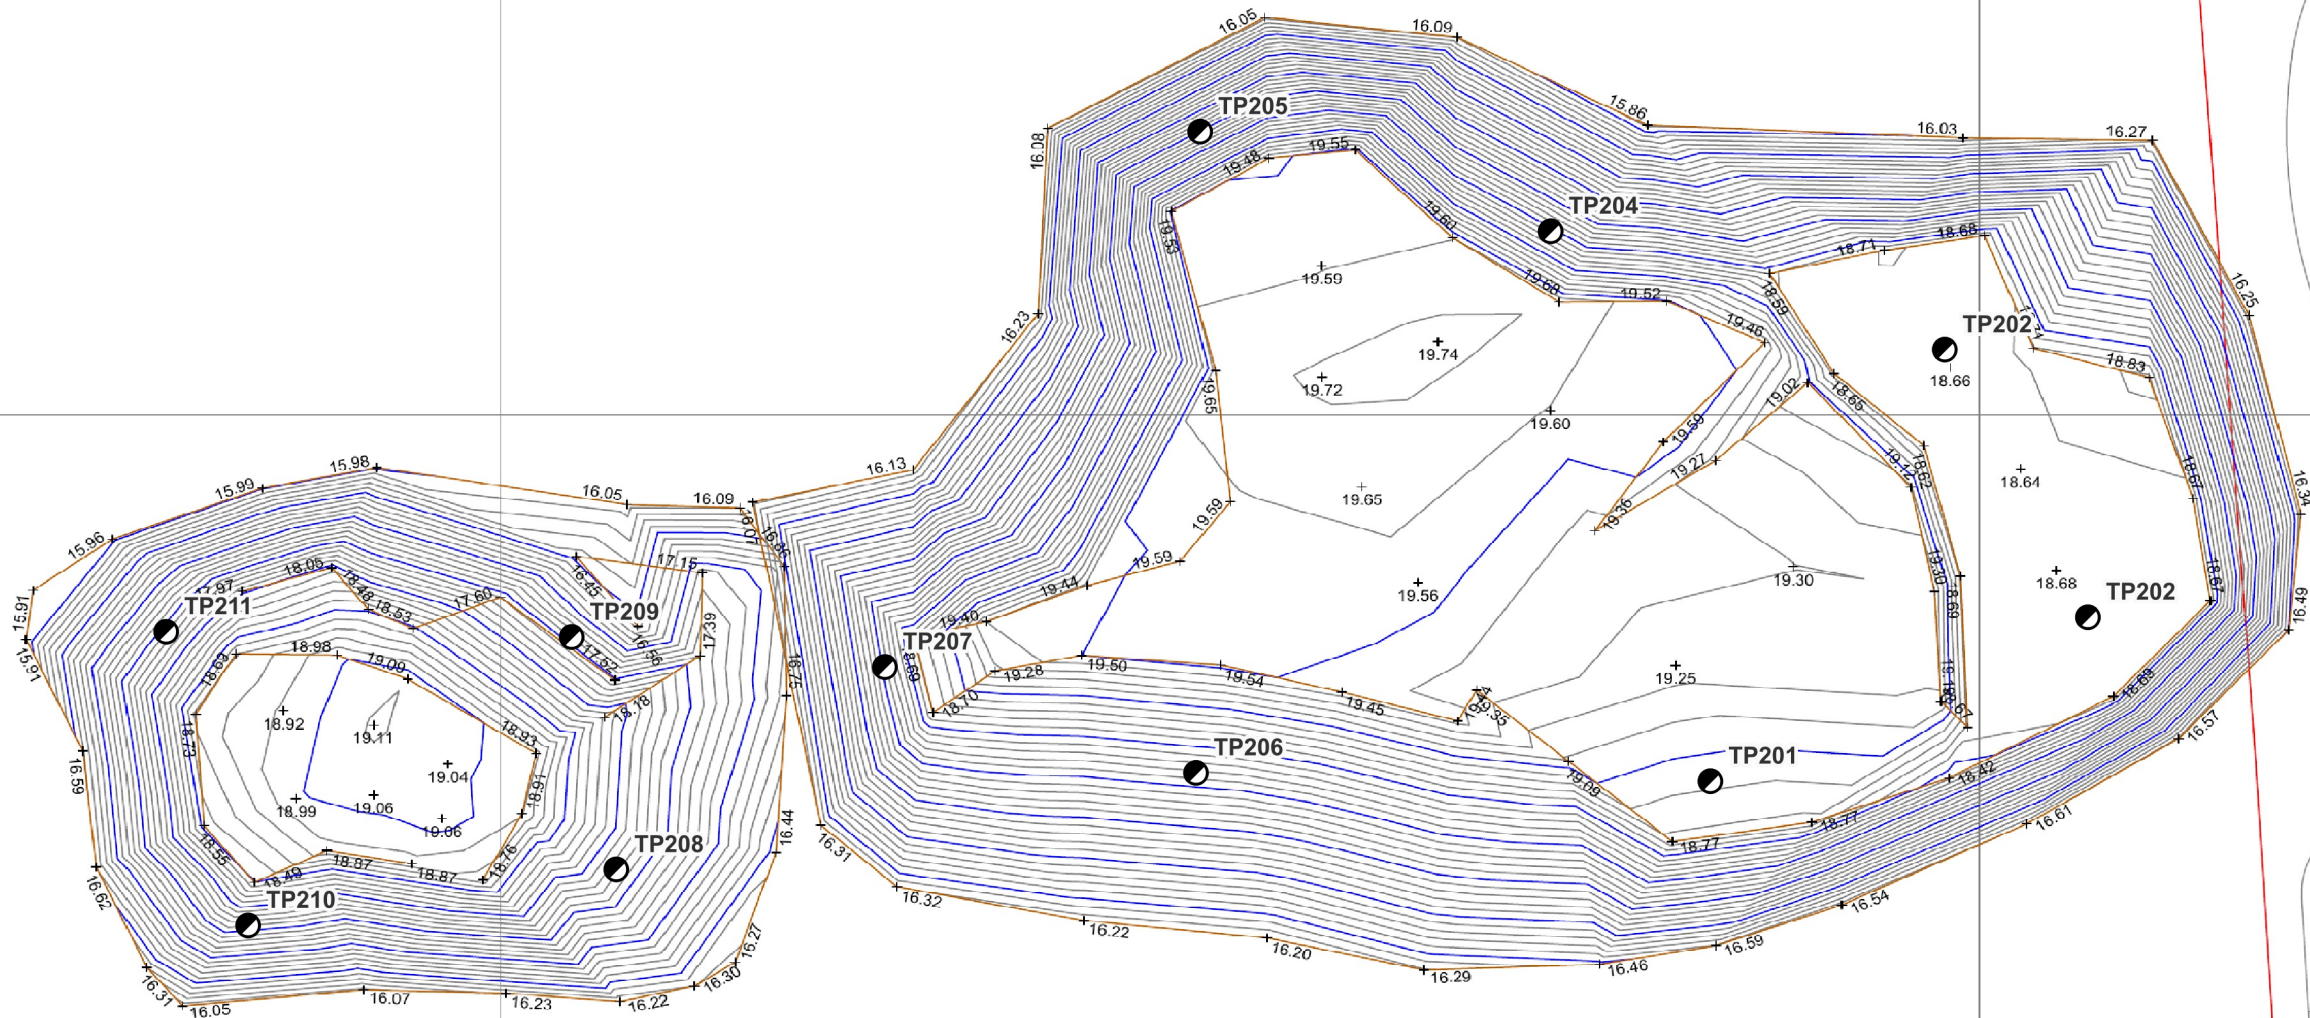
Topsoil stockpile  
area = 424m<sup>2</sup>  
volume = 625m<sup>3</sup>

Subsoil stockpile  
area = 1356m<sup>2</sup>  
volume = 2983m<sup>3</sup>

The Topsoil and Subsoil had been separated and stored into separate stockpiles, with topsoil approximate volume comprising ~625 m<sup>3</sup> and subsoil comprising ~2,983 m<sup>3</sup>.

4 locations were targeted in the Topsoil stockpile (TP09 – TP011) and 7 locations within the Subsoil stockpile (TP201 – TP207). A drawing showing the stockpile sample locations can be seen in Appendix B, drawing ref LW-222-XX-D-G-22203-C01.

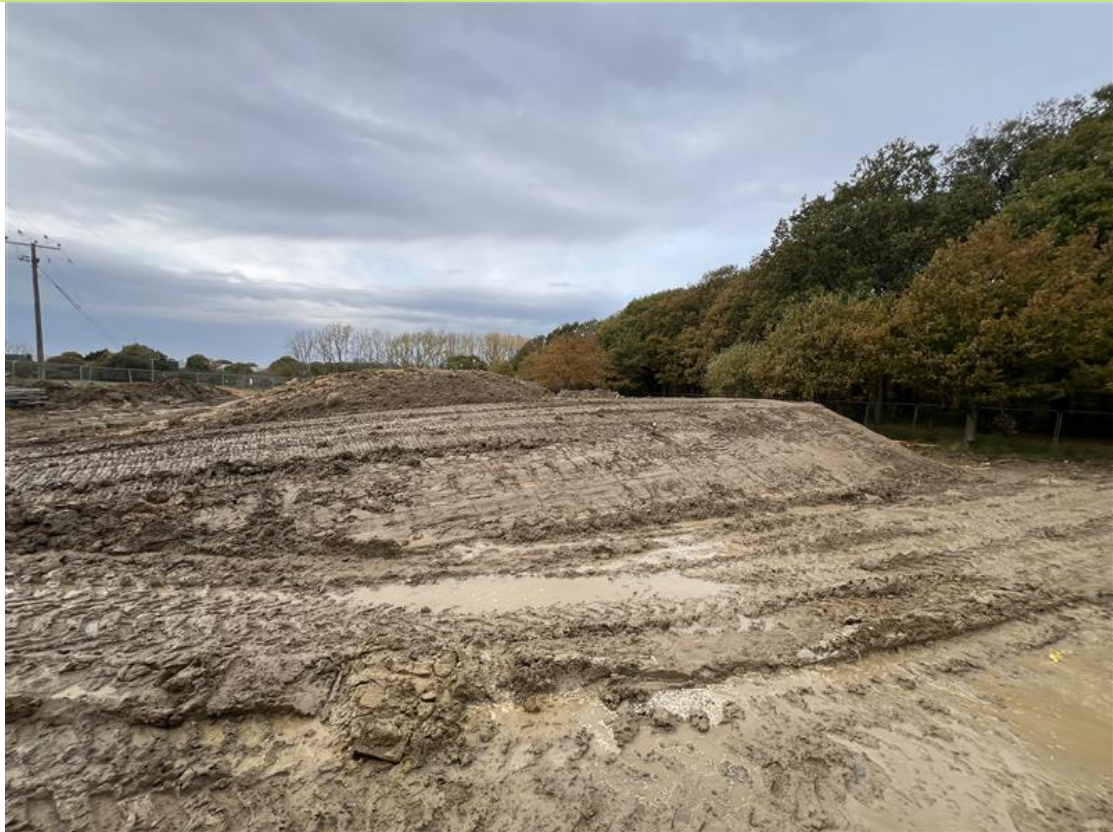
Plate 1 – Overview of topsoil stockpile TSP1 (Dated 05.11.2025)

LEAP attended site on the 5 November to obtain samples of the Topsoil that had been imported and stockpiled on site. 5No. samples were taken from Topsoil stockpiles (3 No. from TSP1 and 2 No. from TSP2). Photographs showing the stockpiles can be seen in **Appendix C**.

The Topsoil was described as a brown slightly sandy, silty CLAY. The sand was fine to medium and occasional rootlets were noted throughout.

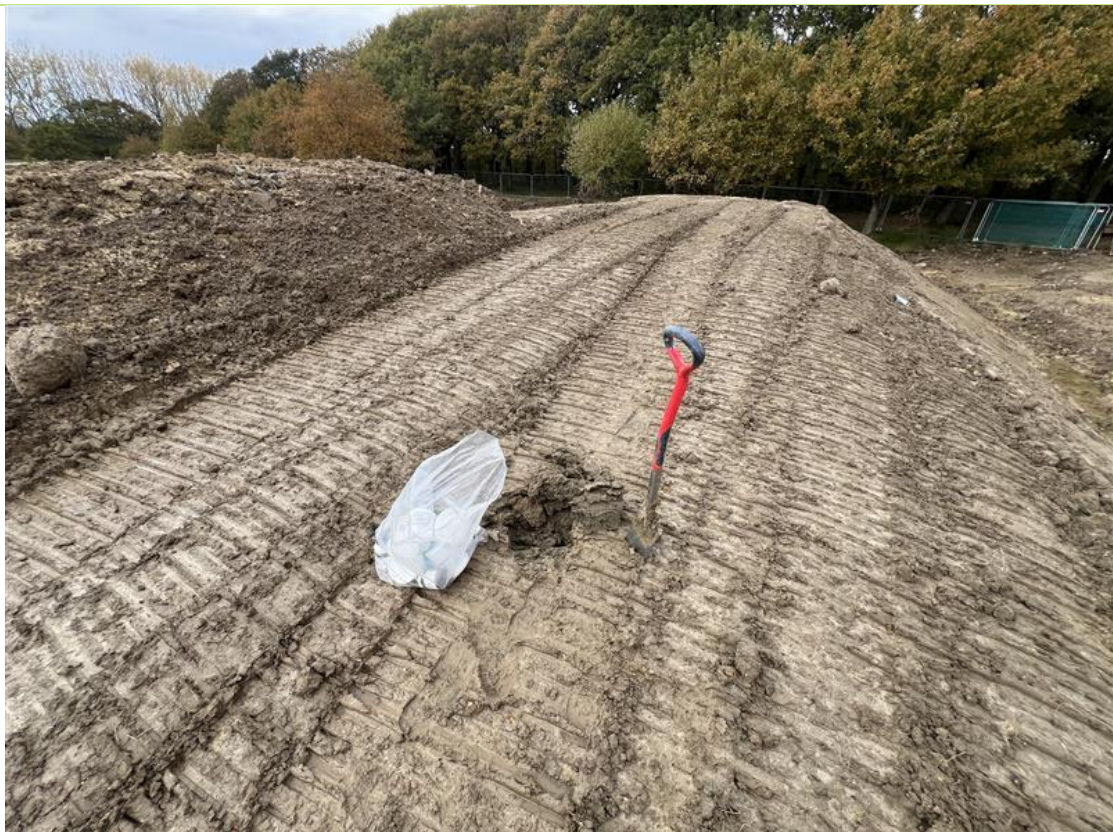
Plate 2 – Sampling of topsoil stockpile TSP1 (Dated 05.11.2025)

5No. Topsoil samples were tested for the LEAP Standard Soil Suite, which includes heavy metals, asbestos, pH, total organic carbon, and polycyclic aromatic hydrocarbons. The laboratory results were compared to the soil assessment criteria outlined in the RMS, as shown in the Screening Table in **Appendix D**. The analysis shows that the Topsoil samples complied with the assessment criteria for all contaminants of concern. No asbestos was identified. The laboratory test certificates are included as **Appendix E**.
