# **Land at Pollards Farm, Ditchling Common, West Sussex**

**Bat Survey**

**March 2019**

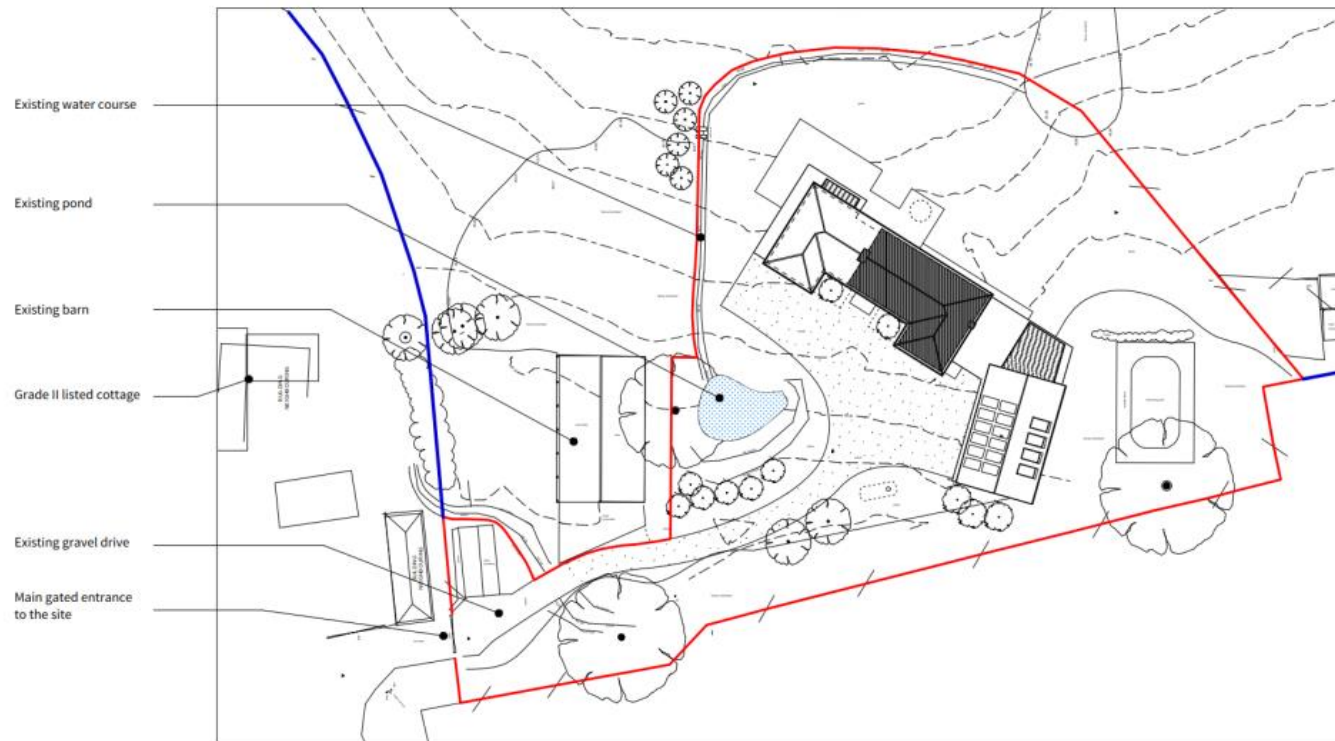
**Figure 1.2: Proposed block plan**

- 1.4.1 Planning consent is being sought for demolition of an existing conservatory and garage, extension and renovation of the existing dwelling, construction of a new garage, and associated works. The proposed block plan is shown at Figure 1.2.

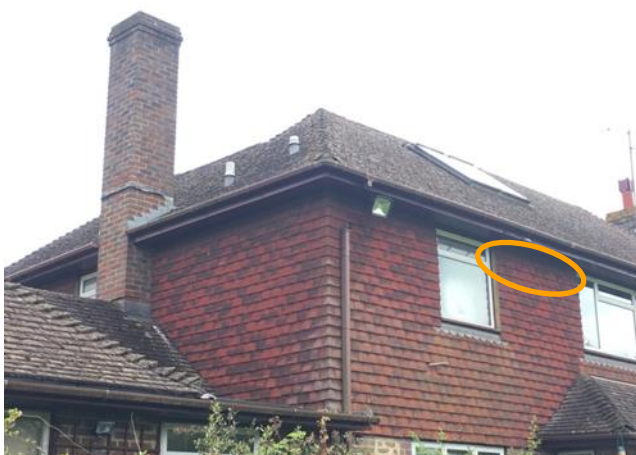
*Survey 1 (B2): Point of emergence, one at 20.34 and one at 20.42 on 15 August (south east aspect, common pipistrelle x 2).*

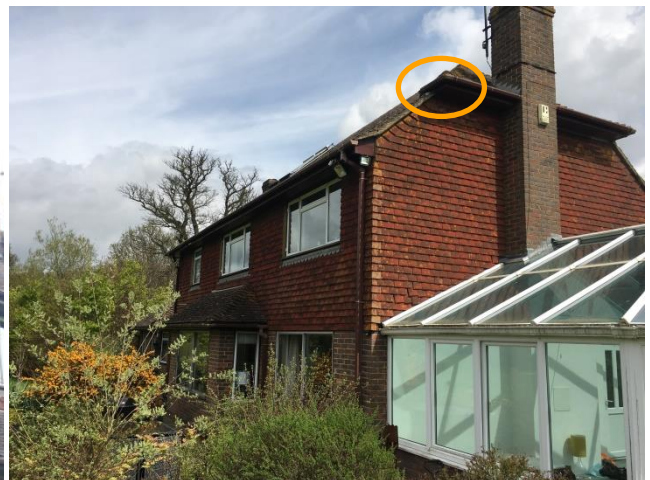
*Survey 1 (B2): Point of emergence at 21.36 on 15 August (south west aspect, west corner, common pipistrelle x 1)*

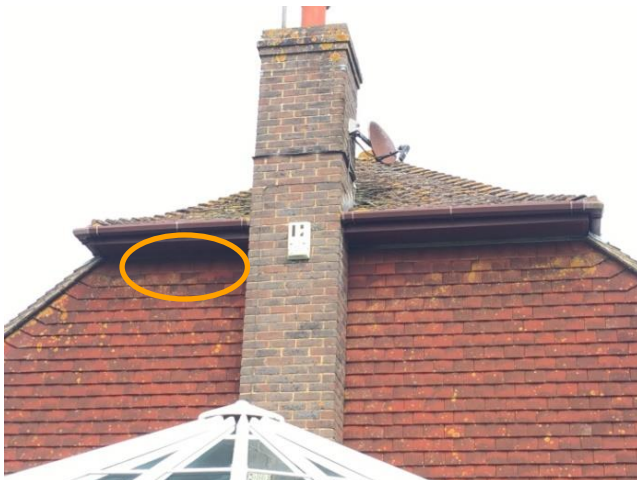
Survey 1 (B2): Point of emergence at 20.40 on 15 August (south elevation common pipistrelle x 1); and Survey 2 (B2): Point of re-entry at 05.32 on 12 September (south elevation common pipistrelle x 1)

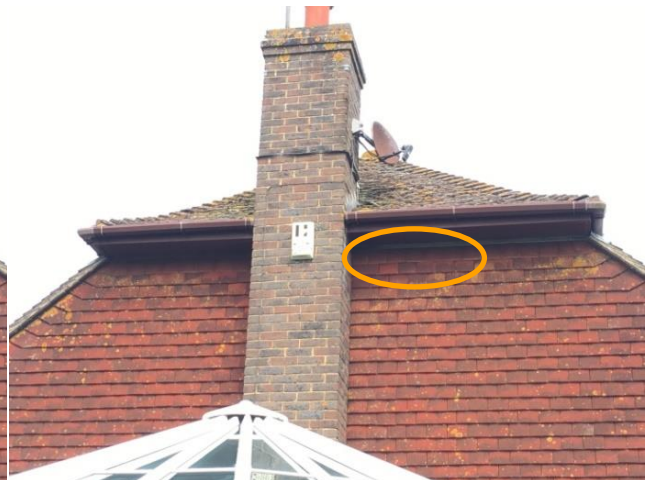
Survey 1 (B2): Point of emergence at 20.40 on 15 August (south elevation, common pipistrelle x 1).

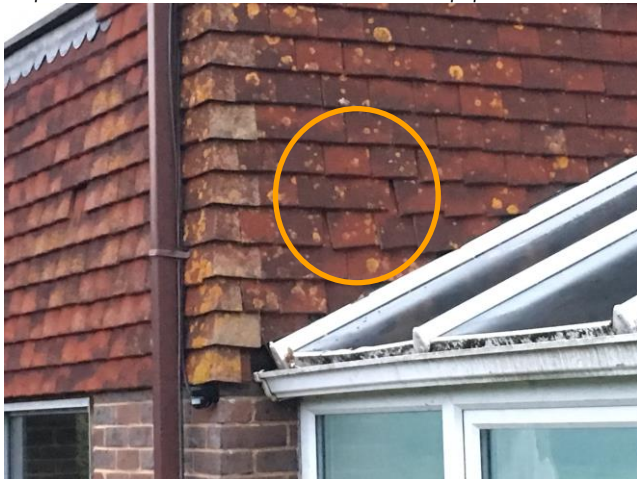
on the south elevation at 05.50, having flown quickly along the west (rear) elevation. No swarming behaviour was observed and the re-entry was very swift, the access point being located beneath a hanging tile slightly above the western side of the conservatory roof.

Survey 2 (B2): Point of re-entry at 05.50 on 29 August (south elevation, common pipistrelle x 1)

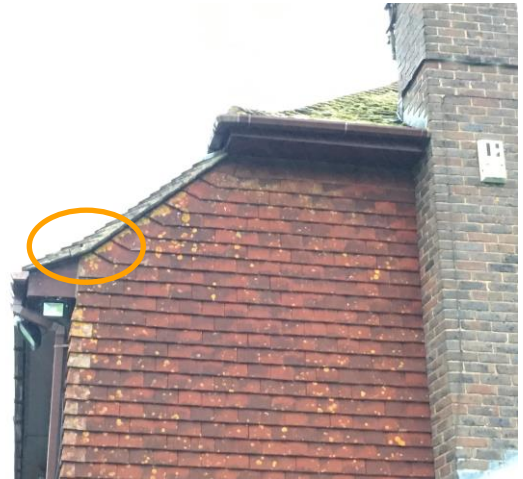
- 4.3.9 Sunrise on 12 September was at 06.29 and the survey started at 04.45. Two common pipistrelle bats were recorded re-entering the building. The first re-entered a roost on the south elevation at 05.32, the access point being located beneath a hanging tile close to the soffit. The second also re-entered a roost on the south elevation, at 06.11, the access point being located in an area of missing mortar on the southern edge of the west-facing roof.
- 4.3.10 Low levels of foraging and commuting activity were recorded within the site. Other than the roosting common pipistrelles, further common pipistrelle and soprano pipistrelle were recorded by all surveyors. The first bat recorded was a common pipistrelle at 05.09 and the last bat recorded was the roosting common pipistrelle at 06.11 (re-entry), 18 minutes before sunrise.

Survey 3 (B2): Point of re-entry at 06.11 on 12 September (missing mortar on edge of roof on south elevation, common pipistrelle x1).

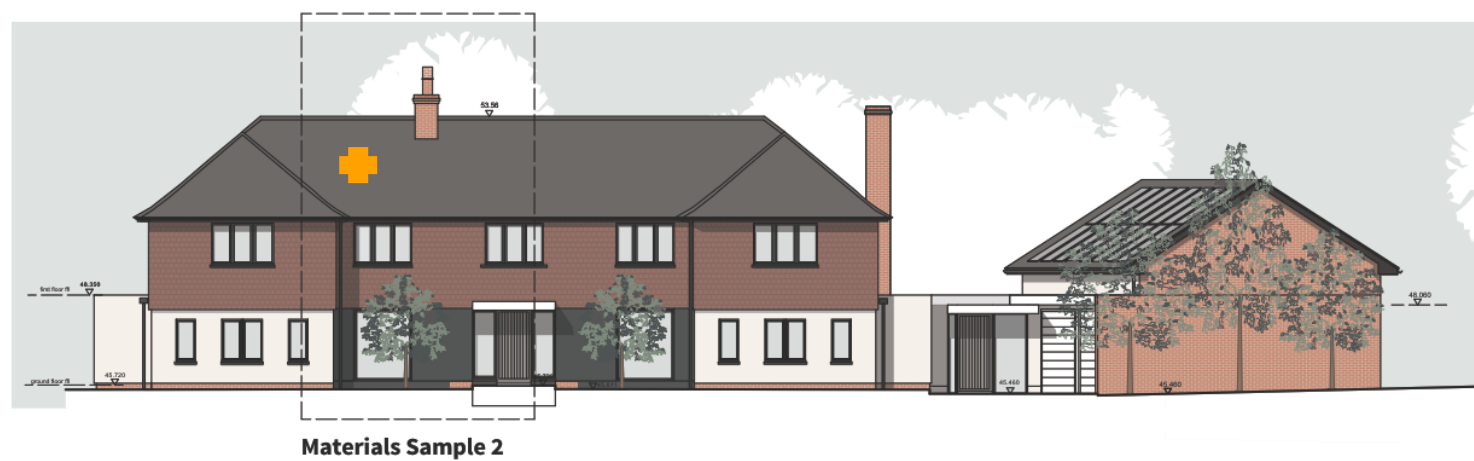
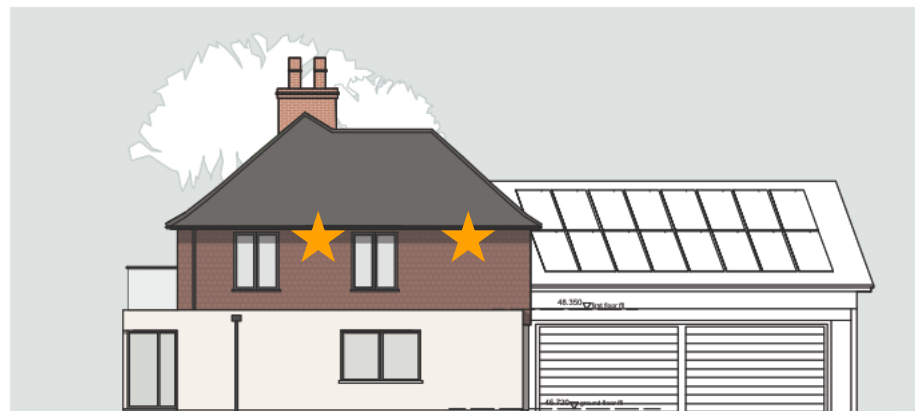
5.6.10 Indicative locations for replacement bat roost features are marked on Figure 5.1.

- ▶ South west aspect: 2no. Schwegler Bat Tube 1FR: provides a self-contained bat box, integrated within the exterior wall.

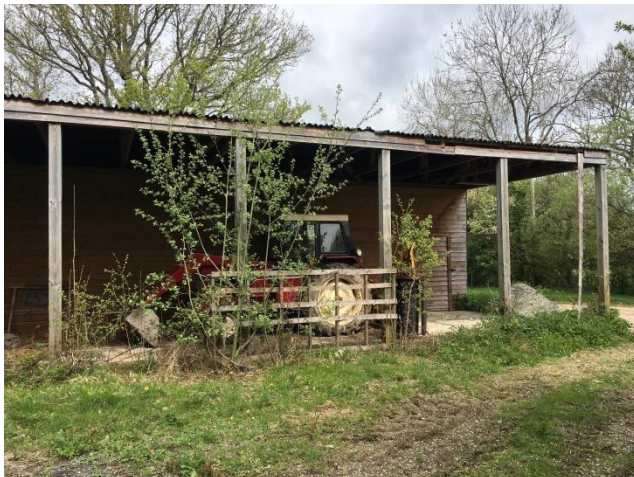
- 4.2.3 Building B1 had a corrugated bitumen panelled roof with a gentle pitch and was c.5m tall at the apex. The external condition of the barn was generally sound although there were occasional gaps in the weather boarding. To the south the barn was open sided, which provided access to the open sided roof void.

Exterior view, open sided to the south

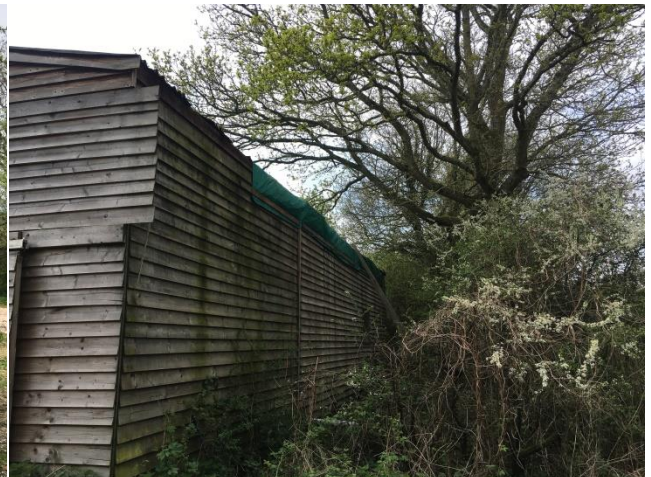
North face of the barn, sound construction

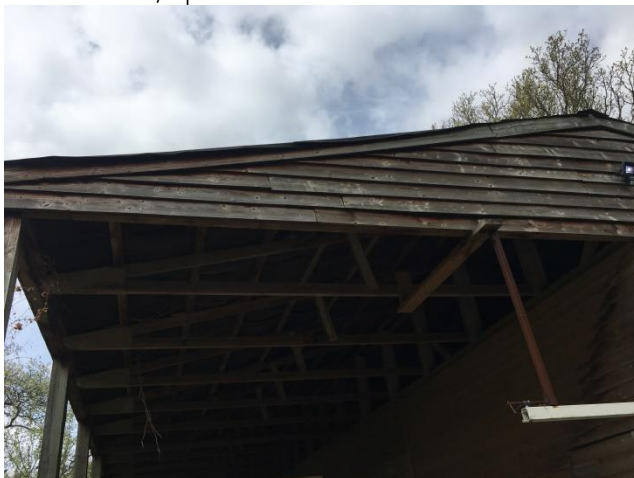
- 4.2.4 The roof void was very exposed due to its open face to the south. It had wood panelled faces at both gable ends. These were occasionally gappy and light could be seen filtering through the knot holes. The timbers were new and presented no access gaps for crevice dwelling bat species. Roof lining was not present and in areas the roofing material had been broken and had fallen into the roof space leaving large areas exposed. In some areas occasional cobwebbing present within the roof void. No signs of bats were present within the roof void, no droppings, urine staining, scratch marks or feeding remains were noted.

Exposed south face of roof void

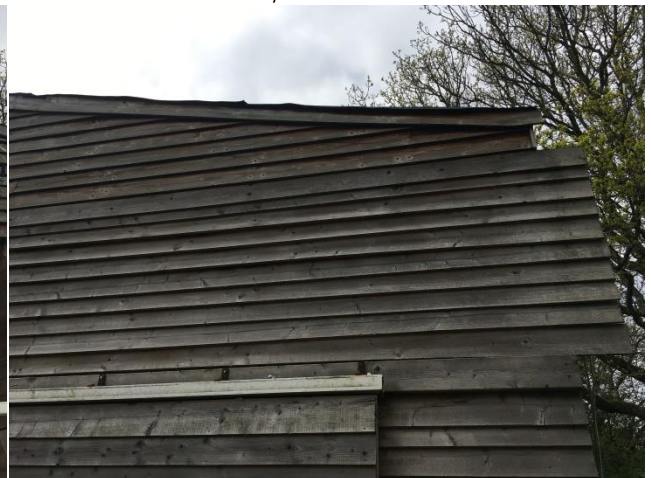
- 4.2.6 The interior inspection of the barn found no evidence that it was being, or had recently been, used by roosting bats. The barn was of low potential for roosting bats, principally due to occasional gaps in the weather boarding.

Eastern face of building, gaps in weather boarding

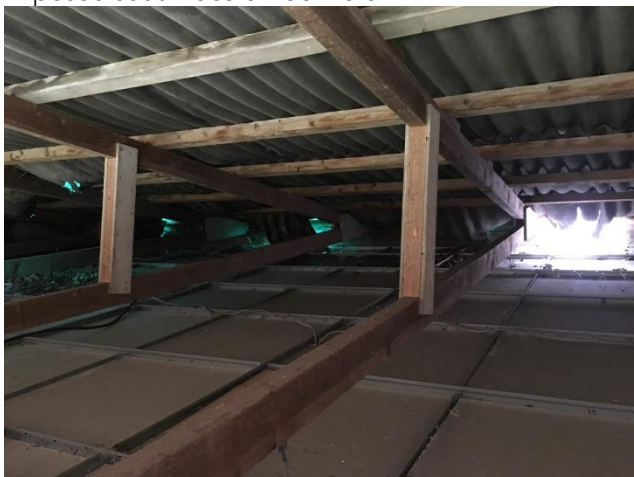
Exposed timbers, tightly fitting

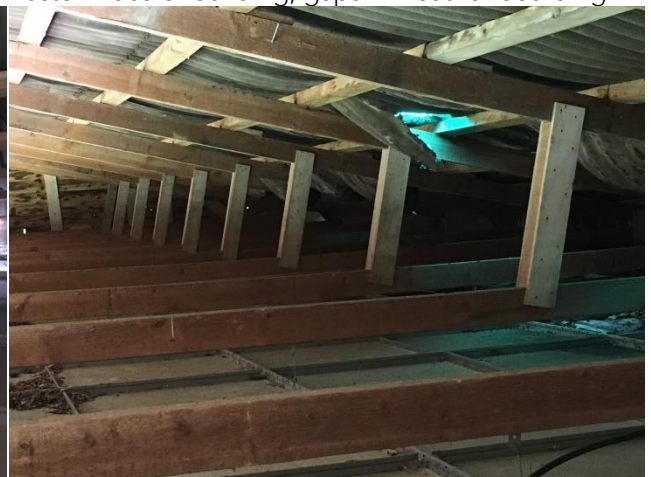
Broken roof panelling

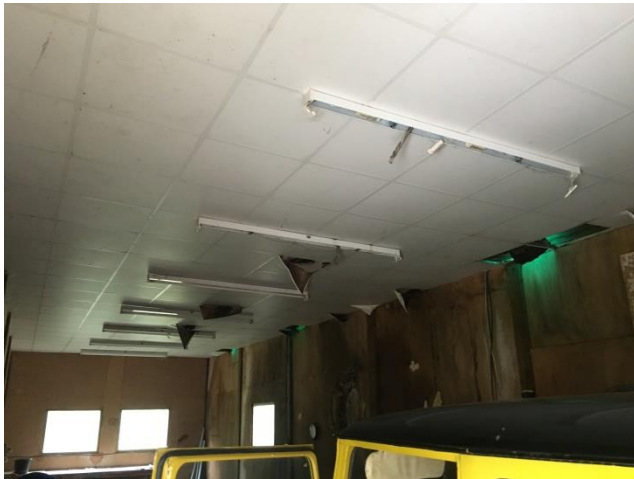
- 4.2.5 The lower internal barn space was used as a garage. It was enclosed and had windows to the westerly face. The ceiling and walls were mostly sound but had occasional peeling and some panels were damaged. The space appeared not to be water tight a there was a lot of water staining on the walls and ceiling. The area was cobwebbed and no signs of bats were found. Occasional rat or mouse droppings were scattered throughout.

Internal space, peeling ceiling panels, light

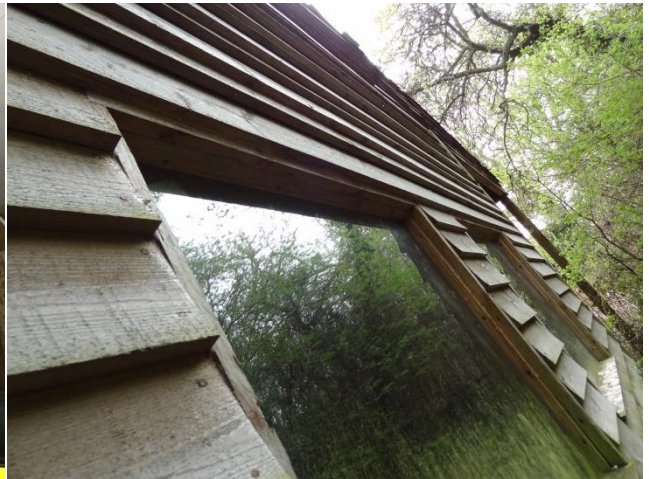
Windows and boarding tightly fitting to the west face

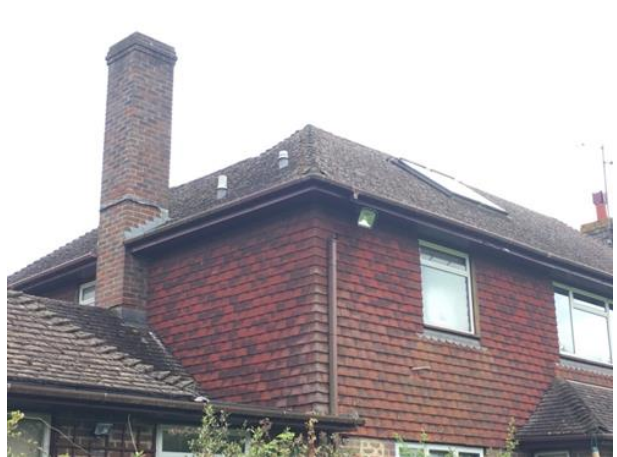
Tightly fitting lead flashing to the window, drainage pipe

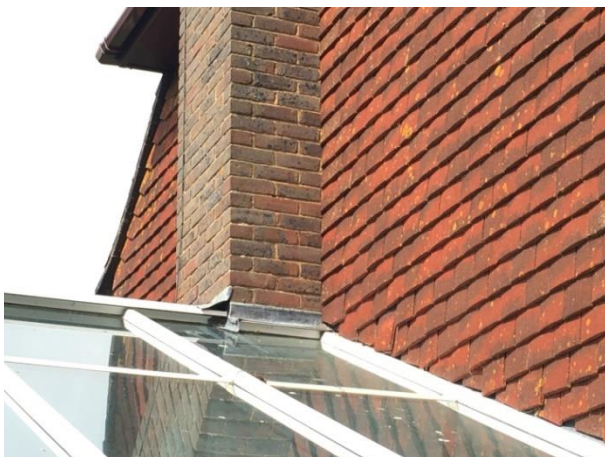
- 4.2.12 The interior inspection of B2 found that that building had previously been used by roosting bats. Overall B2 was considered to be of moderate potential for roosting bats, principally due to occasional gaps beneath the hanging tiles and lifted lead flashing.

Lifted lead flashing at chimney join with conservatory

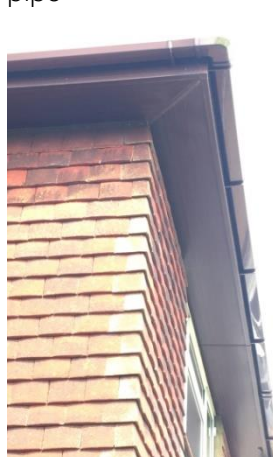
Tightly fitting soffits, no gaps

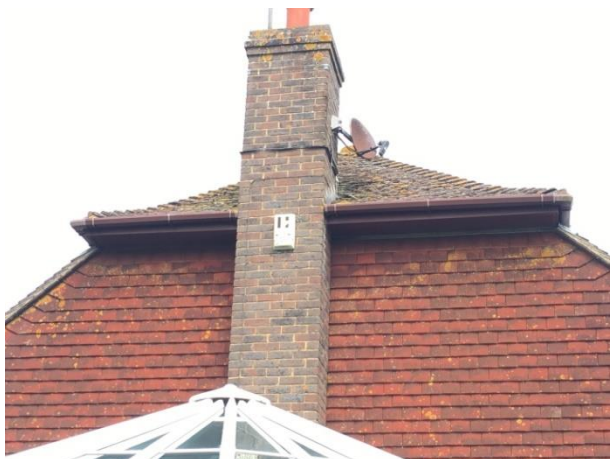
Many hanging tiles in good condition

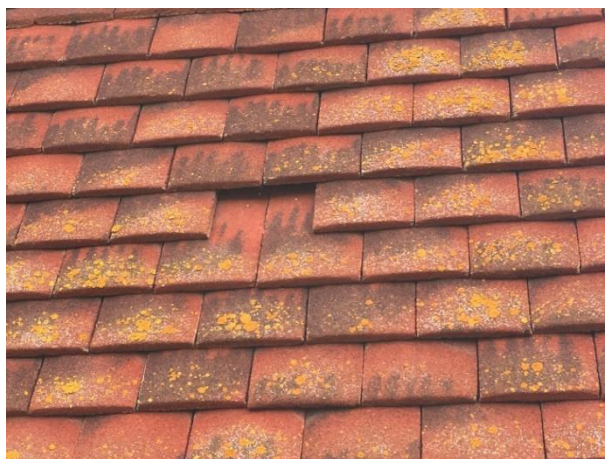
- 4.2.8 The brick work to B2 was sound with no observable gaps or cracks in the mortar that could provide roosting opportunities for bats. The upper storey was clad in hanging clay tiles which were in a generally sound condition, although there were occasional slipped and missing tiles that could allow entry for crevice roosting bat species such as pipistrelles *Pipistrellus spp.*.
- 4.2.9 The pitched and hipped roof was tiled and in generally good condition, with a height of c.8m at the ridge. There were occasional gaps where lead flashing connected the wall to the conservatory and the roof to chimney. Lead flashing around the window features was generally sound however. The soffits were of uPVC type construction, tightly fitting and presented no gaps. Large downward-facing security lights were present at each of the four main corners.

Occasional missing hanging tiles

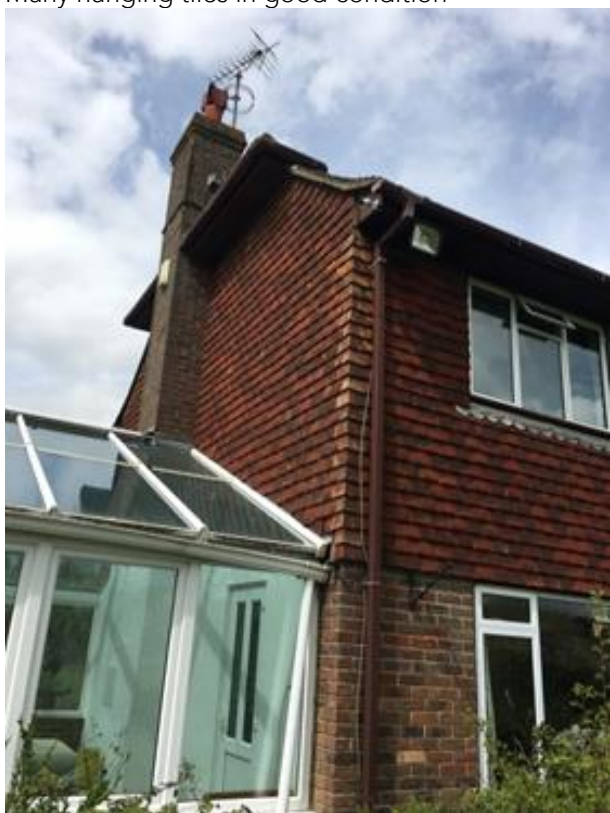
Brickwork in good condition

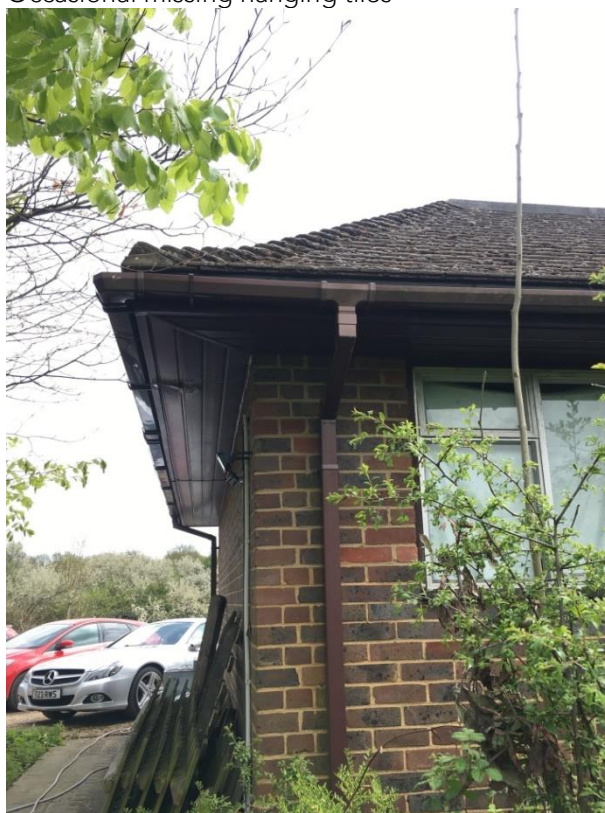
Garage in good condition, no access points for bats

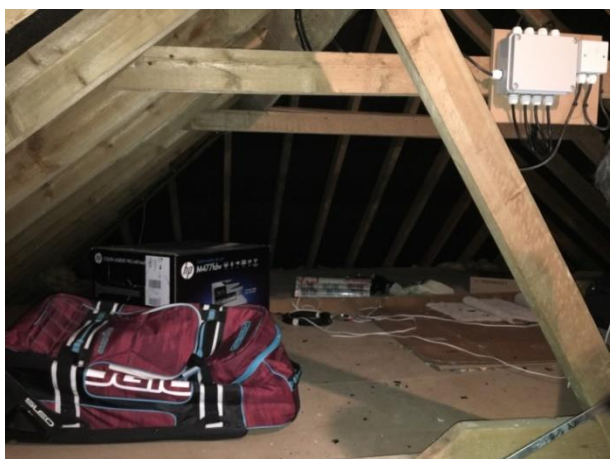
Rough timber beams

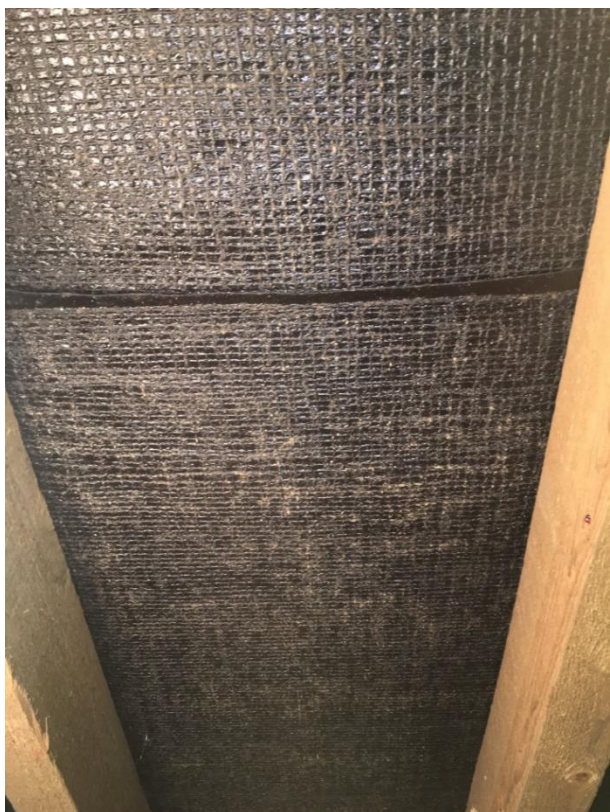
Tightly fitting lining

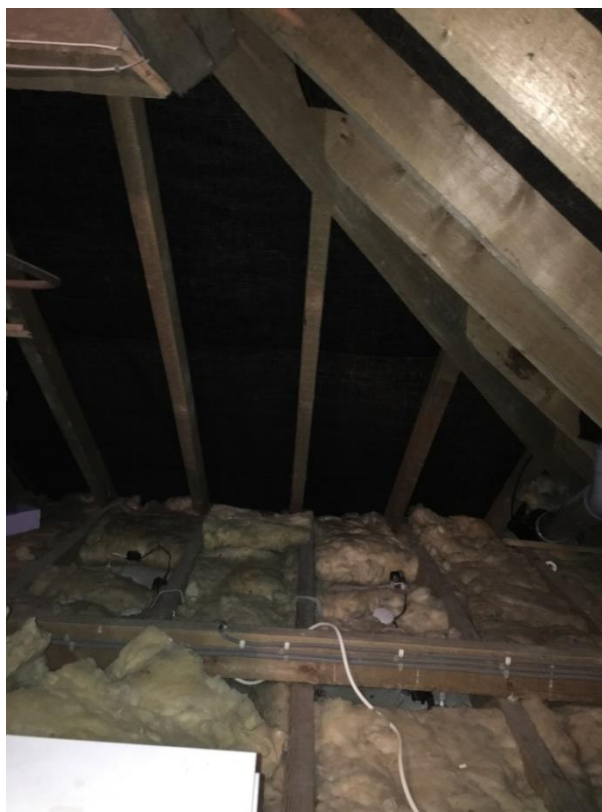
Non cluttered space

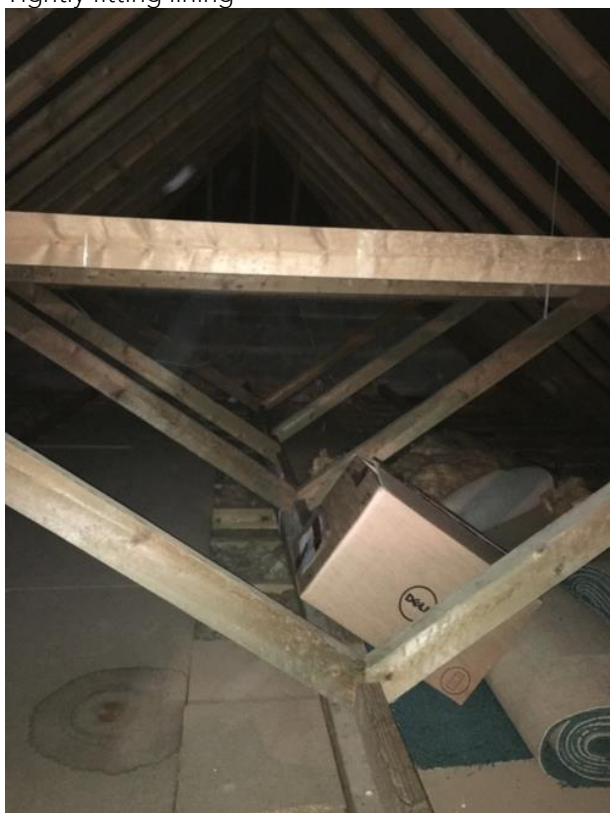
- 4.2.10 The internal roof void was accessed through a hatch in the central corridor on the first floor. The internal space was open and consisted of two connected voids. The first second ran on a north-west to south-east alignment, with approximate internal dimensions of 8.8m length, 4.8m width and 2.5m ridge height. The second ran on a north-east to south-west alignment over the length of the house, with approximate internal dimensions of 7.9m length, 6.3m width and 2.5m ridge height. The beams were rough-hewn and in good condition, with no evident gaps between the joists. The roof lining was a textured plastic, in good condition with no light coming through at any point. A high degree of cobwebbing throughout the void suggested that bats had not recently used the void as a flight space. Although the void space was generally uncluttered, there was a water tank to the north-east of the entrance hatch, below the ridge beam, and cross beams protruded through the centre of the void.

Internal flight space, some cross beams

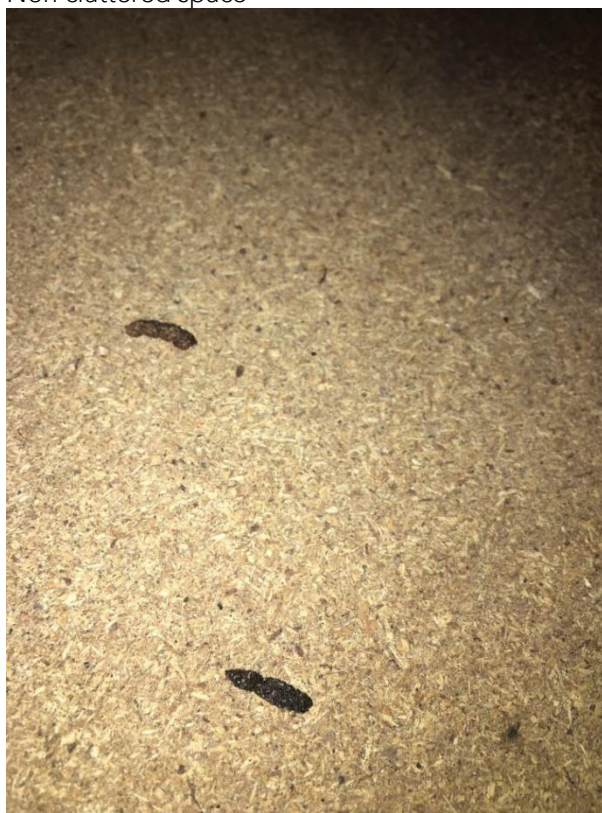
- 4.2.11 A small number of bat droppings were found on top of the water tank, a mixture of mainly old and some fresher droppings were noted; see Appendix III. Around twenty droppings were found in total, scattered but primarily underneath the ridge beam. The size and shape were characteristic of pipistrelle, and long-eared *Plecotus spp.* bats. Occasional mouse droppings were also noted. A large inactive wasp nest was found towards the south west gable.

Bat droppings on top of water tank

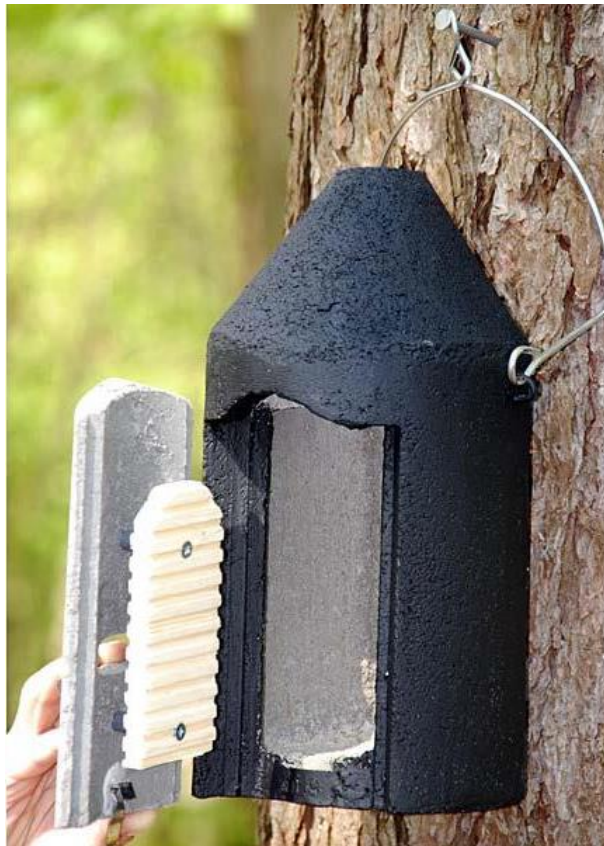
**Schwegler 2F DFP General Purpose Bat Box:**  
Apex roof to mimic tree cavity, suitable for noctule, brown long-eared, Bechstein's and Daubenton's. Internal double front panel creates a crevice suitable for pipistrelles

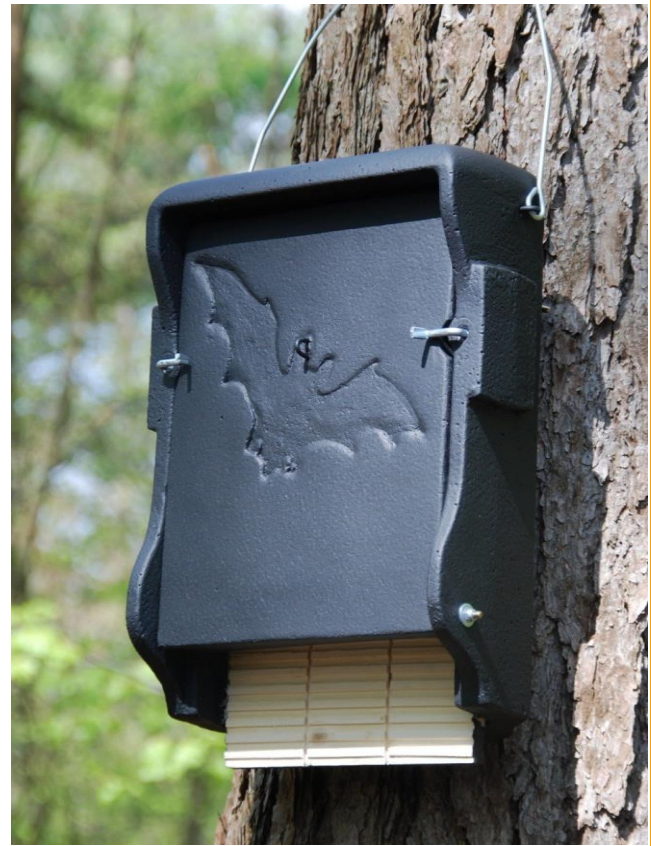
**Schwegler 1FF Flat Bat Box:**

Open at bottom so cleaning not required. Varied internal roost surfaces. Suitable for crevice roosters such as pipistrelles, and large enough for use as maternity roost

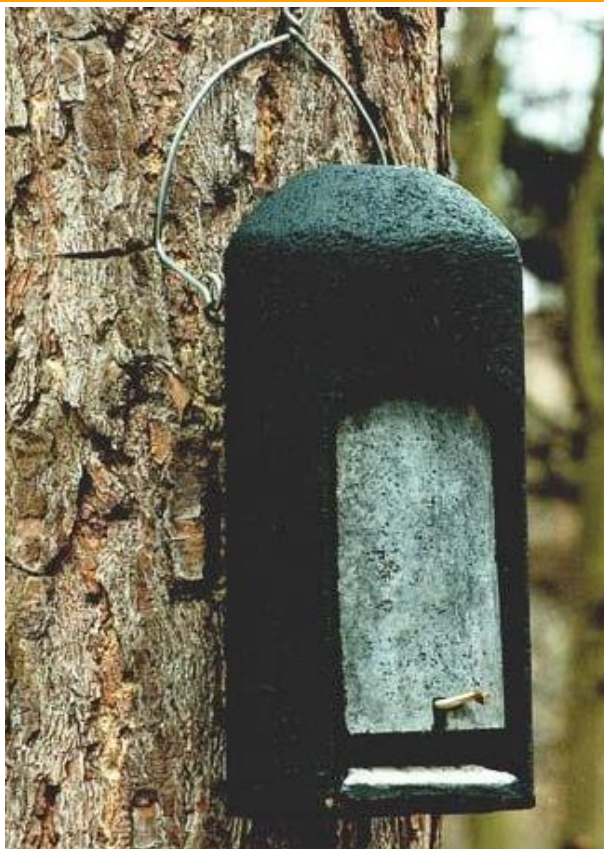
**Schwegler 2FN Woodland Bat Box:**

Two entrances, one at the rear against the tree trunk and one at the front. A domed roof to form clusters and an increased internal height. Suitable for brown long-eared and woodland species e.g. noctule

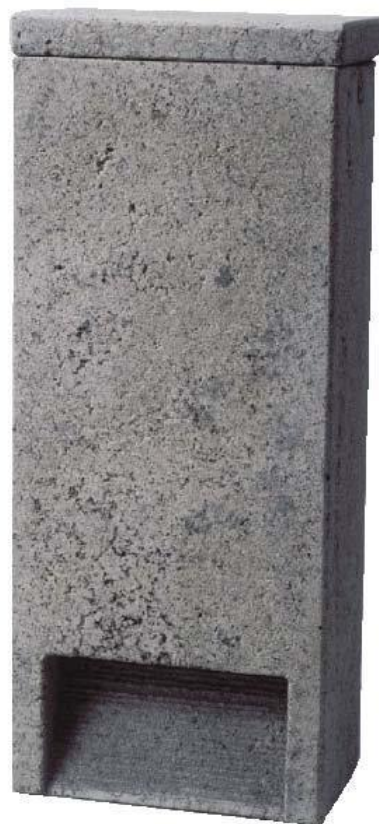
**Schwegler 1FR/2FR Bat Tube:**

Suitable for building into or mounting onto external walls. Open at bottom so cleaning not required. Can be used individually (1FR) or by connecting two or more 2FR. Suitable for bats that use buildings e.g. pipistrelles or serotine

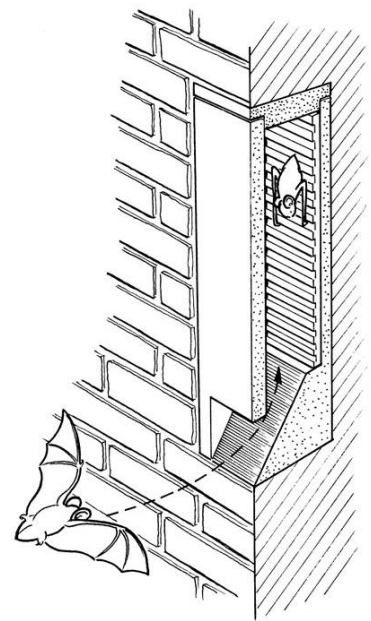
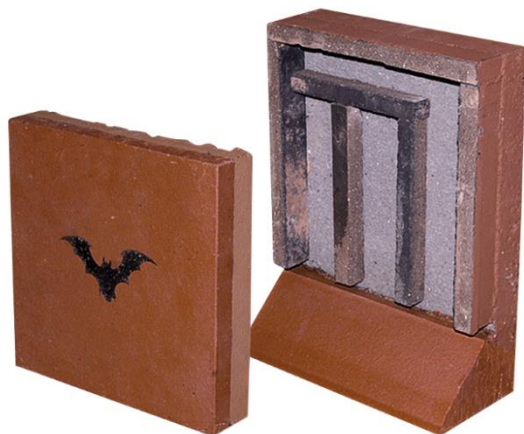
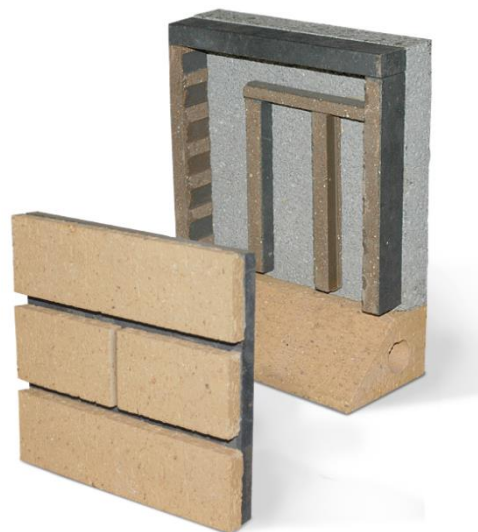
**Ibstock Enclosed Bat Box (Type B or C):**

- Designed specifically for pipistrelle bats
- Available in all brick types
- Discrete home for bats
- Various sizes
- Several roosting zones are created inside the box
- Bats are contained within the bat box itself
- Maintenance free with entrance at the base
- Suitable for new build & conservation work
- Bat Box Type B: 215 x 215 or 215 x 290 / Bat Box Type C: 215 x 215 or 215 x 290

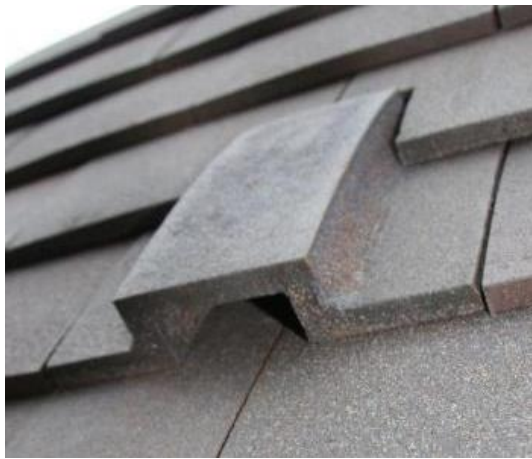
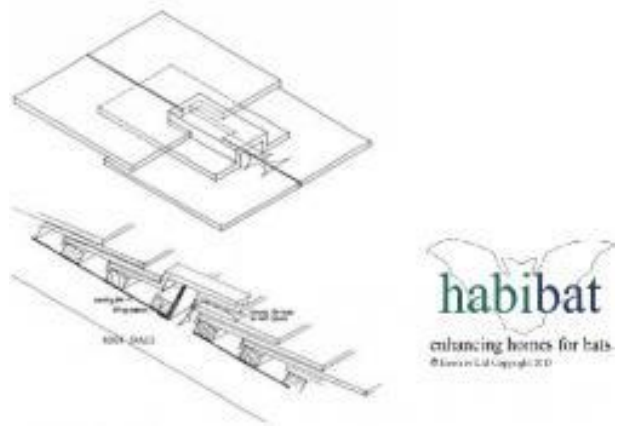
**Habibat Bat Access Tile (available in clay, slate or lead):**

The Habibat Access Tile is a roof tile which has been modified to allow bats either into the batten space (between tiles and liner for pipistrelles) or into the roof void (for brown long-eared bats).
