DESK STUDY REPORT

HURST FARM, TURNERS HILL ROAD

CRAWLEY DOWN, WEST SUSSEX

Desk Study Report

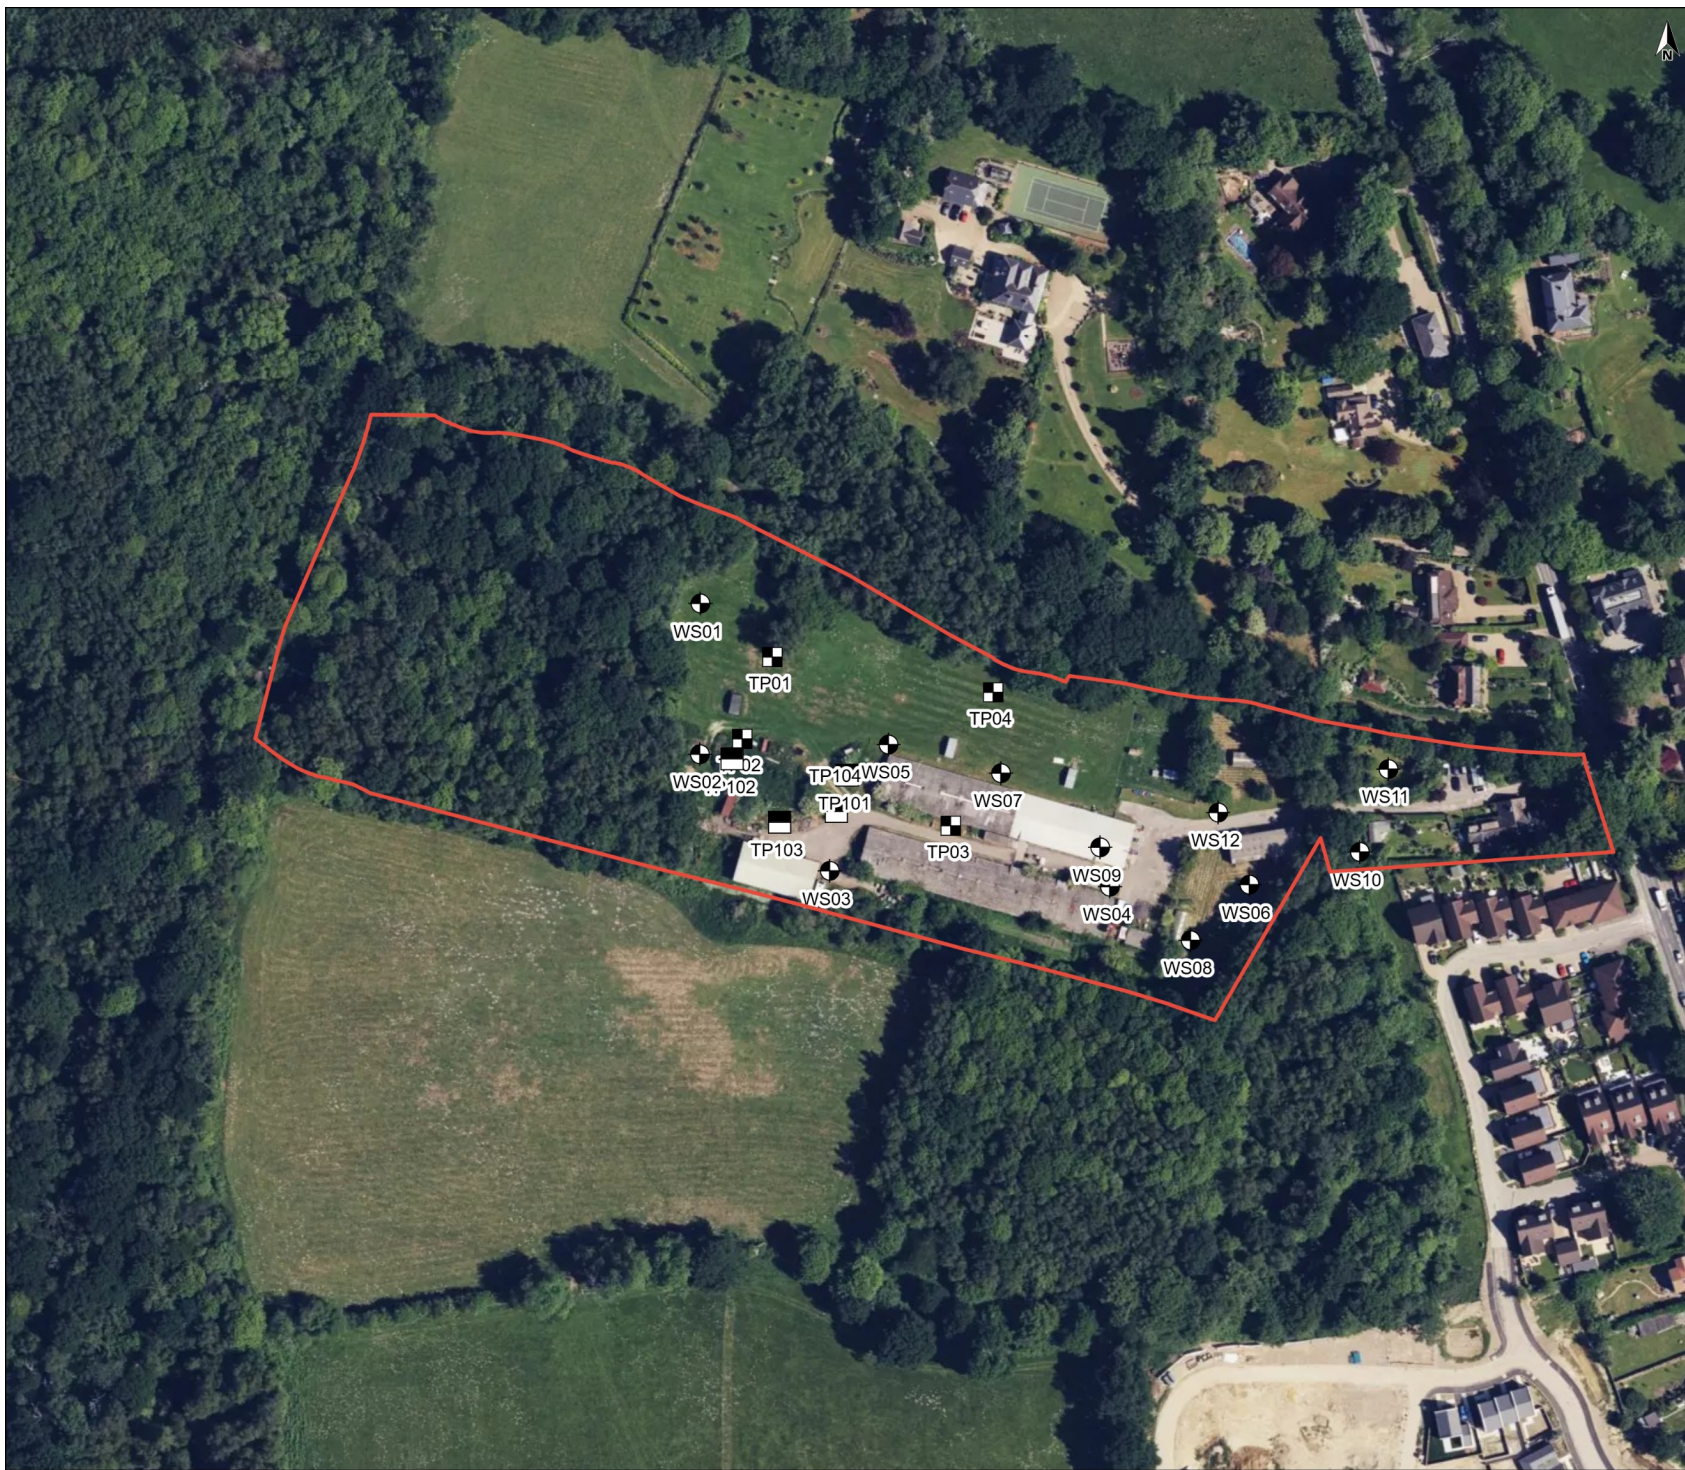
FIGURE 2

Exploratory Hole Location Plan (Existing Layout)
