## TANYARD MANOR

Renewal of Tile Hanging

HERITAGE  
STATEMENT

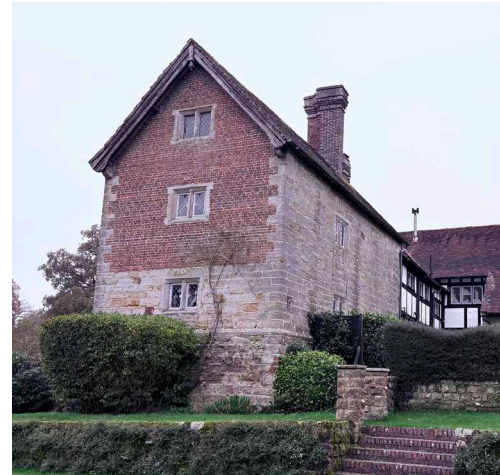
The circa C15th stone range is positioned on an east-west axis raised on a coursed stone plinth above the sloping ground level to the east. The form comprises a single gable-ended range of 2 bays bay set over 2 storeys plus attic with stone mullioned windows containing leaded light casements and entrance door to the south set under a cranked Tudor arch. A large back-to-back inglenook fireplace effectively forms a baffle entry to the range. The form appears to have been truncated to the west and is now abutted to the circa 17th century range.

*east gable of C15th range*

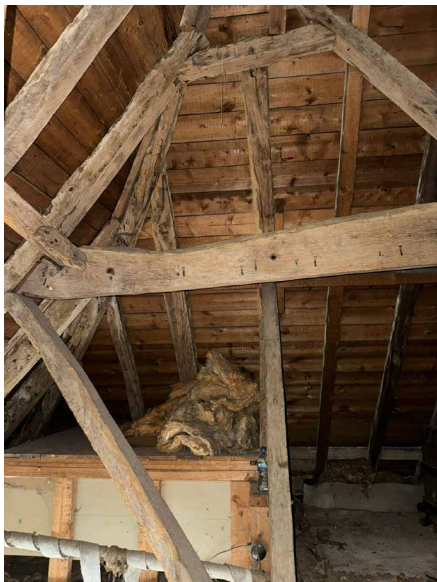
*interior of north hip of C17th range  
showing sarking boards*

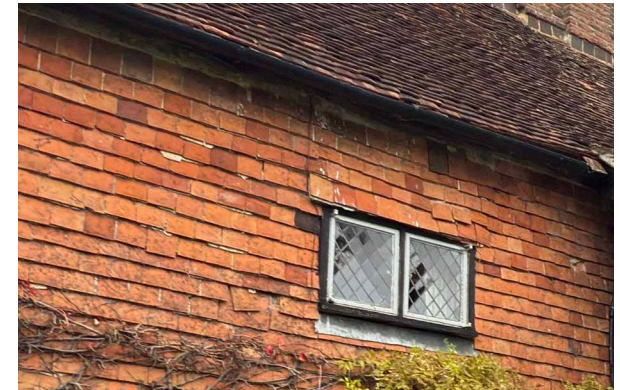
The C17th century 2-storey range projecting to the south features tile hanging which wraps around the first floor of the southern and western elevation. The tiles appear to be a mix of russet coloured handmade plain clay tiles in horizontal rows which are double lapped. Slipped, cracked and missing tiles are present throughout. There appears to be mortar bedding to the tile hanging which was commonplace to prevent wind uplift, particularly in exposed areas. Some mortar is of untidy application, spilling onto tiles below. The composition of the mortar has not been analysed, it is uncertain if it is cementitious in nature or if it is consistent with the other early C20 repairs.

*slipped and missing tiles present to southern elevation*

- investigation of existing tile hanging including underlay and battens to determine feasibility of periodic renewal
- stripping of tiles to accurately record the gauge of the tiles to aid in determining phasing and significance for reinstatement
- reinstatement of tiles where suitable, where new are required to match the existing tile style, colour, size and gauge
- retention or like-for-like replacement of timber features including corner battens, tilting fillets and window linings are subject to further investigation

It is contended that the tile hanging and requires extensive repair including the replacement of cracked, spalled, split or missing tiles, loss of mortar and possible failure of inappropriate cement rich mortar. The condition of fixings and substrates cannot be fully assessed without stripping. This application seeks consent to replace and renew the tile hanging and associated timber features.

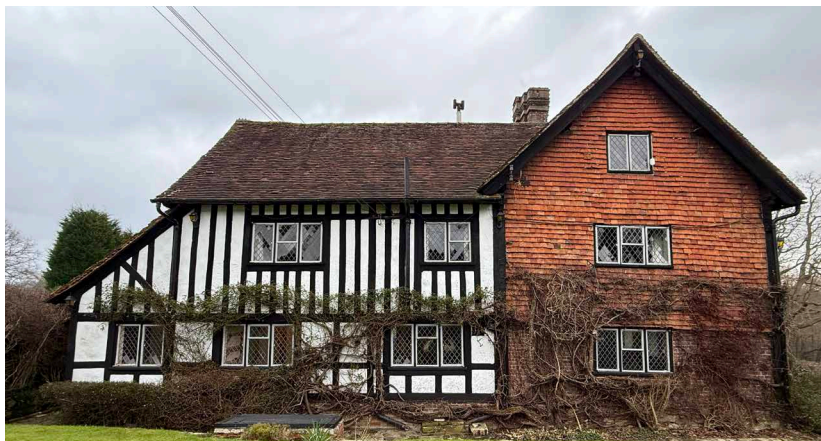
Black painted timber corner cover battens are present to either side of the gable end and can be seen on the southern corner to support the rainwater downpipe. The batten is of a basic, rustic variety whereby the tile tails are contained within the edge of the batten and again are mortared. Tile and a half abutments are present to the verges and corner battens. There appears to be a tilting fillet to support the lowest course of the tile hanging though the presence of vegetation makes it difficult to confirm. The windows (diamond leaded steel casements with timber surround) to these elevations appear to be planted on, sitting slightly proud of the tiles in places, with timber cover strips placed around the projecting openings, pointed mortar to exposed tile edges and lead flashing below. Tilting fillets are present to the window heads - most prominently to the southern window where there is a distinct flared camber to the tiling above.

*tile hanging to western elevation*

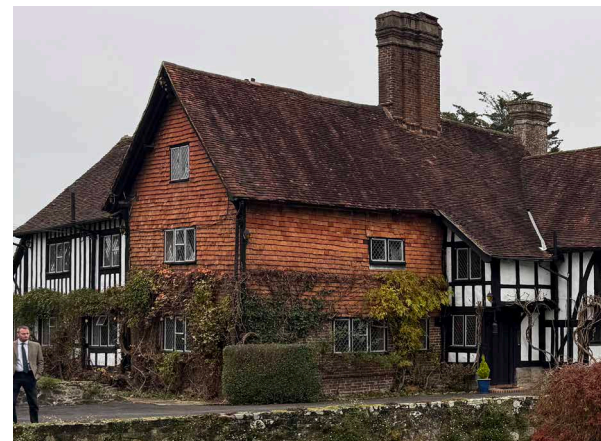
*tile hanging southern elevation*

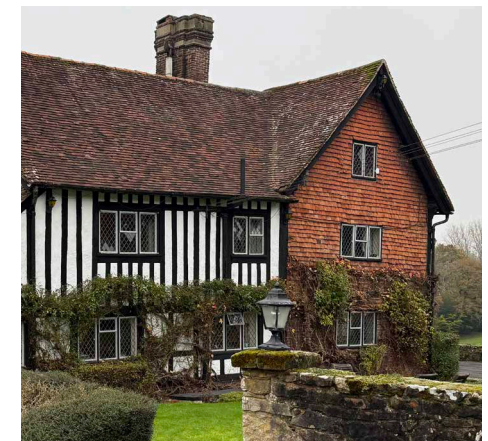
*alternative view of western gable*

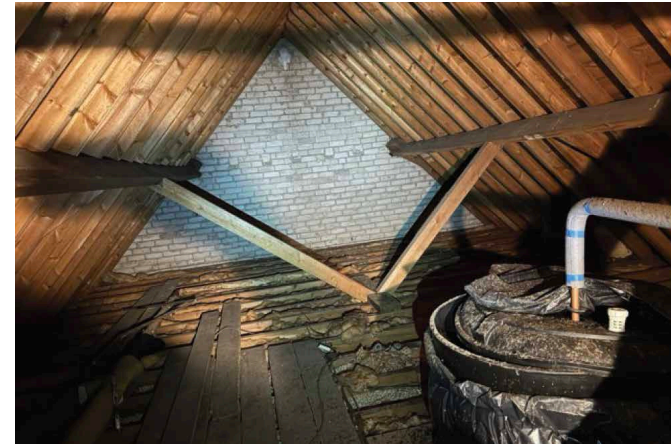
The main loft void is constructed of early C20th sawn regularised timbers finished in sarking boards. The lean-to roof is of similar construction.

*loft space*
