## Bat Emergence and Re-Entry Surveys (BERS)

Rose Cottage, Haywards Heath, West Sussex, RH16 1XT

Bright Horizons

This report is prepared to inform a planning application with Mid Sussex District Council. The proposal is described as: "Conversion of existing barn into usable child space for existing adjacent nursery."

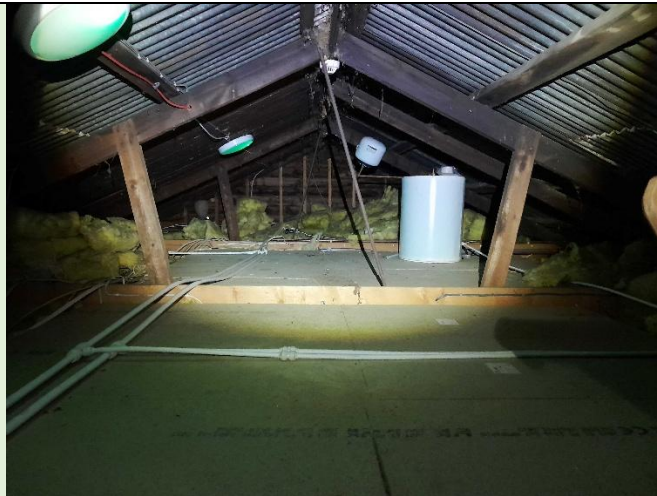
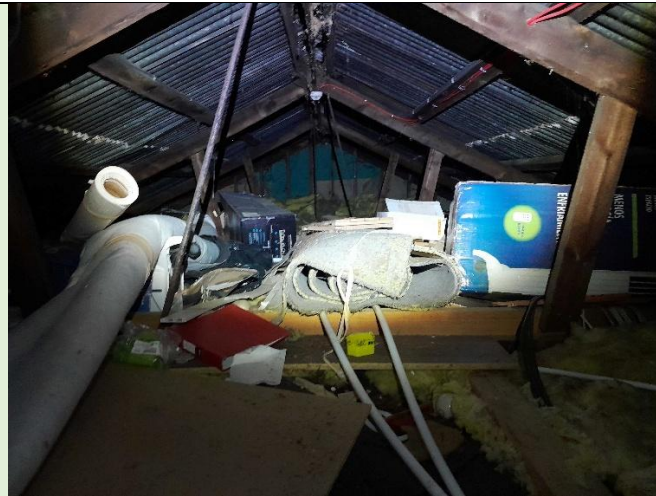
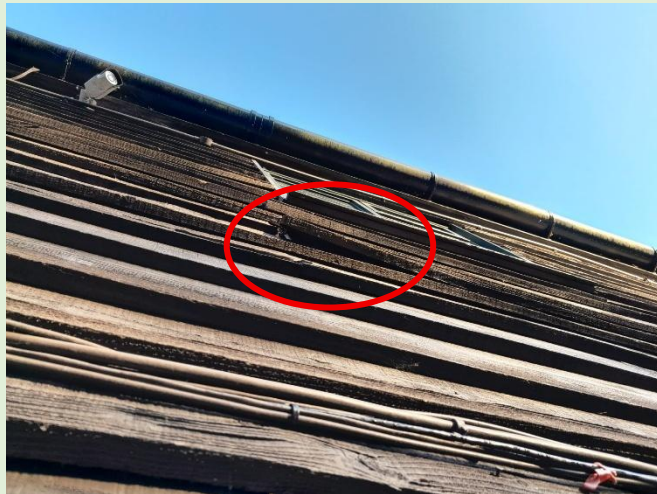
| <i>Building inspection prior to survey</i> | <p>Carried out by: Chantae Bleakman-Wells BSc (Hons) MSC MRSB, (Accredited Agent on Natural England Bat Licence Number: 2018-33540-CLS-CLS)</p> <p>Structures inspected: Loft space of building and exterior timber panels</p> <p>Bat evidence found: None in loft. Individual bat (pipistrelle species) observed under lifted timber board on South elevation (as shown by red circle)</p> |

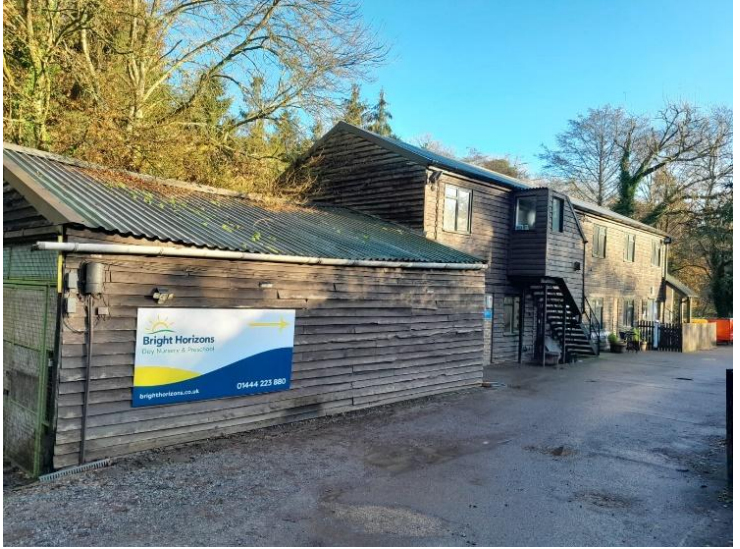
| Surveyor observations | | |
|---|---|---|
| <p><i>Surveyor 1</i></p> | <p>A total of <b>eight emergences</b> were observed, all from a lifted timber board underneath the third window on the south elevation of the building (as shown by blue star). Three emergences were observed at 21:10 and the further five were observed at 21:12.</p> <p>Bats were not echolocating at time of emergence but are deemed to be Soprano pipistrelles, based on flight patterns, emergence times, presence of soprano pipistrelle droppings found at the site and general soprano pipistrelle foraging activity for the duration of the survey.</p> <p>The first bat activity was a soprano pipistrelle flying over the building at 20:49, with further soprano pipistrelle intermittent foraging activity recorded until 21:57. A Serotine was head not seen at 21:53.</p> | |

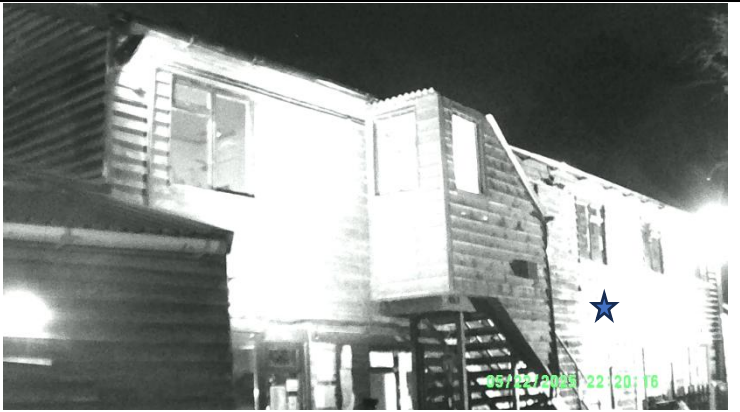
| Surveyor observations | | |
|---|---|---|
| <p><i>IR position 1</i></p> | <p>IR reviews confirm the observations of the surveyor. No further bat activity was recorded.</p> | |

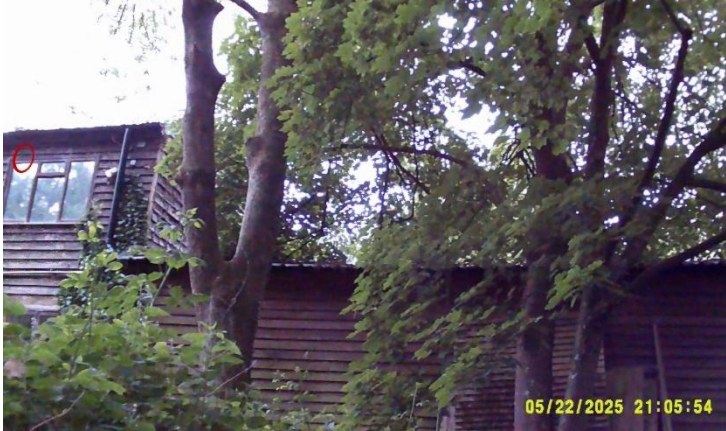
| <i>Surveyor 3</i> | <p><b>No bat emergences or re-entries were observed</b> from the single storey timber shed attachment. <b>One Soprano pipistrelle bat emergence was observed</b> on the main building (as also observed by Surveyor 4), under lifted timber panel by the far west side of the building (as shown by blue star).</p> <p>The first bat seen was a Common pipistrelle, passing over the main building at 20:38.</p> <p>Between 21:04 to 21:12 there was constant bat activity: Soprano pipistrelles were seen foraging (after emerging from the lifted weatherboarding above the far right top window). At 21:46, Soprano pipistrelles continued to forage.</p> <p>The last bat activity recorded was a single Noctule, heard not seen at 22:16.</p> | A daytime photograph of a wooden building (Rose Cottage) partially obscured by green trees. A red circle is drawn around a window on the upper left side of the building. A yellow timestamp in the bottom right corner reads "05/22/2025 21:05:54". |

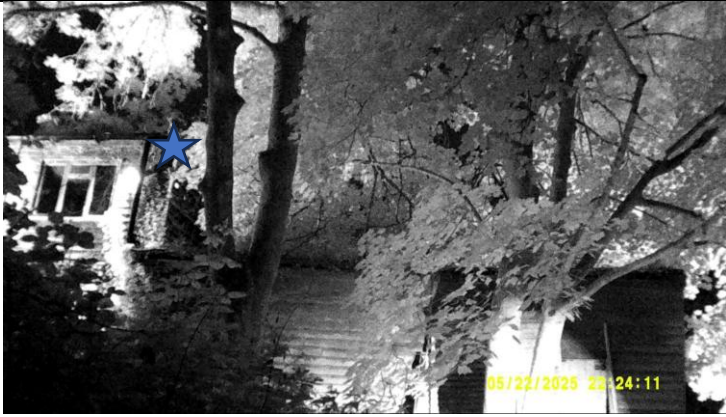
| <i>IR position 3</i> | IR reviews confirm the observations of the surveyor. No further bat activity was recorded. | An infrared (IR) photograph of the same building and trees. A blue star is marked on the wall of the building, corresponding to the location of the window mentioned in the text. A yellow timestamp in the bottom right corner reads "05/22/2025 22:24:11". |

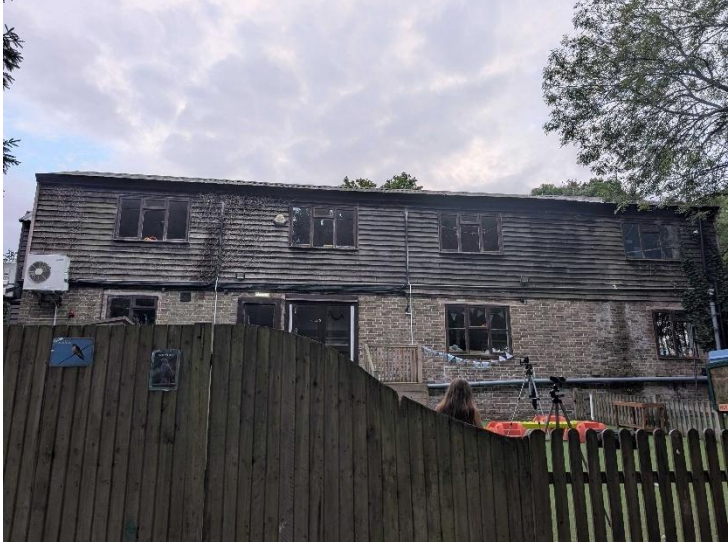
| <p><i>Surveyor 4</i></p> | <p><b>One bat emergence survey was observed</b> at 21:03, which was a Soprano pipistrelle. The bat emerged from the raised weatherboarding about the far west window (as shown by blue star).</p> <p>The first bat activity recorded was a Common pipistrelle at 20:48, which was observed passing over the roof of the building. This was followed by several more Common pipistrelle passes</p> <p>From 21:03 until 21:12 there was constant Soprano pipistrelle commuting activity up and down the edges of the building. At 21:46, Soprano pipistrelle activity returned with constant activity until 21:49. The last Soprano pipistrelle pass was 22:13 (heard not seen).</p> | |

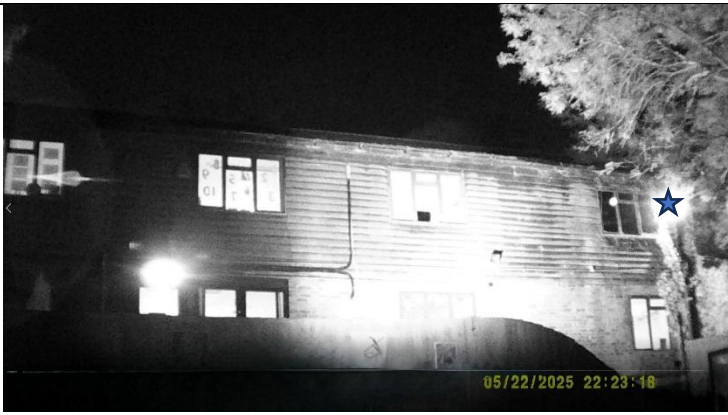
| <p><i>IR position 4</i></p> | <p>Due to the overexposure on the IR camera caused by the IR security light, the emergence was not visible within the IR review. However, the emergence was confirmed by IR review of Surveyor 3's IR camera.</p> <p>No further bat activity was recorded.</p> | |

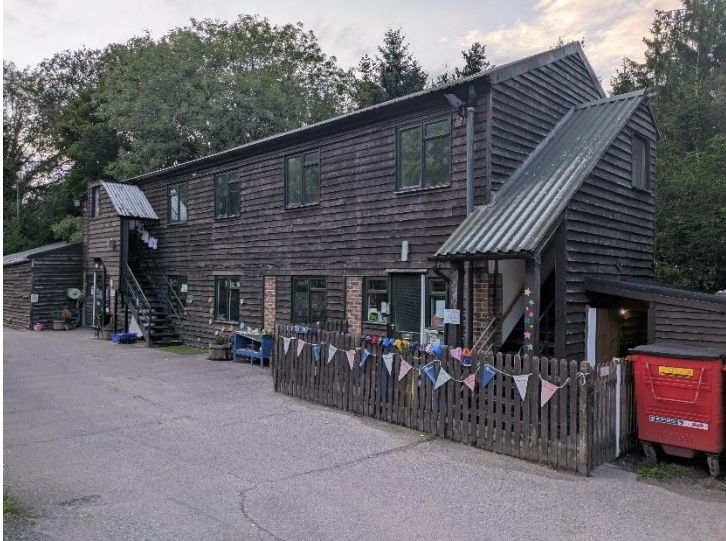
| <i>Surveyor 5</i> | <p><b>Nine bat emergences were observed</b> (as shown by blue star in below image).</p> <p>Eight emergences were observed between 21:10-21:13 from lifted cladding board beneath third window from the right. These were non-echolocating bats, however likely to be Soprano pipistrelles based on evidence from droppings, emergence time, flight patterns and activity heard throughout the survey.</p> <p>The first bat activity observed was a Common pipistrelle at 20:48, seen passing over the building and foraging above the roof. Further passes were observed at 20:54 and 21:06. A Soprano pipistrelle was heard not seen (HNS) at 21:20 and both Common and Soprano pipistrelles were HNS occasionally throughout the survey. A Serotine was seen at 21:52 foraging around the treetops to the north of the building. The last bat activity recorded was a Serotine, HNS at 22:15.</p> | |

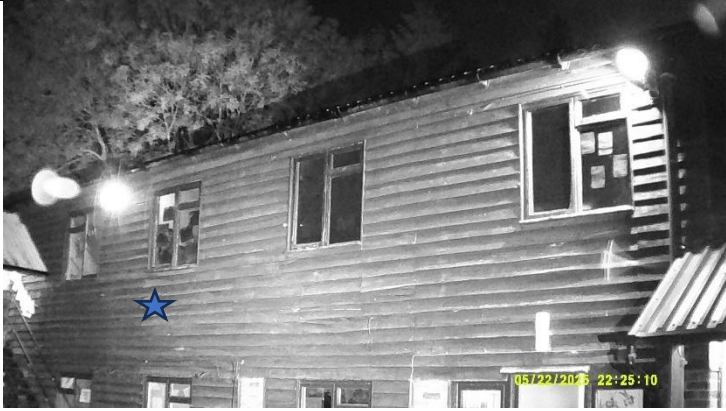
| <i>IR position 5</i> | IR reviews confirm the observations of the surveyor. No further bat activity was recorded. | |

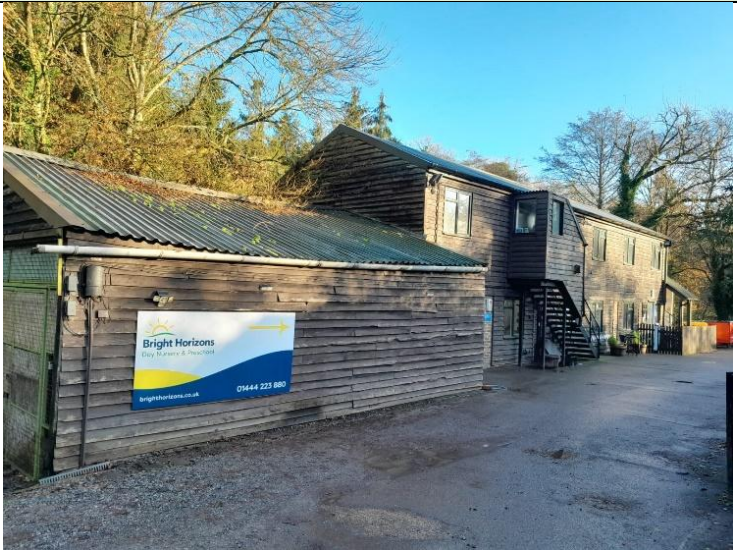
| Surveyor observations | | |
|---|---|---|
| Surveyor 1 | <p><b>No emergences or re-entries were observed.</b></p> <p>The first bat activity recorded was a Common pipistrelle at 21:27. Common and Soprano pipistrelles were heard frequently throughout the duration of the survey, and occasionally seen within the trees. A Serotine was heard not seen at 22:06. The last bat activity recorded was a Soprano pipistrelle at 22:24.</p> | |

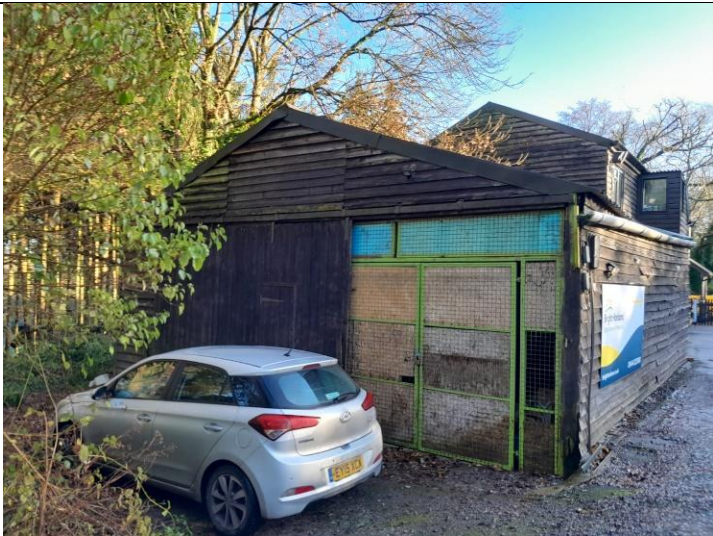
| <i>Surveyor 2</i> | <p><b>No emergencies or re-entries were observed.</b></p> <p>The first bat activity recorded was a Common pipistrelle at 21:26, observed flying over the building. Common pipistrelles were frequently heard foraging throughout the duration of the survey. A Serotine flew over the building at 22:07. The last bat activity recorded was a Common pipistrelle, heard not seen, at 22:24.</p> | |

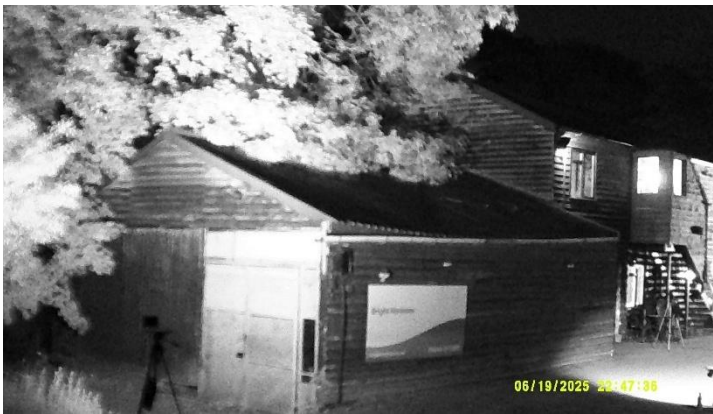
| <i>IR position 2</i> | <p>IR reviews confirm the observations of the surveyor. No further bat activity was recorded.</p> | |

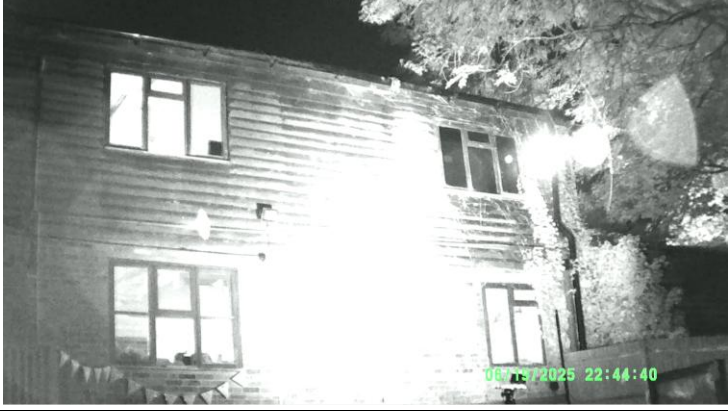
| <i>IR position 3</i> | <b>No emergences or re-entries observed.</b><br><br>Numerous bat passes were recorded, in line with the summary of Surveyor 4. | |

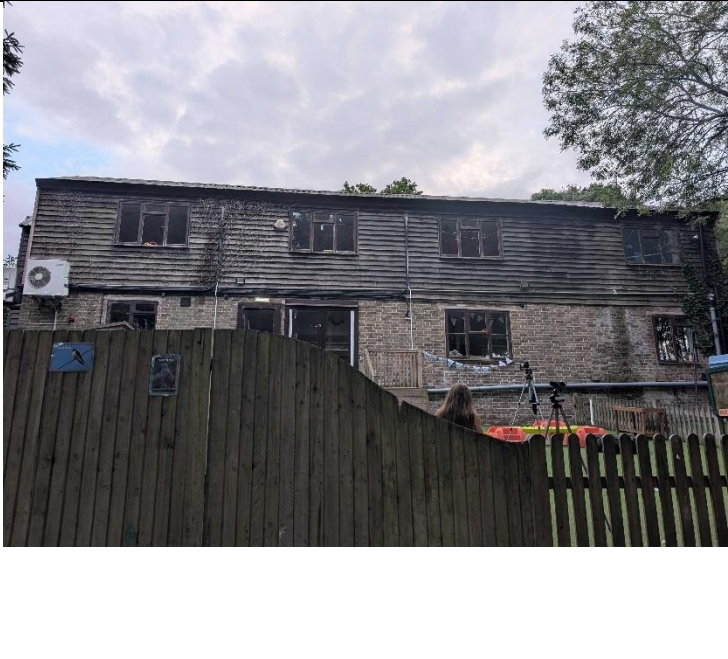
| <i>Surveyor 4</i> | <b>No emergences or re-entries observed.</b><br><br>The first bat activity was a Common pipistrelle, which was heard not seen at 21:26 and frequently heard not seen throughout the survey until 21:43. At 21:48, two Common pipistrelles were seen passing over the roof of the north elevation from south-east to north-west towards the treeline to the north of the site. Common pipistrelle was seen passing from south-east to north-west at 22:01 and foraging activity was heard between 22:00 and 22:02. A further two Common pipistrelles flew above the roof of the north elevation, from east to west and vice versa, as well as above the trees to the wider northern area of the site at 22:02. At 22:08, a Common pipistrelle was seen passing from north-west to south-east. The final bat activity was at 22:34, when a Common pipistrelle was heard not seen. | |

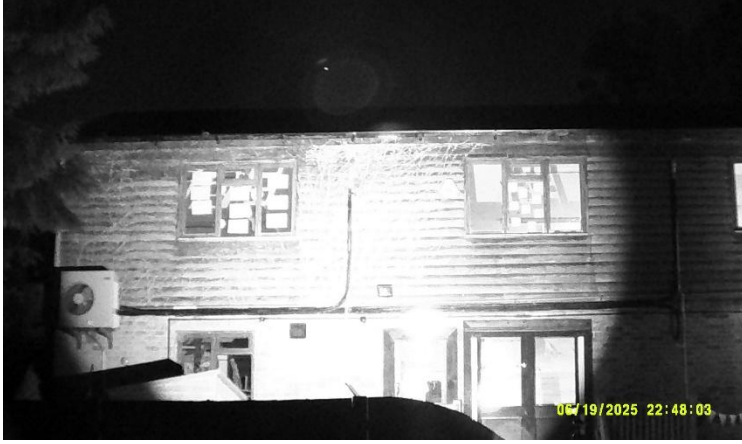
| <i>IR position 4</i> | <p>IR reviews confirm the observations of the surveyor.</p> <p>Further passes and foraging activity was seen throughout the duration of the survey, including at 22:19, where a bat can be seen passing from west to north-east, heading towards the trees.</p> | |

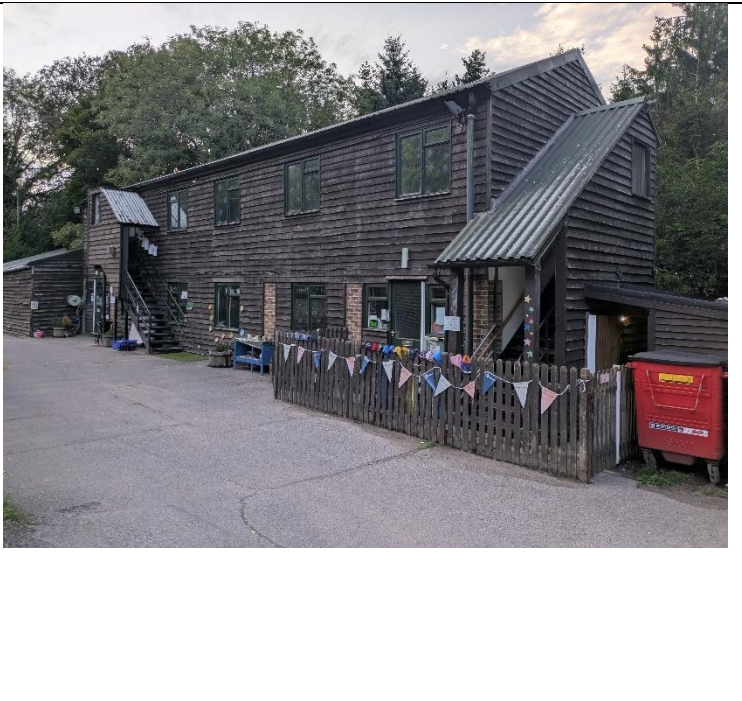
| <i>Surveyor 5</i> | <p><b>One bat emergence</b> (Soprano pipistrelle) was observed, emerging from between wooden board and lefthand brick (as shown by blue star in below image) section at 21:30, and flew east.</p> <p>The first bat activity was a Common pipistrelle, which was observed flying South to North over the building. Regular passes from Common pipistrelles were observed throughout the survey above and around the building, as well as two Common pipistrelles seen foraging between the eastern elevation and trees to the east of the building at 22:00. At 22:24 two common pipistrelles were foraging over the roof of the building. A Soprano pipistrelle was observe at 21:55, passing in front of the southern elevation. At 22:06, two Serotines were seen passing above the building and across the carpark area both flying east to west. A Brown long-eared bat was heard not seen at 22:04 and at 22:46.</p> | |

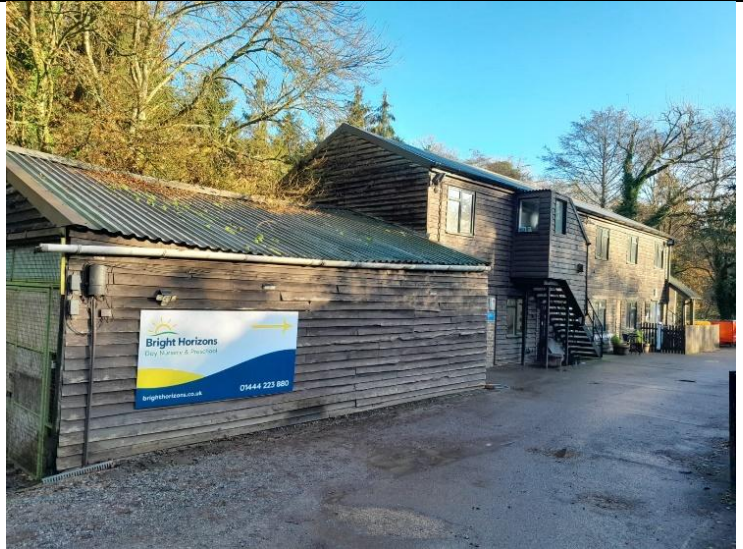
| Results | | |
|---|---|---|
| Surveyor 1 | <p><b>One bat (Soprano pipistrelle) emergence</b> seen at 21:16:23 from the lifted timber boards at the very edge of the single-storey attached building, where the south elevation meets the west elevation. Common and Soprano pipistrelle foraging and commuting behaviour was observed and heard throughout the entirety of the survey, first heard at 21:15 and last heard at 21:48. Two Soprano pipistrelle bats were observed foraging around the south of the building and over the building at 21:33. Both Soprano and Common pipistrelle bats were observed commuting frequently from south-west to north-east. The last bat activity recorded was a Common pipistrelle at 21:48.</p> | |

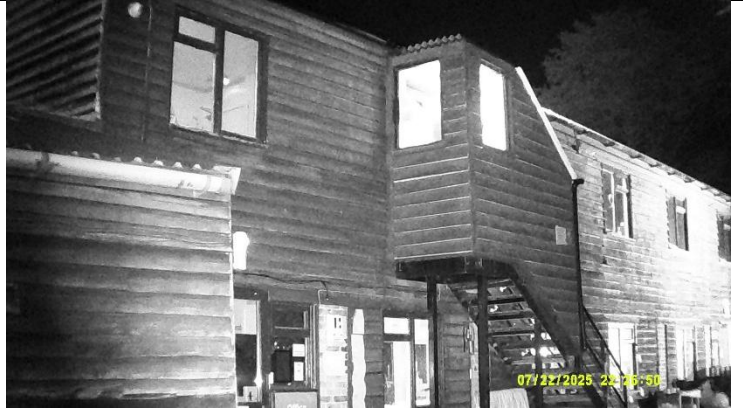
| Results | | |
|---|---|---|
| IR position 1 | <p>The emergence was not captured by the IR camera, however this was confirmed upon IR review of Surveyor 2's camera. No further bat activity was recorded.</p> | |

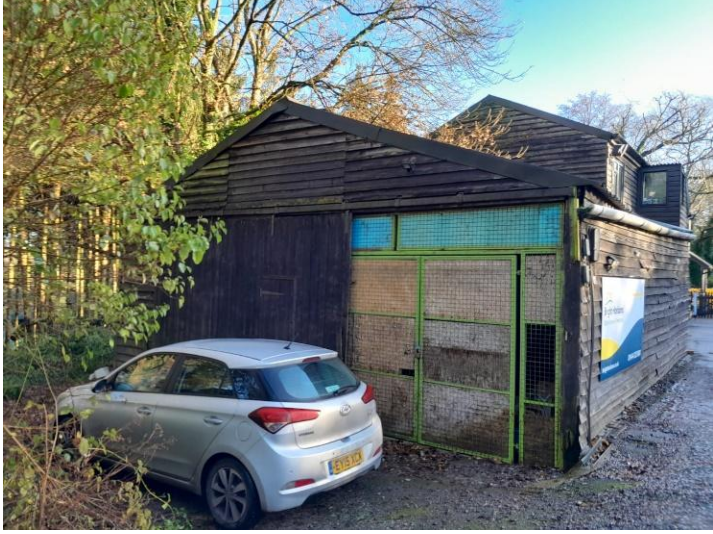
| <i>Surveyor 2</i> | <b>One bat (Soprano pipistrelle) emergence</b> seen at 21:16:23 from the lifted timber boards at the very edge of the single-storey attached building, where the south elevation meets the west elevation (as shown by blue star in below image). The first bat activity recorded was a Common pipistrelle at 21:13, which flew from south to north over the building. Common and Soprano pipistrelles were heard frequently throughout the duration of the survey, observed foraging over the trees to the west of the building. The last bat activity recorded was a Common pipistrelle which was heard not seen at 21:51 | |

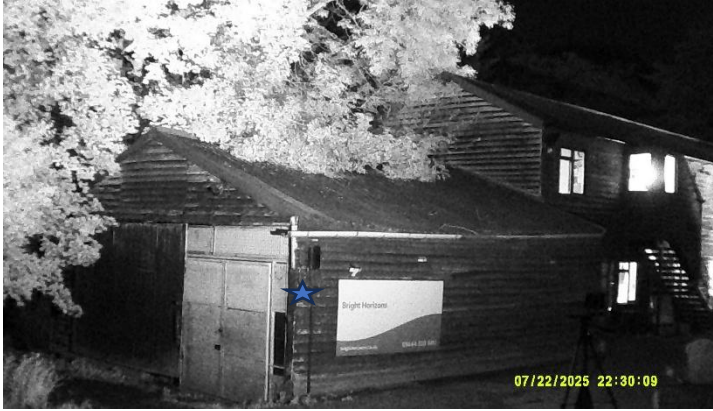
| <i>IR position 2</i> | IR reviews confirm the observations of the surveyor. No further bat activity was recorded. | |

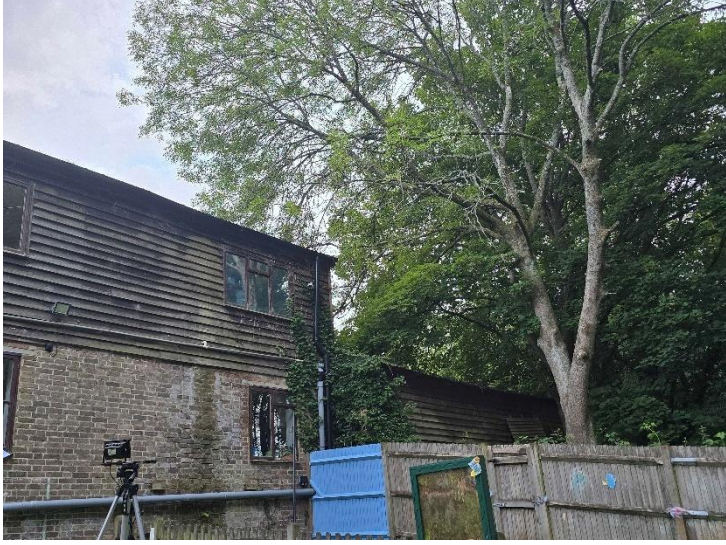
| <i>Surveyor 3</i> | <p><b>No emergences or re-entries observed.</b></p> <p>The first activity of the night was a Common pipistrelle, heard not seen at 21:12. At 21:14, the first bat was seen, a Common pipistrelle which was flying in a Southern direction along the treeline to the West of the building. A Noctule was heard not seen for the first and only time at 21:16. From 21:17, there was moderate activity from Common and Soprano pipistrelles until the end of the survey. The bats were mainly observed foraging in the rear garden and above the building. There were intervals throughout the survey of heard not seen Common and Soprano pipistrelles, with the last activity recorded being a faint Common pipistrelle echolocation at 22:27.</p> | |

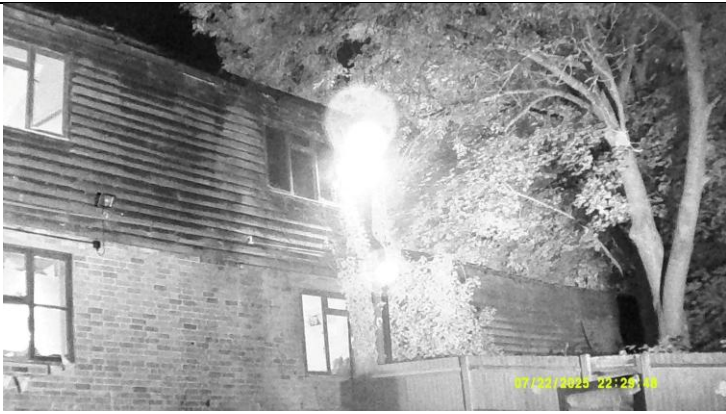
| <i>IR position 3</i> | <p>IR reviews confirm the observations of the surveyor. No further bat activity was recorded.</p> | |

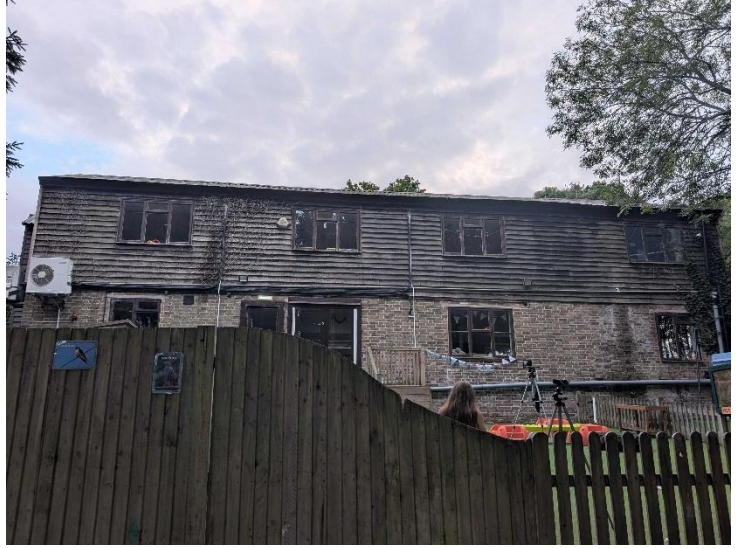
| <i>Surveyor 4</i> | <p><b>No emergencies or re-entries observed.</b></p> <p>There was moderate bat activity throughout the survey with the first activity being a Common Pipistrelle pass at 21:12, heard and not seen. A Noctule was briefly recorded at 21:16, before a period of constant Common and Soprano pipistrelle activity, with regular passes and foraging above the building from 21:19 until 21:45. Several further Common pipistrelle passes were recorded throughout the rest of the survey, with the last activity recorded being a Common pipistrelle heard not seen at 22:26.</p> | |

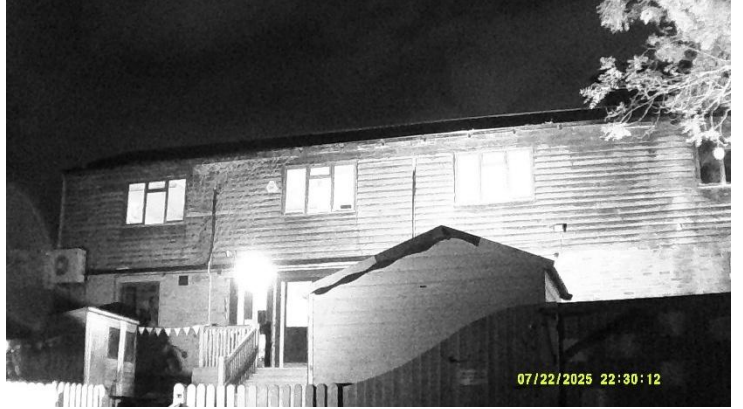
| <i>IR position 4</i> | <p>IR reviews confirm the observations of the surveyor. No further bat activity was recorded.</p> | |

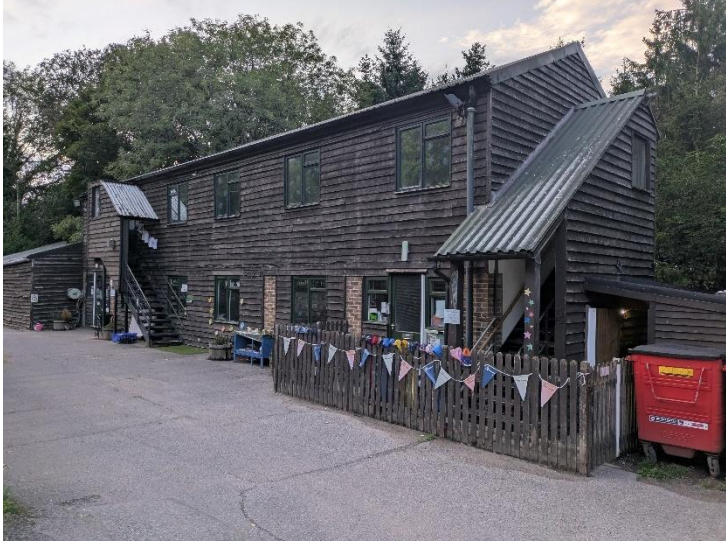
| <i>Surveyor 5</i> | <p><b>Two emergences were observed</b></p> <p>The first activity was a Common pipistrelle at 21:11, which was observed emerging from between lifted wooden cladding and right side brick section (as shown by blue star in below image), then flying east.</p> <p>At 21.20 a Soprano pipistrelle was seen emerging from between lifted wooden cladding and left side brick section and flying east (as shown by red star in below image).</p> <p>There was frequent foraging and commuting activity throughout the survey from Soprano and Common pipistrelles, with a common flight path being from the South/Southwest to North/Northeast. A Noctule was heard not seen at 21.16, and a Serotine was heard not seen at 22.17. The final activity was a Common pipistrelle heard not seen at 22.29.</p> | |

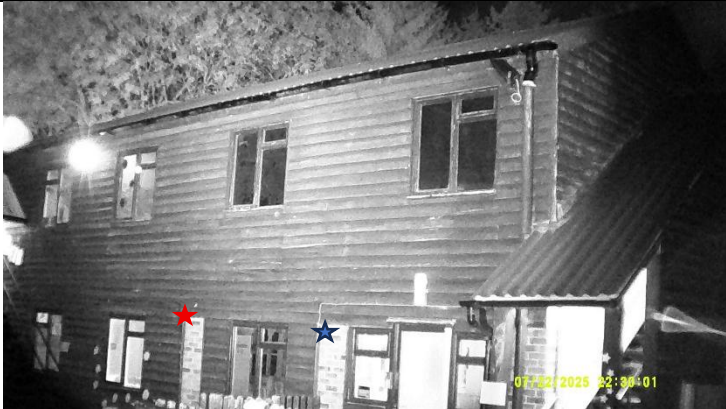
| <i>IR position 5</i> | <p>IR reviews confirm the observations of the surveyor.</p> <p>One pass from soprano pipistrelle seen flying east, no further additional activity recorded.</p> | |

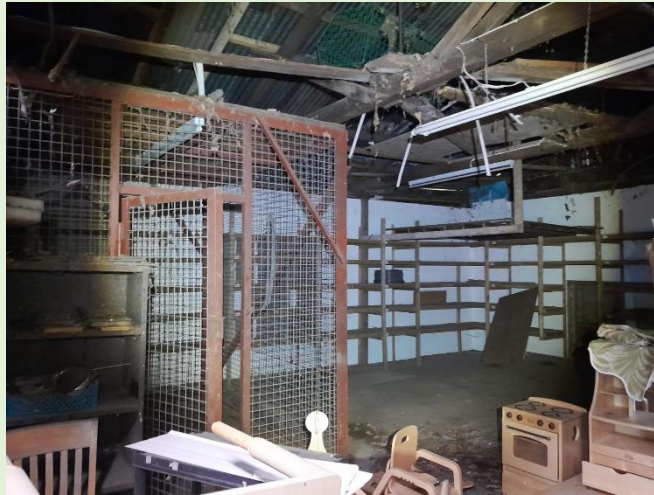
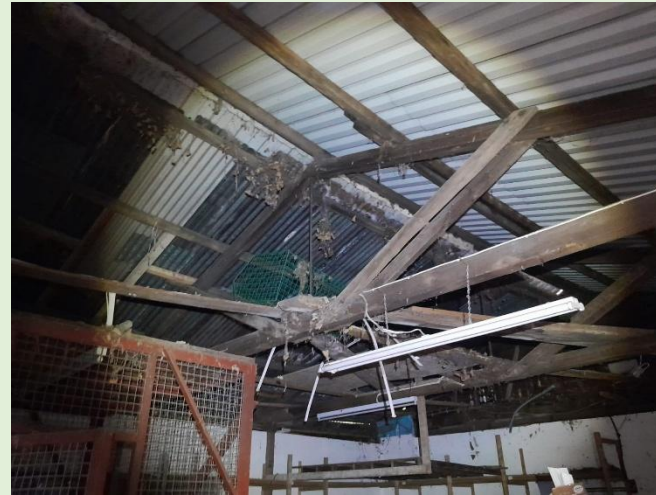
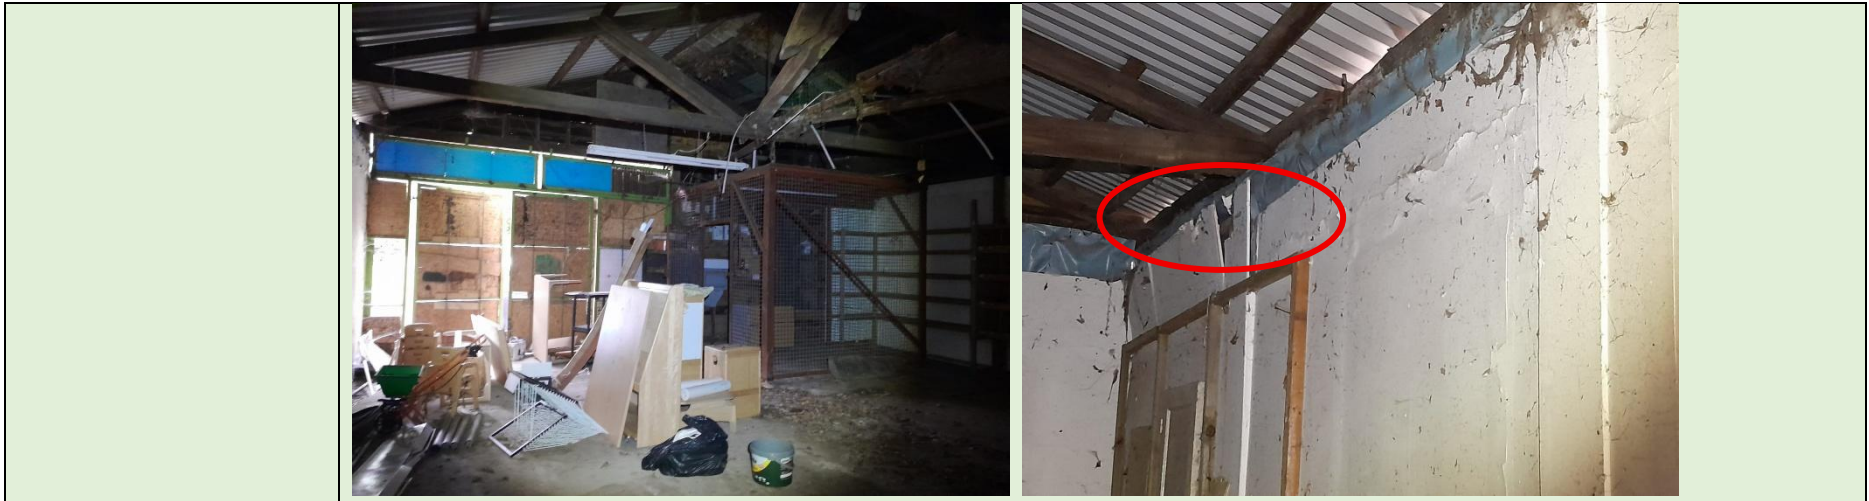
**Internal Inspection**

Structures inspected: Interior of adjoined barn building

Bat evidence found: None

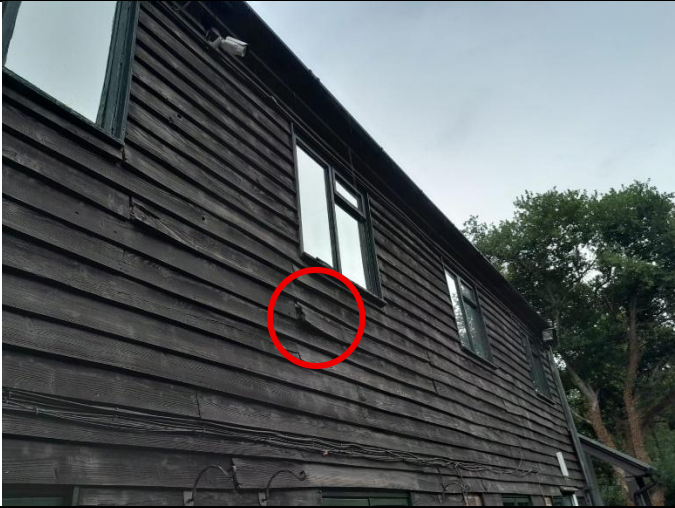
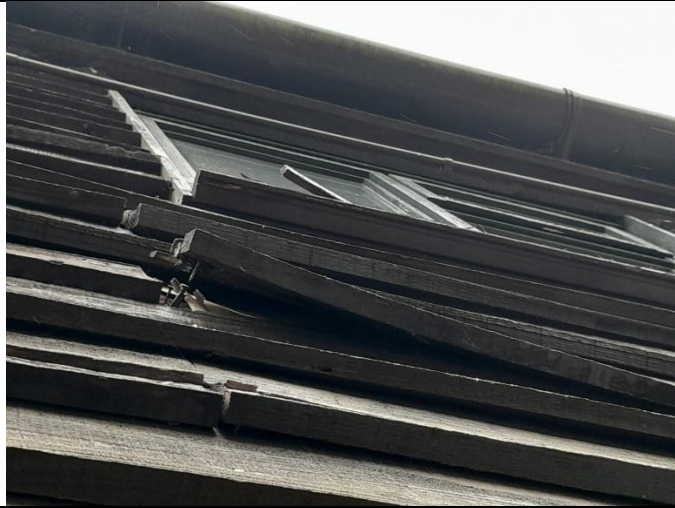
| Roost | Photograph | |
|---|---|---|
| 1 | | |

| Roost number | Species | Roost type | Peak number of individuals | Roost location |
|---|---|---|---|---|
| 1 | Soprano pipistrelle | Maternity roost | 9 | Under lifted timber board on south elevation, underneath window. |

<table><tr> <th data-bbox="562 225 862 260">Roost number</th><th data-bbox="862 225 1944 260">Impact</th></tr><tr> <td data-bbox="562 260 862 655">1,2,4,5</td><td data-bbox="862 260 1944 655"> <p>The roosts will be disturbed by noise and vibrations during the works to the attached barn building.</p> <p>Only internal works are proposed on the nursery building and as such, no roosts are anticipated to be destroyed. Access route from the barn to the nursery will be created, impacting the west elevation of the nursery building, where the current barn building is attached.</p> <p>The proposed development is not anticipated to significantly increase current levels of lighting or human disturbance, due to the main nursery building already producing levels of artificial light and human activity disturbance.</p> </td></tr></table>

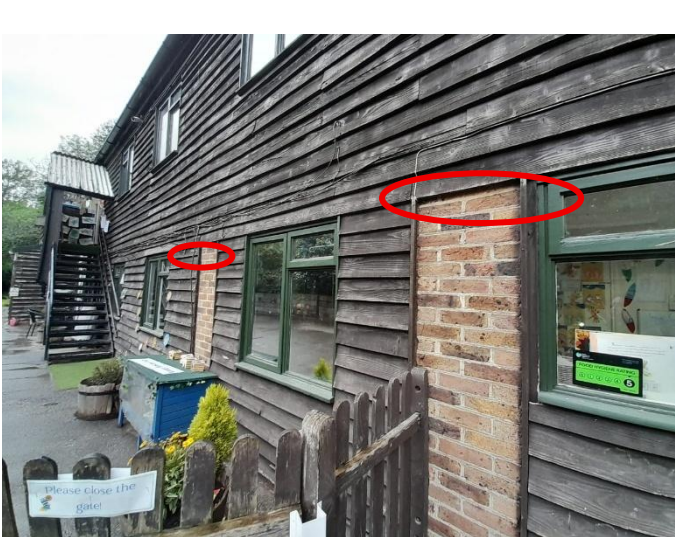
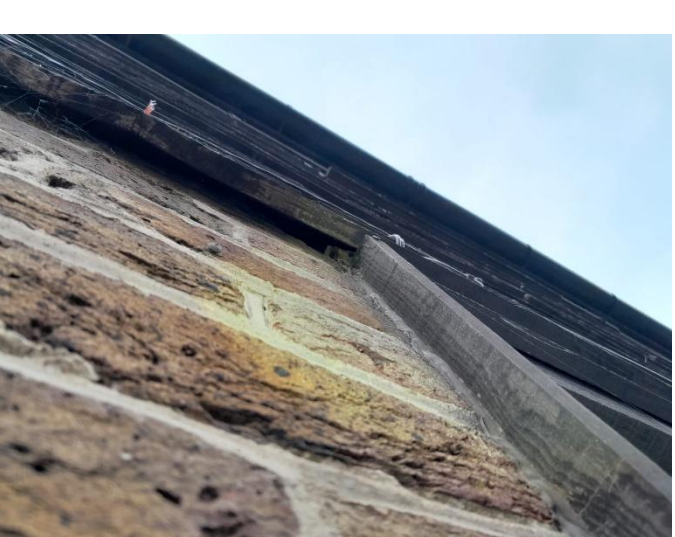
| Roost | Photograph | |
|---|---|---|
| 4 and 5 | | |

| Roost number | Species | Roost type | Peak number of individuals | Roost location |
|---|---|---|---|---|
| 4 | Soprano pipistrelle | Day Roost | 1 | Gap where timber panels meet the exposed brick (left hand exposed brick section), on the south elevation. |
| 5 | Common pipistrelle | Day Roost | 1 | Gap where timber panels meet the exposed brick (left hand exposed brick section), on the south elevation. |

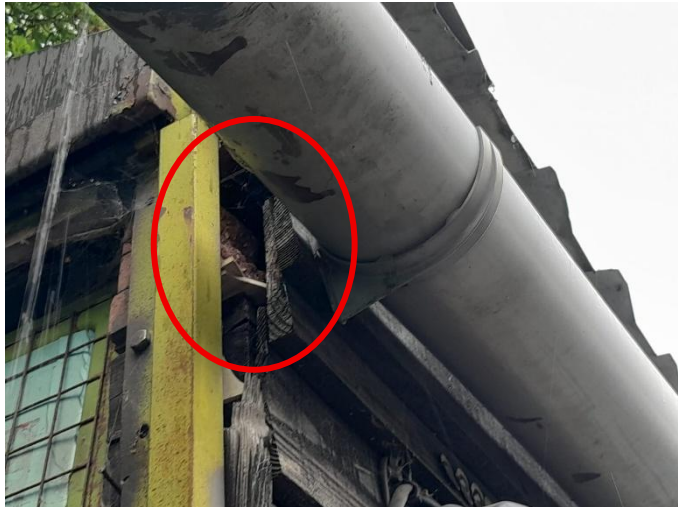
| 3 | | |

| Roost number | Species | Roost type | Peak number of individuals | Roost location |
|---|---|---|---|---|
| 3 | Soprano pipistrelle | Day Roost | 1 | Under lifted timber board of single storey attached outbuilding, where the south elevation meets the west elevation |

<table><tr> <th data-bbox="562 225 862 260">Roost number</th><th data-bbox="862 225 1944 260">Impact</th></tr><tr> <td data-bbox="562 655 862 802">3</td><td data-bbox="862 655 1944 802"> <p>The roosts will be destroyed when the timber panels/weatherboarding is made watertight. Furthermore, interior construction will result in the removal of the existing lining, which will cause the destruction of the bat roost (as bats are roosting between the lining and timber weatherboarding).</p> </td></tr></table>
