## Bat Emergence Survey Report

Stonehurst – Main House

Ian Adam Smith  
Architects

**Project No: 10042**

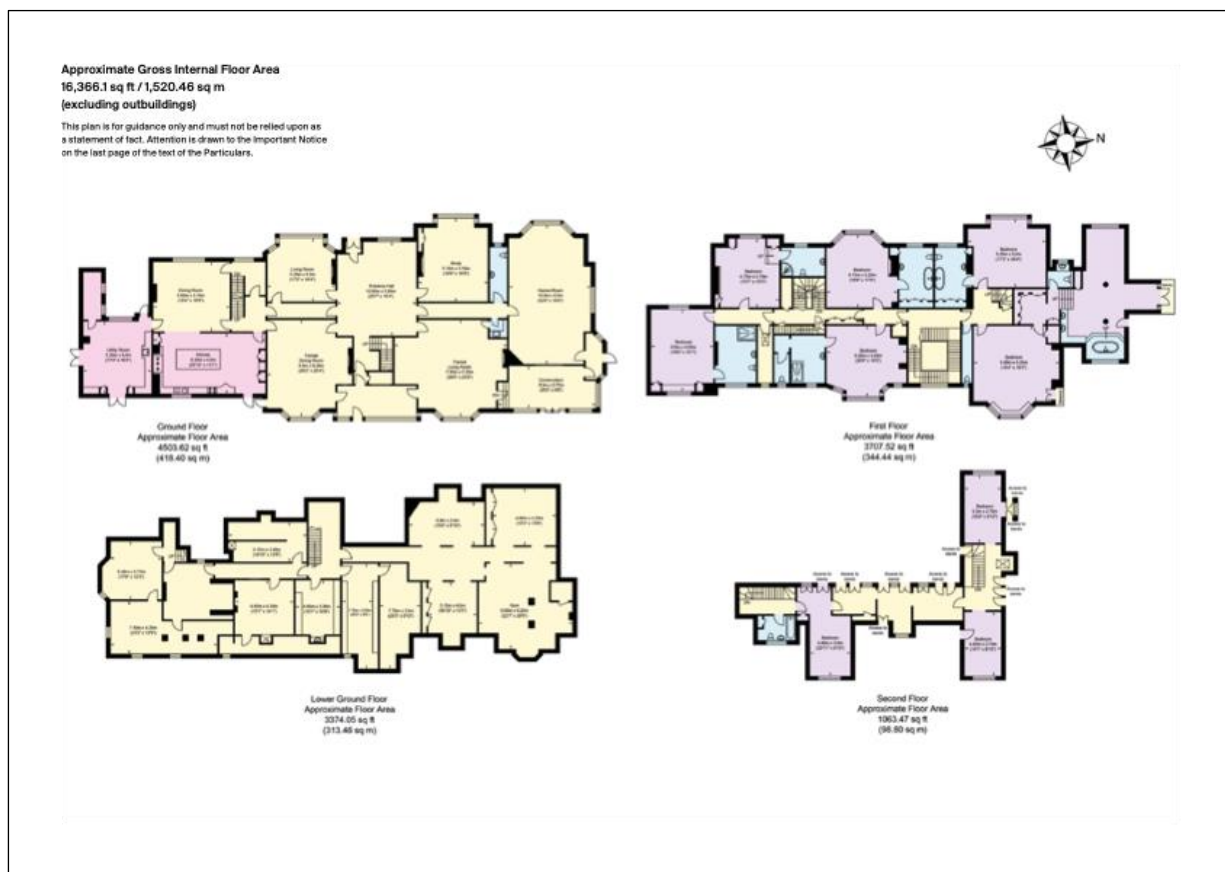
**Figure 2.** Existing floor plan of Stonehurst Main house. Image produced courtesy of Ian Adam Smith Architects

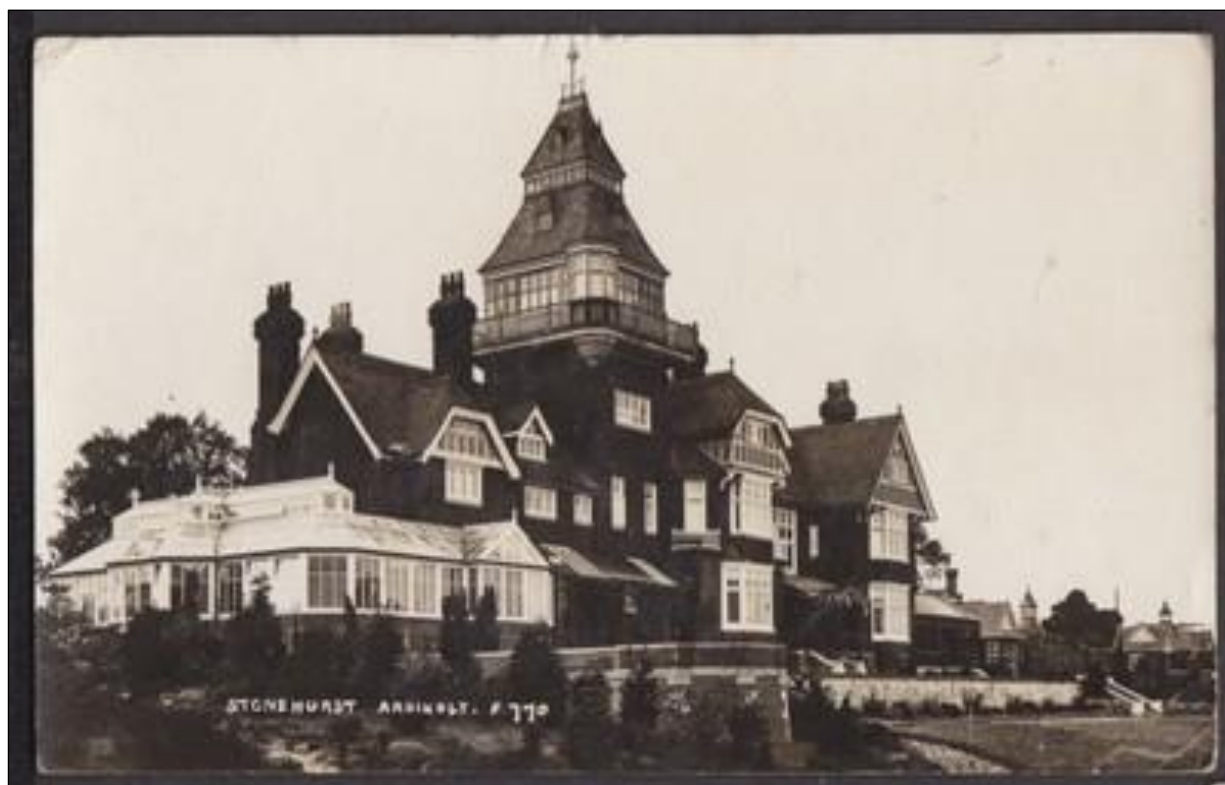
**Figure 3.** Historic view of Stonehurst Main house with view of the tower. Image produced courtesy of Ian Adam Smith Architects.

The proposed development/project seeks to re-instate the main house's iconic tower and renovate sections of the building to restore the overall building to match its historic features and renovate and repair sections. A view of the building with its former tower block is shown in Figure 3 and sections proposed for works in Figure 4.

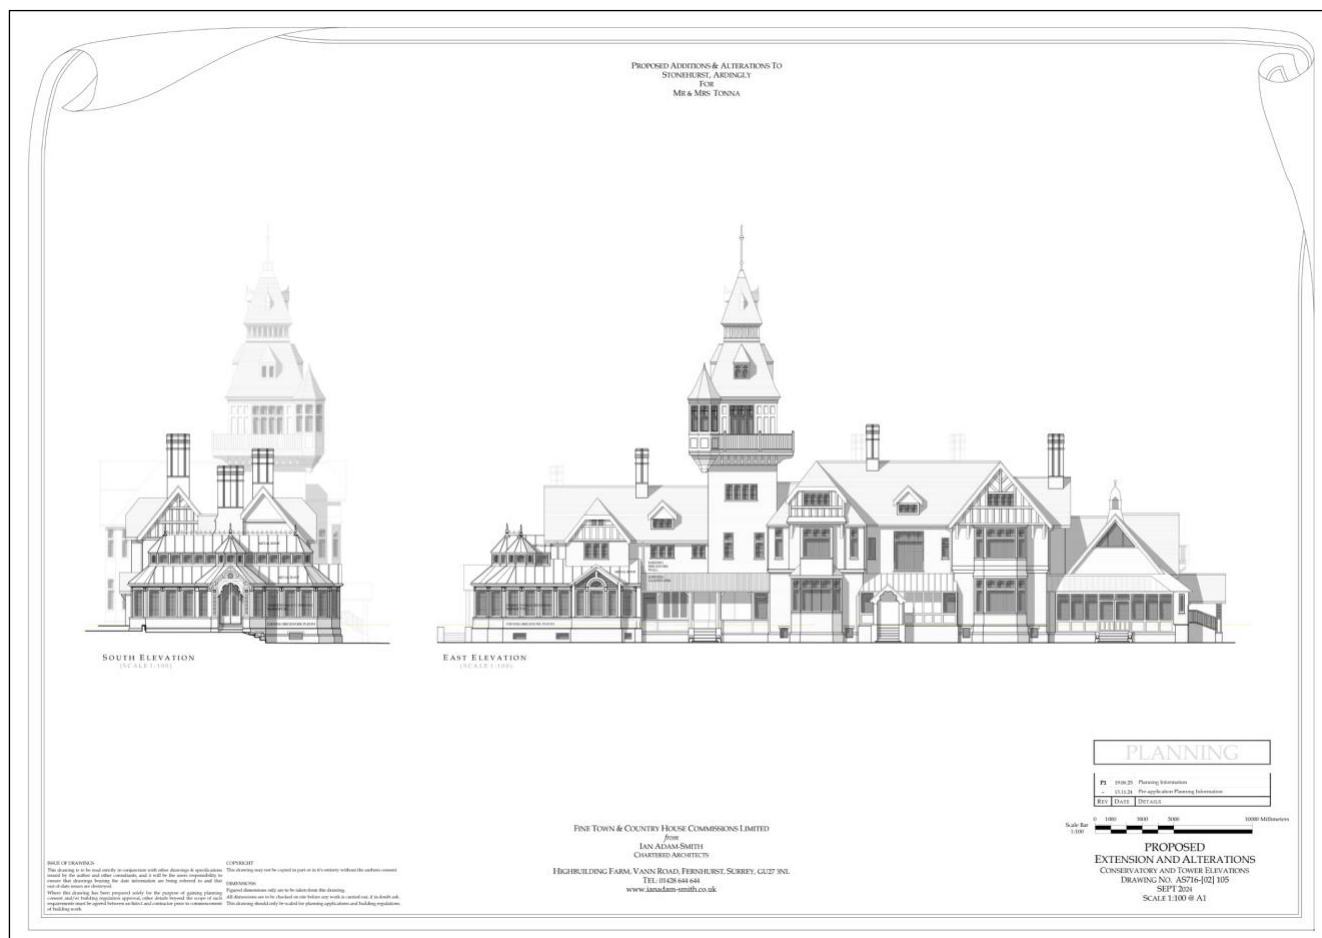
**Figure 7.** View of detailed proposed elevations for southern and eastern aspect produced courtesy of Ian Adam Smith Architects dated 19.06.2025.

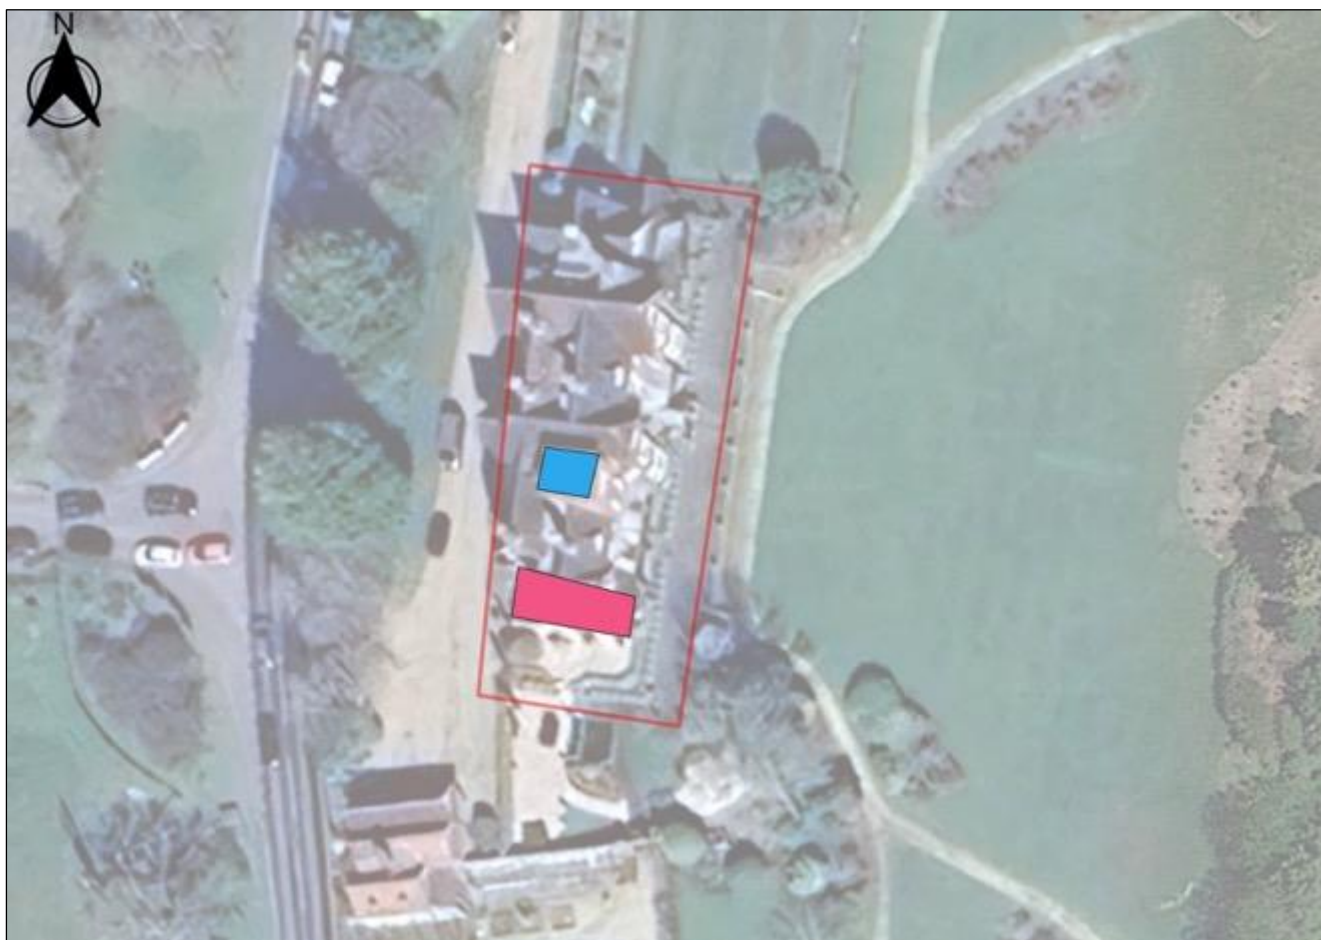
**Figure 8.** An aerial image of Stonehurst main house (indicated with a red border) and the approximate locations of proposed

works. A blue square indicates the clock tower location and pink square indicating the southern extension. Image produced using QGIS version 3.36 - Maidenhead.

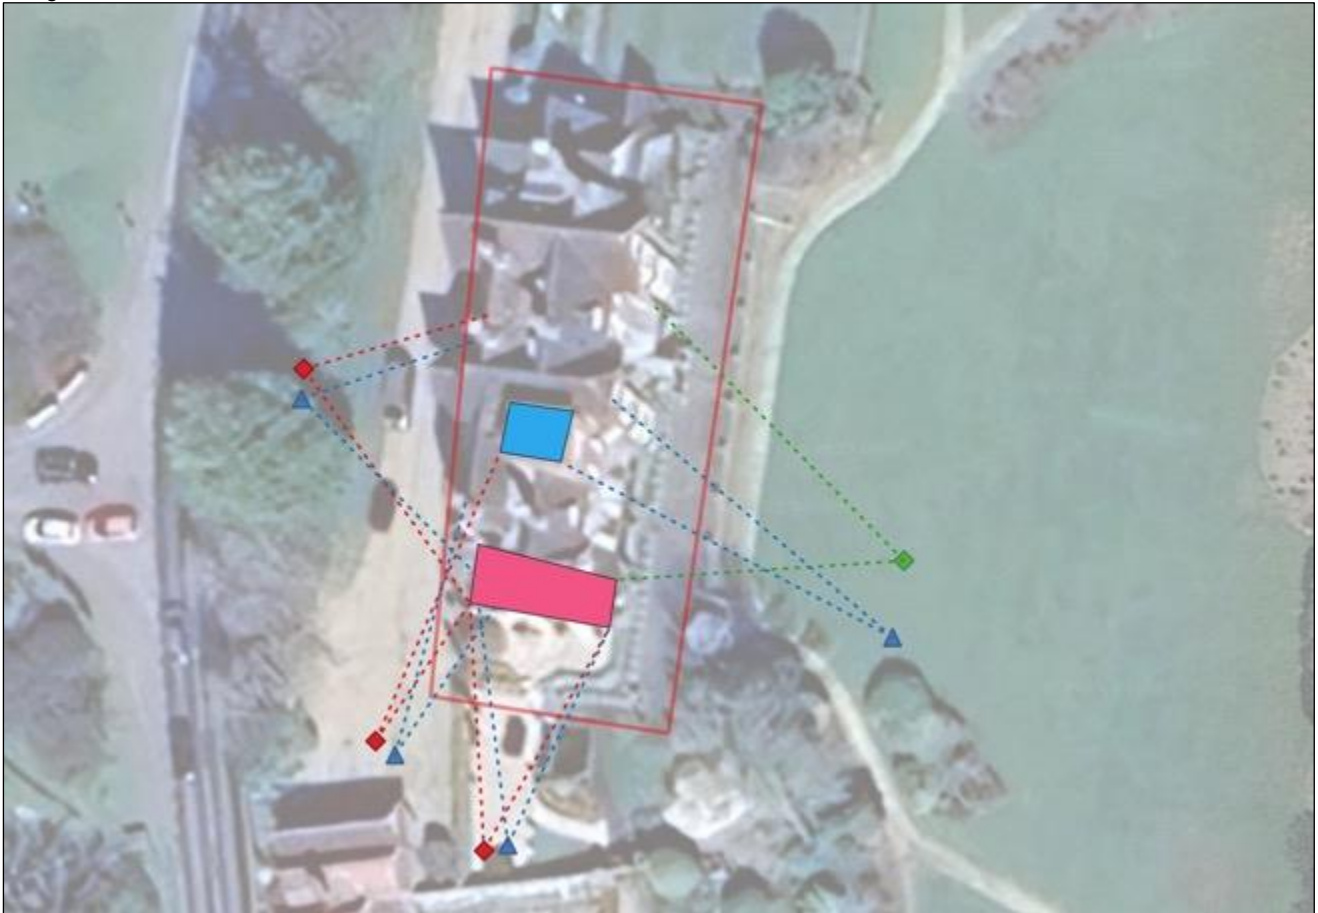
**Figure 9.** An aerial image showing the survey positions during survey 1 (20.05.2025). Surveyors (blue triangles), night-vision cameras (red diamonds) and a thermal camera (green diamond) overlaid upon Figure 8. Approximate fields of view are indicated by dashed lines associated with the corresponding surveyor or camera colours. Image produced using QGIS version 3.36 - Maidenhead.

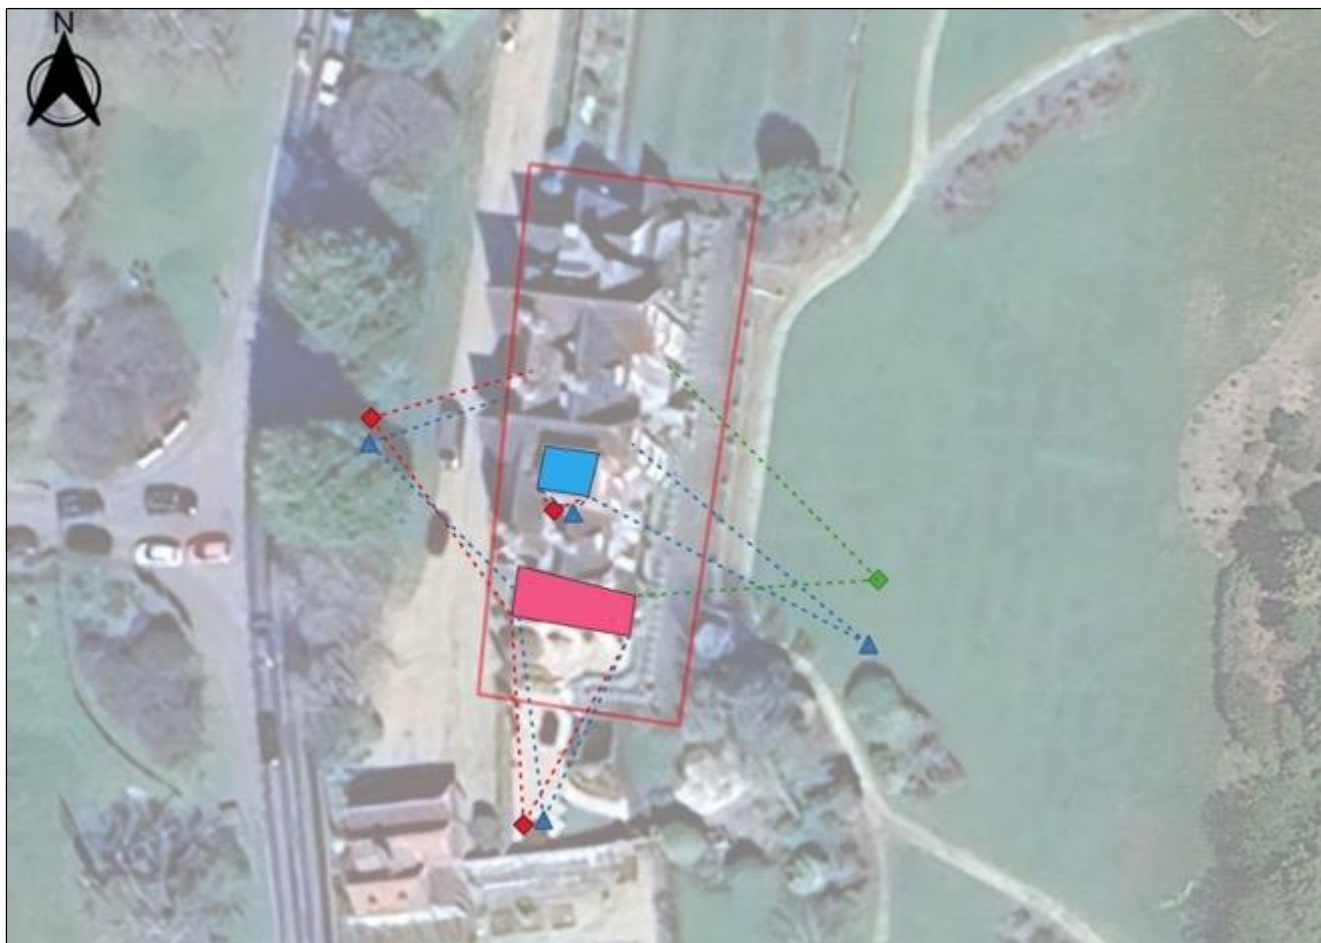
**Figure 10.** An aerial image showing the survey positions during survey 2 (16.06.2025). Surveyors (blue triangles), night-vision cameras (red diamonds) and a thermal camera (green diamond) overlaid upon Figure 6. Approximate fields of view are indicated by dashed lines associated with the corresponding surveyor or camera colours. Image produced using QGIS version 3.36 - Maidenhead.

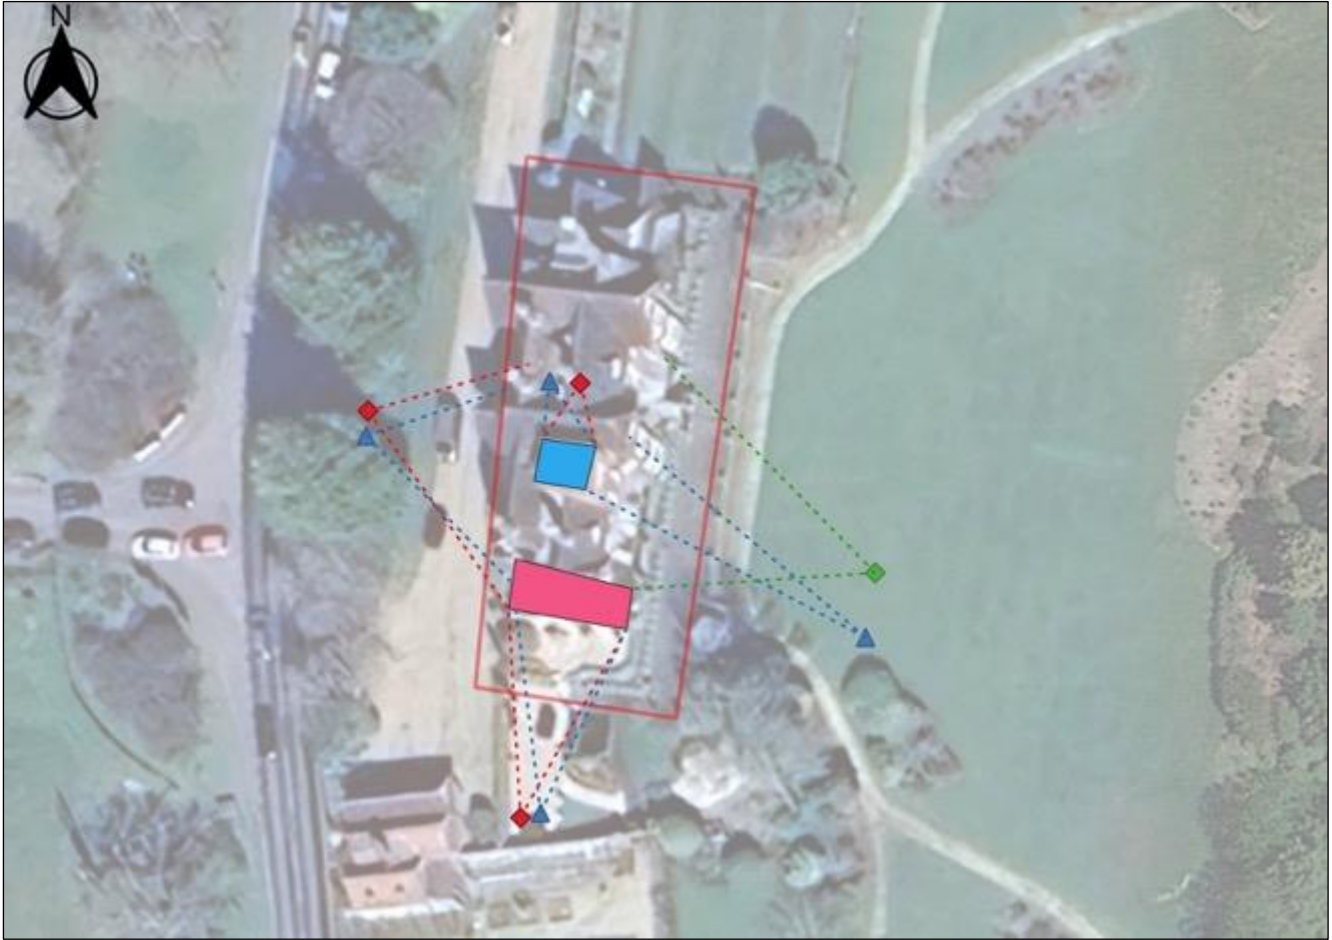
**Figure 11.** An aerial image showing the survey positions during survey 3 (22.07.2025). Surveyors (blue triangles), night-vision cameras (red diamonds) and a thermal camera (green diamond) overlaid upon Figure 6. Approximate fields of view are indicated by dashed lines associated with the corresponding surveyor or camera colours. Image produced using QGIS version 3.36 - Maidenhead.

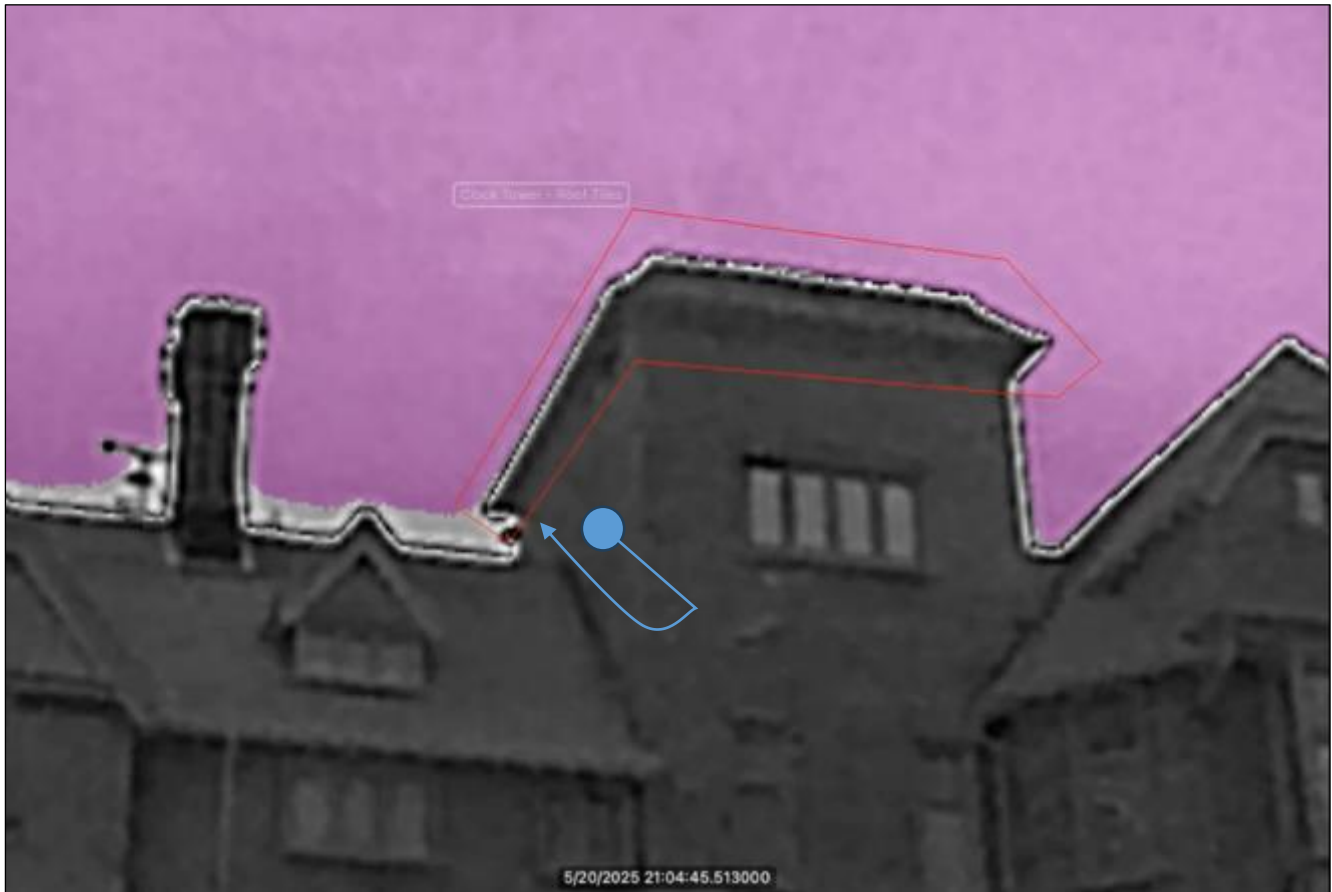
**Figure 12.** View of the eastern aspect of the site with the approximate emergence location and flight line of the survey 1 emergence at 22:04 (note that the Thermal camera uses an incorrect time zone and is ~ 1 hour behind GMT).

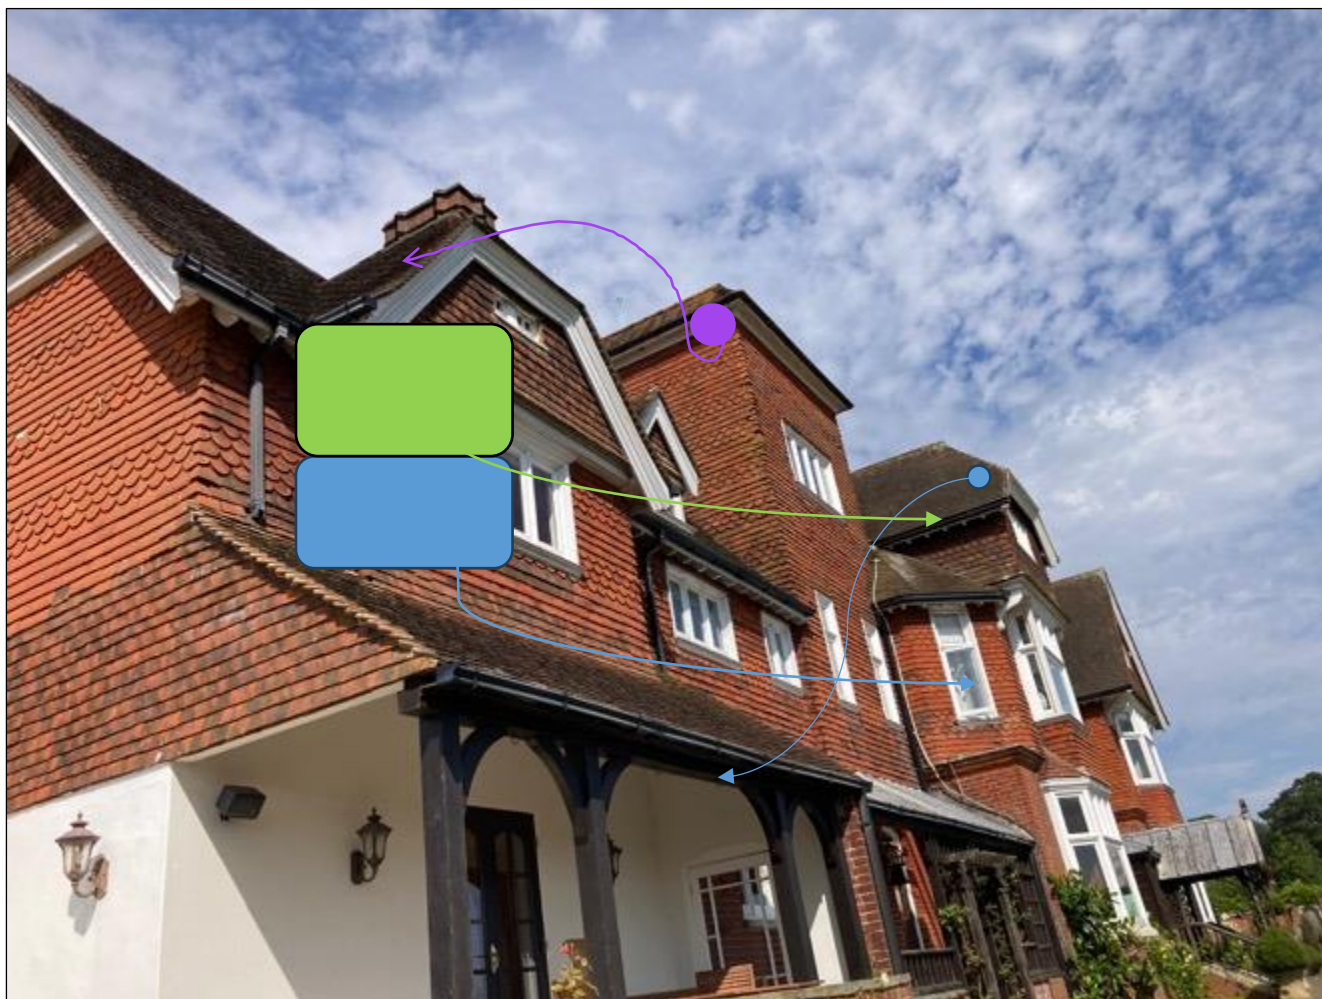
**Figure 14.** View of the south eastern aspect of the site with the approximate emergence location and flight lines of the soprano pipistrelles (indicated in green), common pipistrelles (indicated in blue) and *Myotis* sp. (indicated in purple) during survey 2. Square emergence points are approximate as precise locations could not be determined during the survey.

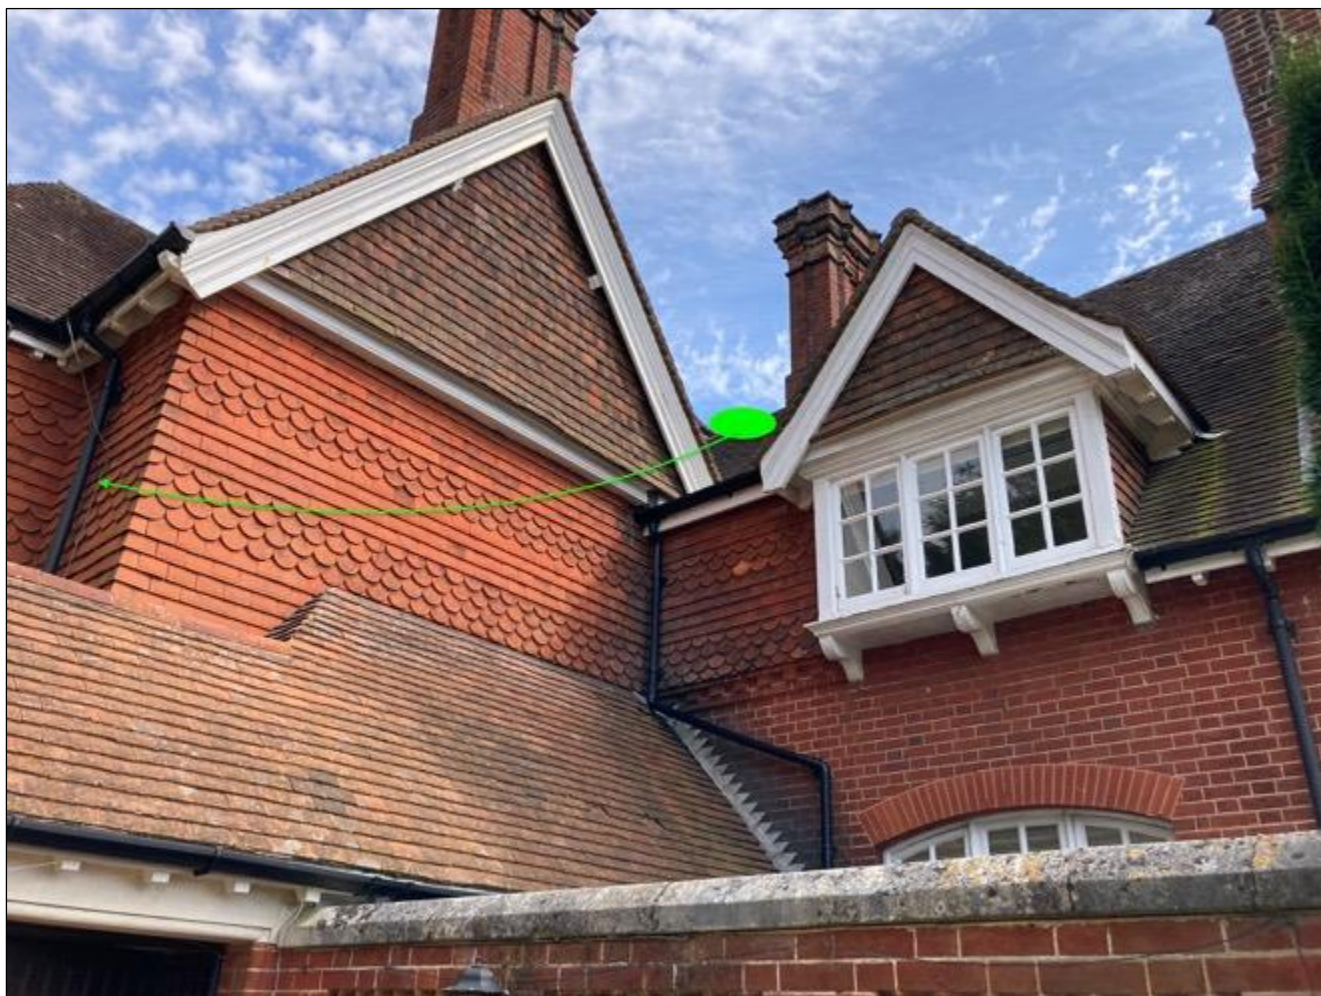
**Figure 15.** View of the western aspect of the site with the approximate emergence location and flight line of the soprano pipistrelle recorded at 21:33 on survey 2.

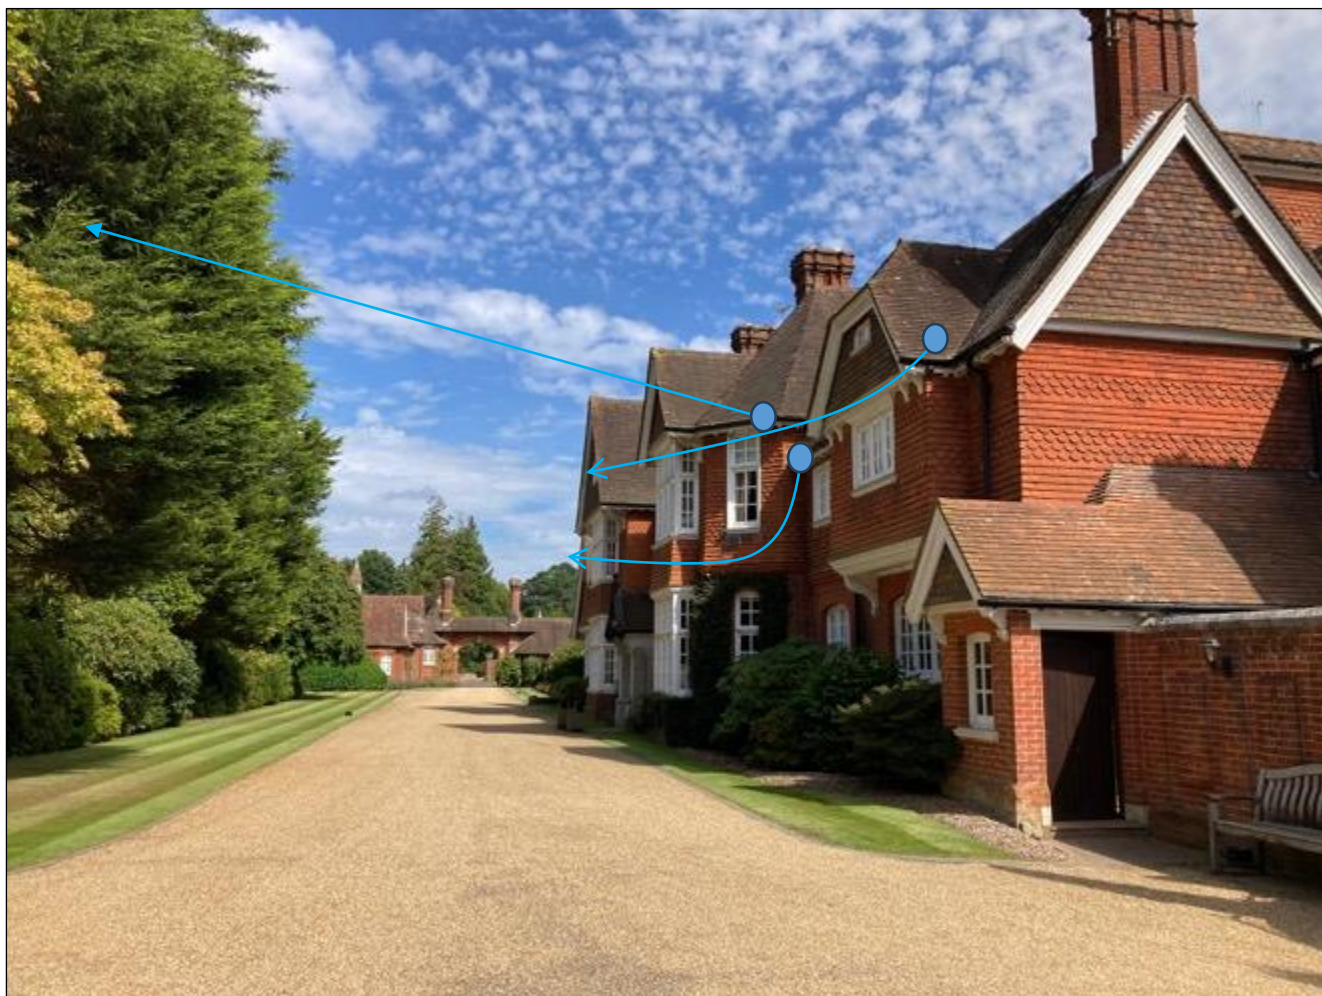
**Figure 17.** View of the western aspect of the site with the approximate emergence location and flight line of the common pipistrelles recorded on survey 3.

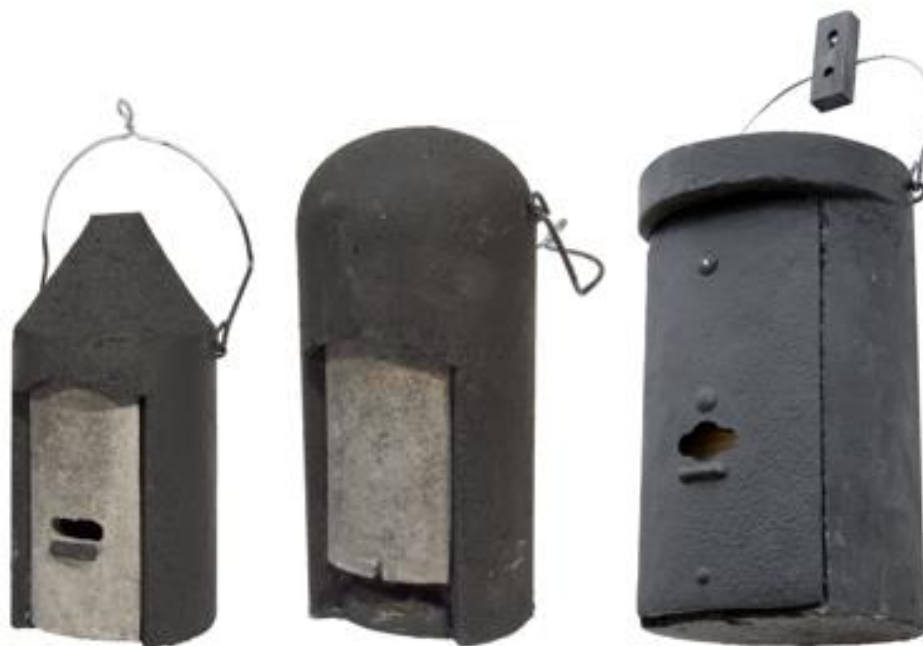
Figure 19 Left to right, the 2F, 2FN and the 1FS bat boxes produced by Schwegler. These and other brands are available at many on-line wildlife stores. These are constructed of 'woodcrete' (a mixture of cement and woodchip) and are designed to be durable and replicate the stable thermal properties of trees and buildings. They may be attached to trees or buildings.

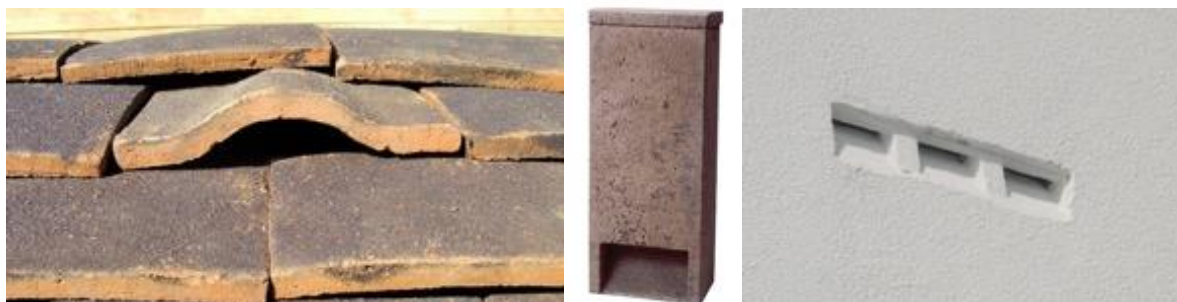
Figure 20 Examples of integral bespoke bat roosting features that may be incorporated into buildings during construction/renovation. From left to right: an example of bat access tile into loft space; the 2FR bat tube; and an example of 2FR bat tubes installed into a house wall in a series of three. Other brands and designs are available.

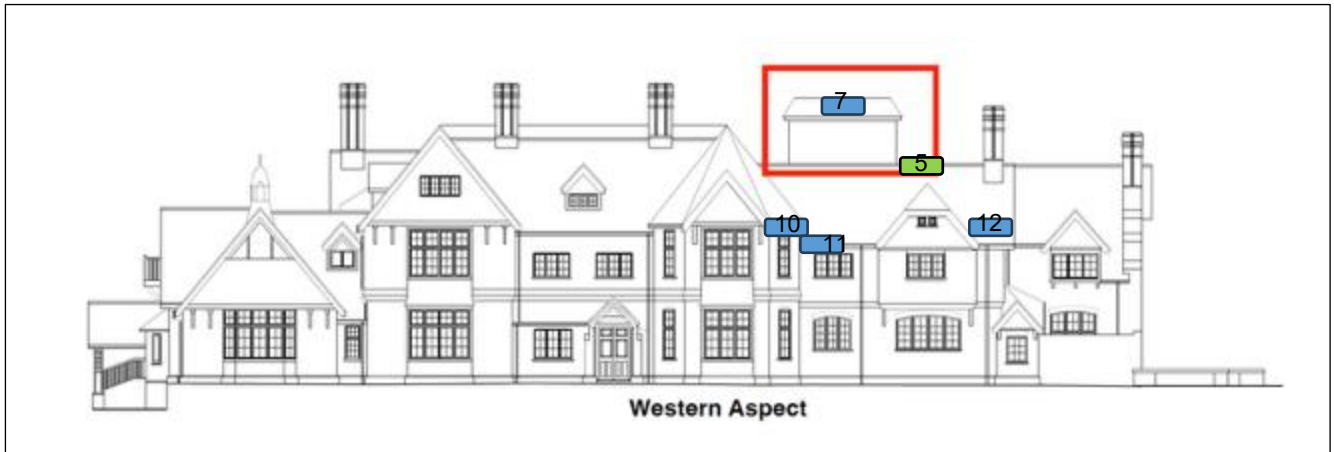
Figure 33. View of the approximate bat roost locations on the western aspect with the approximate areas of development indicated in red boxes. Numbered squares indicate roost locations and numbers (Table 4) blue indicating common pipistrelle and green indicating soprano pipistrelle. Image produced courtesy of Ian Adam Smith Architects.

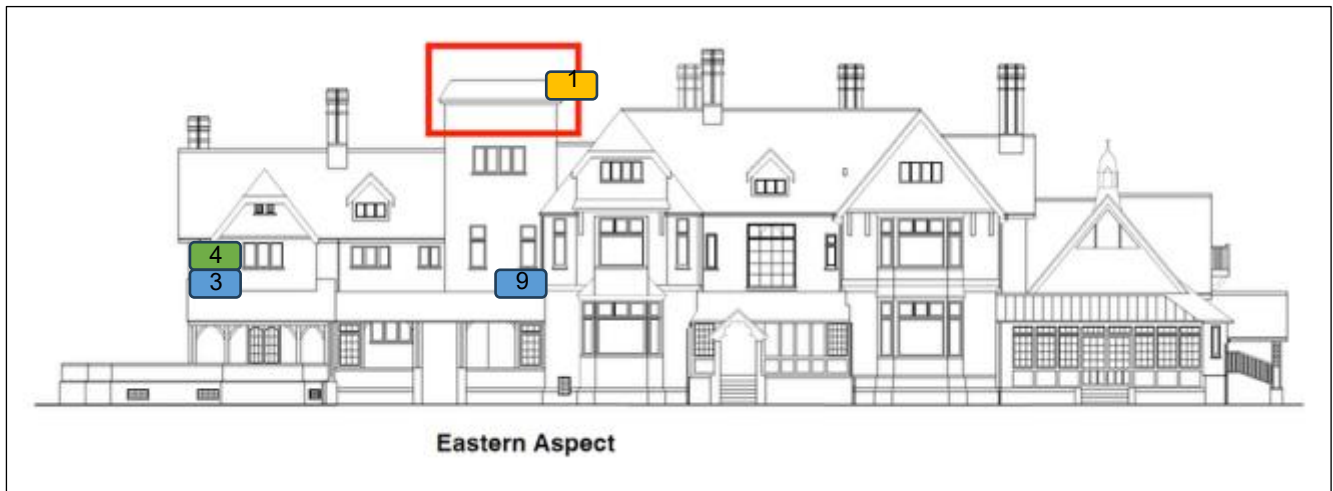
Figure 35. View of the approximate bat roost locations on the eastern aspect with the approximate areas of development indicated in red boxes. Numbered squares indicate roost locations and numbers (Table 2) blue indicating common pipistrelle, green indicating soprano pipistrelle and orange indicating brown long eared bat. Image produced courtesy of Ian Adam Smith Architects.
