## Bat Emergence Survey Report

Stonehurst – North Lodge

19<sup>th</sup> September 2025

**Project No: 10344**

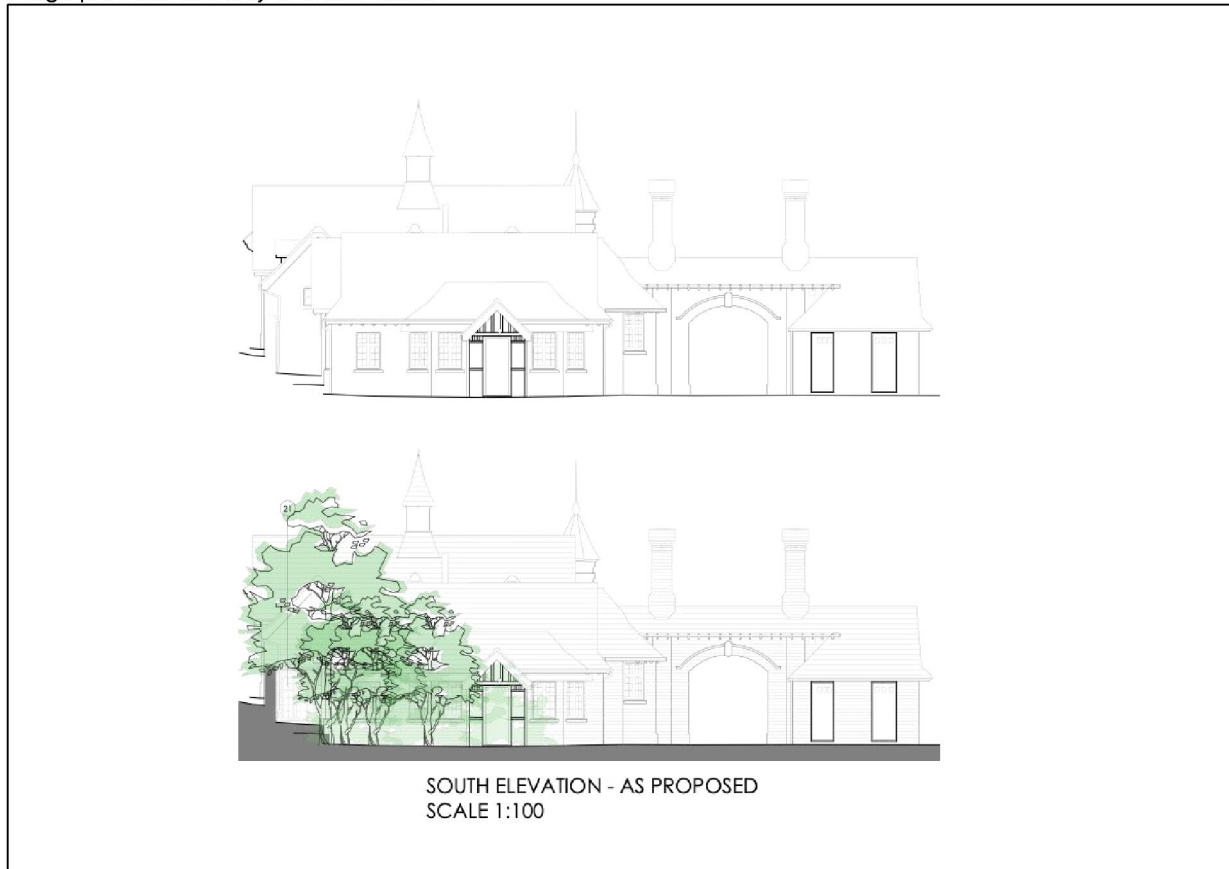
**Figure 4.** View of the southern elevation with the existing layout illustrated in the top layout and the proposed to the bottom. Image provided courtesy of Gould baxter.

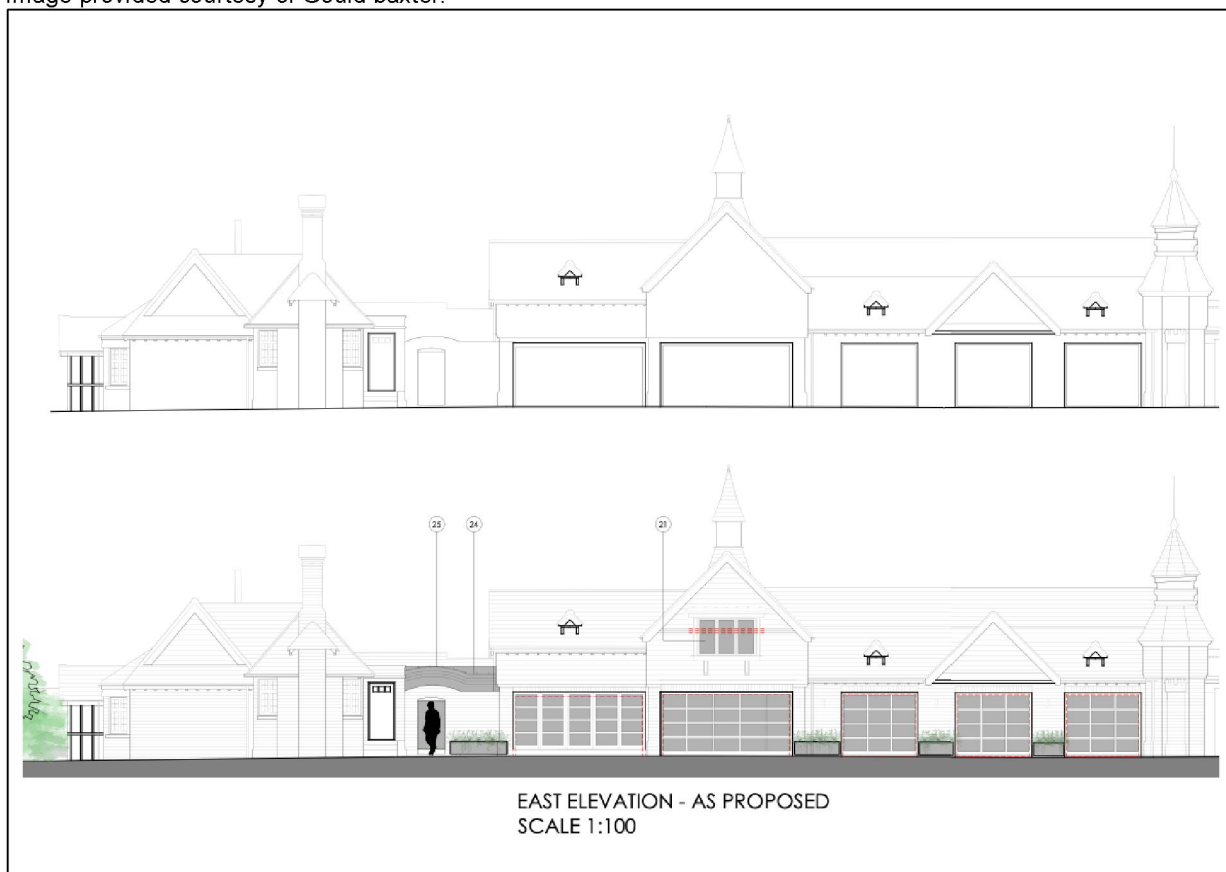
**Figure 6.** View of the eastern elevation with the existing layout illustrated in the top layout and the proposed to the bottom. Image provided courtesy of Gould baxter.

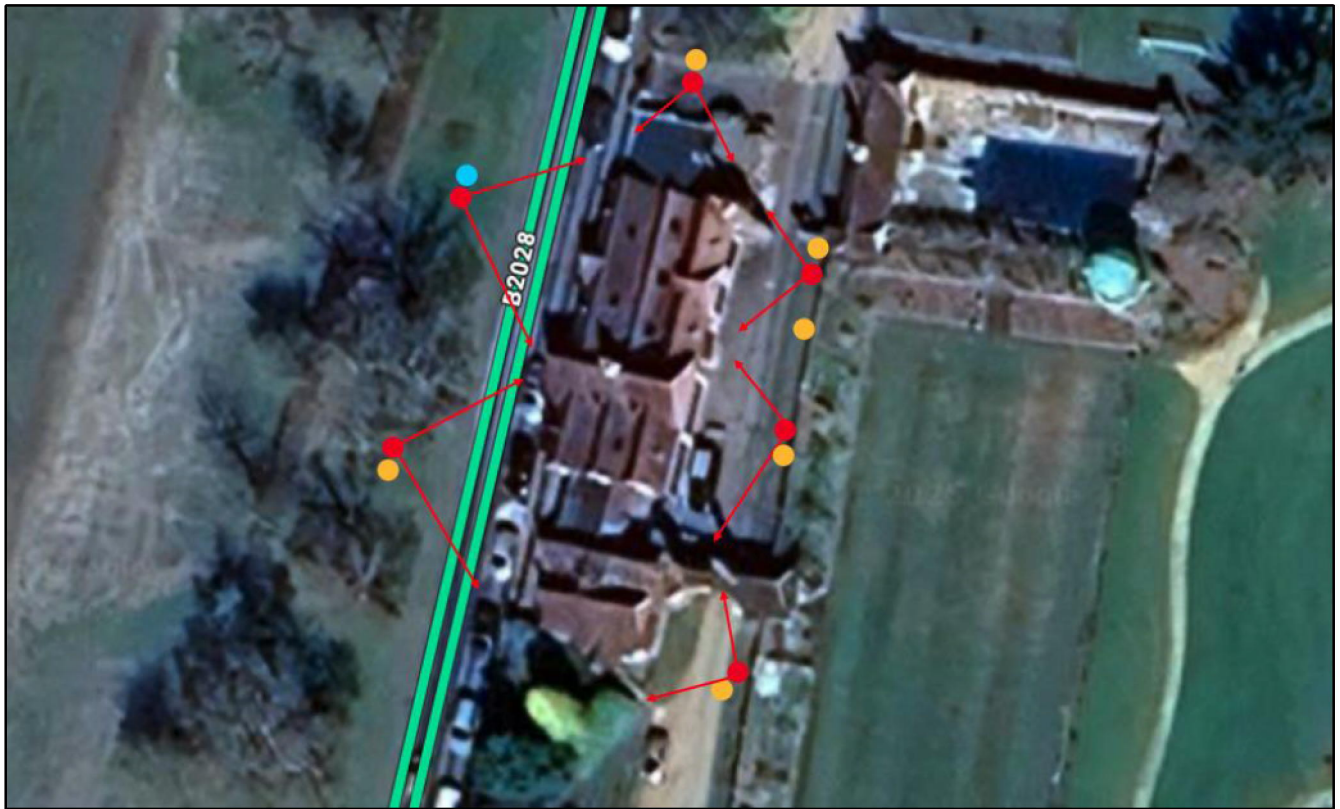
**Figure 8.** An aerial image of the site, showing the positions of surveyors (red dots), night-vision cameras (orange dots) and thermal-vision camera (blue dot) during the first survey visit. Arrows indicate the primary focus of each surveyor. Image produced court

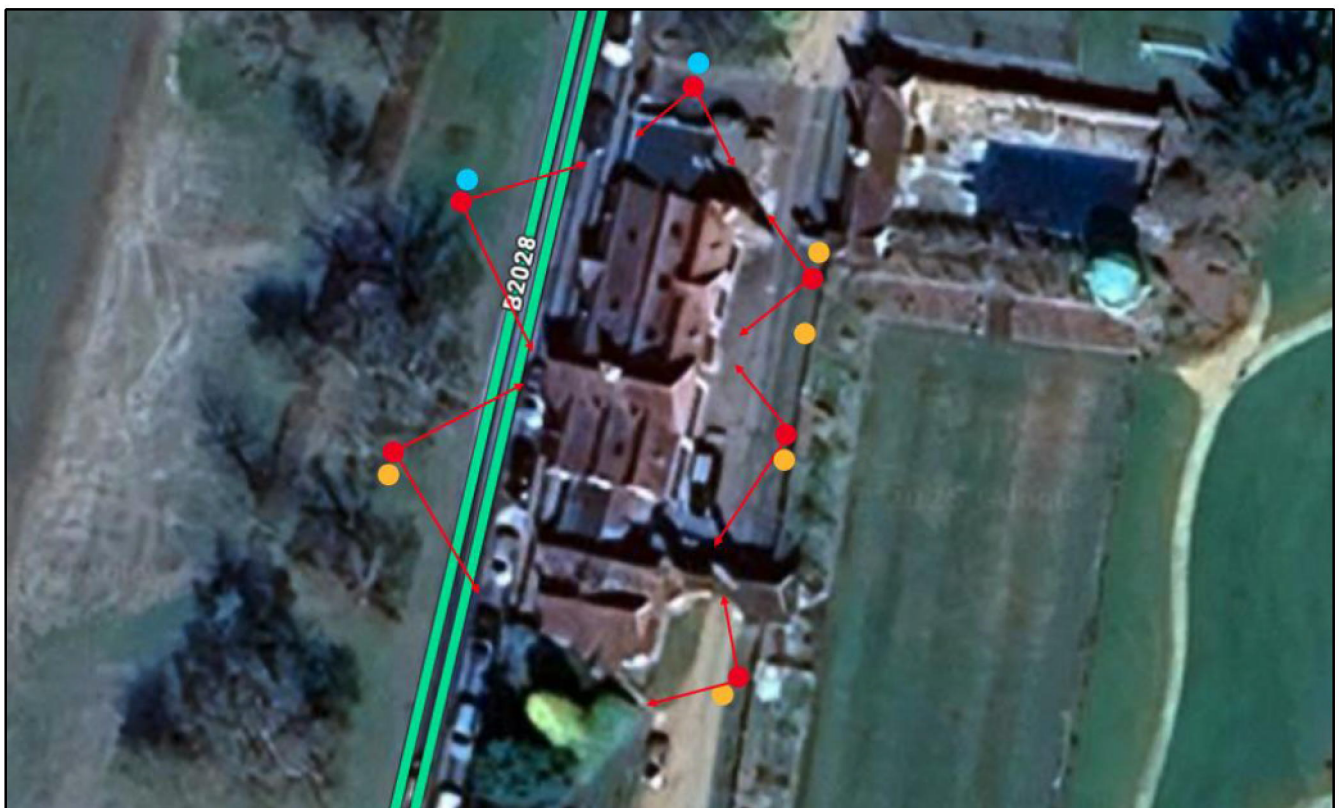
**Figure 9.** An aerial image of the site, showing the positions of surveyors (red dots), night-vision cameras (orange dots) and thermal-vision cameras (blue dots) during the second survey visit. Arrows indicate the primary focus of each surveyor. Image

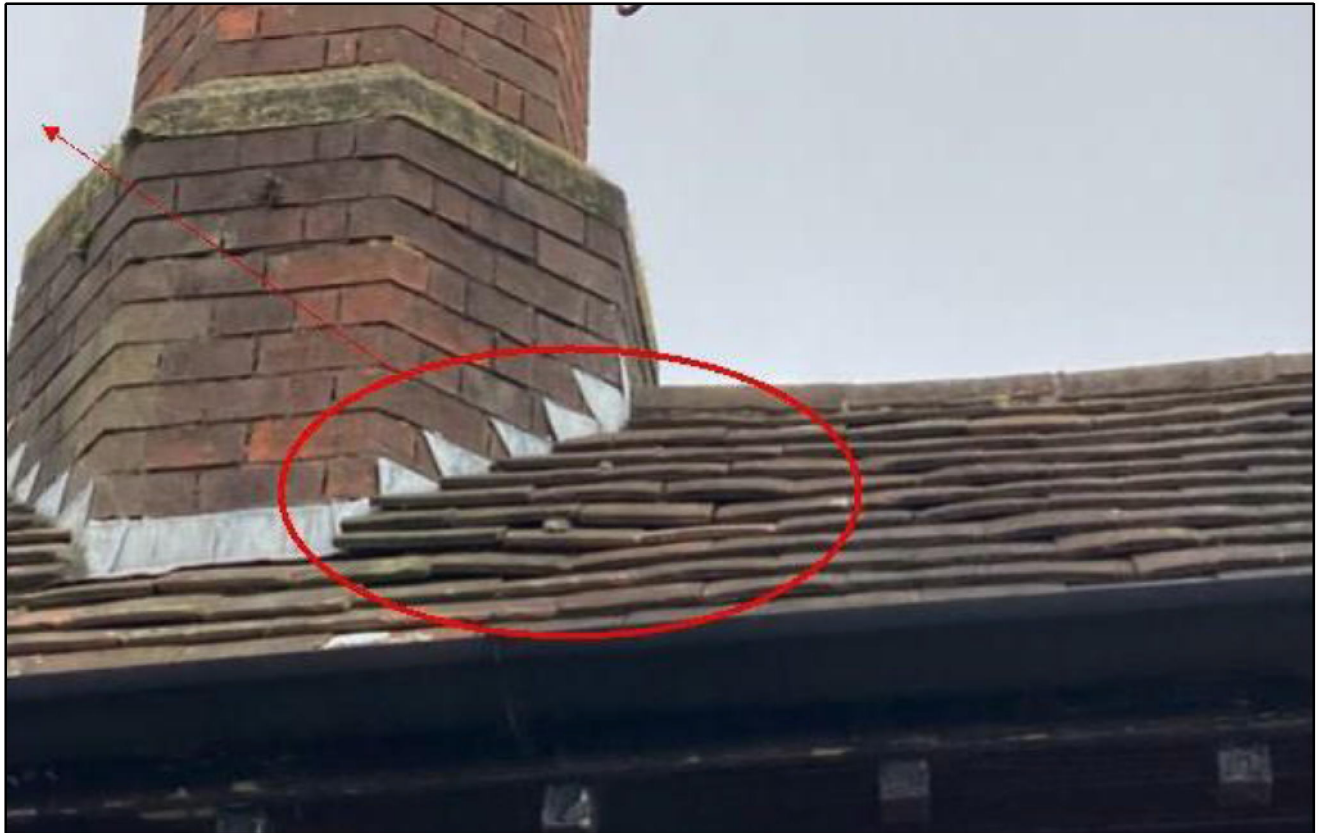
One common pipistrelle bat was seen to emerge from beneath roof tiles to the right of the chimney stack (adjacent to Tower 1) on the eastern elevation of the property 21 minutes after sunset (Figure 10 and Figure 11).

**Figure 10.** An image of the eastern aspect of North Lodge, showing the approximate emergence location of one common pipistrelle bat (red arrow) from beneath roof tiles to the right of the chimney stack (adjacent to Tower 1), and its flight path during the survey on the 21<sup>st</sup> July 2025 indicated.

The emergence surveys of North Lodge have identified the presence of one solitary common pipistrelle day roost associated with the roof tiles to the right of the chimney stack (adjacent to Tower 1) on the eastern elevation of the property. The location of this bat roost is illustrated in Figures 3 and 4 (above). The roost will be unaffected by the proposed works. Common pipistrelle bats are the most common and widespread species in the UK, and solitary day roosts have the lowest conservation significance for any species. Overall, the conservation significance of this roost is considered to be low at site level given the abundance of this species locally and nationally.

As the proposed development involves the destruction of void features, the destruction of the roost features used by bats cannot be avoided and, in the absence of mitigation, this could potentially result in harm to individual bats. Therefore, a European Protected Species (EPS) licence will be required for the development to legally proceed. The possible measures that would be required to safeguard bats and achieve this are outlined below:

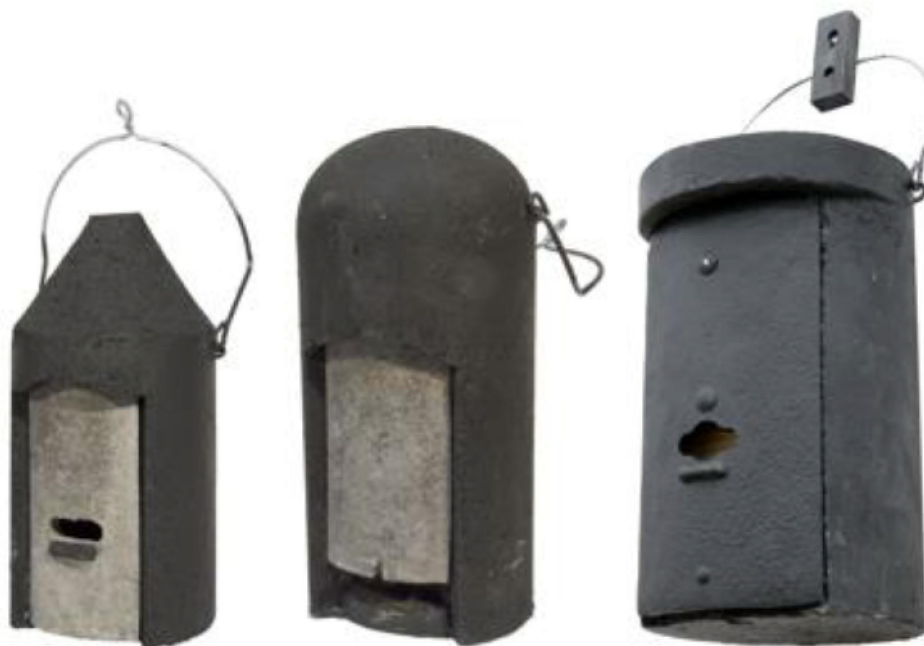
**Figure 1.** Left to right, the 2F, 2FN and the 1FS bat boxes produced by Schwegler. These and other brands are available at many on-line wildlife stores. These are constructed of ‘woodcrete’ (a mixture of cement and woodchip) and are designed to be durable and replicate the stable thermal properties of trees and buildings. They may be attached to trees or buildings.

As a contingency measure, should the development result in the abandonment of roosts, suitable alternative roosting opportunities for, brown long-eared bats will be installed on the exterior of the Stonehurst north lodge or an adjacent building within the same ownership boundary. As only one roost

The brown long eared roost can be compensated for by an appropriately sized cavity. The bat box must be appropriately installed and approved by a suitably qualified ecologist prior to any works on site being undertaken and can serve as a rescue box if needed.

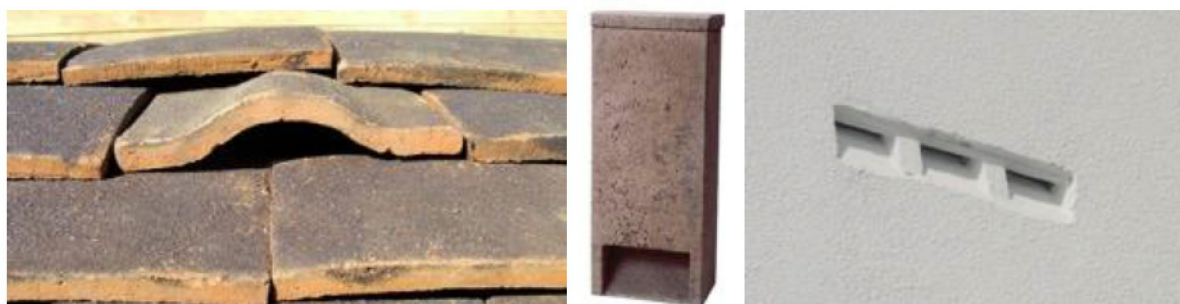
**Figure 2.** Examples of integral bespoke bat roosting features that may be incorporated into buildings during construction/renovation. From left to right: an example of bat access tile into loft space; the 2FR bat tube; and an example of 2FR bat tubes installed into a house wall in a series of three. Other brands and designs are available.
