# Firs Farm, Copthorne Common, Crawley – Barn 4 and 5

Project No  
**CES\_AV\_184**

Date  
**July 2024**

Document  
**Structural Condition Report**

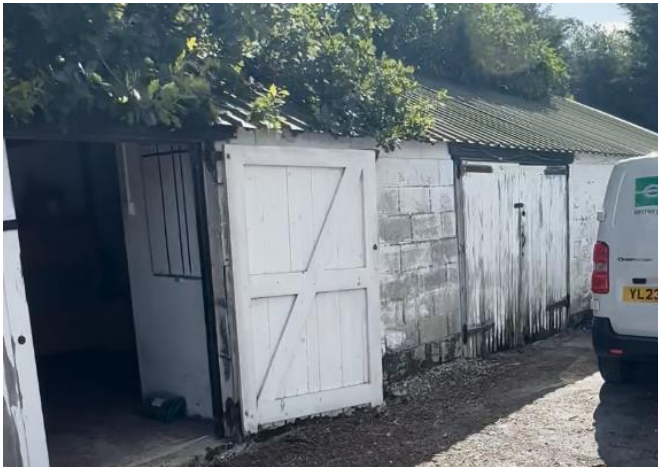
*Figure 1; Photographs of the exterior of barn 4*

Following the site visit and visual observations, it is evident that the barn 4 is a masonry structure with a timber roof and a ground-bearing concrete slab. We confirm that this barn can be converted into a residential dwelling with some improvements to the existing building. The existing masonry walls can be enhanced by adding another 100 mm thick masonry wall with a cavity between the existing and new walls to create a cavity wall. Additionally, there are a few cracks in the existing masonry walls that can be repaired using Helifix Helibars. The existing timber roof trusses are in good condition and capable of supporting the loadings of the new residential dwelling. Furthermore, the ground-bearing slab is in solid condition and suitable for use of the converted residential dwelling. With these structural improvements, this barn can be successfully converted into a residential dwelling.

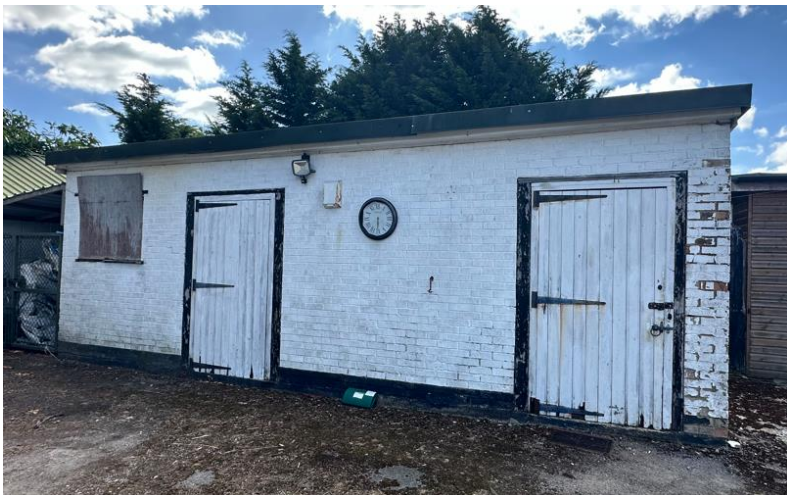
*Figure 2; Photographs of the exterior of barn 5*

The existing Barn 5, with solid masonry walls and a concrete ground-bearing slab, is in solid condition. No structural defects were observed during the visit. Therefore, this barn can be converted into a residential dwelling without requiring any structural improvements to the existing structure.

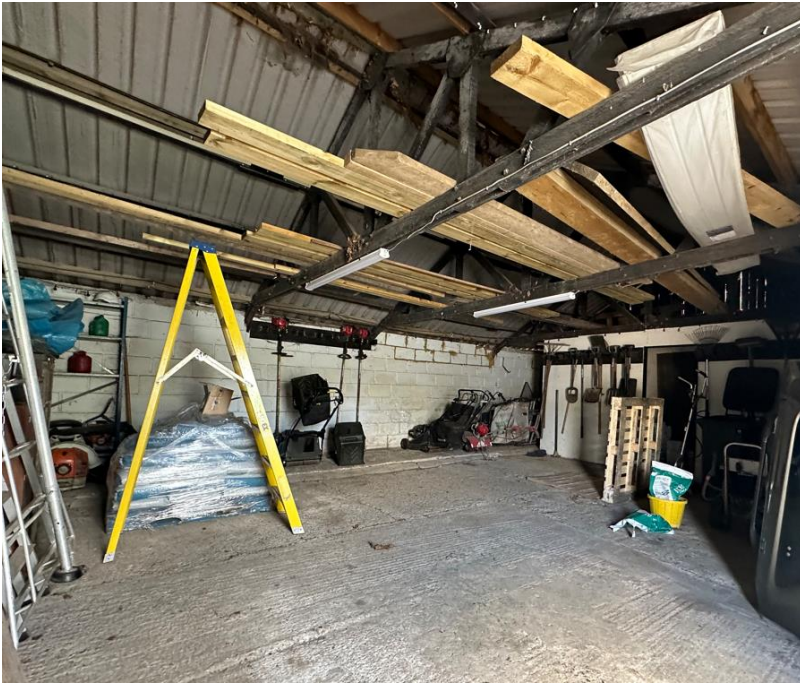
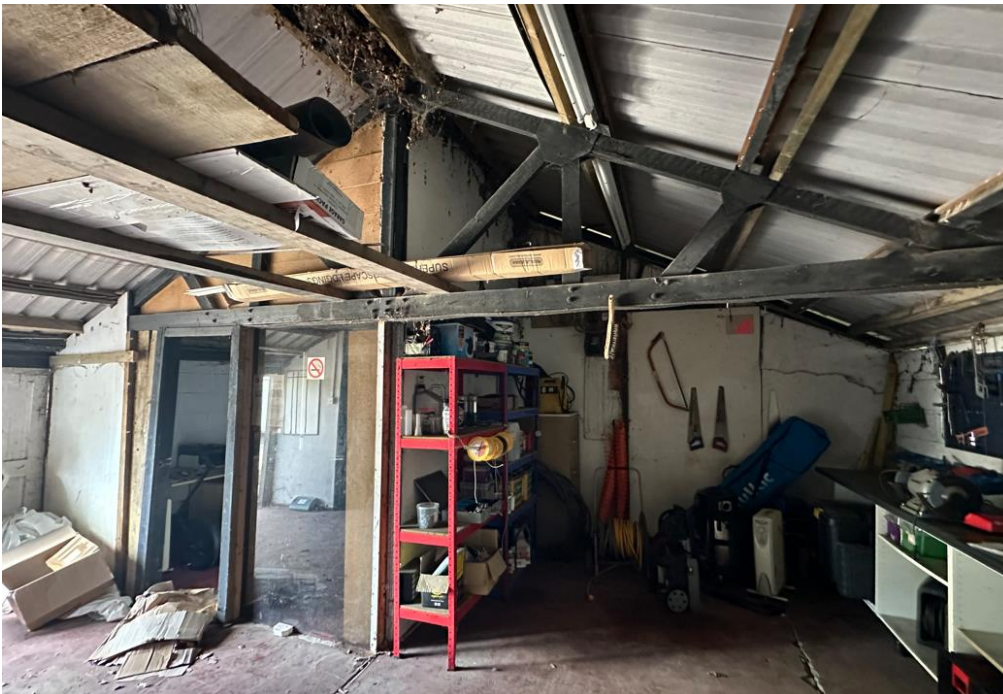
The existing barn 4 is constructed with 100 mm thick external masonry walls, featuring a timber truss roof and a concrete ground-bearing slab for the ground floor. The timber trusses are composed of 125x47mm and 100x47mm members and are spaced approximately 2.4 m apart.

Figure 3; Photographs of showing the interior of the barn 4

Based on our visual assessment at the site, we confirm that barn 4 can be successfully converted into a residential dwelling with few structural improvements to the existing structure. Conversely, Barn 5 is suitable for residential use without requiring any structural enhancements to the existing structure.

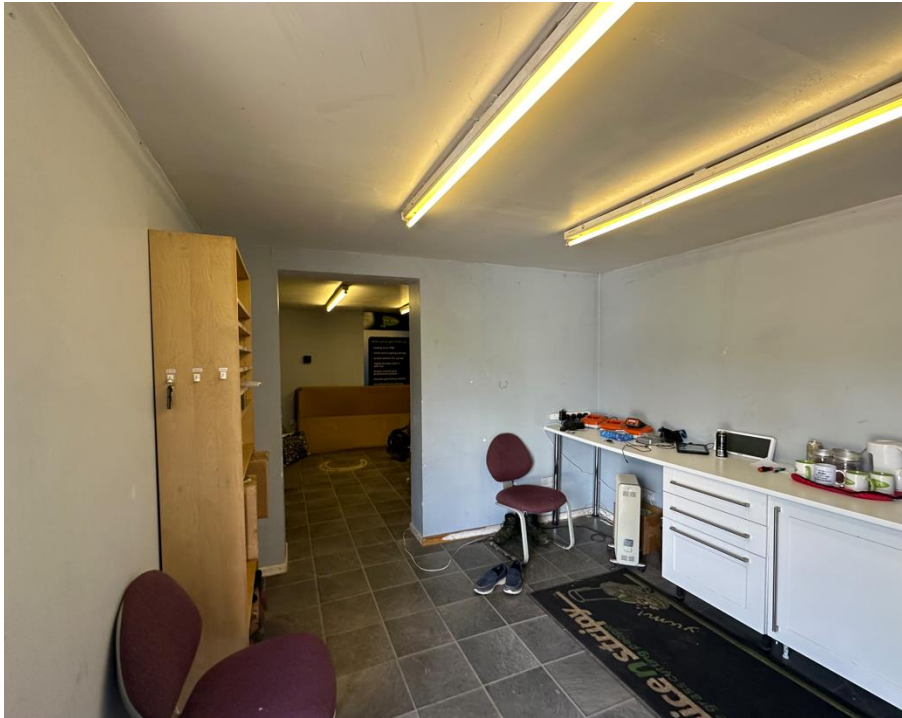
The barn 5 is constructed of solid masonry walls with a ground-bearing slab. The roof type and members were not visible during the site visit as they are covered by the ceiling.

Figure 4; Photographs of showing the interior of the barn 5
