North Hall Cottage, Staplefield, West Sussex

Bat survey and  
assessment

Report ref.:  
MSH101/R001V1

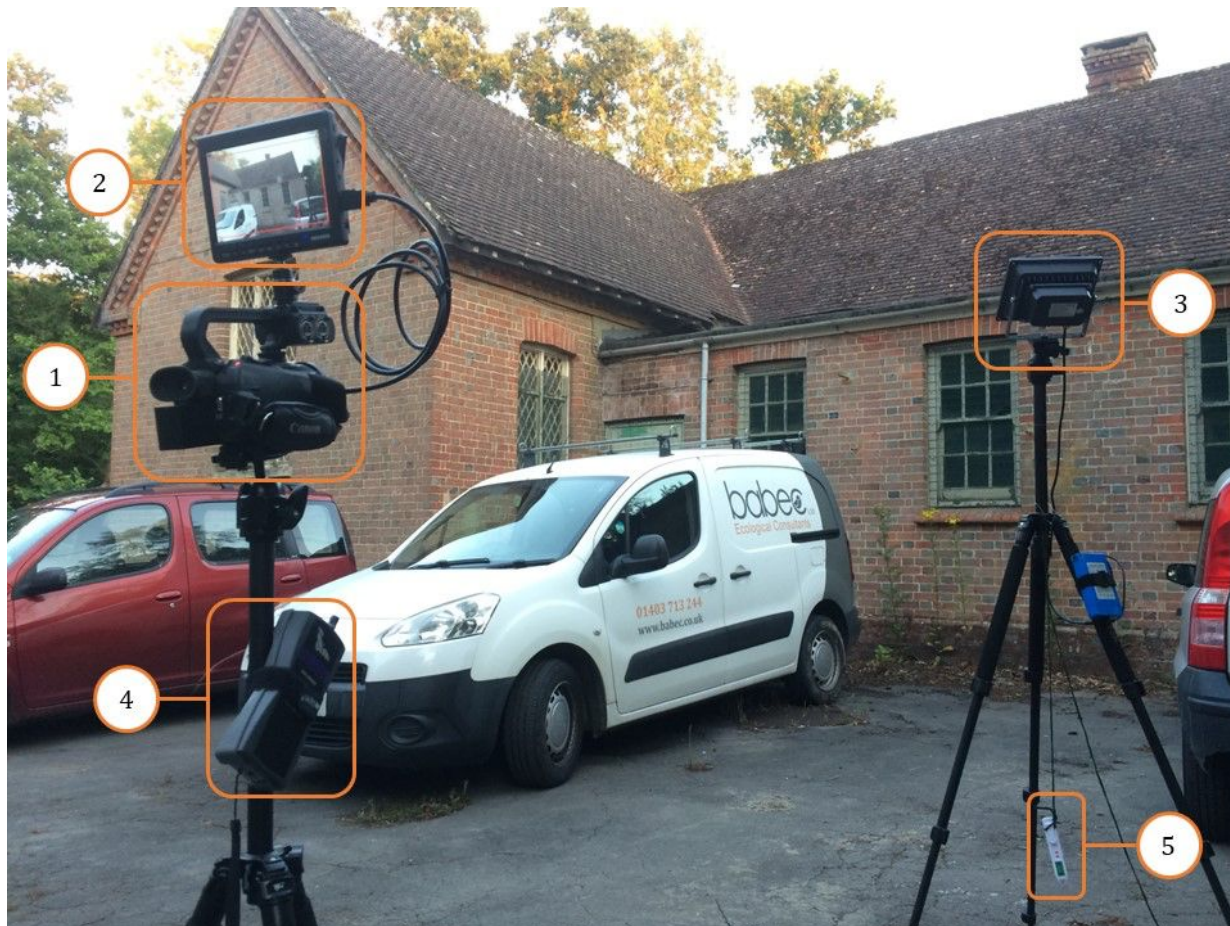
**Figure 1.** (1) Canon XA series video camera, (2) 7" high-definition screen attached to NVA (used at attended survey locations only), (3) Infrared floodlamp, (4) Batlogger-M, (5) Thermometer.

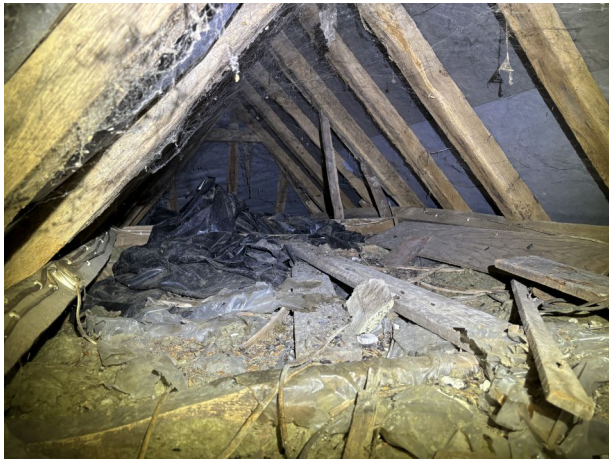
Photograph 1. The inaccessible section of the roof void within the property.

- 3.5.2** During the building inspection, a large section of the properties roof void could not be thoroughly checked as the ceiling joists were unsafe to walk on. This is not considered a significant limitation as no evidence of bats was found in the accessible part of the roof void and the proposed development will not affect the section of roof void that could not be accessed.

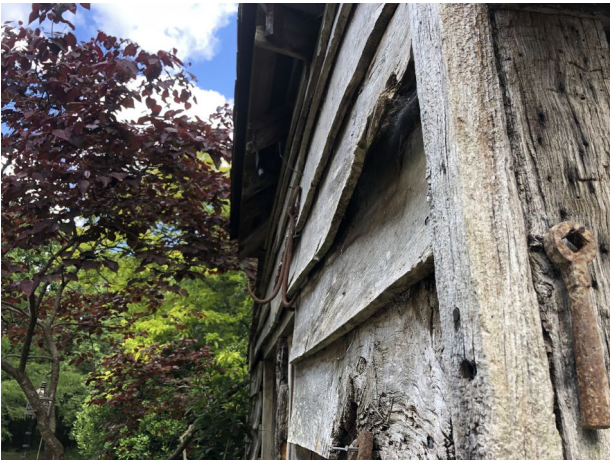
Photograph 2. Gaps between weather boarding on the western elevation of the annexe.

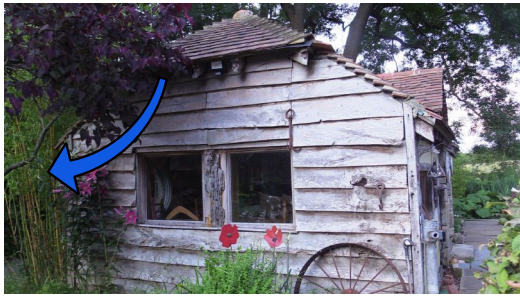
Photograph 1. Emergence of a soprano pipistrelle from a gap under the eaves of the annexe at 8 minutes before sunset (Roost 1).

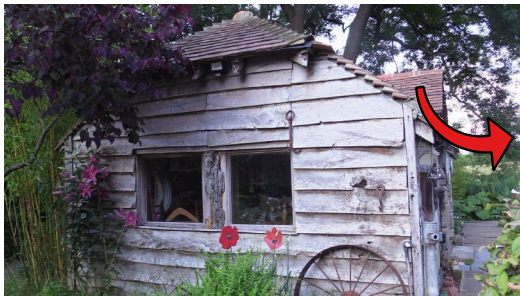
Photograph 2. Emergence of a common pipistrelle from under a roof tile on the southern elevation of the annexe at 11 minutes after sunset (Roost 2).

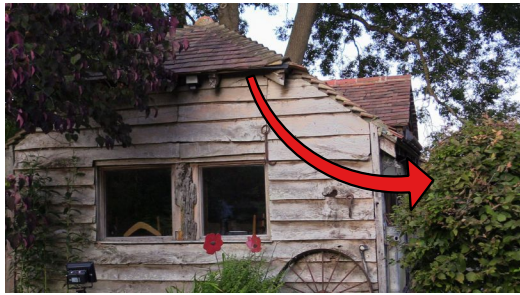
Photograph 2. Emergence of a common pipistrelle from a gap under the eaves of the annexe at 14 minutes after sunset (Roost 3).

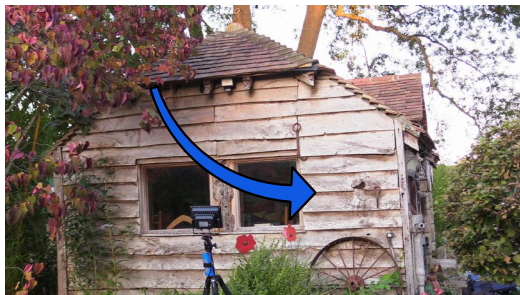
Photograph 1. Emergence of a soprano pipistrelle from a gap under the eaves of the annexe at 3 minutes before sunset (Roost 1).

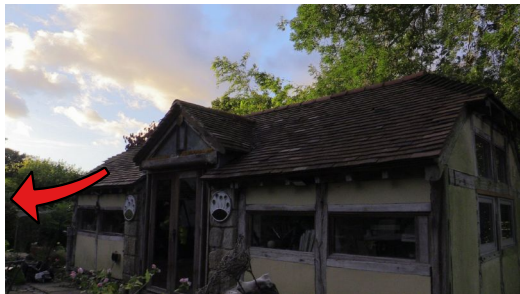
Photograph 2. Emergence of two common pipistrelles from gaps under roof tiles on the annexe at 19 and 28 minutes after sunset (Roost 2).

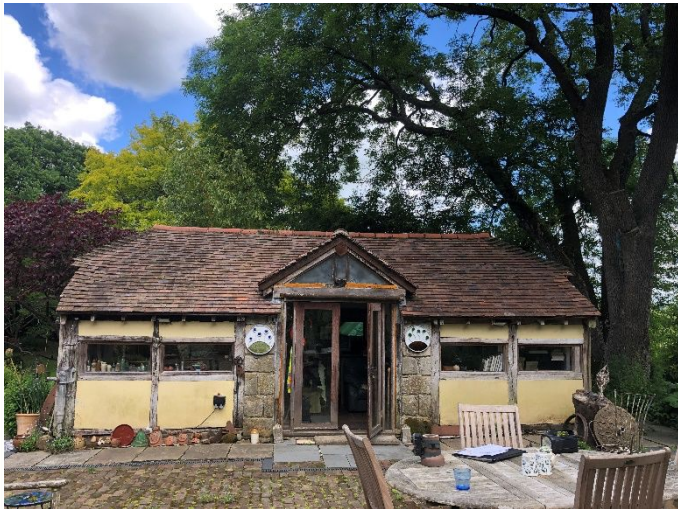
Photograph 3. Southern elevation of the annexe.

- 1.1.9** An active wren nest was recorded under the eaves on the southern elevation of the annexe during the building inspection. All birds, their eggs and active nests are protected from damage and destruction under the Wildlife and Countryside Act, 1981 (as amended). If possible, the demolition of the annexe should be undertaken outside of the breeding bird season (1 March to mid-September). However, should this not be possible, then a thorough check for breeding birds should be undertaken prior to demolition taking place. If an active nest is discovered, then the demolition of the annexe must be delayed until the young have fledged or the nest is no longer active.

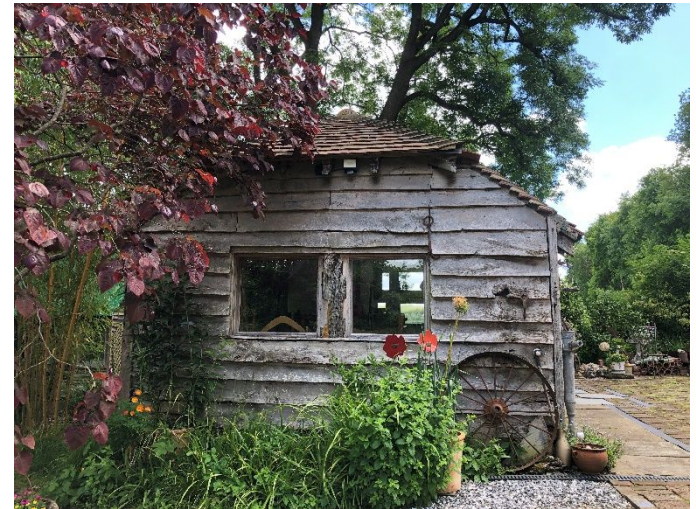
Photograph 4. Western elevation of the annexe.
