## **Drainage Statement**

Proposed Residential Development at

**66 Victoria Road, Burgess Hill**

**Less2Buildit**

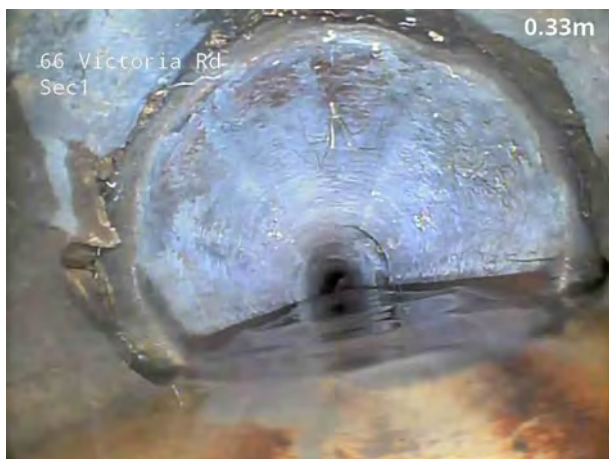
3, 00:00:22, 0.50 m  
Fracture, circumferential at joint from 8 o'clock to 5 o'clock

| No. | m+ | Code | Observation |
|---|---|---|---|
| 3 | 0.50 | FCJ | Fracture, circumferential at joint from 8 o'clock to 5 o'clock |

| Scale: 1:147 | Position [m] | Code | Observation | MPEG | Photo | Grade |
|---|---|---|---|---|---|---|
| | | 0.50 | FCJ | Fracture, circumferential at joint from 8 o'clock to 5 o'clock | 00:00:22 | 3 3 / 2 |

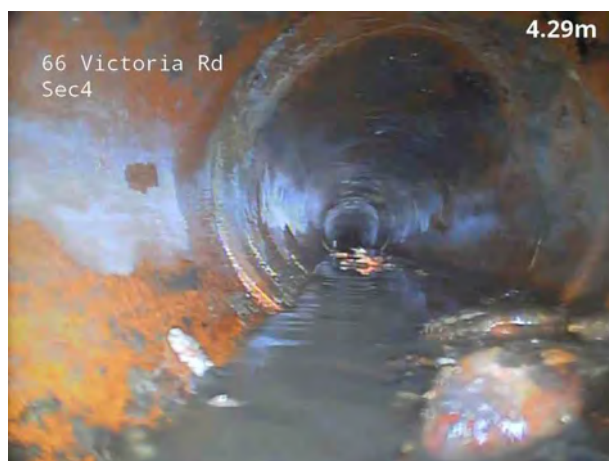
7, 00:00:44, 4.50 m  
Fracture, circumferential at joint from 12 o'clock to 12 o'clock

| No. | m+ | Code | Observation |
|---|---|---|---|
| 7 | 4.50 | FCJ | Fracture, circumferential at joint from 12 o'clock to 12 o'clock |

| Scale: | 1:77 | Position [m] | Code | Observation | MPEG | Photo | Grade |
|---|---|---|---|---|---|---|---|
| | | 4.50 | FCJ | Fracture, circumferential at joint from 12 o'clock to 12 o'clock | 00:00:44 | 7 | 3 / 2 |

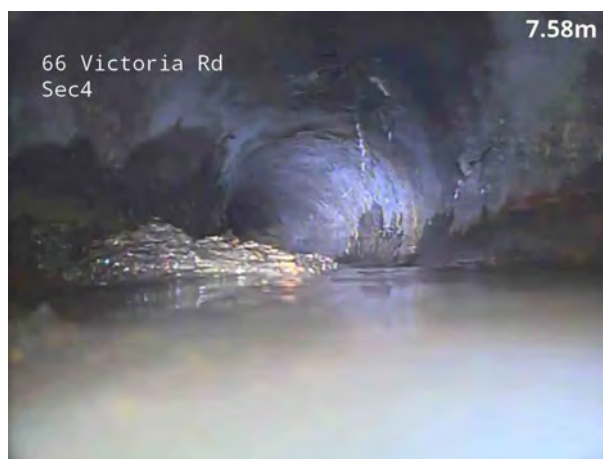
10, 00:01:02, 7.80 m  
Other obstacles from 4 o'clock to 9 o'clock, 30% cross-sectional area loss

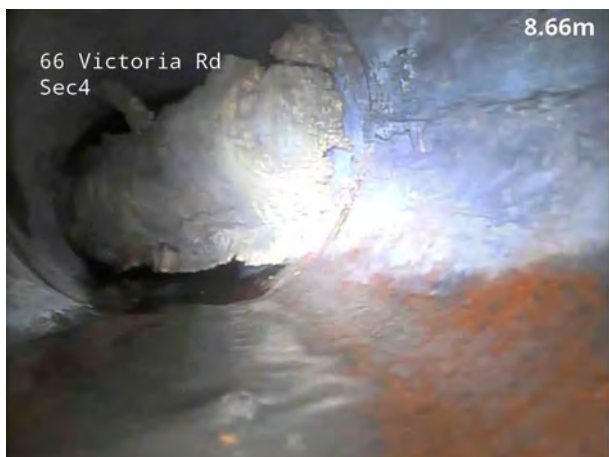
13, 00:01:23, 8.80 m  
Other obstacles from 1 o'clock to 10 o'clock, 80%  
cross-sectional area loss, Unknown

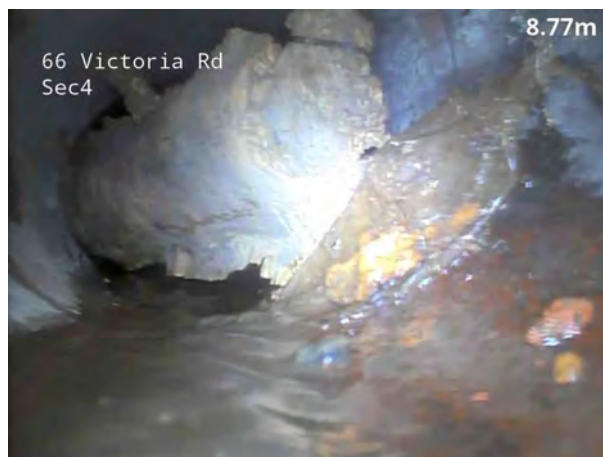
14, 00:01:34, 8.80 m  
Survey abandoned, Unable to pass

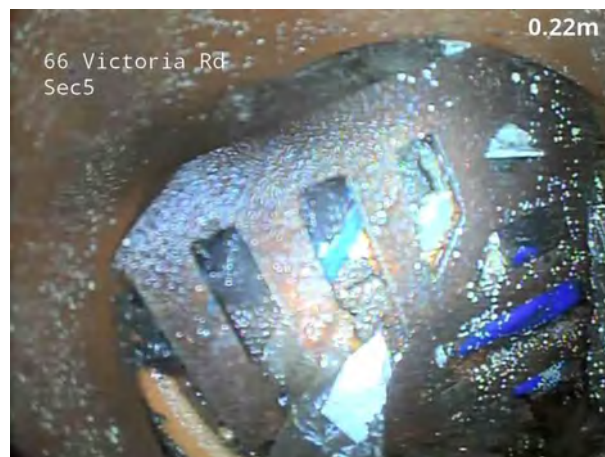
2, 00:00:12, 0.40 m  
Settled deposits, coarse, 100% cross-sectional area loss,  
Broken gully grill

| Scale: | 1:50 | Position [m] | Code | Observation | MPEG | Photo | Grade |
|---|---|---|---|---|---|---|---|
| | | 0.40 | DER | Settled deposits, coarse, 100% cross-sectional area loss:<br>Broken gully grill | 00:00:12 | 2 | 5 |

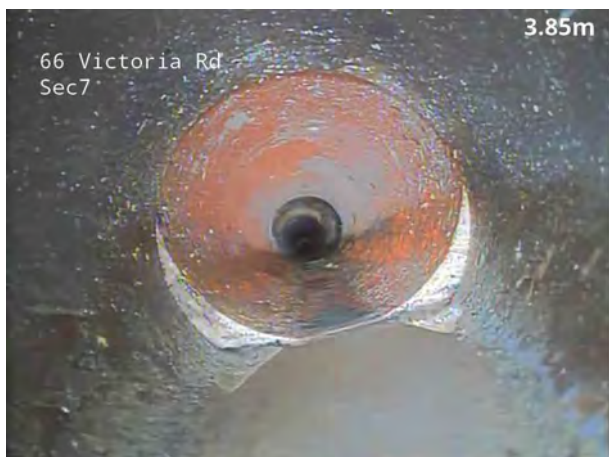
5, 00:00:38, 4.00 m  
Joint displaced, medium

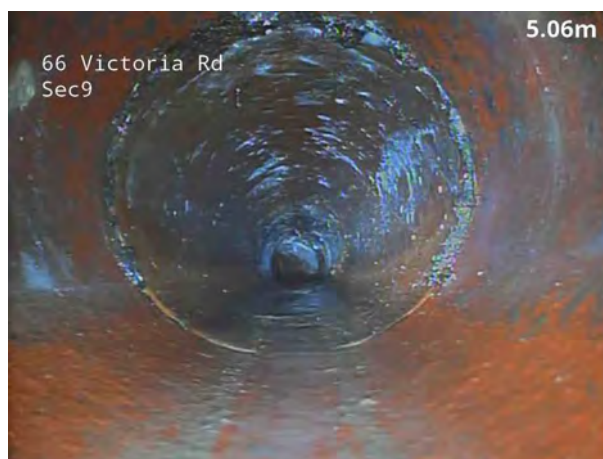
2, 00:00:45, 5.20 m  
Roots, fine at joint

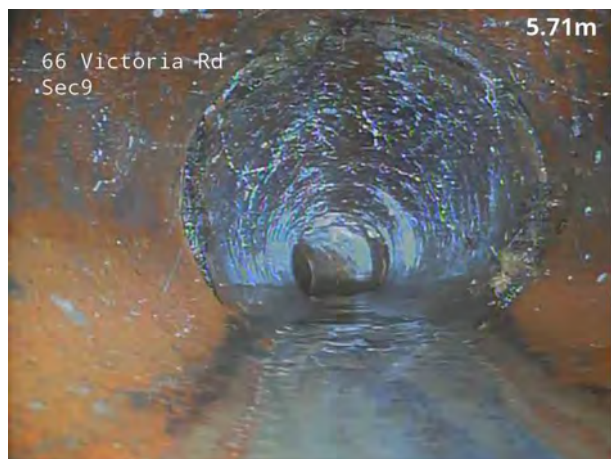
3, 00:00:48, 6.00 m  
Roots, fine at joint
