## Drainage Design Validation Report

Downlands Park  
Bolnore Farm Lane  
Haywards Heath  
RH16 4BQ

21279-SYM-XX-XX-RP-C-0100

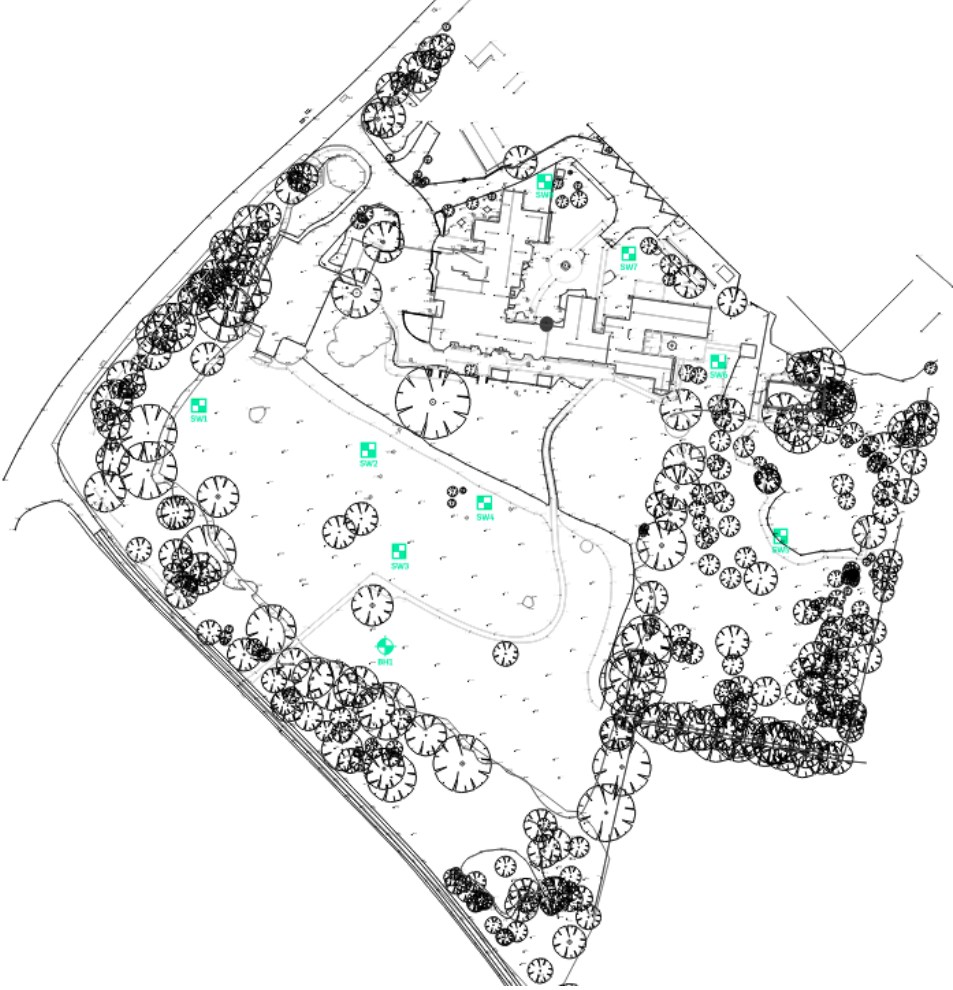
Figure 3: Site Investigation Plan – LMB Geosolutions

3.4.9 Figure 3 below shows the locations of the exploratory holes referenced.

3.4.10 Review of results indicates that SW7 has the most suitable infiltration rate at 1.15x10<sup>-5</sup>. Note that the majority of these tests were carried out within the sandstone strata.

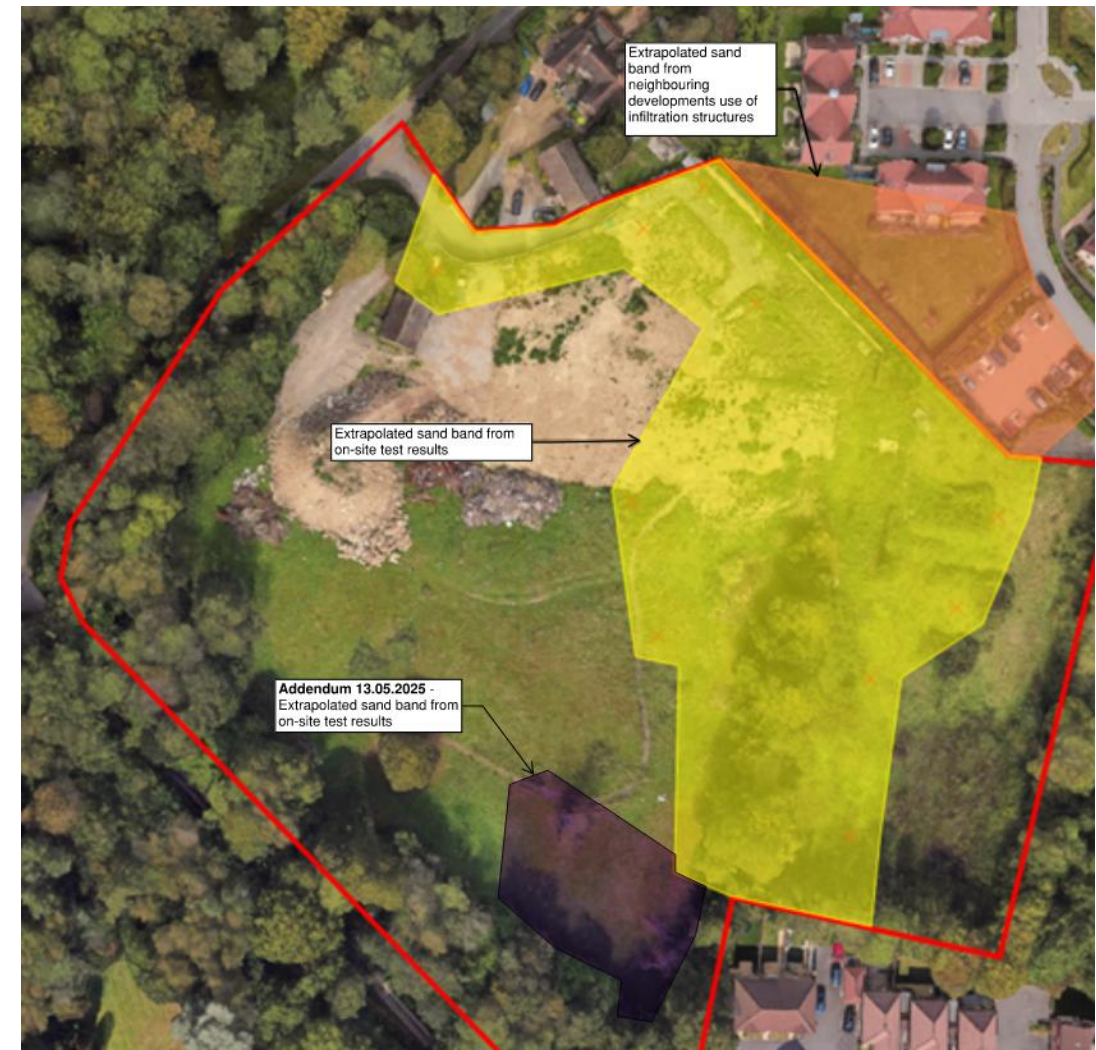
Figure 6: Estimated Sand Band

5.3 Figure 6 provides an estimated outline of a sand band within both the site and the neighbouring site to the north, based on the observed sand strata from on-site exploratory hole results.

5.4 The top layer of sandy soil was largely excluded due to its minimal depth (generally less than 500mm from ground level).

5.7 Figure 6 is intended as an indicative visualisation, offering an approximation of the sand band's extent.

5.8 The band is likely more extensive than illustrated, as its depiction relies on a limited number of tests; additional testing would enhance data accuracy and allow for a more precise extrapolation.

5.2 Figure 6 has been updated to show the extension of the likely sand band, following further on-site tests, more specifically in the location of the proposed basin.

5.9 Figure 6 has been updated to show the extension of the likely sand band, following further on-site tests, more specifically in the location of the proposed basin.
