## Plummerden House

## Flood Risk Assessment & Drainage Strategy

241875-FRA\_DS-LB-RS-01

Rev C

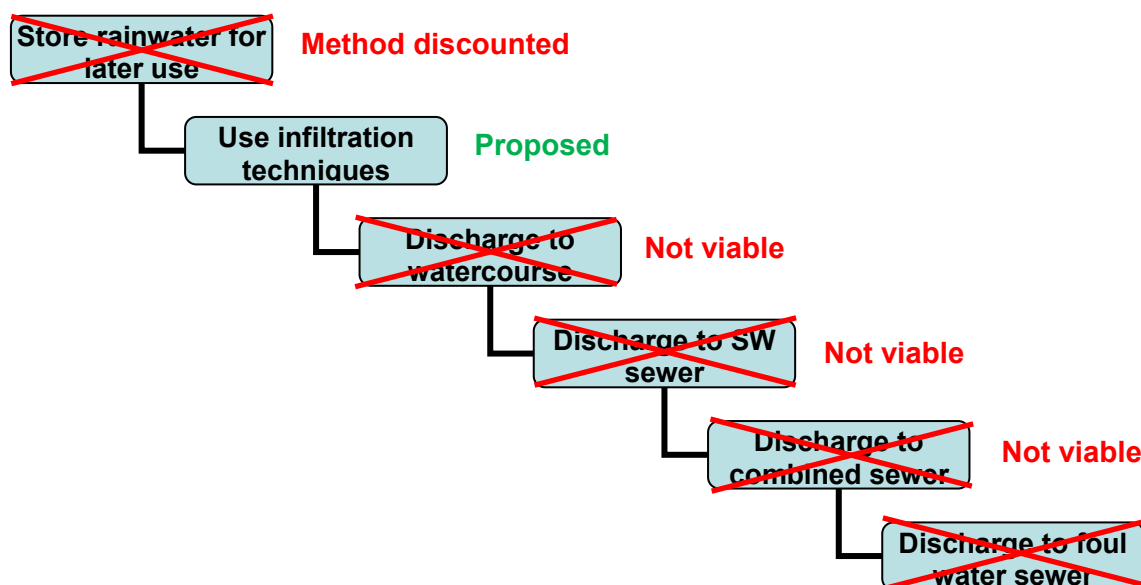
Figure 6.1 – Sustainable Drainage Hierarchy

- 6.3.1 The Sustainable Drainage Systems (SuDS) hierarchy has been used to set the drainage strategy for the development. The proposed buildings will incorporate pitched roofs, and therefore the use of blue or green roofs is not viable.

- 6.3.5 Therefore, this report has found that discharge to ground via deep bore soakaway is the most sustainable method for discharge of surface water runoff from site, and is in accordance with the sustainable drainage hierarchy.
