# A Feasibility Study for the Development of Natural Turf Football Pitches & Cricket Facilities at

Imberhorne Farm  
East Grinstead.

25<sup>th</sup> March 2026

**GTC001046/001 Issued**

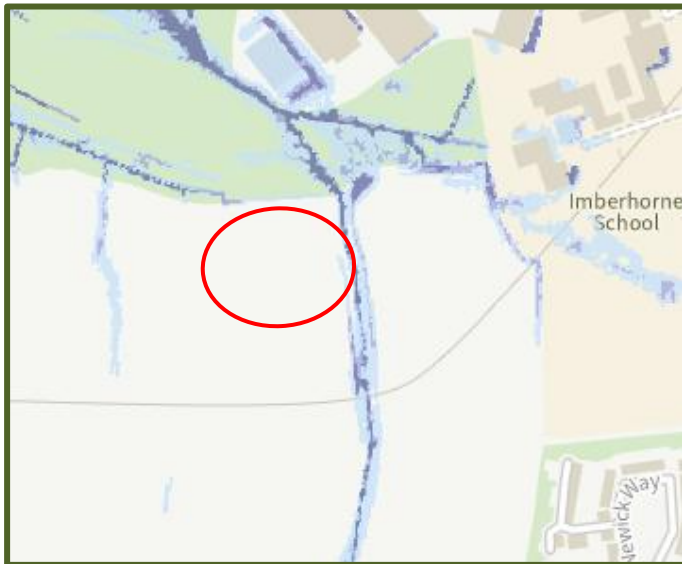
Based on information obtained from the Environment Agency website on 16<sup>th</sup> March 2026. The eastern edge of the development area is at low risk of surface water flooding (Figure 3). The whole area is outside flood-risk areas from rivers and sea (Figures 4 & 5).

Figure 3. Flooding from surface water.

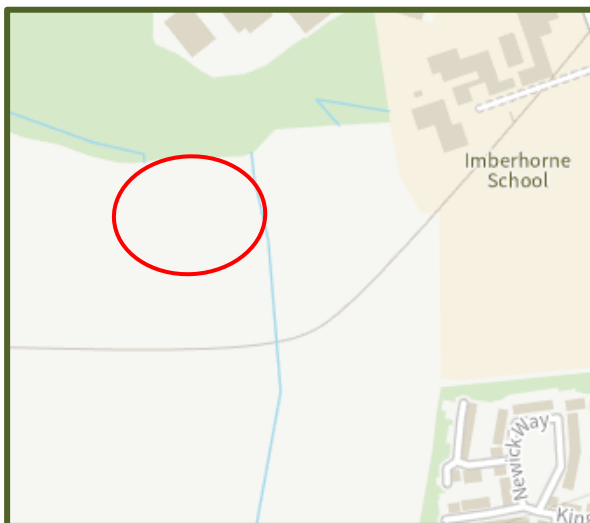
Figure 4. Flooding from rivers and sea

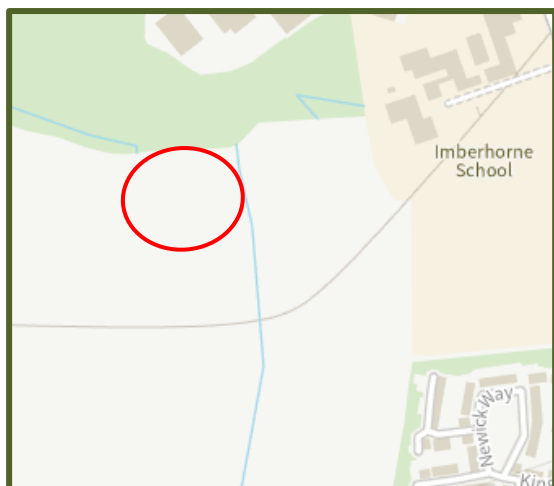
*Figure 5. Flooding from reservoirs*

- Extent
- When river levels are normal
  - When there is also flooding from rivers

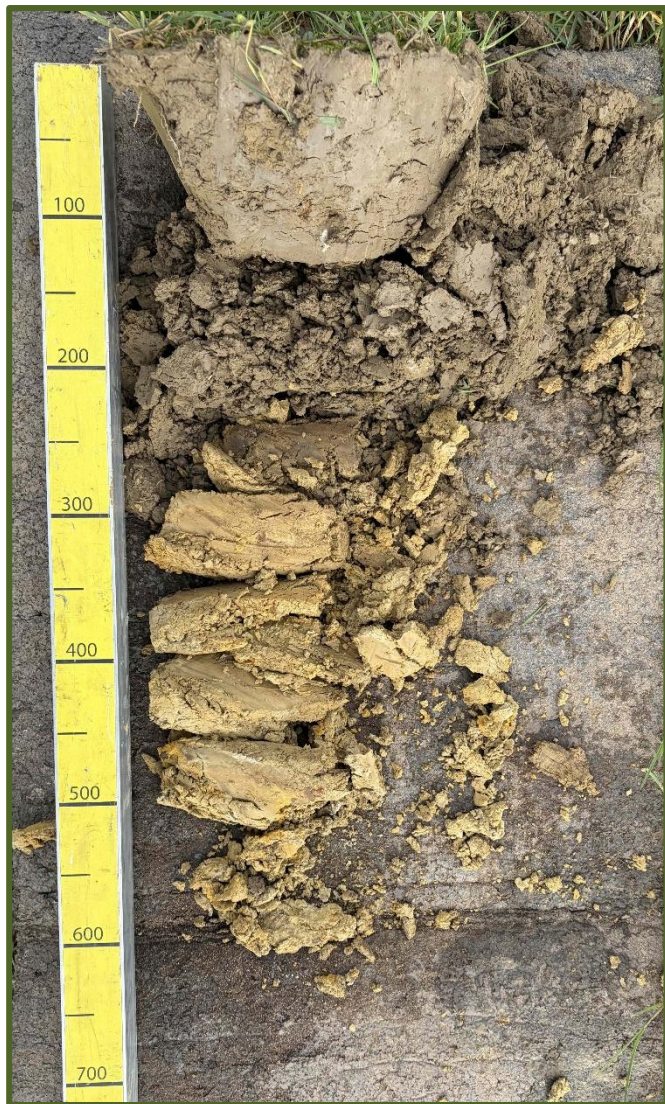
*Plate 1 – Trial hole 1*

0-250mm clay loam topsoil – low stone content

300 -600mm moist silty clay

600mm refusal possible large stone encountered.

No groundwater encountered

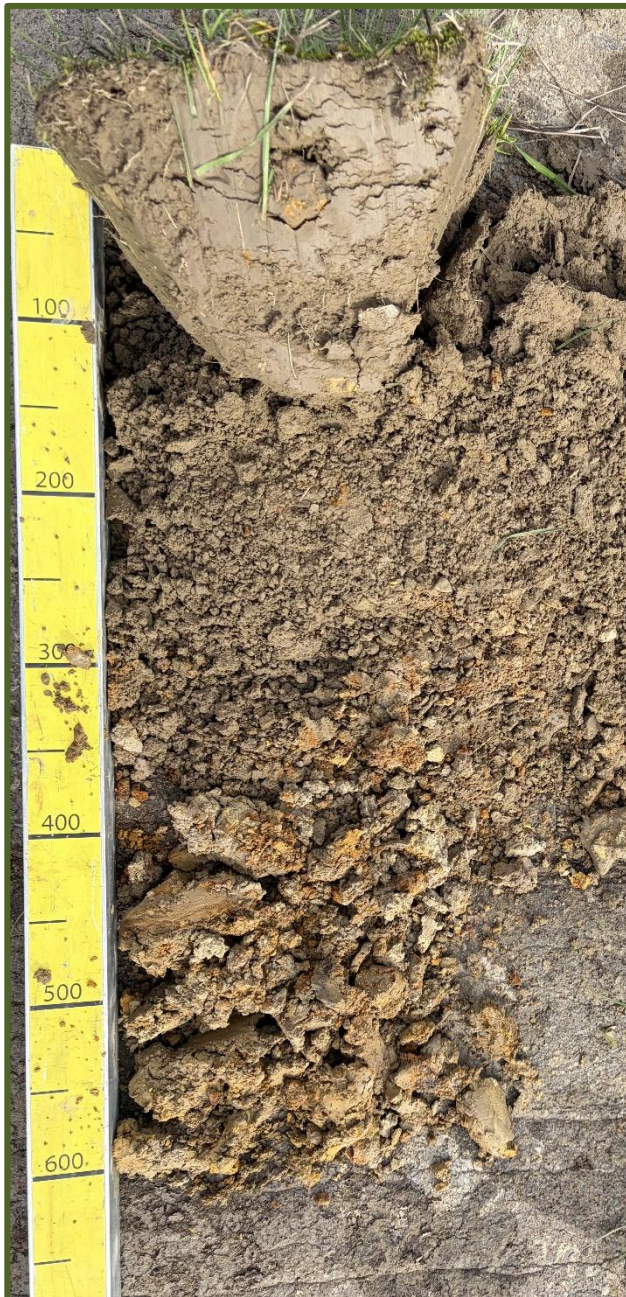
*Plate 2 – Trial hole 2*

0-300mm clay loam topsoil –  
moderate stone content

300 - 600mm moist silty clay with iron  
staining

600mm refusal possible large stone  
encountered.

No groundwater encountered.

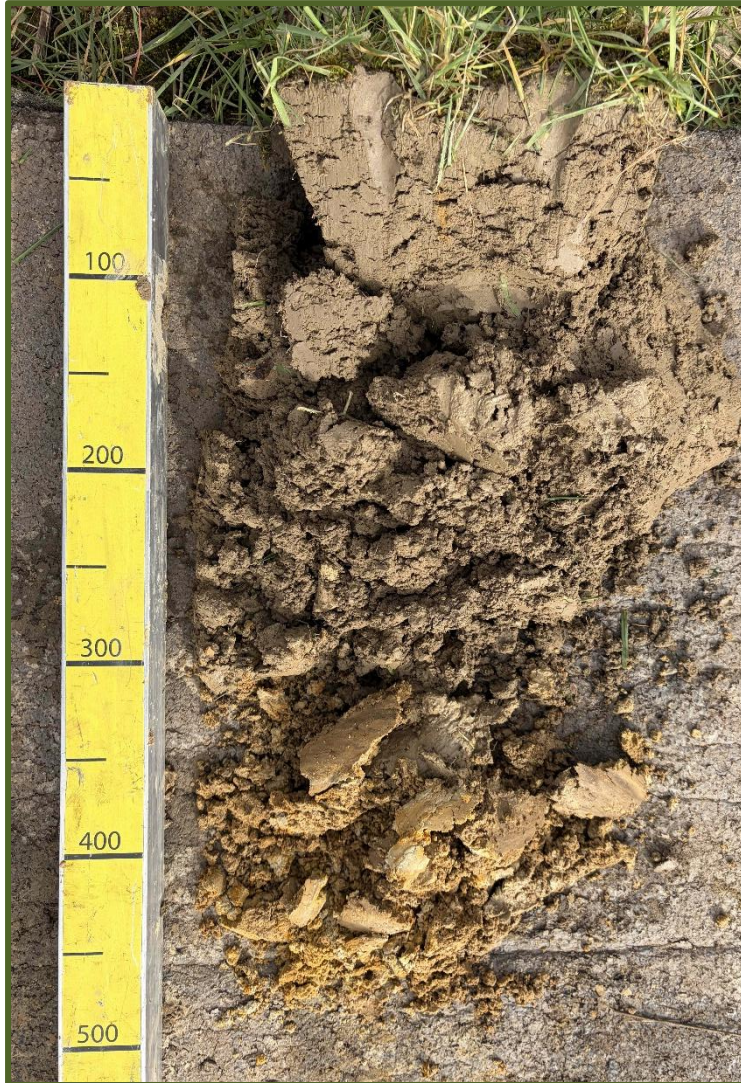
*Plate 3 – Trial hole 3*

0-300mm clay loam topsoil  
with low stone content.

300 - 500mm moist silty clay

500mm refusal possible  
large stone encountered.

No groundwater encountered

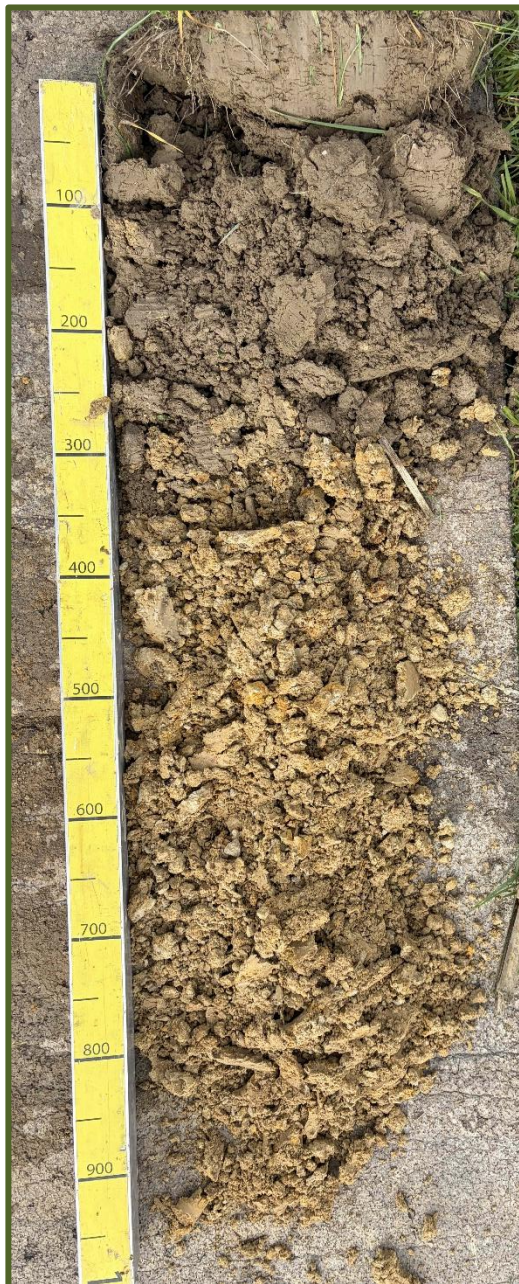
*Plate 4 – Trial hole 4.*

0-250mm clay loam topsoil with low stone content.

250 – 1,000 mm moist silty clay.

No groundwater encountered

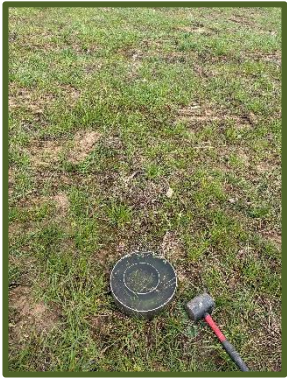
Three water infiltration rate tests were undertaken with double ring infiltrometers and the infiltration rates recorded are detailed below:

*Plate 5 – Water infiltration rate test.*

A value of 3mm/hour is considered to be very low and will not cope with moderate to high rainfall. When soil with a high fines content such as that on the site become compacted under sports turf use drainage infiltration rates will reduce further. This is evident with standing water noticed in areas of trafficked soil. Also, the high silt content of the soil means soil will remain wet following a rainfall event. This will result in reduced durability of the playing surface and increased rate of grass loss.

The key to producing good pitches will be to increase the rate of water movement from the playing surface through the soil and to reduce soil moisture content following a rainfall event. It is recommended that an intensive drainage system is installed and the fines content of the topsoil is reduced by ameliorating the topsoil with sand.

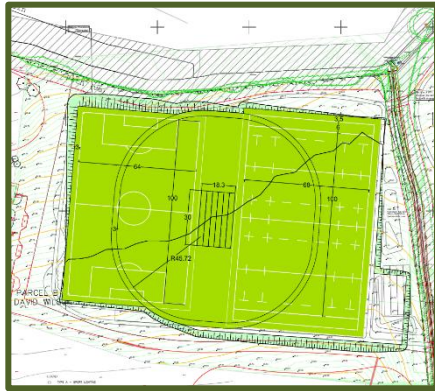
Plate 6 – Facility layout.

In terms of orientation of the area, Sport England has published guidance on optimum pitch orientation for a range of sports. The limits of orientation for football pitches are 285° and 20°. The limits of orientation for cricket pitches are 300° and 55°. The orientation of the football and cricket pitches are inside the ranges at approximately 10°.

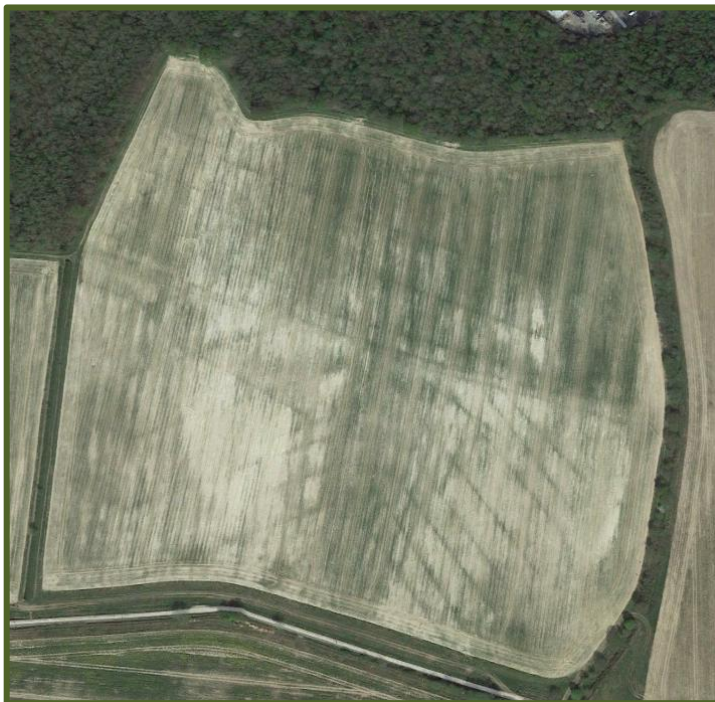
Aerial photographs and the site assessment indicates there is an existing agricultural drainage system. With drains oriented east to west at 40m centres. The drains will become disrupted as a result of the earthworks required to reduce falls on the site.

Plate 7 – Existing drainage.

In order to correct this situation, the installation of a surface by-pass drainage system should be undertaken. These systems work by intercepting rain water at the surface before it has had an opportunity to soak in to the soil profile, and then removing this water to a system of piped drains. Typical systems would comprise sand grooves installed at 0.5m centres (Figure 7) linked into a system of lateral drains installed at 4.0m centres through the pitches.

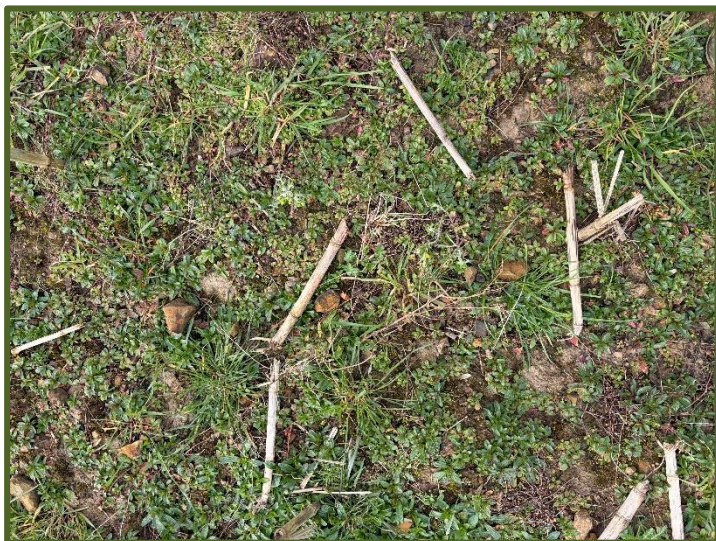
Grass cover on the area is comprised primarily of meadow grass with a high amount of broad-leaved weeds. There was also evidence of maize being grown on the field.

*Plate 8 –Generally low grass density.*

- 1 Spray off grass, weeds and vegetation with total non residual herbicide
- 2 Cultivate topsoil
- 3 Strip topsoil and place in stockpile
- 4 Cut and fill earthworks
- 5 Laser grade formation
- 6 Decompact subsoil
- 7 Replace topsoil
- 8 Ameliorate topsoil with 40mm sand
- 9 Install primary drainage with lateral drains at 4.0m centres
- 10 Ameliorate topsoil with 20mm sand
- 11 Remove remaining stones
- 12 Fertilise & seed
- 13 Establish grass with intensive maintenance and irrigation.
- 14 Install secondary drainage
- 15 Top-dress with sand and over-seed
- 16 Top-up settled drains.

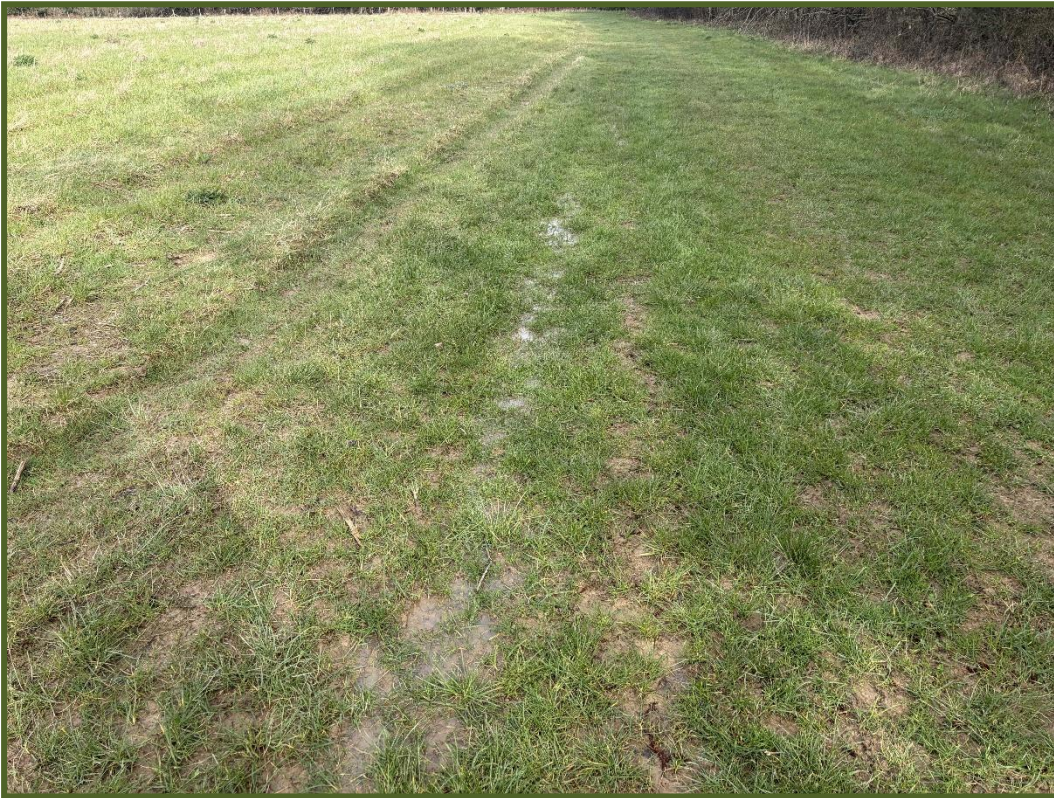
*Plate 10 – Standing water*

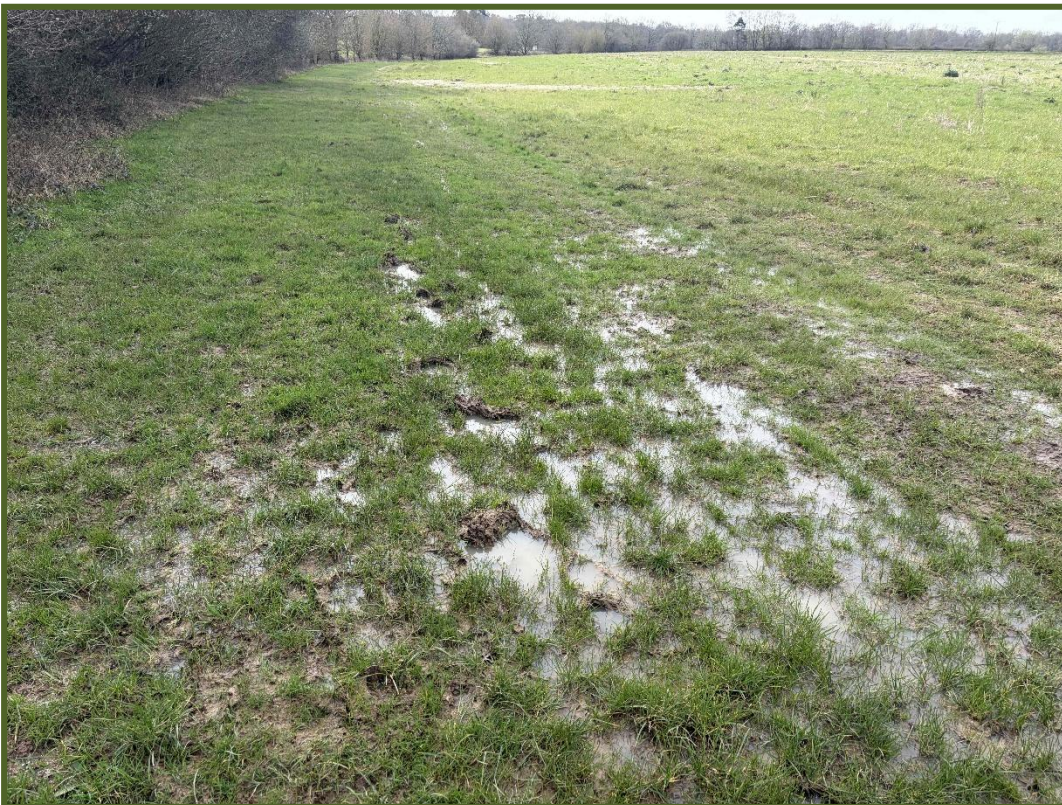
*Plate 11 – Standing water*

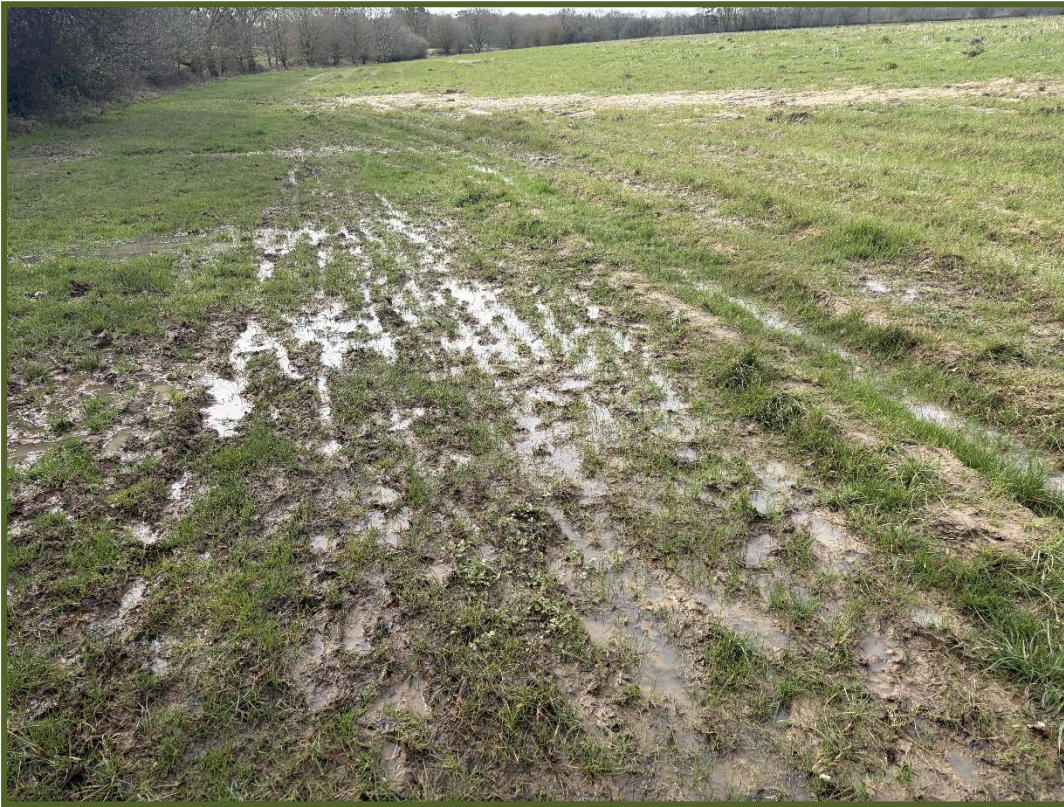
*Plate 12 – Standing water.*

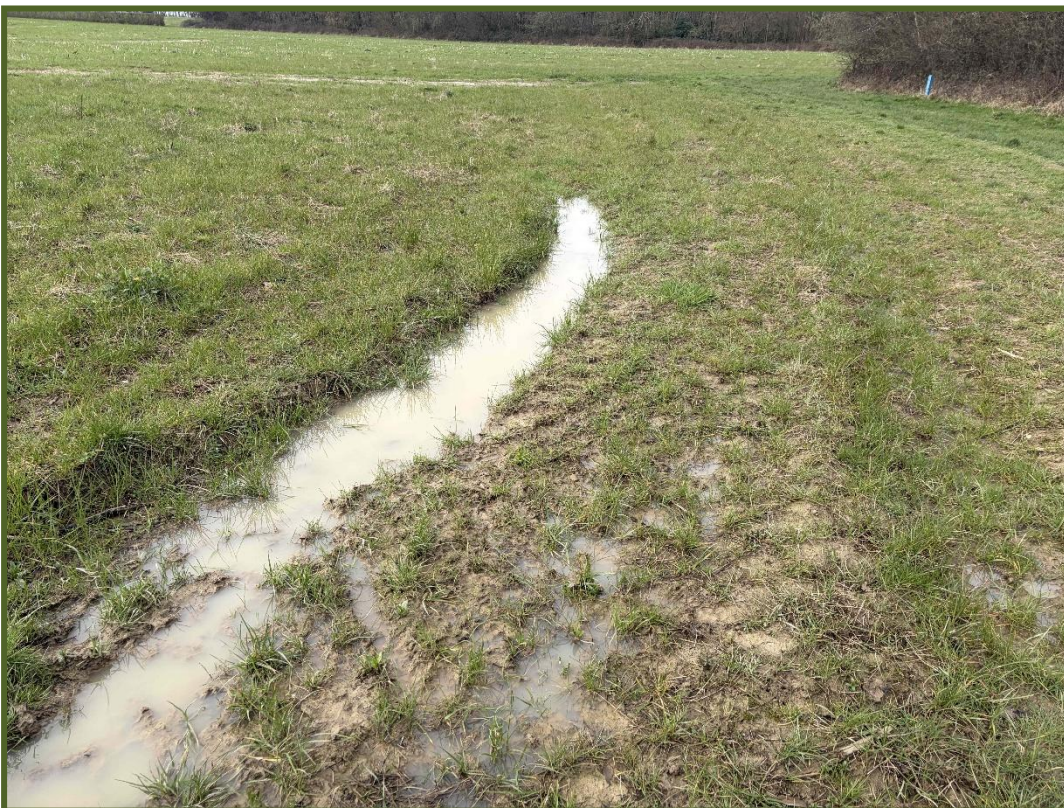
*Plate 13 – Standing water.*

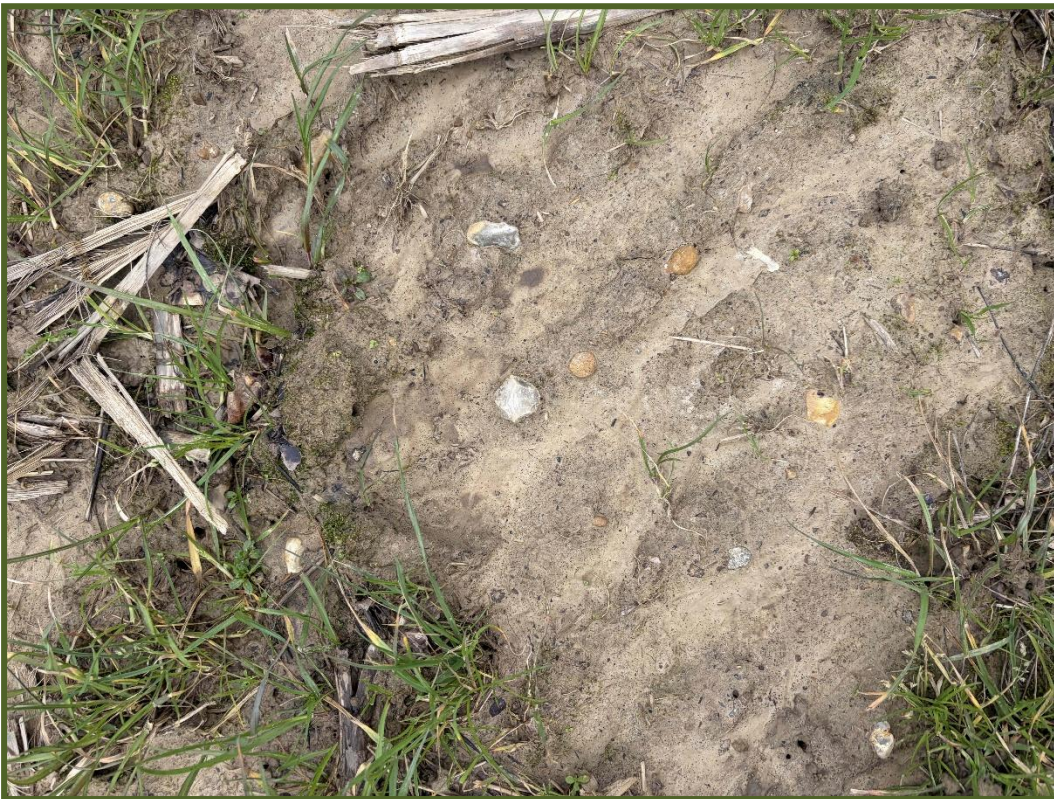
*Plate 17 – Stones and flints.*

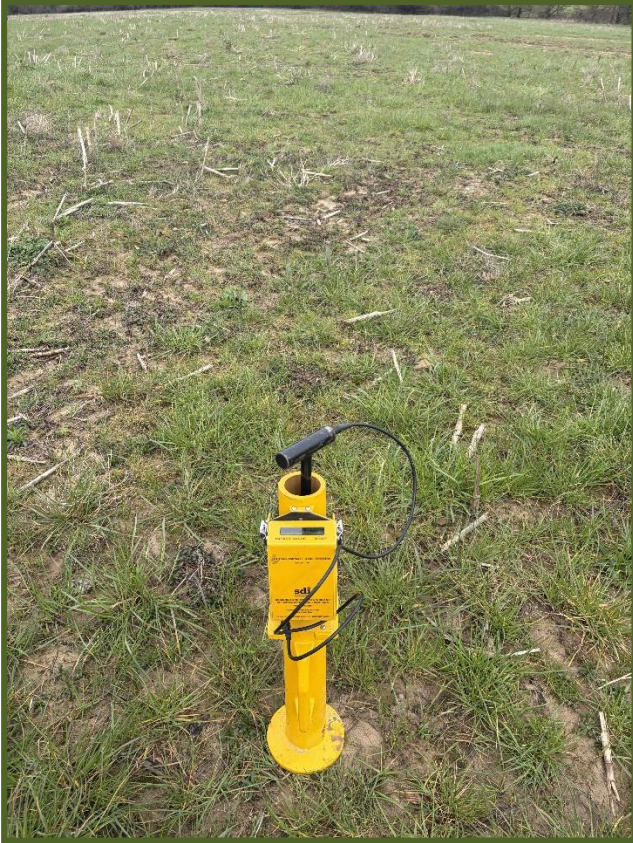
*Plate 18 – Surface harness testing with 2.25kg Clegg Hammer*

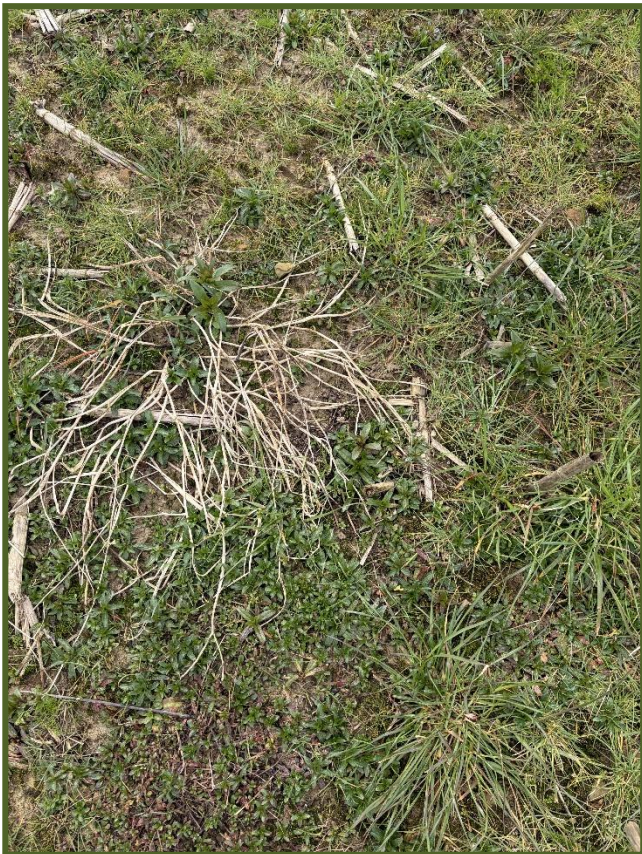
*Plate 19 – Surface vegetation.*
