Table 3.2: Catchment B Photographs

Appendix E Long Sections and Additional Information/Figures

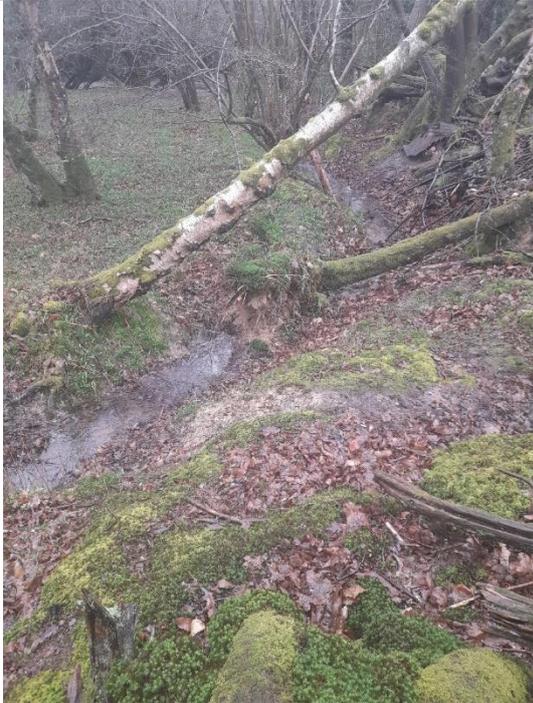
7. View of watercourse flowing from east to west. View looking west. Watercourse shown to take flows from ditch separating Catchments A and B. Topography sloping from east to west.

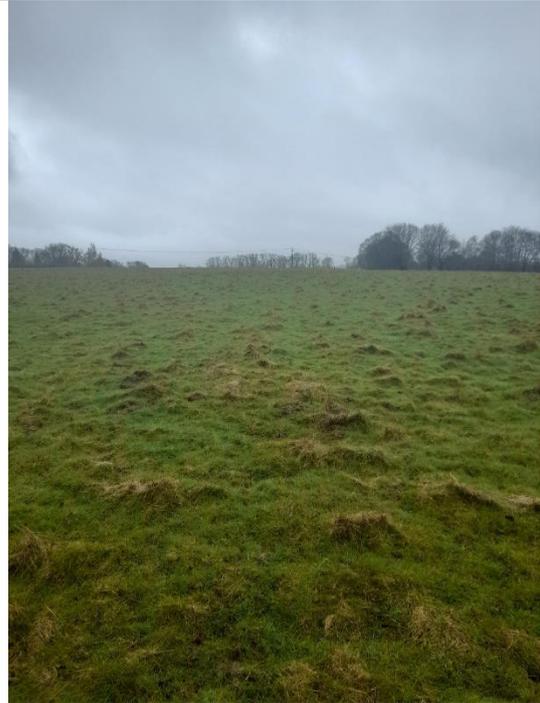
8. View looking south from north of catchment. Topography visibly sloping from south to north.

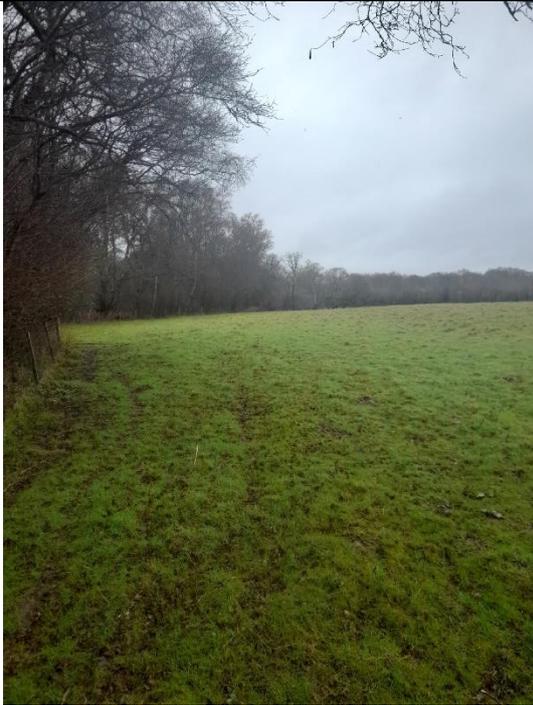
9. View of Catchment B looking north from the west of the catchment. Topography visibly sloping from south to north and east to west.

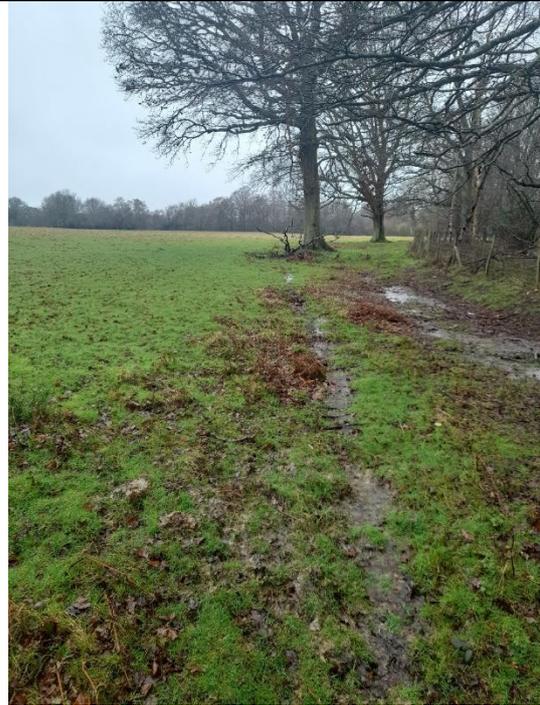
10. View of Catchment B looking west from the northeast of the catchment. Topography visibly sloping from south to north leaving localised low point in northeast of catchment.

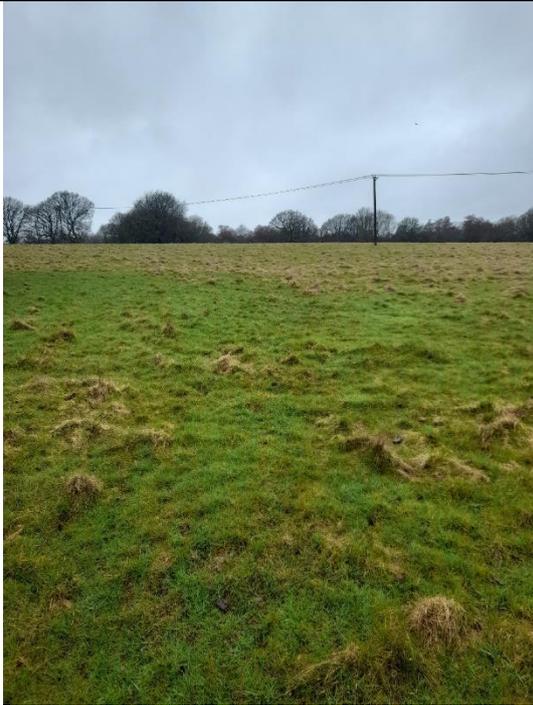
11. View of Catchment B looking west from southeast of catchment. Topography visibly sloping from west to east in the east of the catchment.

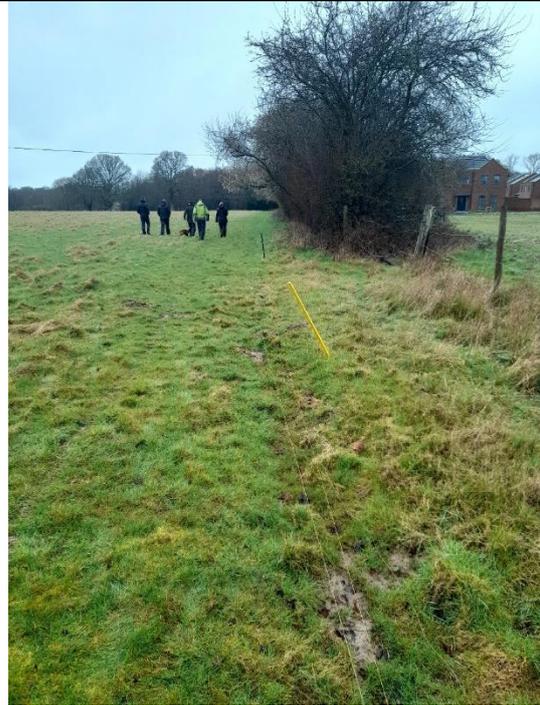
12. View of Catchment B looking north from southeast of catchment. Topography sloping from west to east in the east of the catchment.

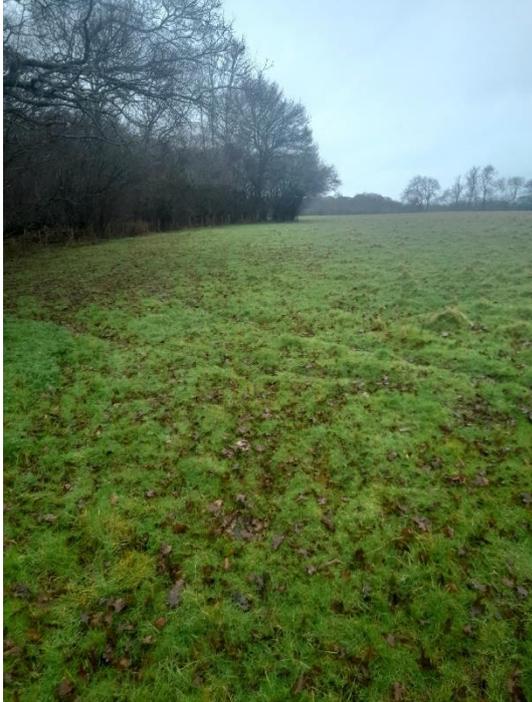
13. View of Catchment C looking north along western boundary of site. Topography sloping from east to west and northeast to southwest.

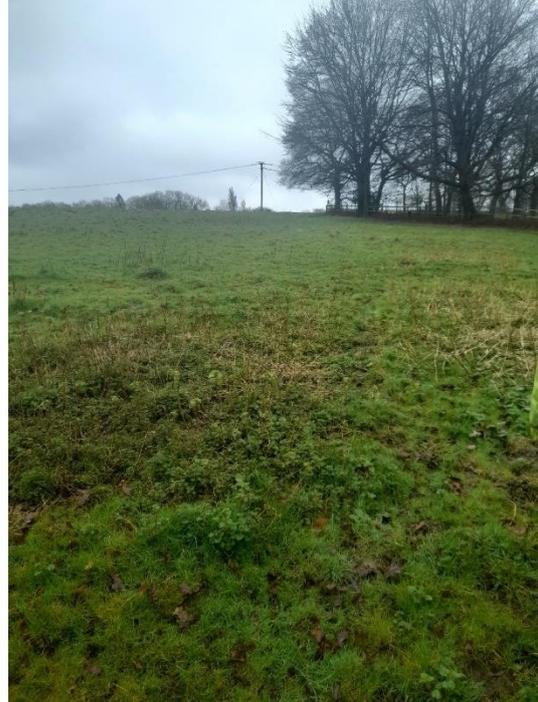
14. View of Catchment C looking east. Topography sloping from east to west. Likelihood is that any potential swale will need to be placed further from the site boundary to ensure a massive depth is not needed.

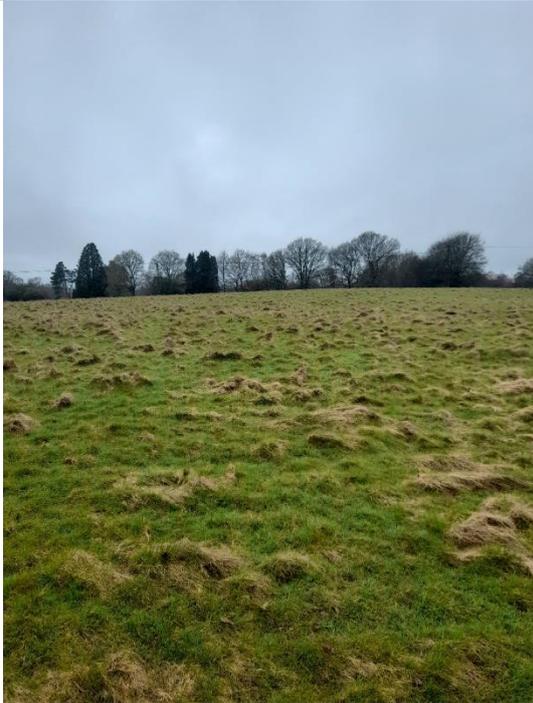
15. View of Catchment D looking west from northeast of catchment. Topography visibly sloping from west to east.

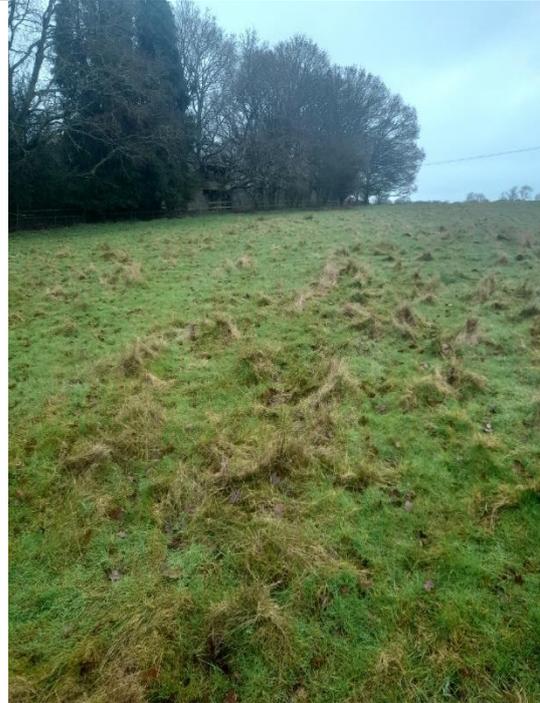
16. View of Catchment D looking north from northwest of catchment. Topography visibly sloping from north to south.

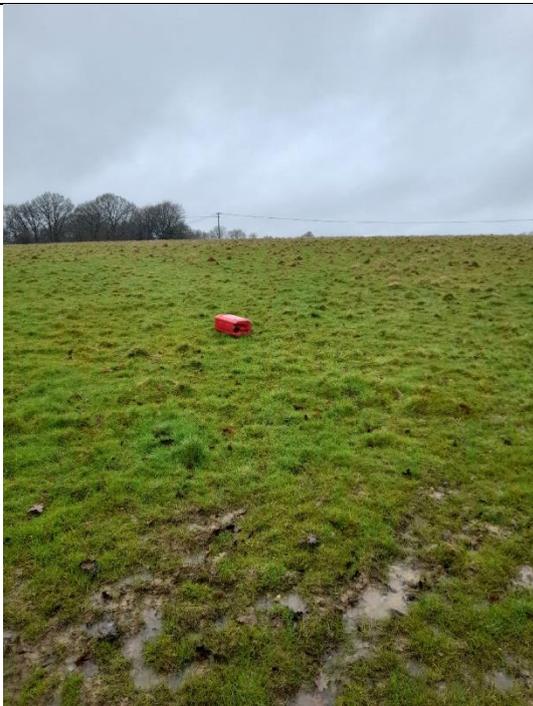
17. View of Catchment D looking northwest from the east of the catchment. Topography visibly sloping from north to south.

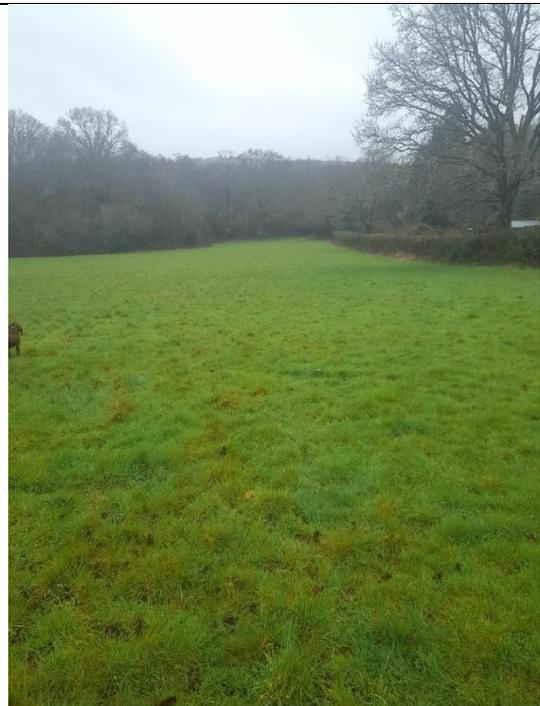
18. View of Catchment D looking south along the western boundary. Topography visibly sloping from west to east.

north to south down toward existing watercourse that separates Catchments D and E.

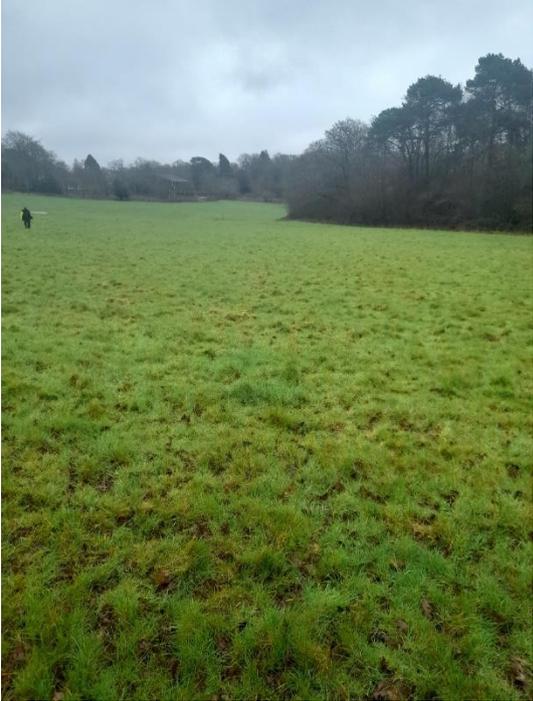
<p>19. View of Catchment D looking east from the southwest of the catchment. Topography visibly sloping from north to south.</p>

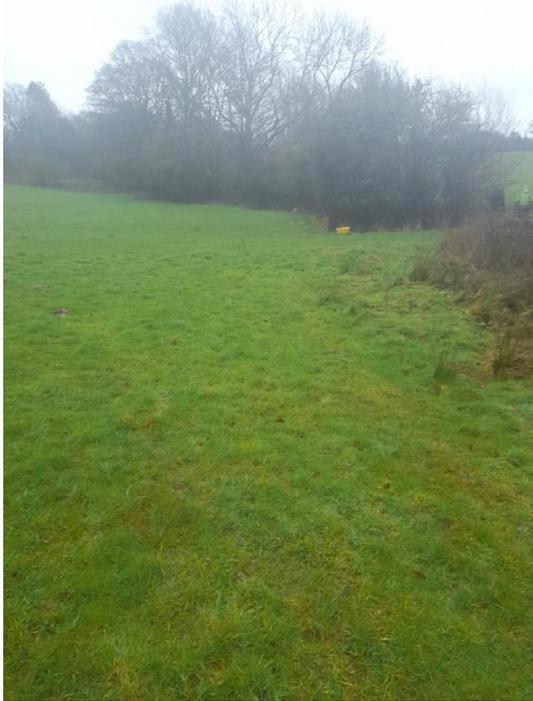
<p>20. View of Catchment D looking east from the south of the catchment. Bridge over watercourse visible in top right of image. EA Surface Water Flood Risk mapping suggests a surface water flow path is present to the south of this watercourse in Catchment E. The EA mapping does not account for culverts (like the one beneath this bridge) and the indication therefore is that the surface water flow path shown to the south of the existing watercourse is the result of the EA model assuming a blockage in the watercourse at this location.</p>

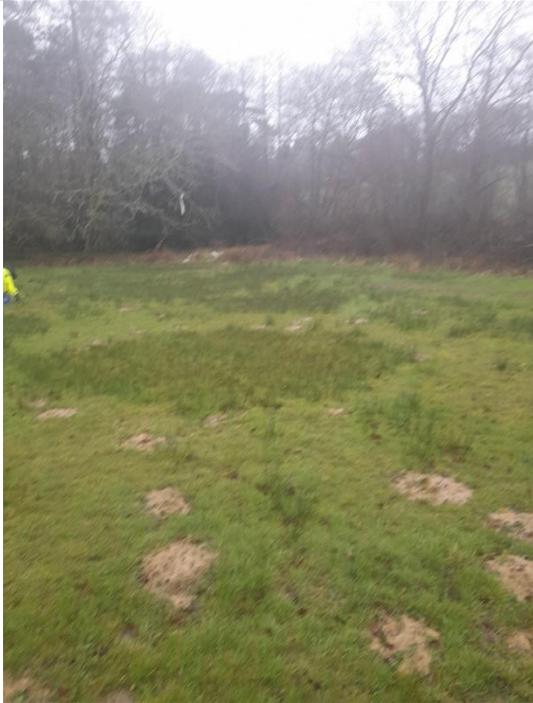
21. View of Catchment E looking northwest from north of catchment, towards existing watercourse. Topography sloping down toward watercourse. Marshy ground ideally suited for an attenuation feature.

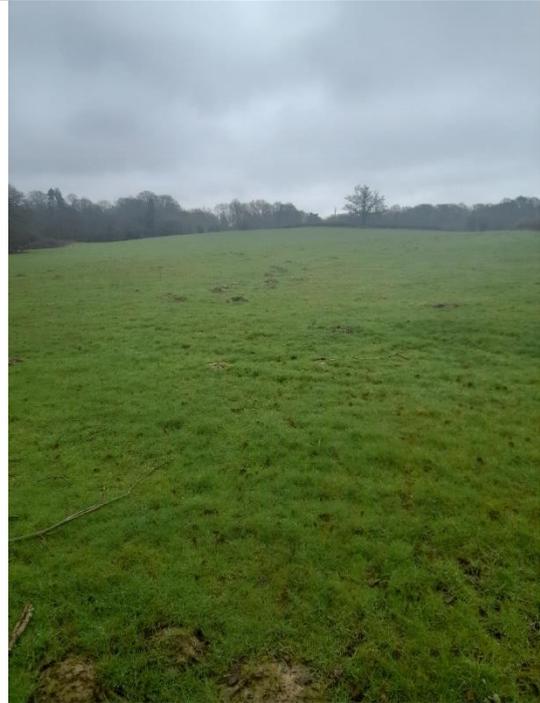
22. View of Catchment E looking southeast from west of catchment. Topography sloping from east to west and south to north, toward the existing watercourse.

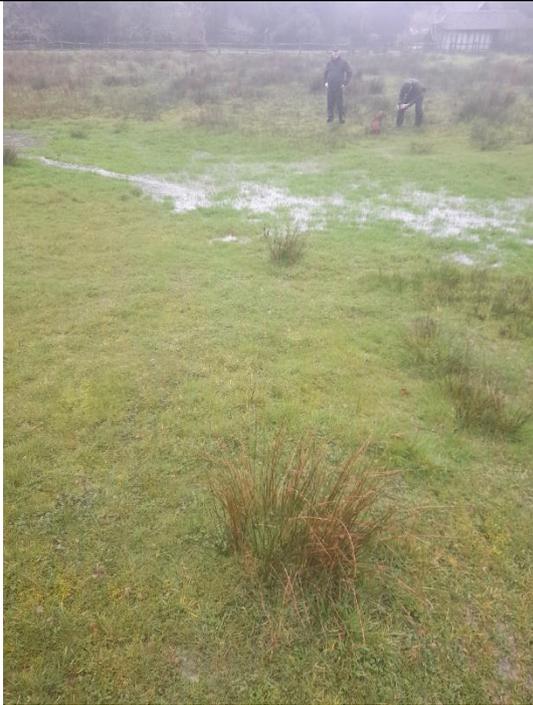
23. Overland surface water flow path flowing from north to south toward the existing watercourse. View looking west.

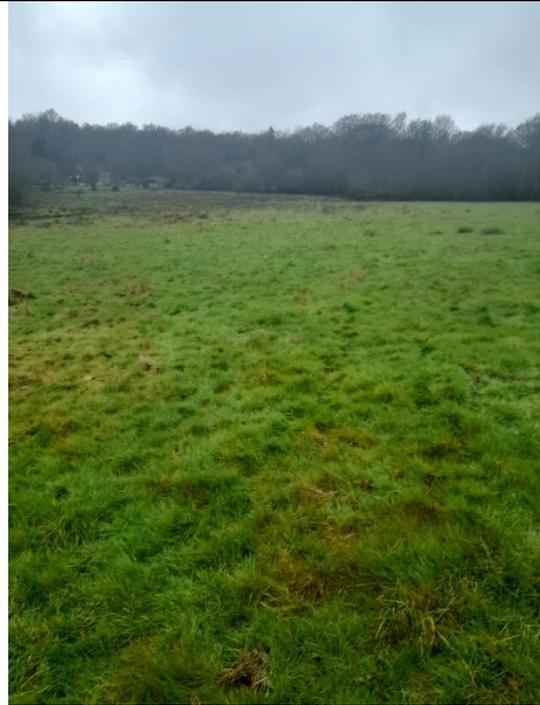
24. View of Catchment E looking northwest from the south of the site. Topography sloping from east to west and southeast to northwest toward existing watercourse.

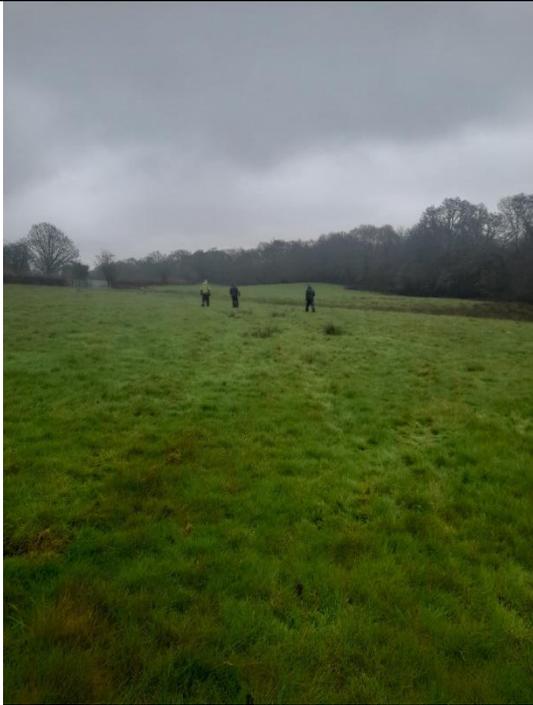
25. View of Catchment E looking east from the south of the site. Topography sloping from north to south toward the south of the site.

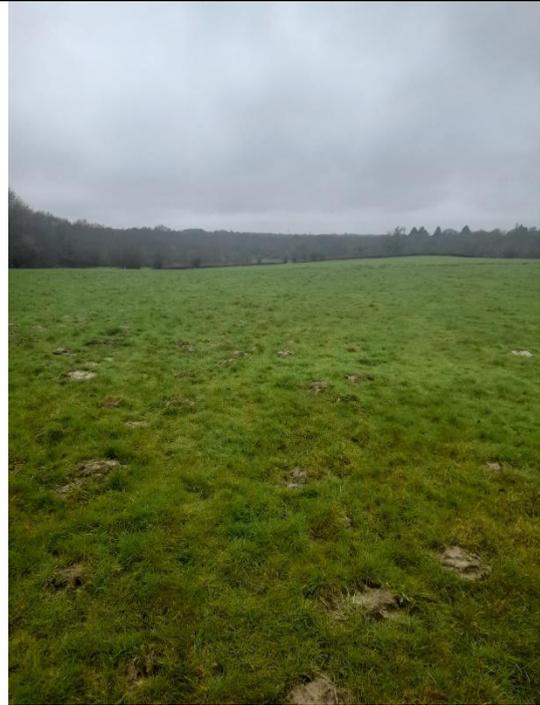
26. View of Catchment E looking west from the southeast of the site. Topography shown to be sloping from east to west but is gentle at location photograph was taken.

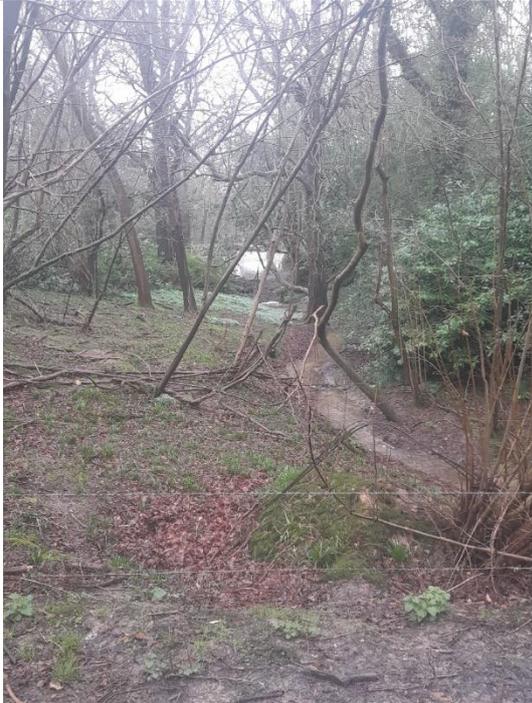
27. View of watercourse between Catchments E and F flowing from east to west. View looking west from atop existing footbridge.

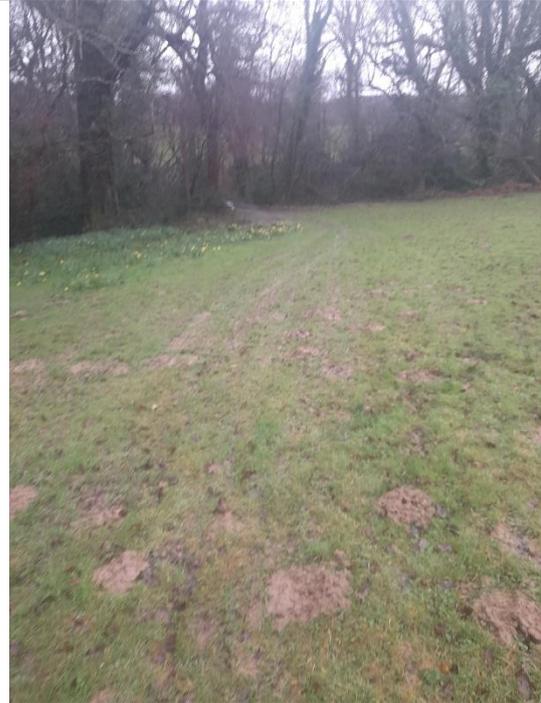
28. View of Catchment F looking south from the south of the catchment. View looking toward existing watercourse. Steeply sloping toward existing watercourse apparent.

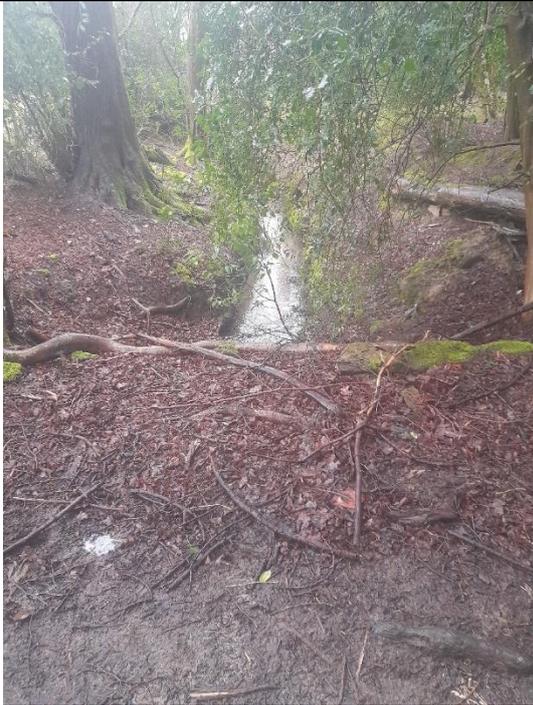
29. Existing tributary watercourse flowing from north to south along eastern boundary of site. View looking north/upstream from atop existing footbridge.

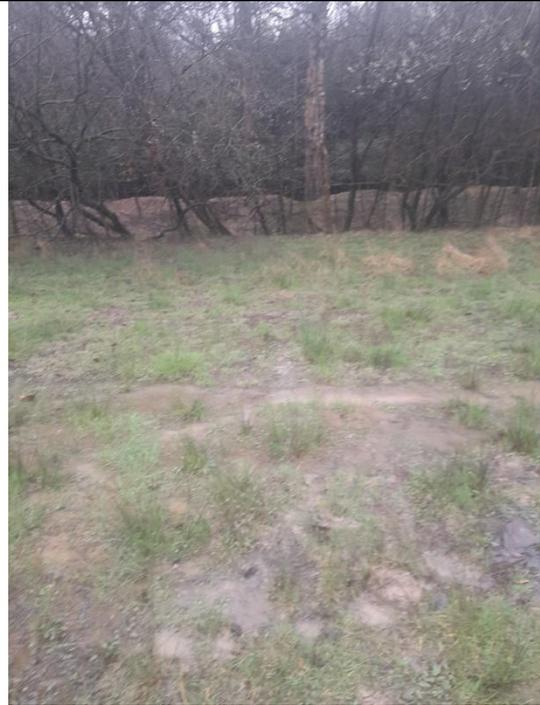
30. View of tributary watercourse flowing from northeast to southwest along eastern boundary of site. Adjacent ground very saturated. View looking south.

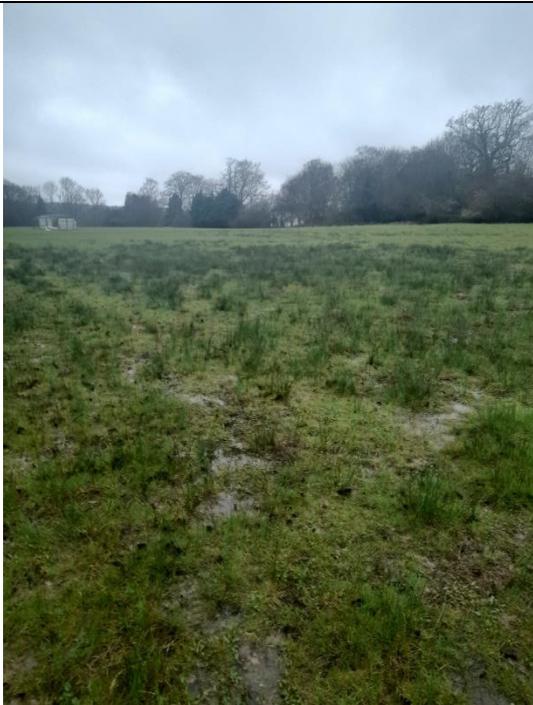
31. View of Catchment F looking northwest from east of catchment. Ground very saturated. Topography gently sloping from north to south.

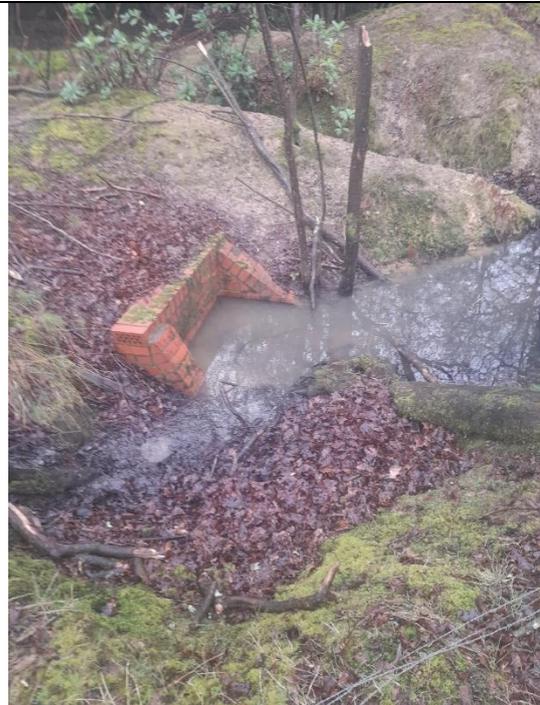
32. View of headwall and culvert along tributary watercourse flowing from northeast to southwest along

<p>eastern boundary of site. Further tributary ditch visible in top of image.</p>

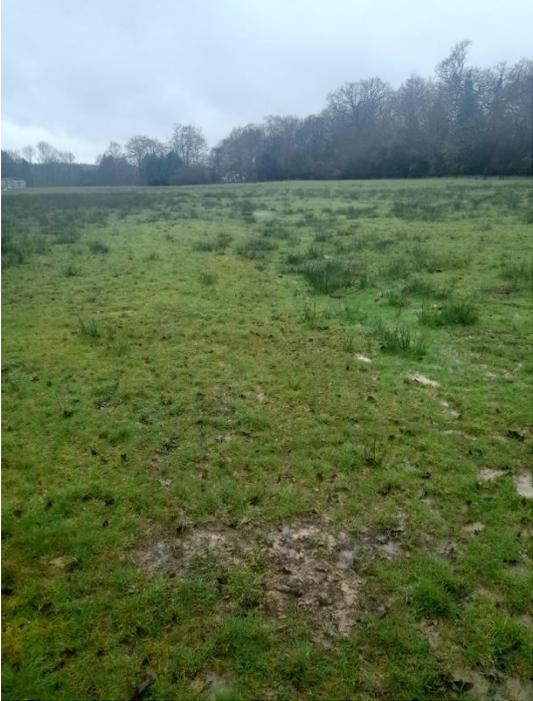
<p>33. View of Catchment F looking approximately west from the northeast of the catchment. Ground very saturated and topography indicative of potential surface water flow path in part due to lowered edge of small ditch ("tributary watercourse"). See Photo 34 for source of overland flow.</p>

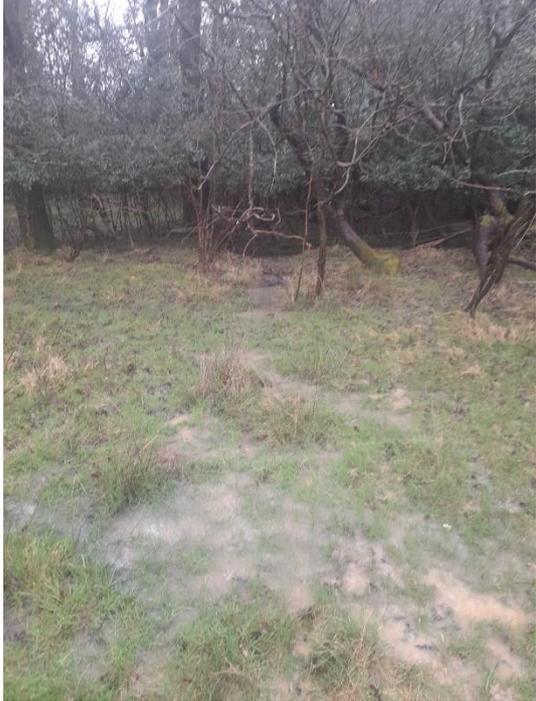
<p>34. View of the tributary watercourse in the northeast of the catchment, beneath tree cover. Backing up and overspill of watercourse onto main catchment area visible. Local land management and potential localised ground raising required to ensure flow remains in the tributary watercourse and is not directed through centre of catchment.</p>

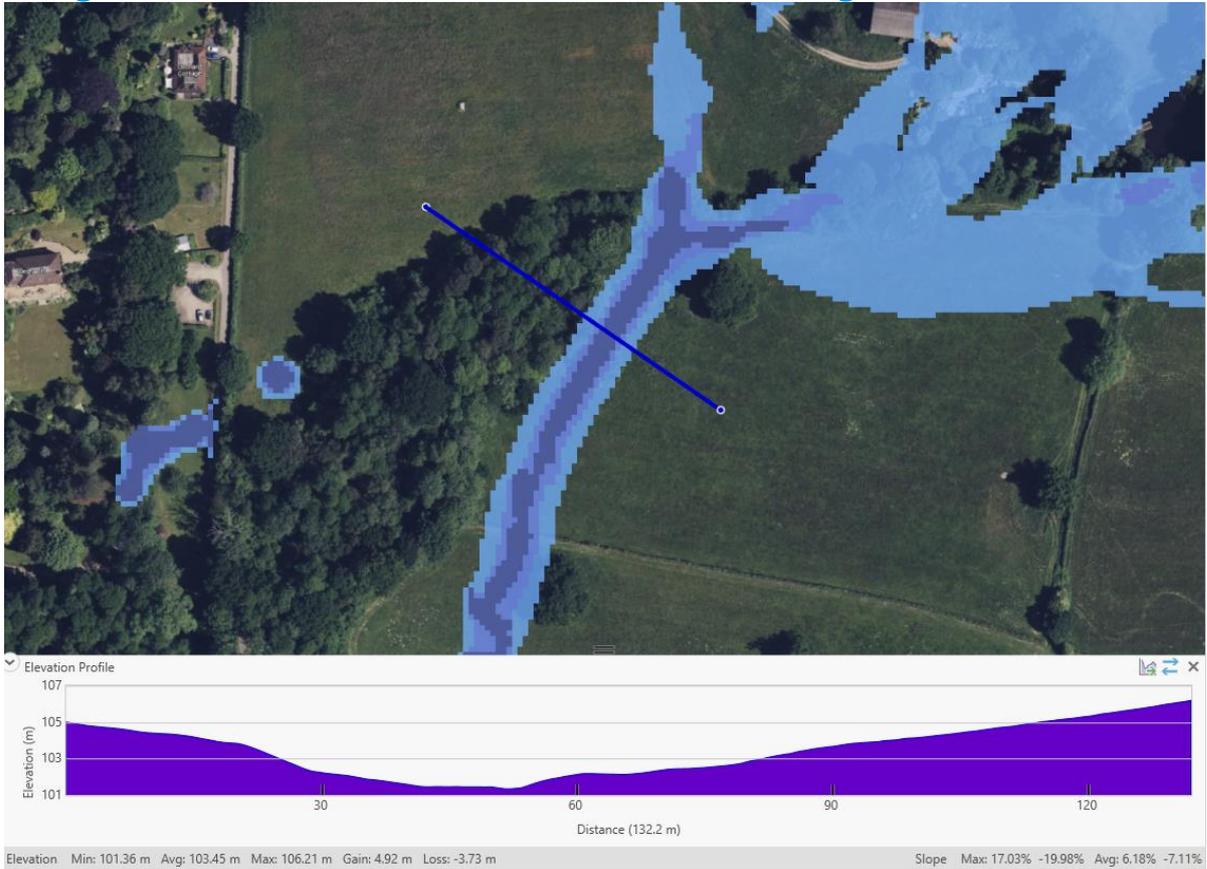
Figure AE.1: Fields 3 & 4 Long Section

The cross section profile presented in Figure AE.1 shows the topography of the dark blue line drawn in the above related image, as it moves across the land from approximately northwest to southeast.

The dark blue line measures approximately 132 m in length. At a chainage of 0 m, at its northwestern most point, the elevation stands at approximately 105 m AOD. At a chainage of approximately 52 m, where the existing east to west watercourse is located beneath the tree cover, the elevation stands at approximately 101 m AOD. At a chainage of approximately 81 m, where an area at a High risk of surface water flooding is located, the elevation stands at approximately 103 m AOD.

Hence, it is not possible for the area part way up the southeastern slope to be at a higher surface water flood risk than that to the northwest where the existing watercourse is located.

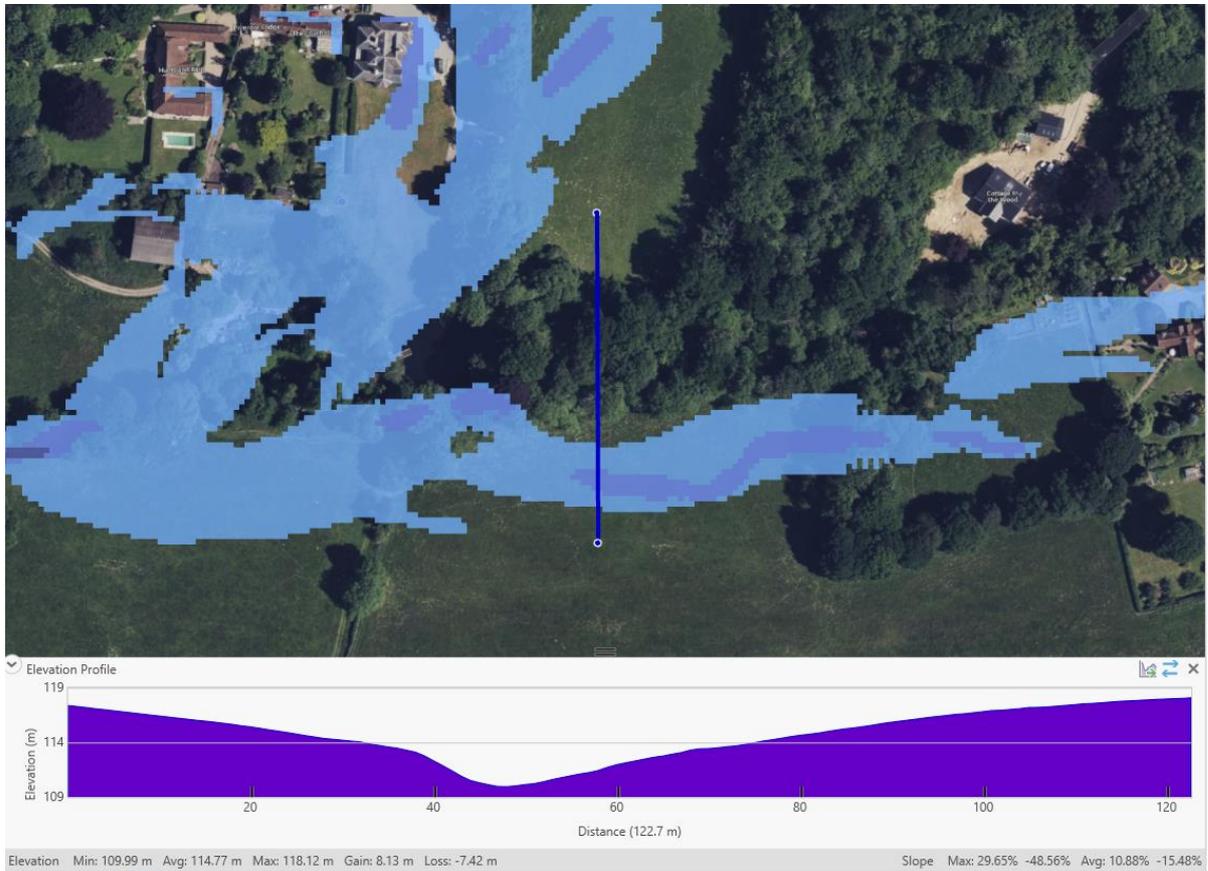
Figure AE.2: Fields 5 & 6 Long Section

The cross section profile presented in Figure AE.2 shows the topography of the dark blue line drawn in the above related image, as it moves across the land from approximately north to south.

The dark blue line measures approximately 123 m in length. At the northernmost point, at a chainage of 0 m, the elevation stands at approximately 117 m AOD. At a chainage of approximately 48 m, where the existing east to west watercourse is located beneath the tree cover, the elevation stands at approximately 110 m AOD. At a chainage of approximately 99 m, where an area at a Medium risk of surface water flooding is located, the elevation stands at approximately 117 m AOD.

Hence, it is not possible for the area part way up the southern slope to be at a higher surface water flood risk than that to the north where the existing watercourse is located.

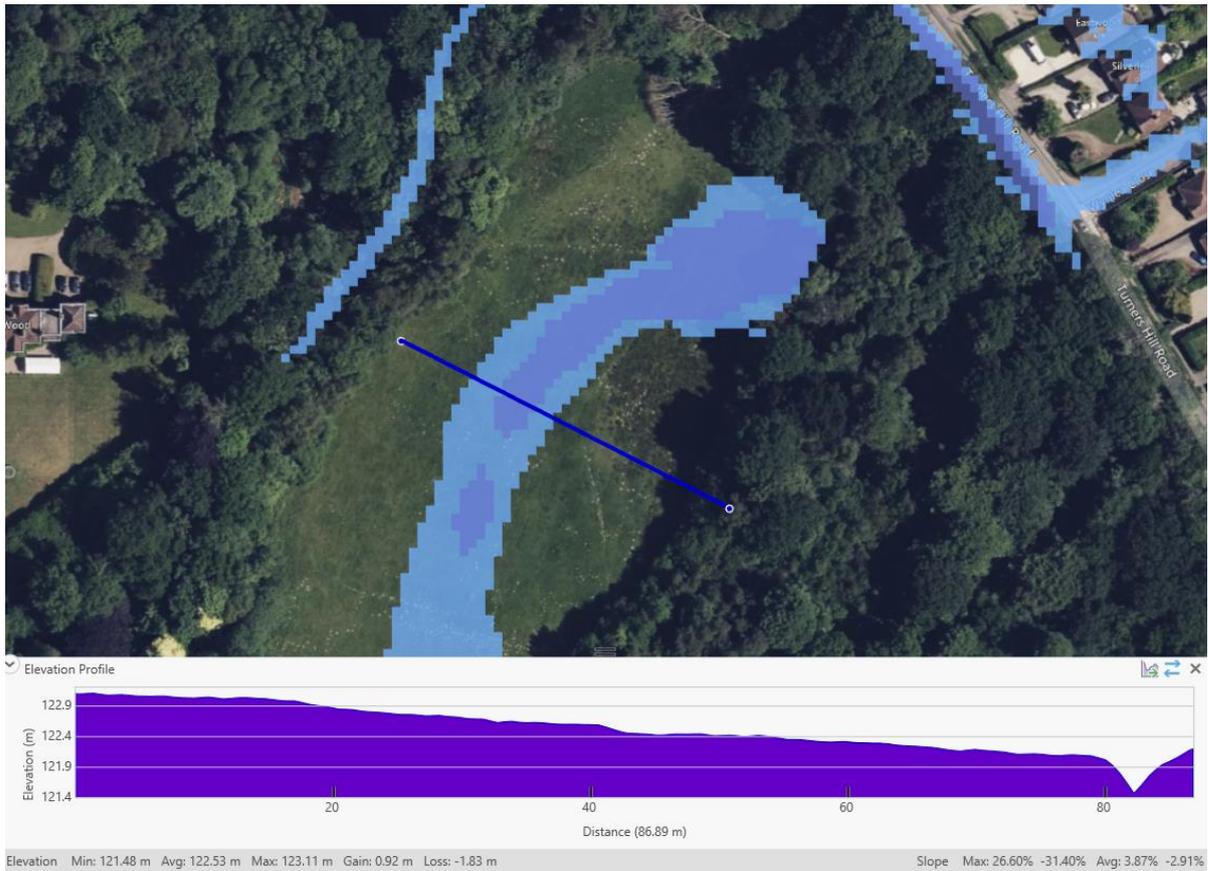
Figure AE.3: Field 5 Long Section

The cross section profile presented in Figure AE.3 shows the topography of the dark blue line drawn in the above related image, as it moves across the land from approximately northwest to southeast.

The dark blue line measures approximately 87 m in length. At the western edge of Field 5, at a chainage of 0 m, the elevation stands at approximately 123.1 m AOD. At a chainage of approximately 32 m, where an area at a Medium risk of surface water flooding is located, the elevation stands at approximately 122.7 m AOD. At the eastern edge of Field 5, at a chainage of approximately 75 m, the elevation stands at approximately 122.1 m AOD.

Hence, while the land is inclined to fall from north to south across Field 5, as indicated by the surface water flow path, the reality is that surface water would also fall toward the east where levels are lower, outside the area of proposed dwellings.

Furthermore, the ditch that is shown on the long section profile at an approximate chainage of 83 m is not identified as an area at risk from surface water flooding despite a base elevation of

approximately 121.5 m AOD, over 1 m lower than the area of Medium surface water flood risk located approximately 50 m to the northwest.

It is not considered realistic for the area at a higher elevation to be at a higher surface water flood risk. Furthermore, were surface water to follow the topography as indicated in Figures AE.3, AE.4, AE.6, and AE.7, any surface water that reached this part of Field 5 from the north and east would

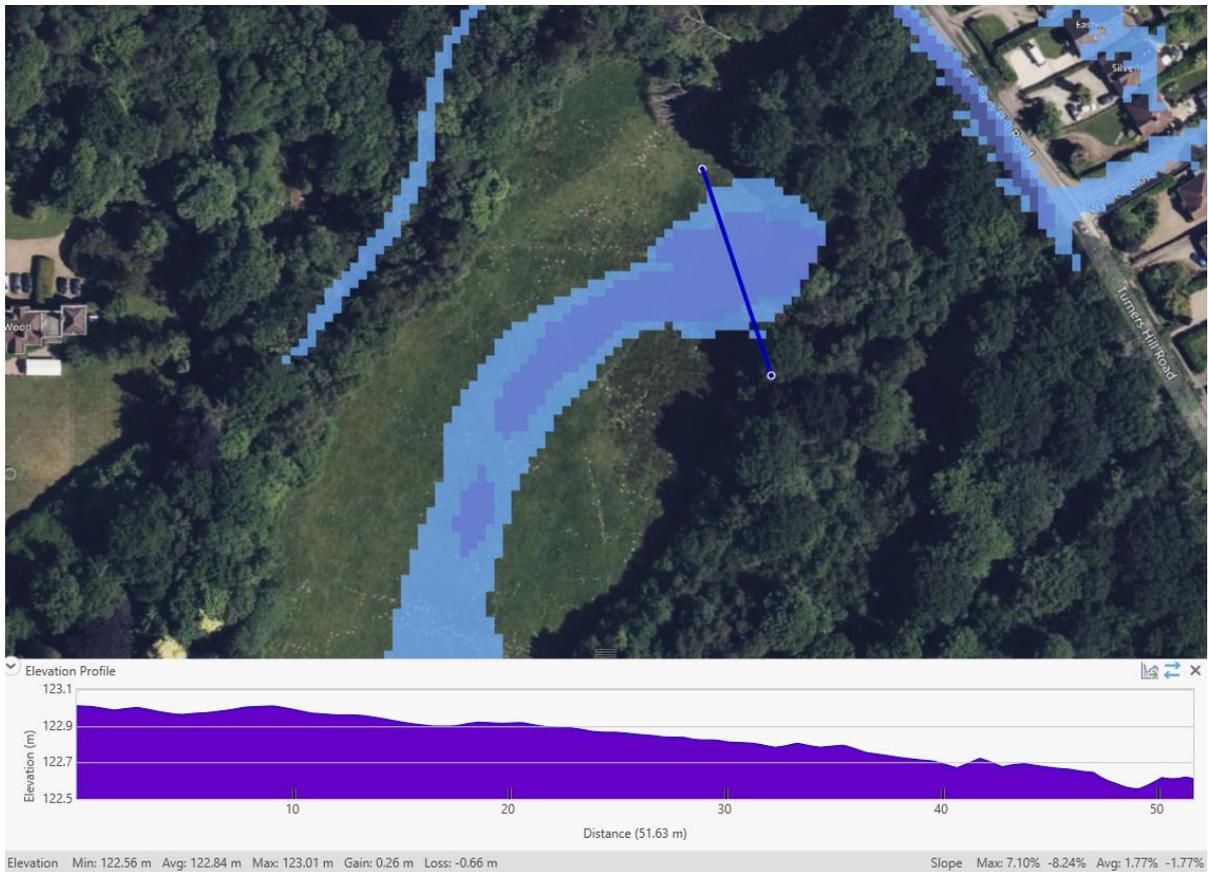
Figure AE.4: Field 5 Long Section 2

The cross section profile presented in Figure AE.4 shows the topography of the dark blue line drawn in the above related image, as it moves across the land from approximately north to south.

The dark blue line measures approximately 52 m in length. At the northernmost point, at a chainage of 0 m, the elevation stands at approximately 123 m AOD. At a chainage of approximately 25 m, where an area at a Medium risk of surface water flooding is located, the elevation stands at approximately 122.9 m AOD. At a chainage of approximately 49 m, where an existing ditch is located and no surface water flood risk is identified by the mapping, the elevation stands at approximately 122.6 m AOD.

Hence, it is not considered feasible for the area at a higher elevation to be at a higher surface water flood risk than the area of the existing ditch approximately 25 m to the south which is shown to be approximately 300 mm lower.

Furthermore, maintenance works have been undertaken in this area of the site to de-silt the existing ditch network where this was observed onsite to be full of silt. This will increase future capacity for surface water runoff from Turners Hill Road. A regular maintenance regime has been

recommended as part of the site wide surface water drainage strategy to ensure no silt build-up in the future.

Furthermore, as part of the surface water drainage strategy, a new network of swales and surface water attenuation areas have been proposed for Field 5 along the entire eastern corridor which will capture any overland runoff from the existing ditches in the event these were to overflow.

Furthermore, among mitigation measures recommended for the management of surface water, all Finished Floor Levels and threshold levels are proposed to be raised between 150 mm and 200 mm above surrounding ground levels.

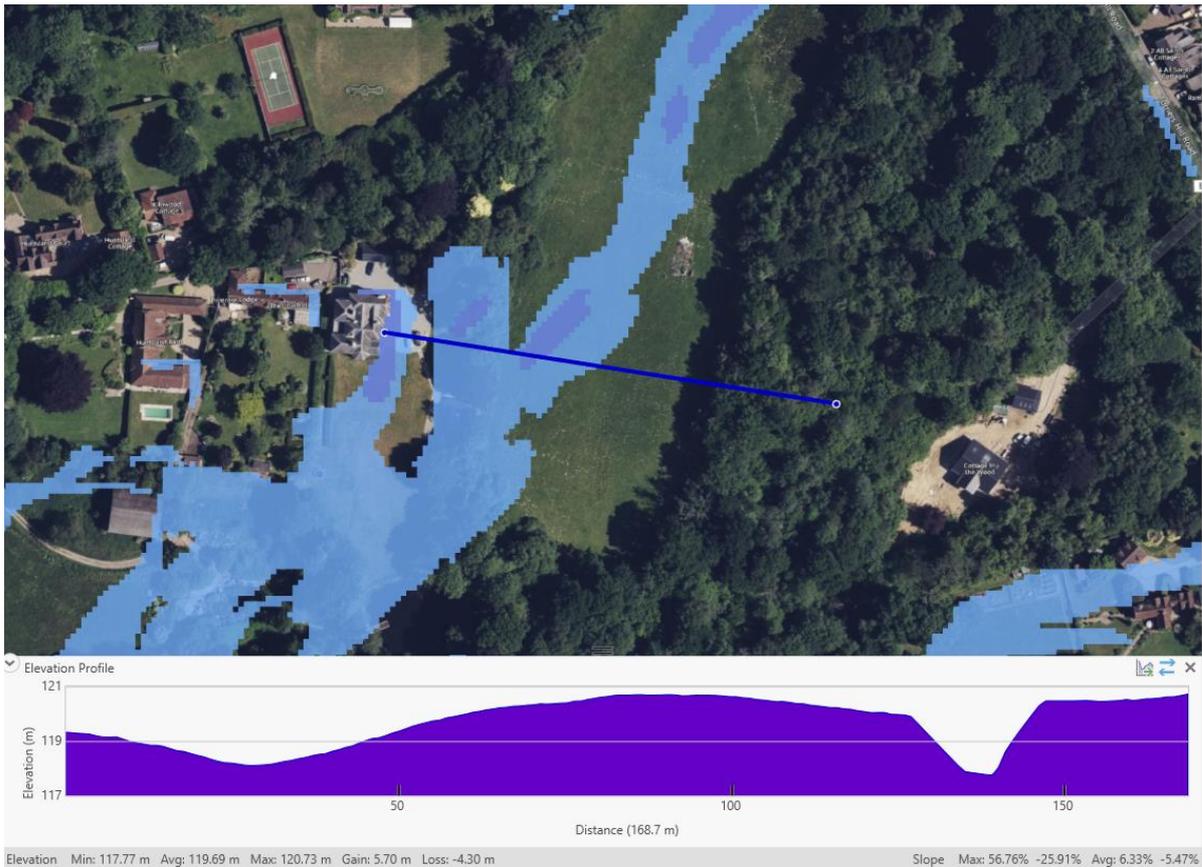
Figure AE.5: Field 5 Long Section 3

The cross section profile presented in Figure AE.5 shows the topography of the dark blue line drawn in the above related image, as it moves across the land from approximately west to east.

The dark blue line measures approximately 170 m in length. At a chainage of approximately 55 m, where an area at a Medium risk of surface water flooding is located, the elevation stands at approximately 119.7 m AOD. At a chainage of approximately 42 m, where an area at a Low risk of surface water flooding is located, the elevation stands at approximately 118.8 m AOD.

naturally drain into the existing ditch network located to the east of Field 5. This is indicated on Figure AE.5 between approximate chainages 126 m and 148 m.

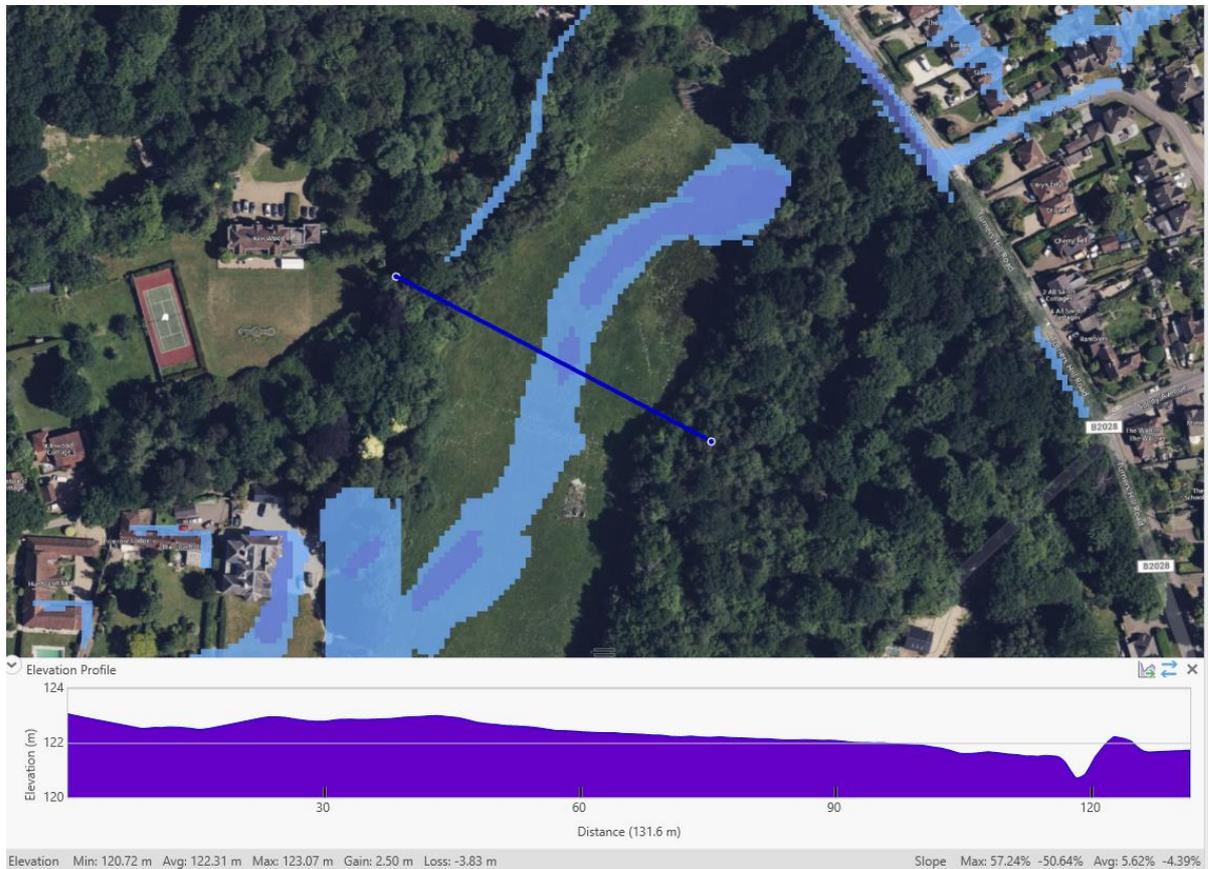
Figure AE.6: Field 5 Long Section 4

The cross section profile presented in Figure AE.6 shows the topography of the dark blue line drawn in the above related image, as it moves across the land from approximately northwest to southeast.

The dark blue line measures approximately 132 m in length. Toward the southeast end of the line, at a chainage of approximately 119 m, the elevation stands at approximately 120.7 m AOD. This is at the base of the existing ditch to the east of Field 5 toward which the topography is shown to fall. The area is not shown to be at risk. At a chainage of approximately 73 m, where the area at a Medium risk of surface water flooding is met, the elevation stands at approximately 122.3 m AOD.

It is not considered realistic for the area at a higher elevation to be at a higher surface water flood risk than that further southeast along the line.

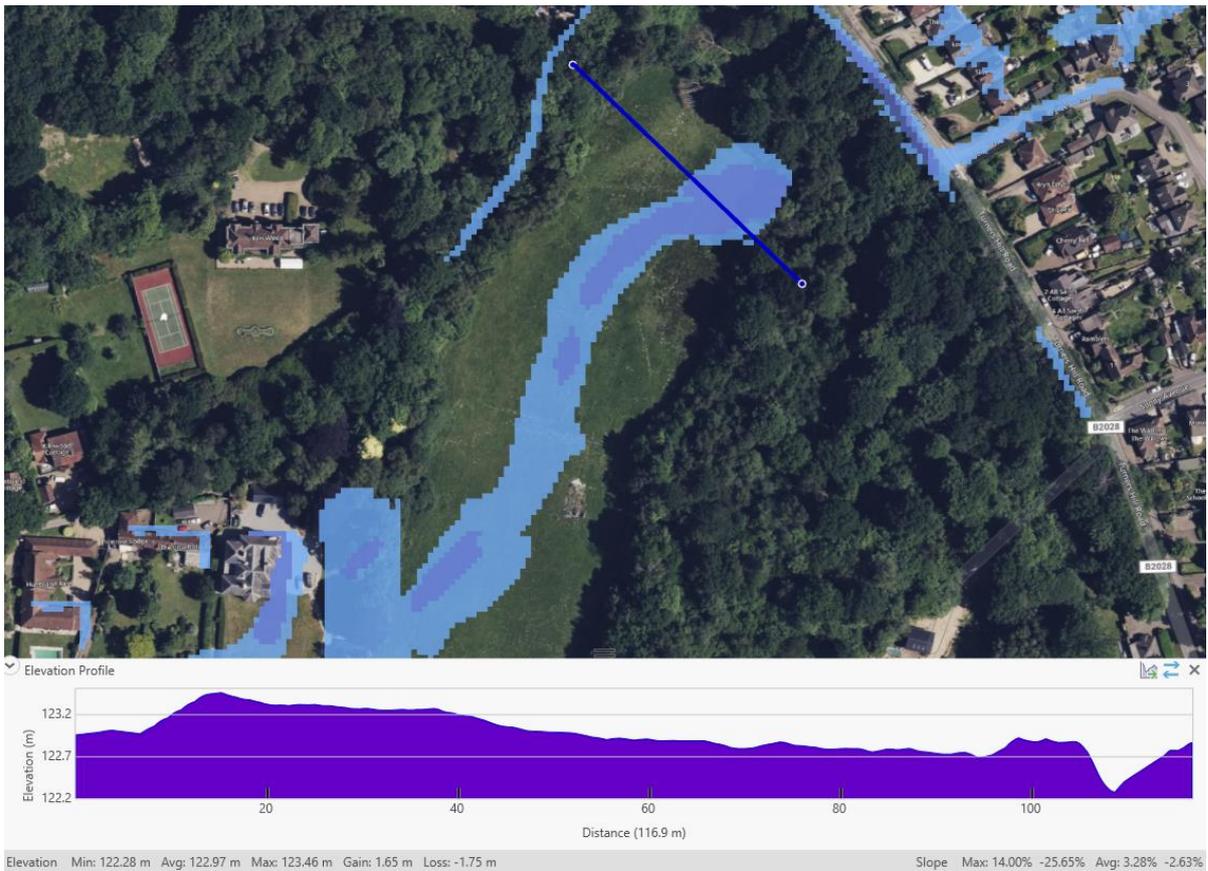
Figure AE.7: Field 5 Long Section 5

The cross section profile presented in Figure AE.7 shows the topography of the dark blue line drawn in the above related image, as it moves across the land from approximately northwest to southeast.

The dark blue line measures approximately 117 m in length. Toward the southeast end of the line, at a chainage of approximately 95 m, the elevation stands at approximately 122.7 m AOD. At a chainage of approximately 86 m, where the area at a Medium risk of surface water flooding is met, the elevation stands at approximately 122.8 m AOD.

It is not considered realistic for the area at a higher elevation to be at a higher surface water flood risk than that further southeast along the line. The existing ditch to the east of Field 5, indicated on Figure AE.7 at a chainage of approximately 109 m, stands at its base at an elevation of approximately 122.3 m AOD. This ditch is not shown to be at risk of surface water flooding despite its low level.

In addition to the above, maintenance and debris removal works have been undertaken in this area of the site to de-silt the existing ditch network as this was observed onsite to be silted up to a significant level. This will increase future capacity for surface water runoff from Turners Hill

Road. A regular maintenance regime has been recommended as part of the site wide surface water drainage strategy to ensure no silt build-up in the future.

Furthermore, as part of the surface water drainage strategy, a new network of swales and surface water attenuation areas have been proposed for Field 5 along the entire eastern corridor which will capture any overland runoff from the existing ditches in the event these were to overflow.

Furthermore, among mitigation measures recommended for the management of surface water, all Finished Floor Levels and threshold levels are proposed to be raised between 150 mm and 200 mm above surrounding ground levels.
