## LAND TO THE SOUTH OF LEACROFT

LONDON ROAD, HICKSTEAD, WEST SUSSEX, RH17 5LZ

### Contamination Risk Assessment

| <b>Requirement</b> | <b>Data</b> |
|---|---|
| Report Ref: | 872/Ellisdon/Leacroft/CRA |

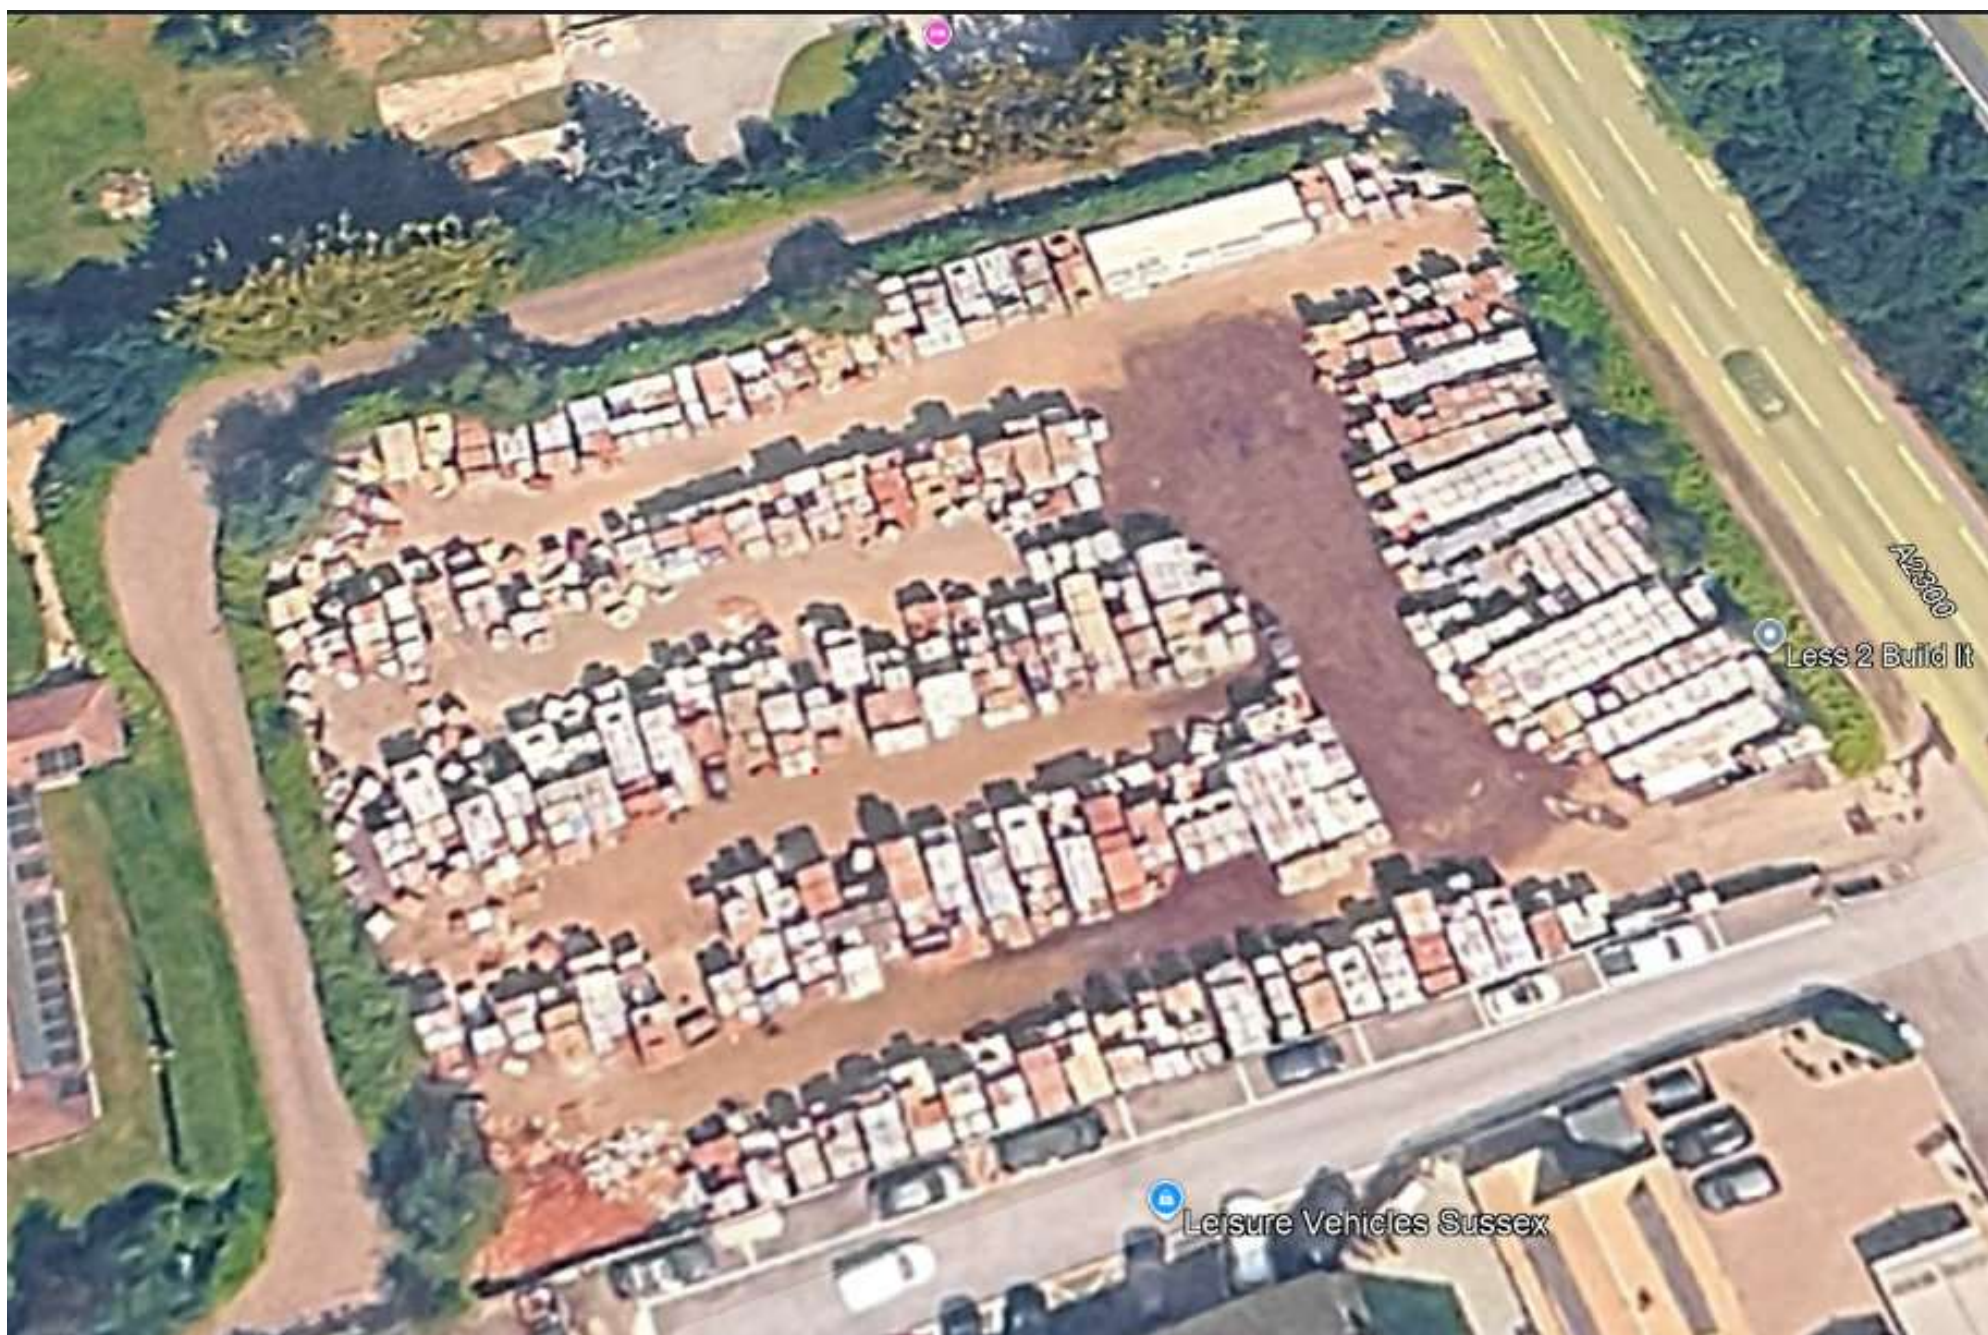
Figure 2: Site as Existing

Leacroft, to the east by the A2300, the slip road to the A23 dual carriageway, to the south by a detached residential dwelling and commercial building, Reindina, and the offices of Sweeptech at Almacadams House and to the west by a detached residential dwelling, Sunny Acres. The neighbouring residential properties all have garden areas surrounding the dwellings. See Appendix A Figure 2 for the existing site layout.

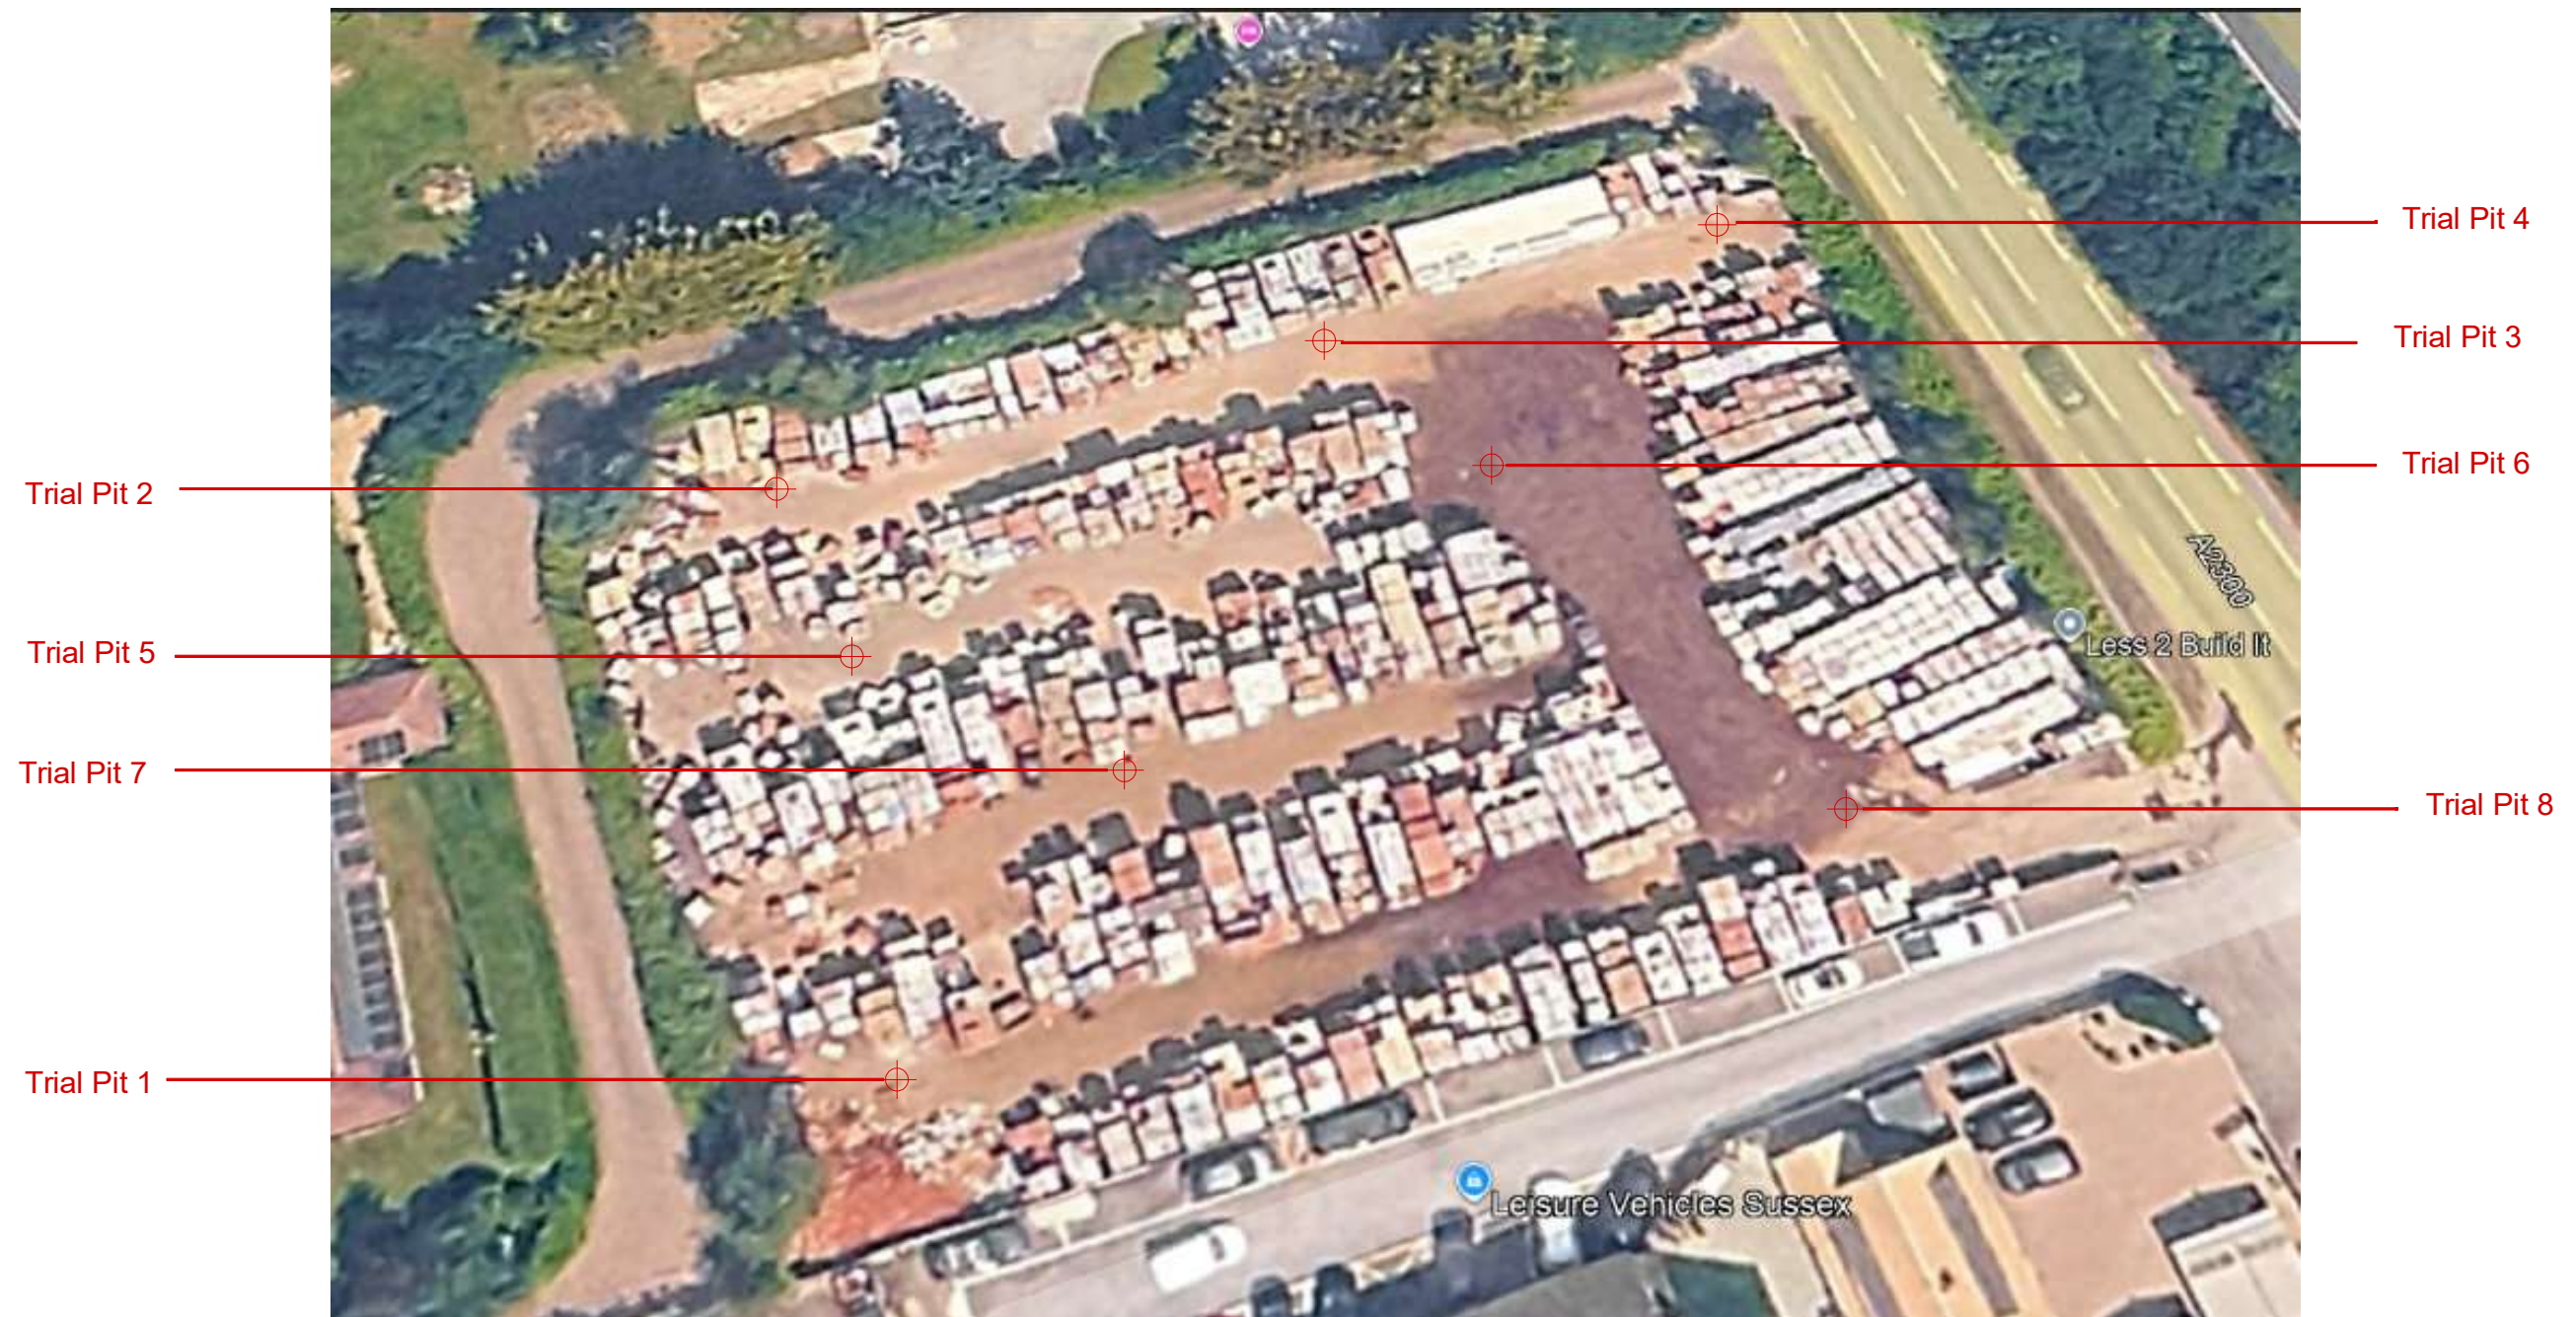
Figure 4: Trial Pit Locations

- 5.3 The trial pits were positioned across the site to give an overall spread of the soil contamination levels throughout the site: Trial pits 2, 3 and 4 were located along the northern boundary with Leacroft, in the approximate location of the southern façade of the northern warehouses. Trial pits 1 and 8 were located along the southern boundary, in the approximate location of the northern façade of the southern warehouses and trial pits 5, 6 and 7 were located across the proposed central parking area.

- 5.5 The trial pit locations are shown in Appendix A, Figure 4. Photographs taken during the site investigation are provided in Appendix B.
- 5.6 A total of 32 soil samples were sent to i2 Analytical Ltd of Croxley Green, Watford, for analysis. All the trial pits were tested for speciated polycyclic aromatic hydrocarbons (PAHs), petroleum hydrocarbons, toxic and phytotoxic heavy metals / metalloids, water soluble Sulphate, pH, soil inorganic matter, and asbestos.

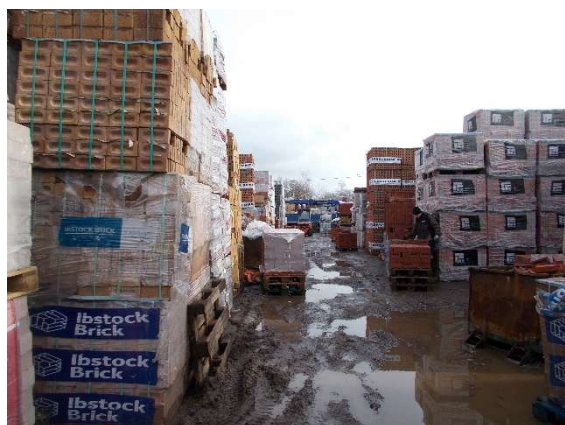
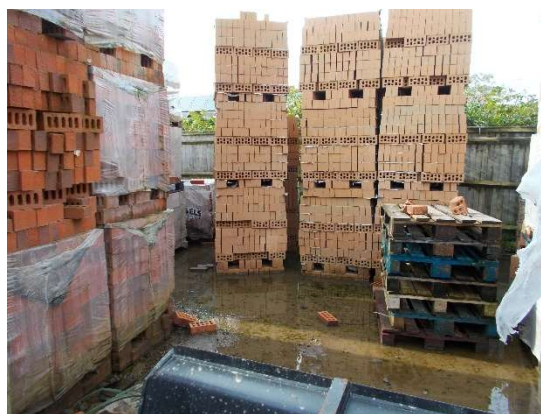
Brick storage at the site

- 4.3 The site comprises a yard laid to permeable gravel and road planings used for storage and distribution of bricks, with a prefabricated site office building in the northeast corner. The site is accessed from London Road public highway to the east via an existing tarmacked driveway/access track. The proposed warehouses will lie along the north, east, west and part of the southern boundary, with a non-permeable parking area in the central section.

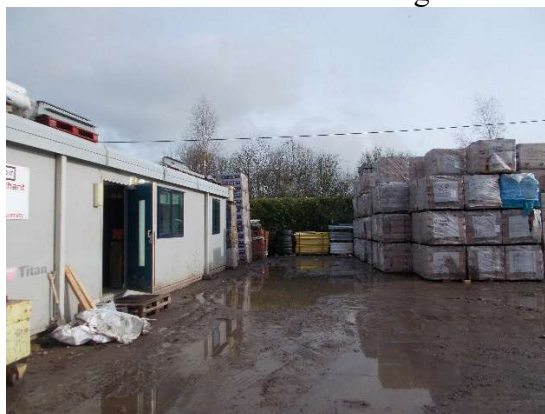
The site office building

- 4.4 The existing office building at the site lies in the northeast corner of the site and part of the proposed northern warehouse will lie on the footprint of this building.

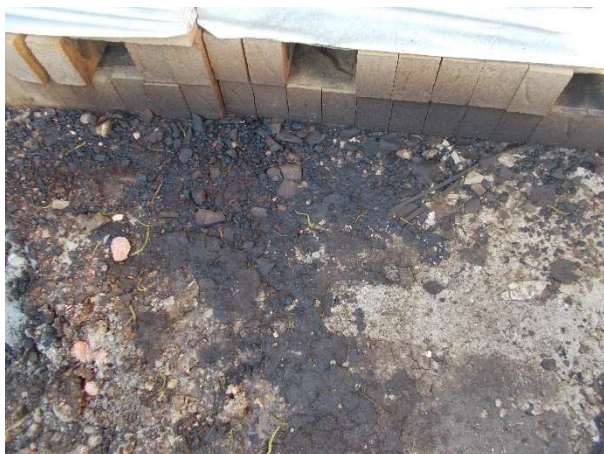
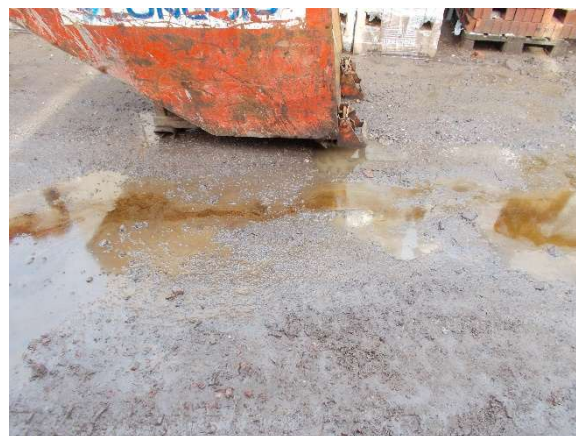
Surface fuel spills onsite

- 4.5 There is a line of trees along the eastern boundary with London Road, the A2300 public highway, this is to remain, post development.
- 4.6 At the time of our recent visits there was some oily residue on the surface of the ground in places, presumable leaking from site delivery vehicles. Potential sources of contamination identified during the site walkover assessment included:

- i. Contamination risks predominantly associated with oil/fuel spills and contaminants (which may include petroleum hydrocarbons, coal tar, heavy metals and possibly asbestos) within surfacing and building materials within the site.

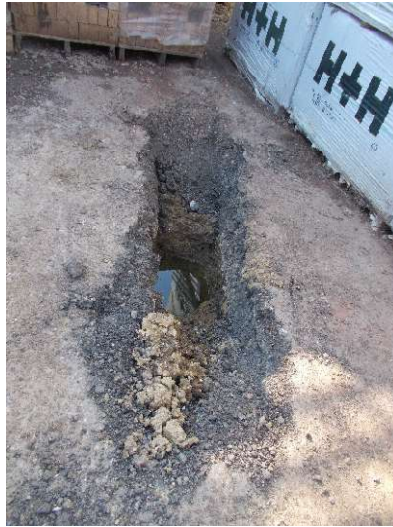
Trial Pit 1

- i. Trial pit 1 was located to the southwestern corner of the site, at the northern façade of the proposed southern warehouse. The trial pit revealed a layer of made ground over subsoil consisting of a clayey matrix, rainwater was present in the trial pit at the time of our sampling. Soil samples were taken from the made ground and subsoil, at a depth of 0.7 m – 0.1 m and from the natural strata.

- Levels of petroleum ether extractable matter were very significantly exceeded in TP1 and TP8 at 0.7 m, with recorded levels of 750 mg/kg and 4200 mg/kg respectively, and target levels of 60 mg/kg and 400 mg/kg respectively.

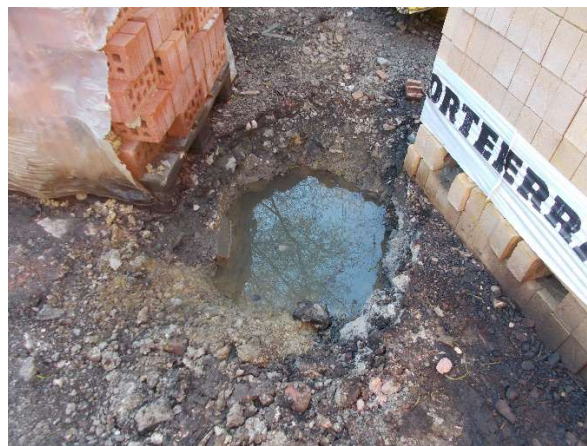
Trial Pit 2

- ii. Trial pit 2 was located to the northwest corner of the site, at the southern façade of the proposed northern warehouse. The trial pit revealed a layer of made ground measuring approximately 0.4 m over clayey subsoil, rainwater was present in the trial pit at the time of our sampling. Soil samples were taken from made ground and subsoil at a depth of 0.7 m – 0.1 m and from the underlying strata.

- Elevated levels of Benzo(a)anthracene were found in TP3 at 0.1 m, with a recorded level of 37 mg/kg and a target level of 29 mg/kg.
  - Significantly elevated levels of Benzo(b)fluoranthene were found in TP2, TP3, and TP5 at 0.1 m, with a recorded level of between 11 and 40 mg/kg and a target level of 7.2 mg/kg; with the highest level recorded at TP3.

- Significantly elevated levels of Benzo(a)pyrene were found in TP2, TP3 and TP5 at 0.1 m, with a recorded level of between 8.7 and 37 mg/kg and a target level of 5.7 mg/kg; with the highest recorded level at TP3.

- Slightly elevated levels of Dibenzo(a,h)anthracene were found in TP2 and TP3 at 0.1 m, with a recorded level of between 0.5 and 3.4 mg/kg and a target level of 0.57 mg/kg, with the highest recorded level at TP3.

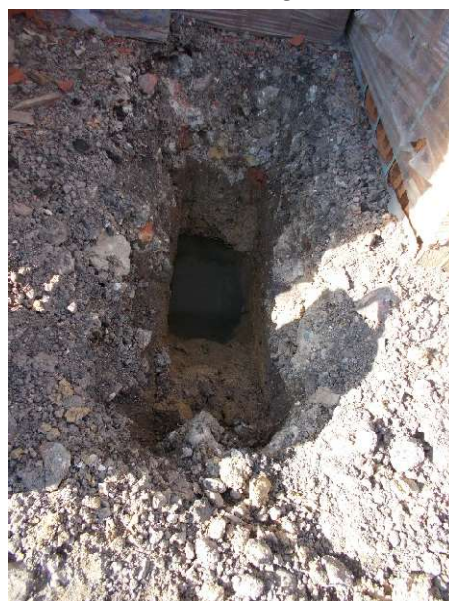
Trial Pit 3

- iii. Trial pit 3 was located on the northern redline boundary of the site, at the southern façade of the proposed northern warehouse. This trial pit revealed a layer of made ground over clayey subsoil within the

underlying strata; rainwater was present in the trial pit at the time of our sampling. Soil samples were taken from the made ground and subsoil at a depth of 0.7 m – 0.1 m.

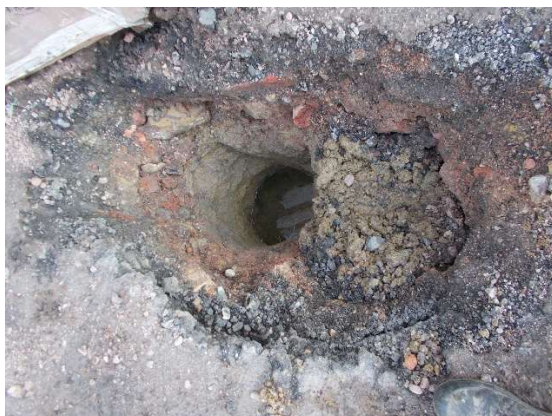
Trial Pit 4

- iv. Trial pit 4 was located on the northeast corner of the site, at the southern façade of the proposed northern warehouse. This trial pit revealed a layer of made ground containing broken bricks over clay subsoil, rainwater was present in the trial pit at the time of our sampling. Soil samples were taken from the made ground and subsoil at depths of 0.7 m and 0.1 m.

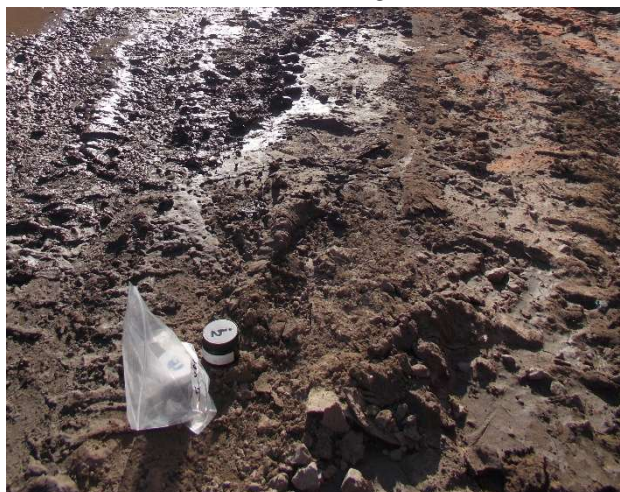
Trial Pit 5

- v. Trial pit 5 was located in the central area of the site, towards the western boundary, in the proposed parking area. This trial pit revealed a layer of made ground over clay subsoil. Soil samples were taken from the made ground at depths of 0.1 m.

- Levels of water-soluble Boron were very slightly exceeded in TP5 at 0.1 m with a recorded level of 1.5 mg/kg with a target level of 1 mg/kg.
- 6.6 There was significant exceedance in miscellaneous organics concentrations in trial pits 1, and 8 found in the 0.7 m deep, lower soil samples:

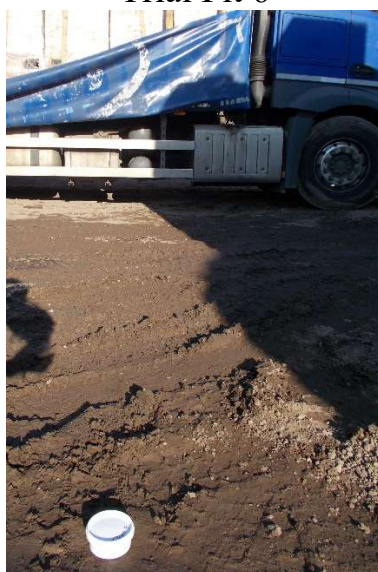
Trial Pit 6

- vi. Trial pit 6 was located in the central area of the site, towards the eastern boundary, in the proposed parking area. This trial pit revealed a layer of made ground over clay subsoil. Soil samples were taken from the made ground at depths of 0.1 m.

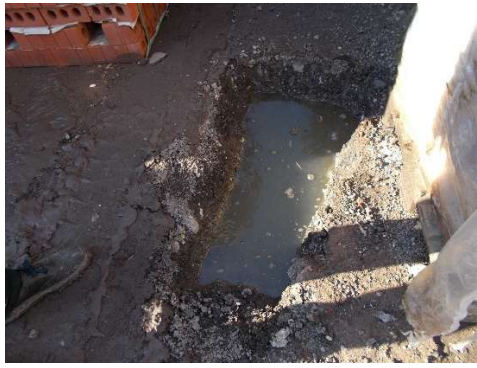
Trial Pit 7

- vii. Trial pit 7 was located in the centre of the site, in the proposed car parking area. This trial pit revealed a layer of made ground over clay subsoil; rainwater was present in the pit during our sampling. Soil samples were taken from the made ground and subsoil at depths of 0.7 m and 0.1 m.

- Levels of petroleum ether extractable matter were very significantly exceeded in TP1, TP2, TP3, TP4, TP5, TP6 and TP7 at 0.1 m, with recorded levels ranging from 7900 – 19000 with a target level of 400 mg/kg, the highest recorded exceedance being in TP7.

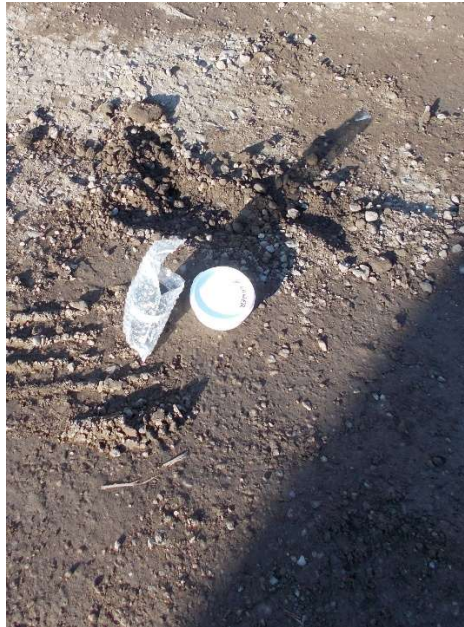
Trial Pit 8

- viii. Trial pit 8 was located in the southeast corner of the site, adjacent to the entrance driveway. This trial pit revealed a layer of made ground over clay subsoil. Soil samples were taken from the made ground at depths 0.1 m.

- Levels of water-soluble Boron were very slightly exceeded in TP8 at 0.7 m with a recorded level of 1.1 mg/kg with a target level of 0.9 mg/kg.
- There was also a very small exceedance in the levels of heavy metal concentrations found in the 0.1 m deep, upper sample from trial pit 5:
