**Brookleigh Eastern Primary School,  
Brookleigh, Burgess Hill**

**Reserved Matters Application**

**Land Quality Statement**

**Homes  
England**

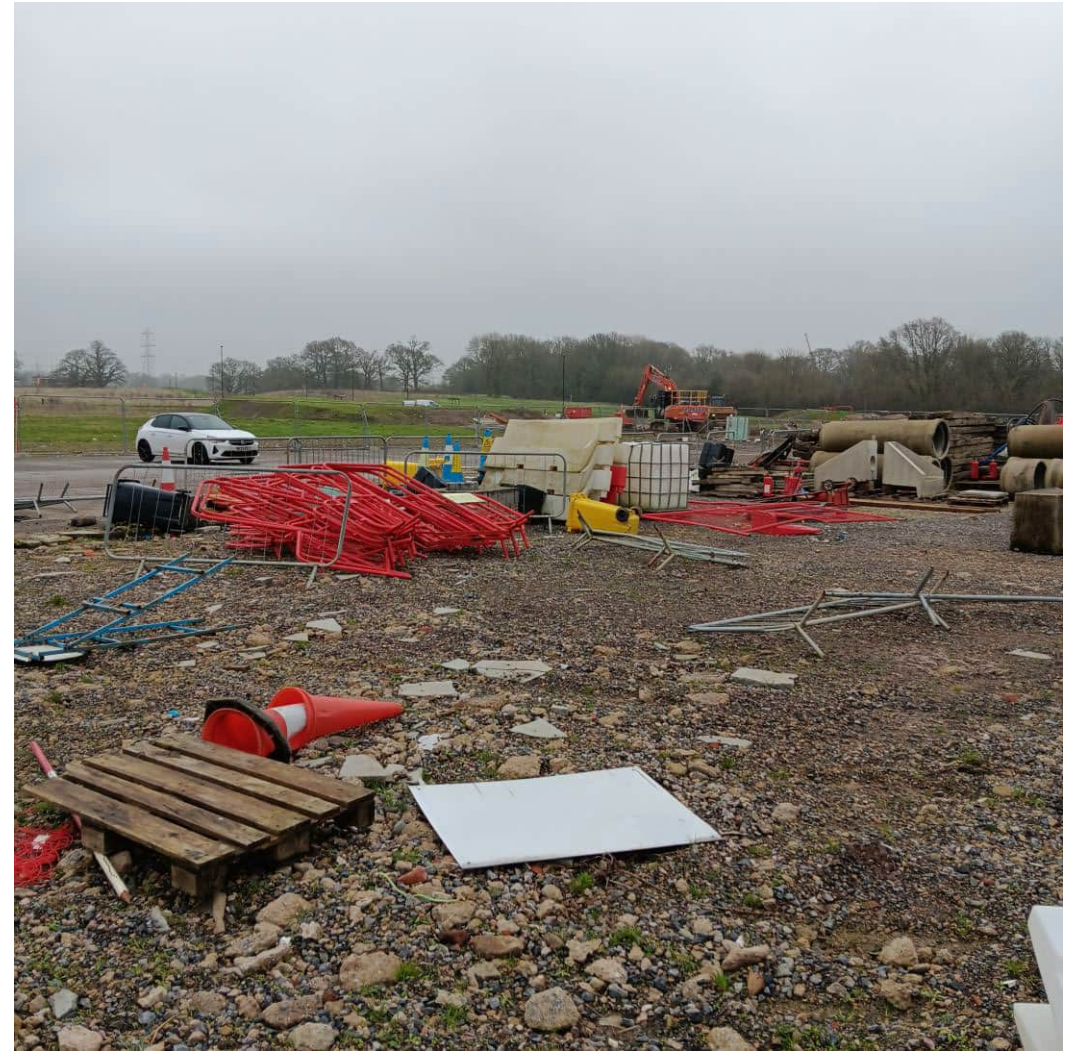
Photograph 2: Site compound area

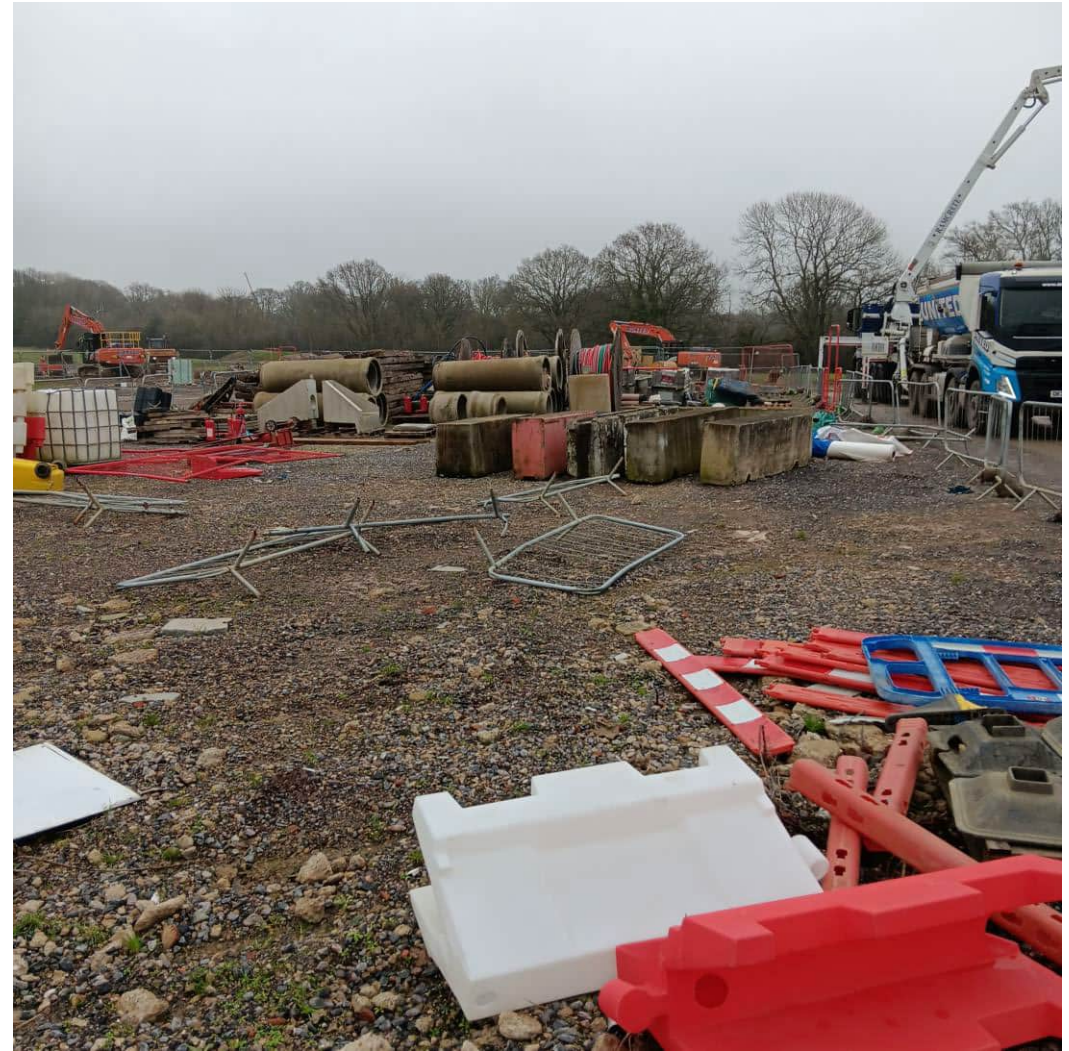
Photograph 4: Materials Storage in compound area
