| Dwg No. | 25041B-P-132 A |
| Drawing Title | Proposed roof plan |
| Address | Wykehurst House |

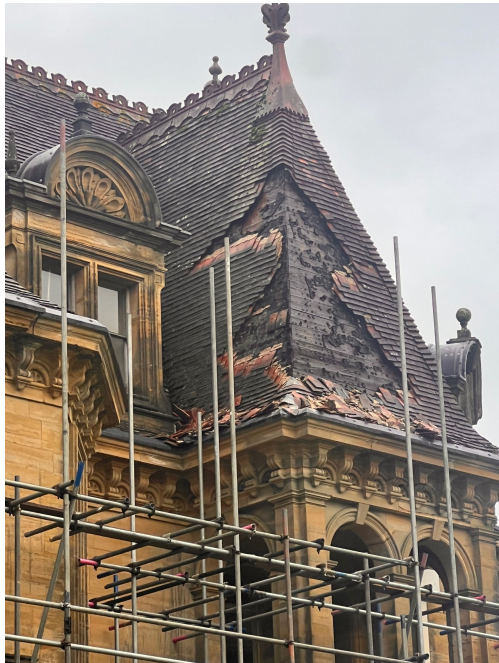
Damaged roof prior to repair

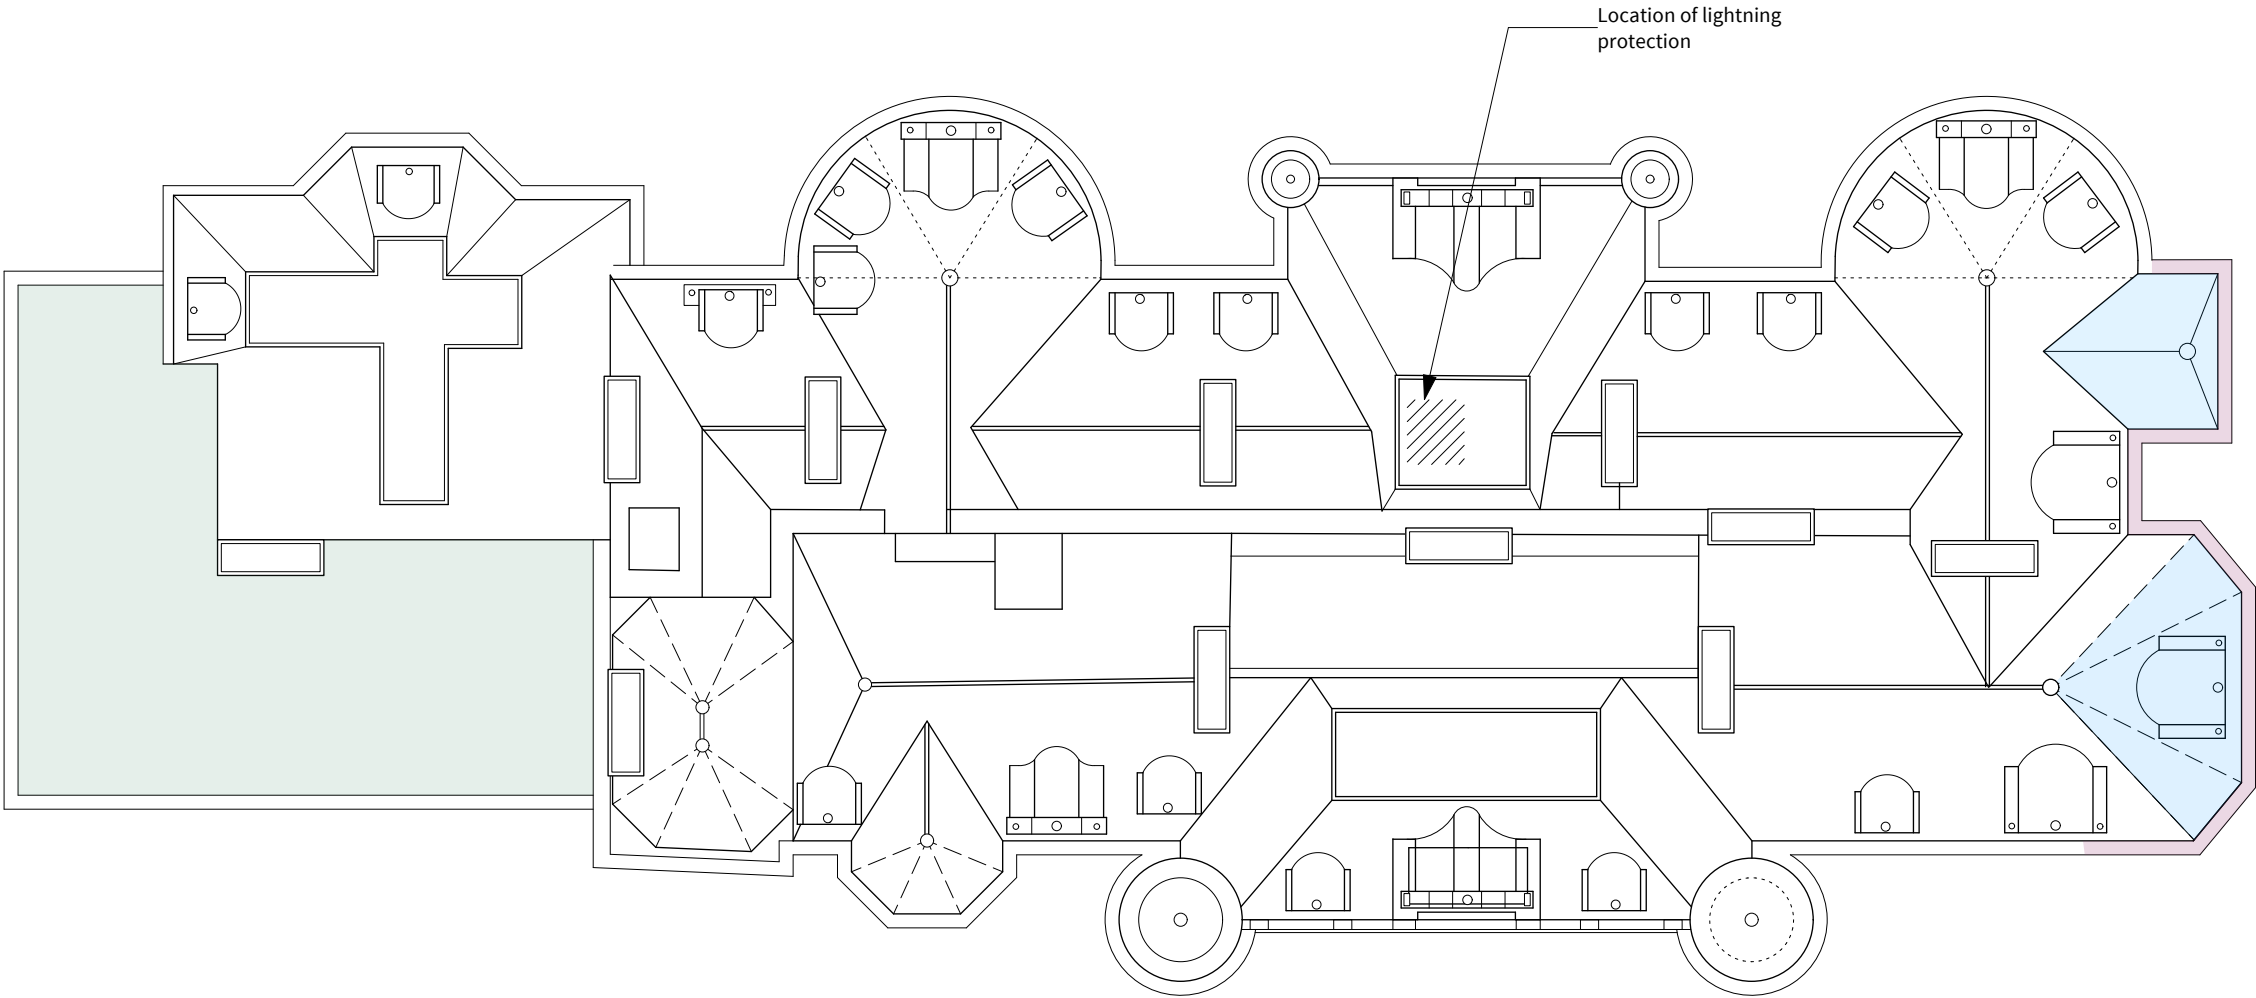
- Damaged areas of existing pitched roof re tiled in red clay tiles to match the existing.
- Modern felt roof being replaced
- Leadwork gutters being repaired as per details

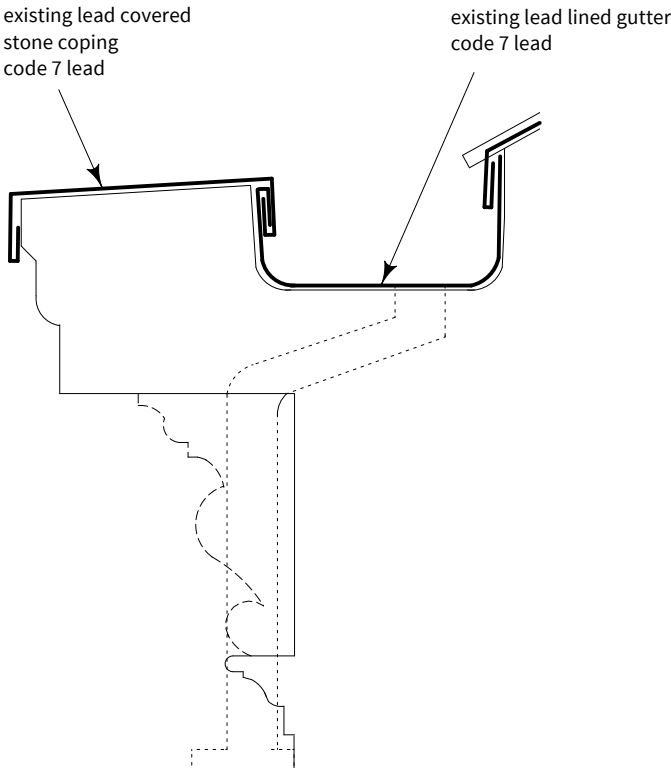
Stone coping-lead gutter detail as existing
