## JOB DETAILS

| Site Address:<br>C488 - Burgess Hill<br>Freeks Farm Landfill<br>Off Freeks Lane<br>Burgess Hill<br>RH15 8DJ | Location of Works:<br>Phase 2 site perimeter. |
| Nature of Works:<br>Reassurance air monitoring during site remediation works. | |

## DETERMINATION OF AIRBORNE FIBRE CONCENTRATION

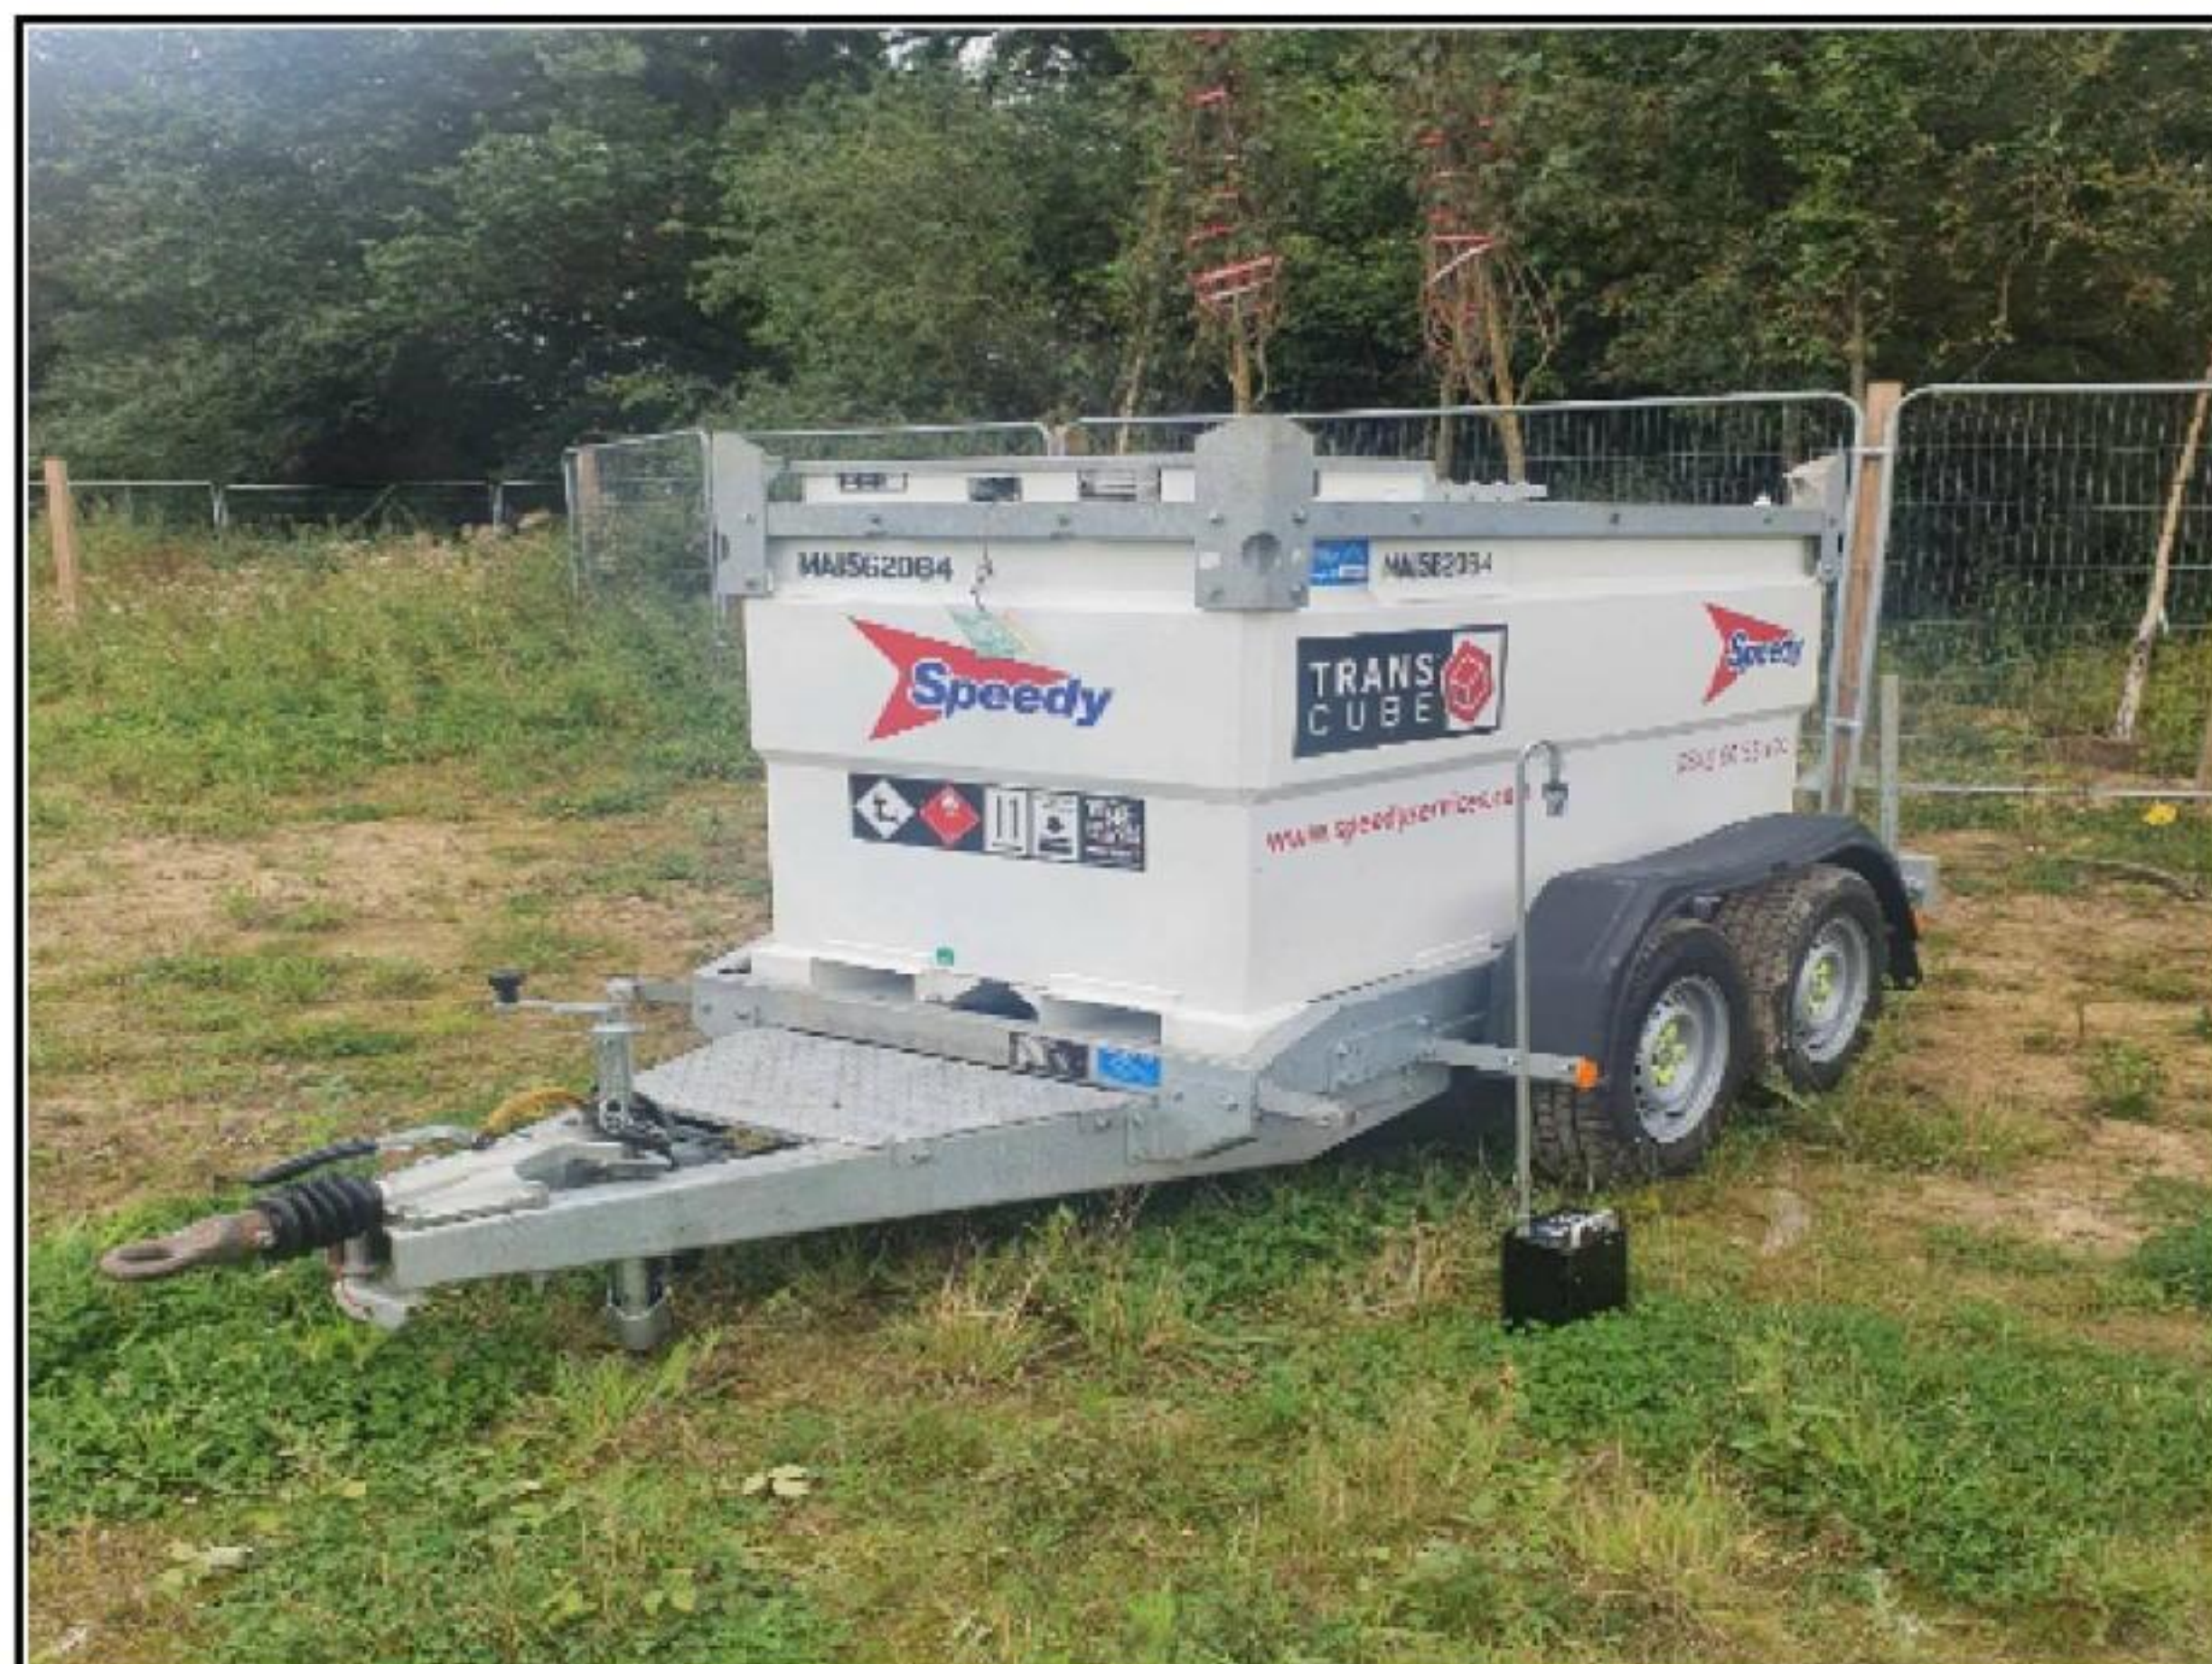
Photograph No.5163 –  
Reassurance air sampling on the South East perimeter monitoring point.

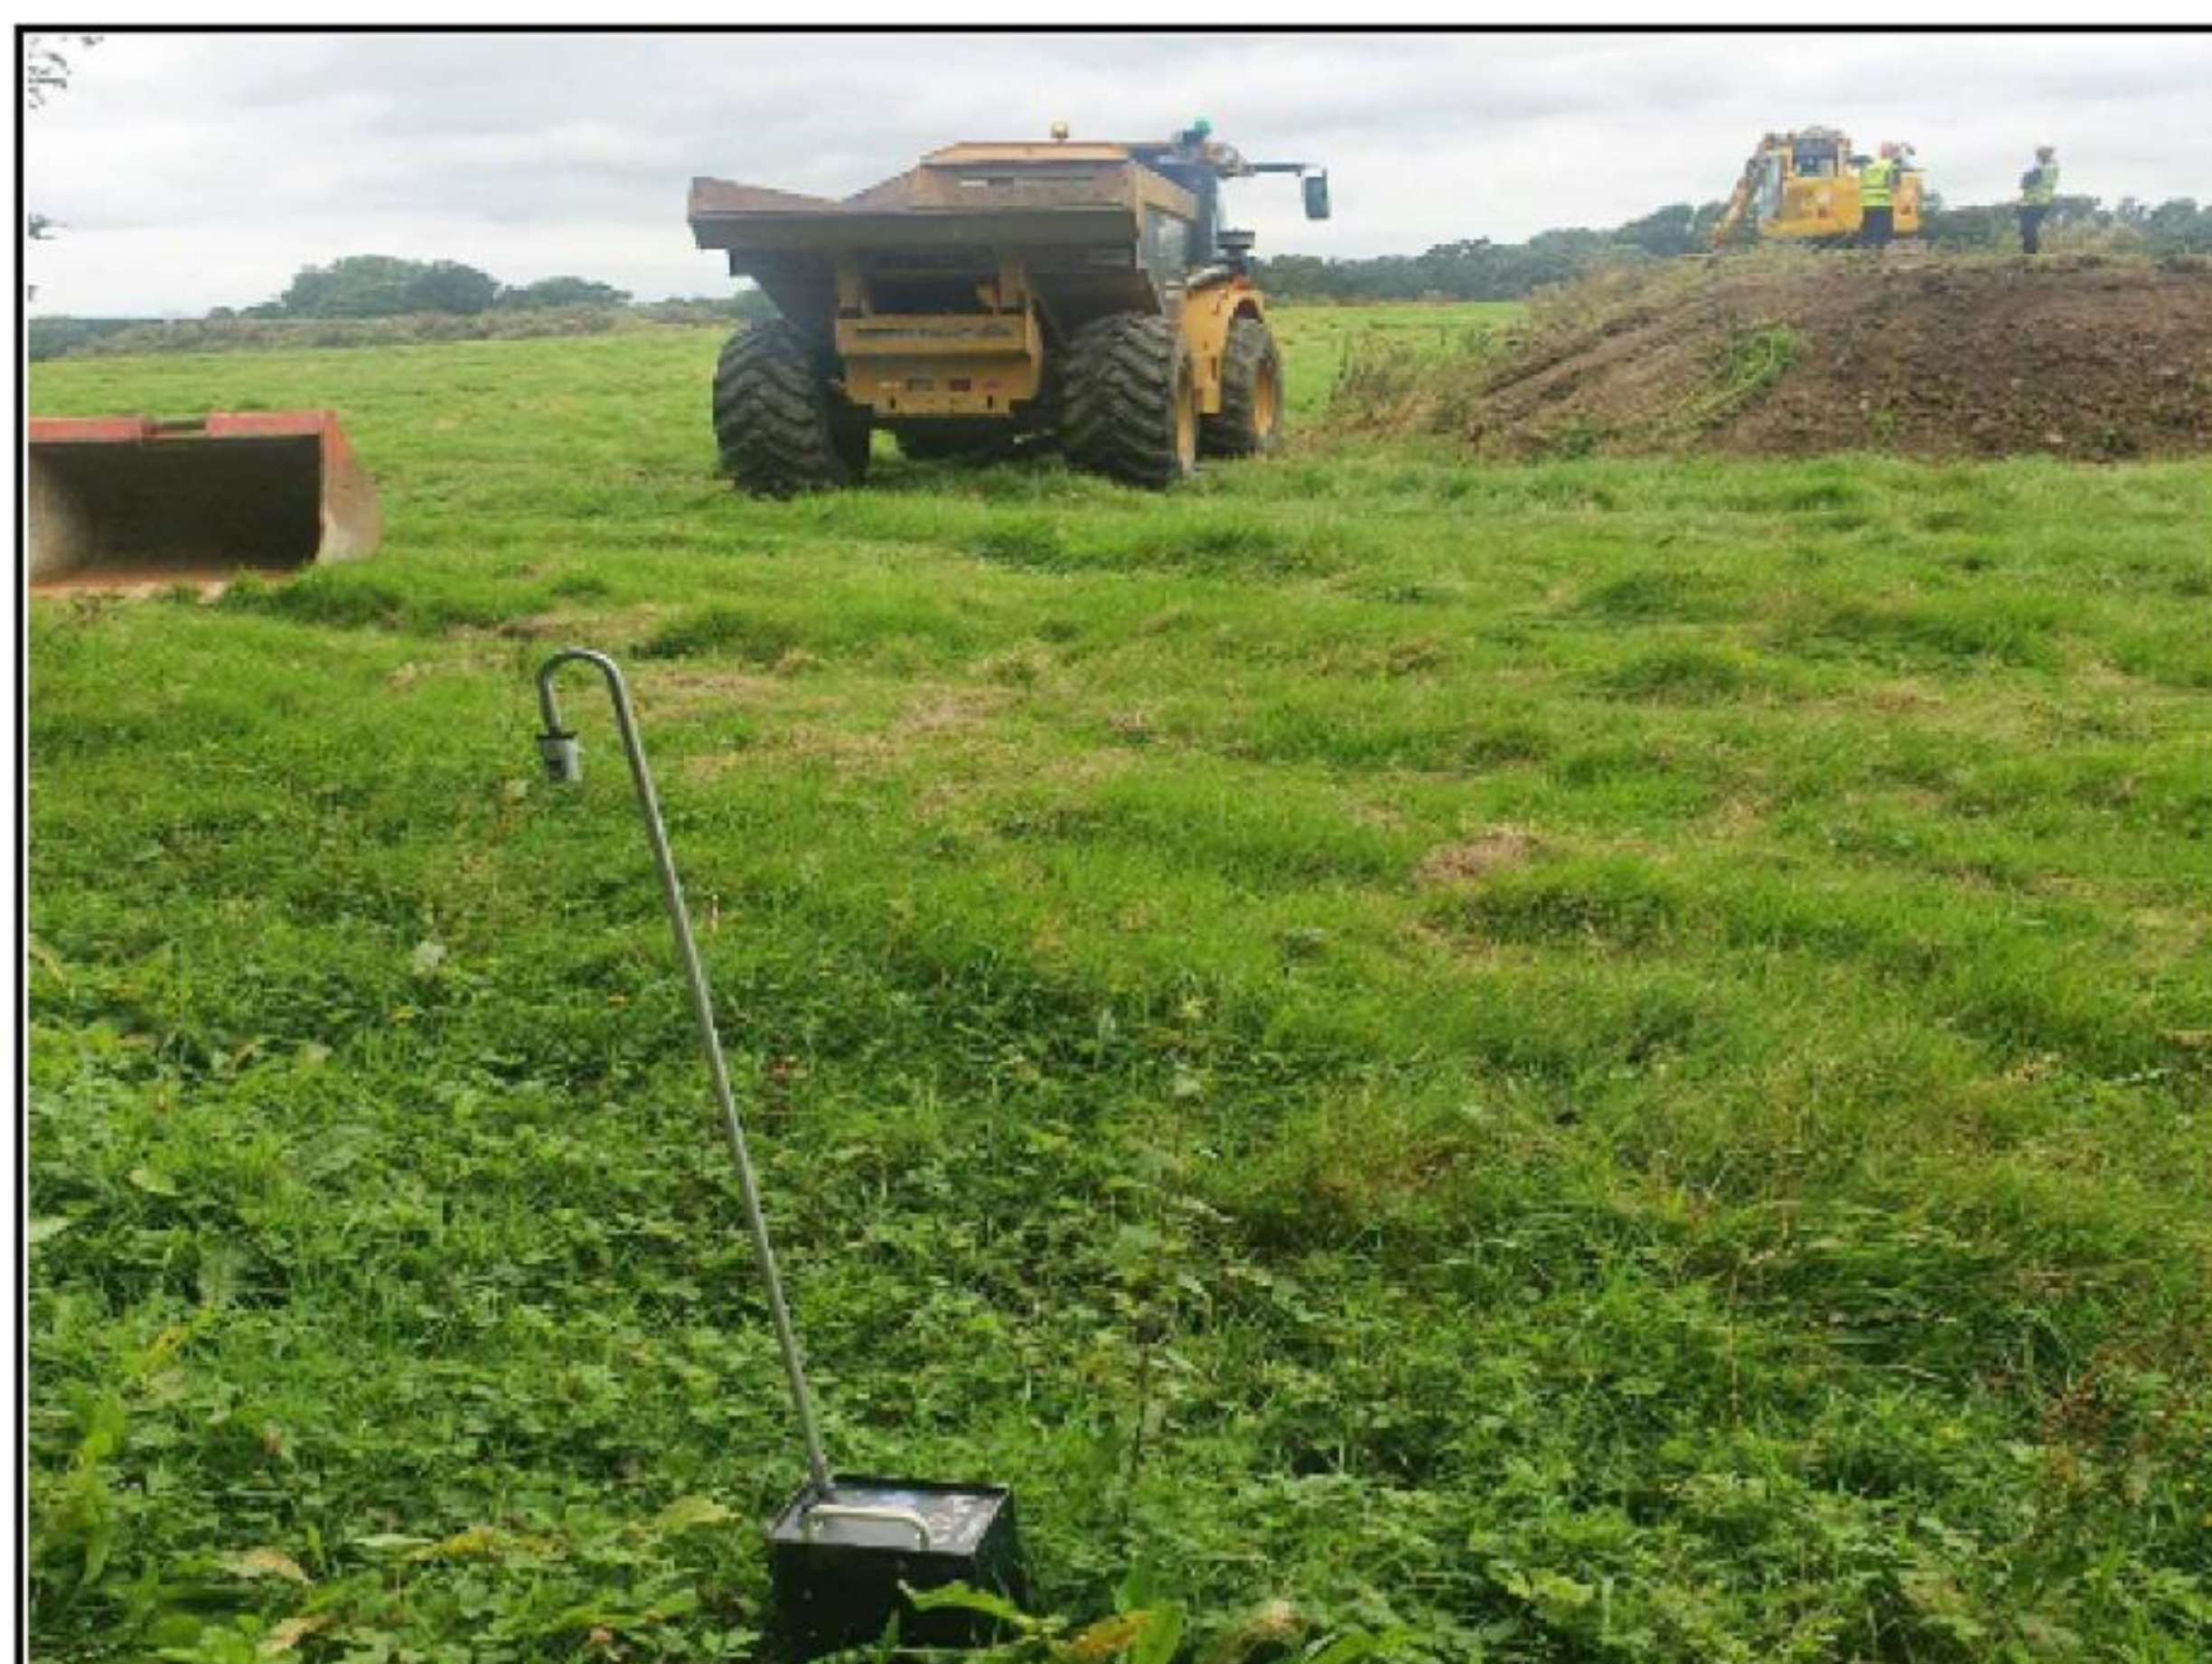
Photograph No.5164 –  
Reassurance air sampling on the North East perimeter monitoring point.

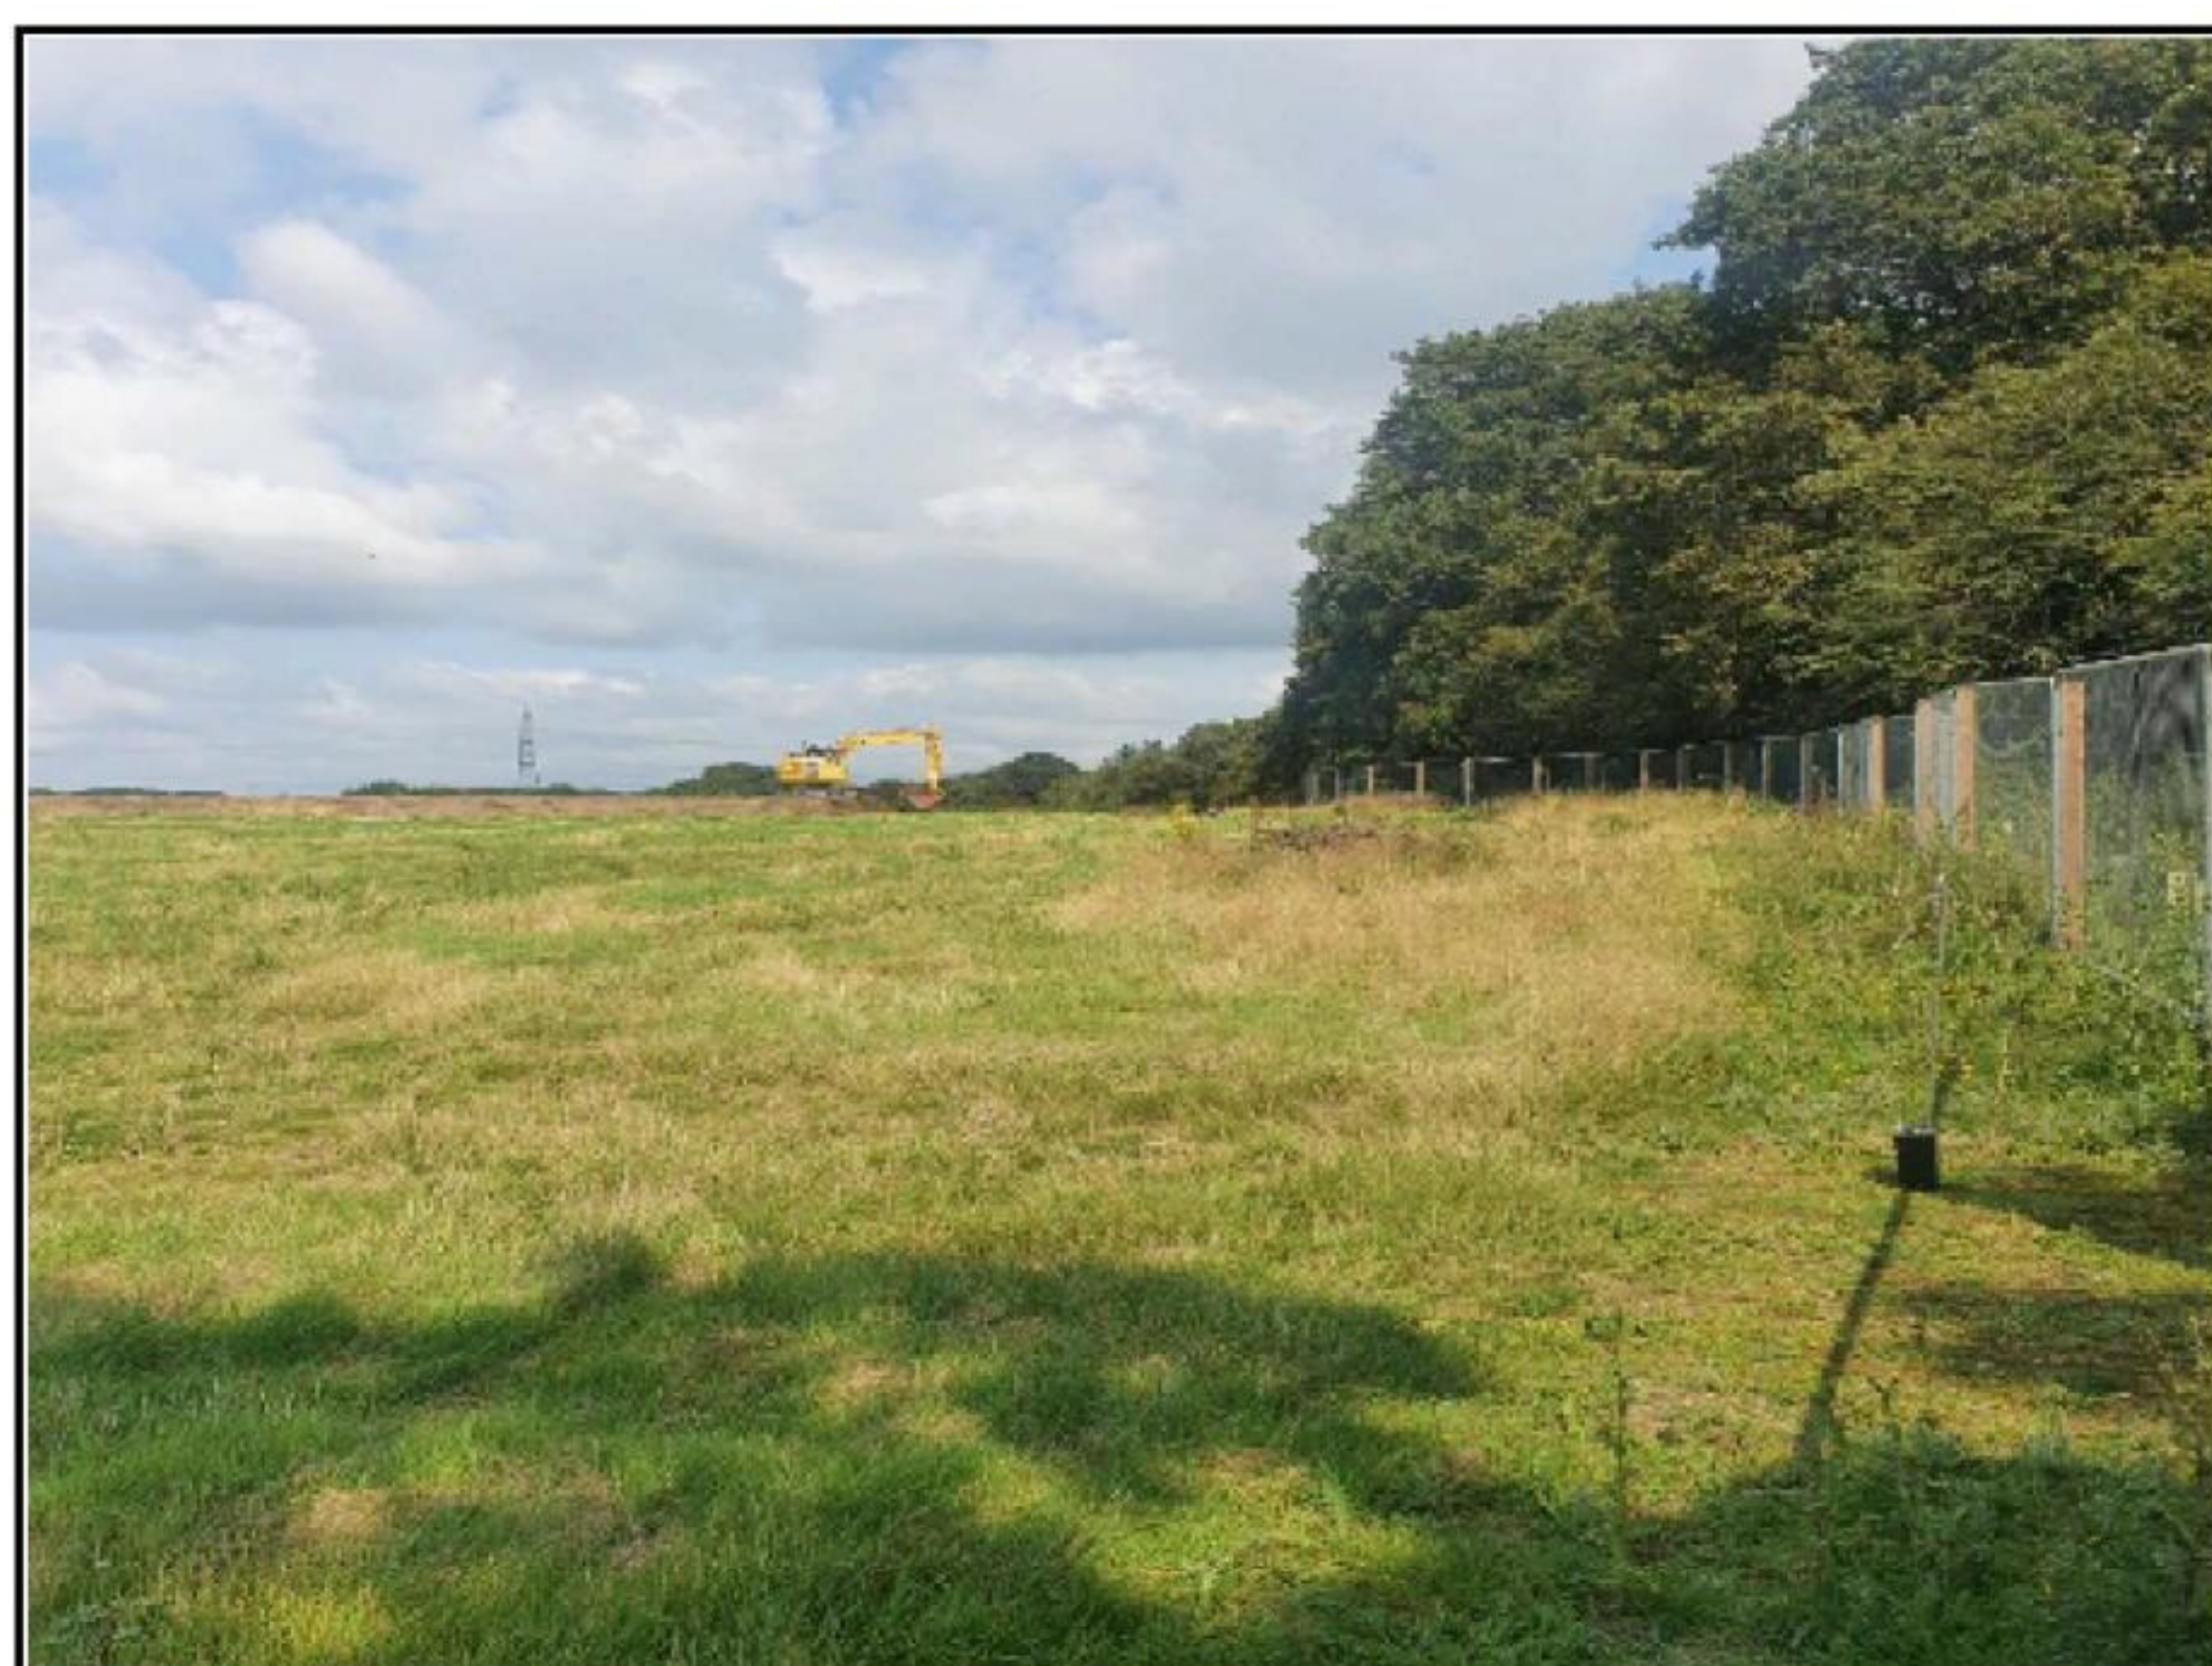
Photograph No.5165 –  
Reassurance air sampling on the East perimeter monitoring point.

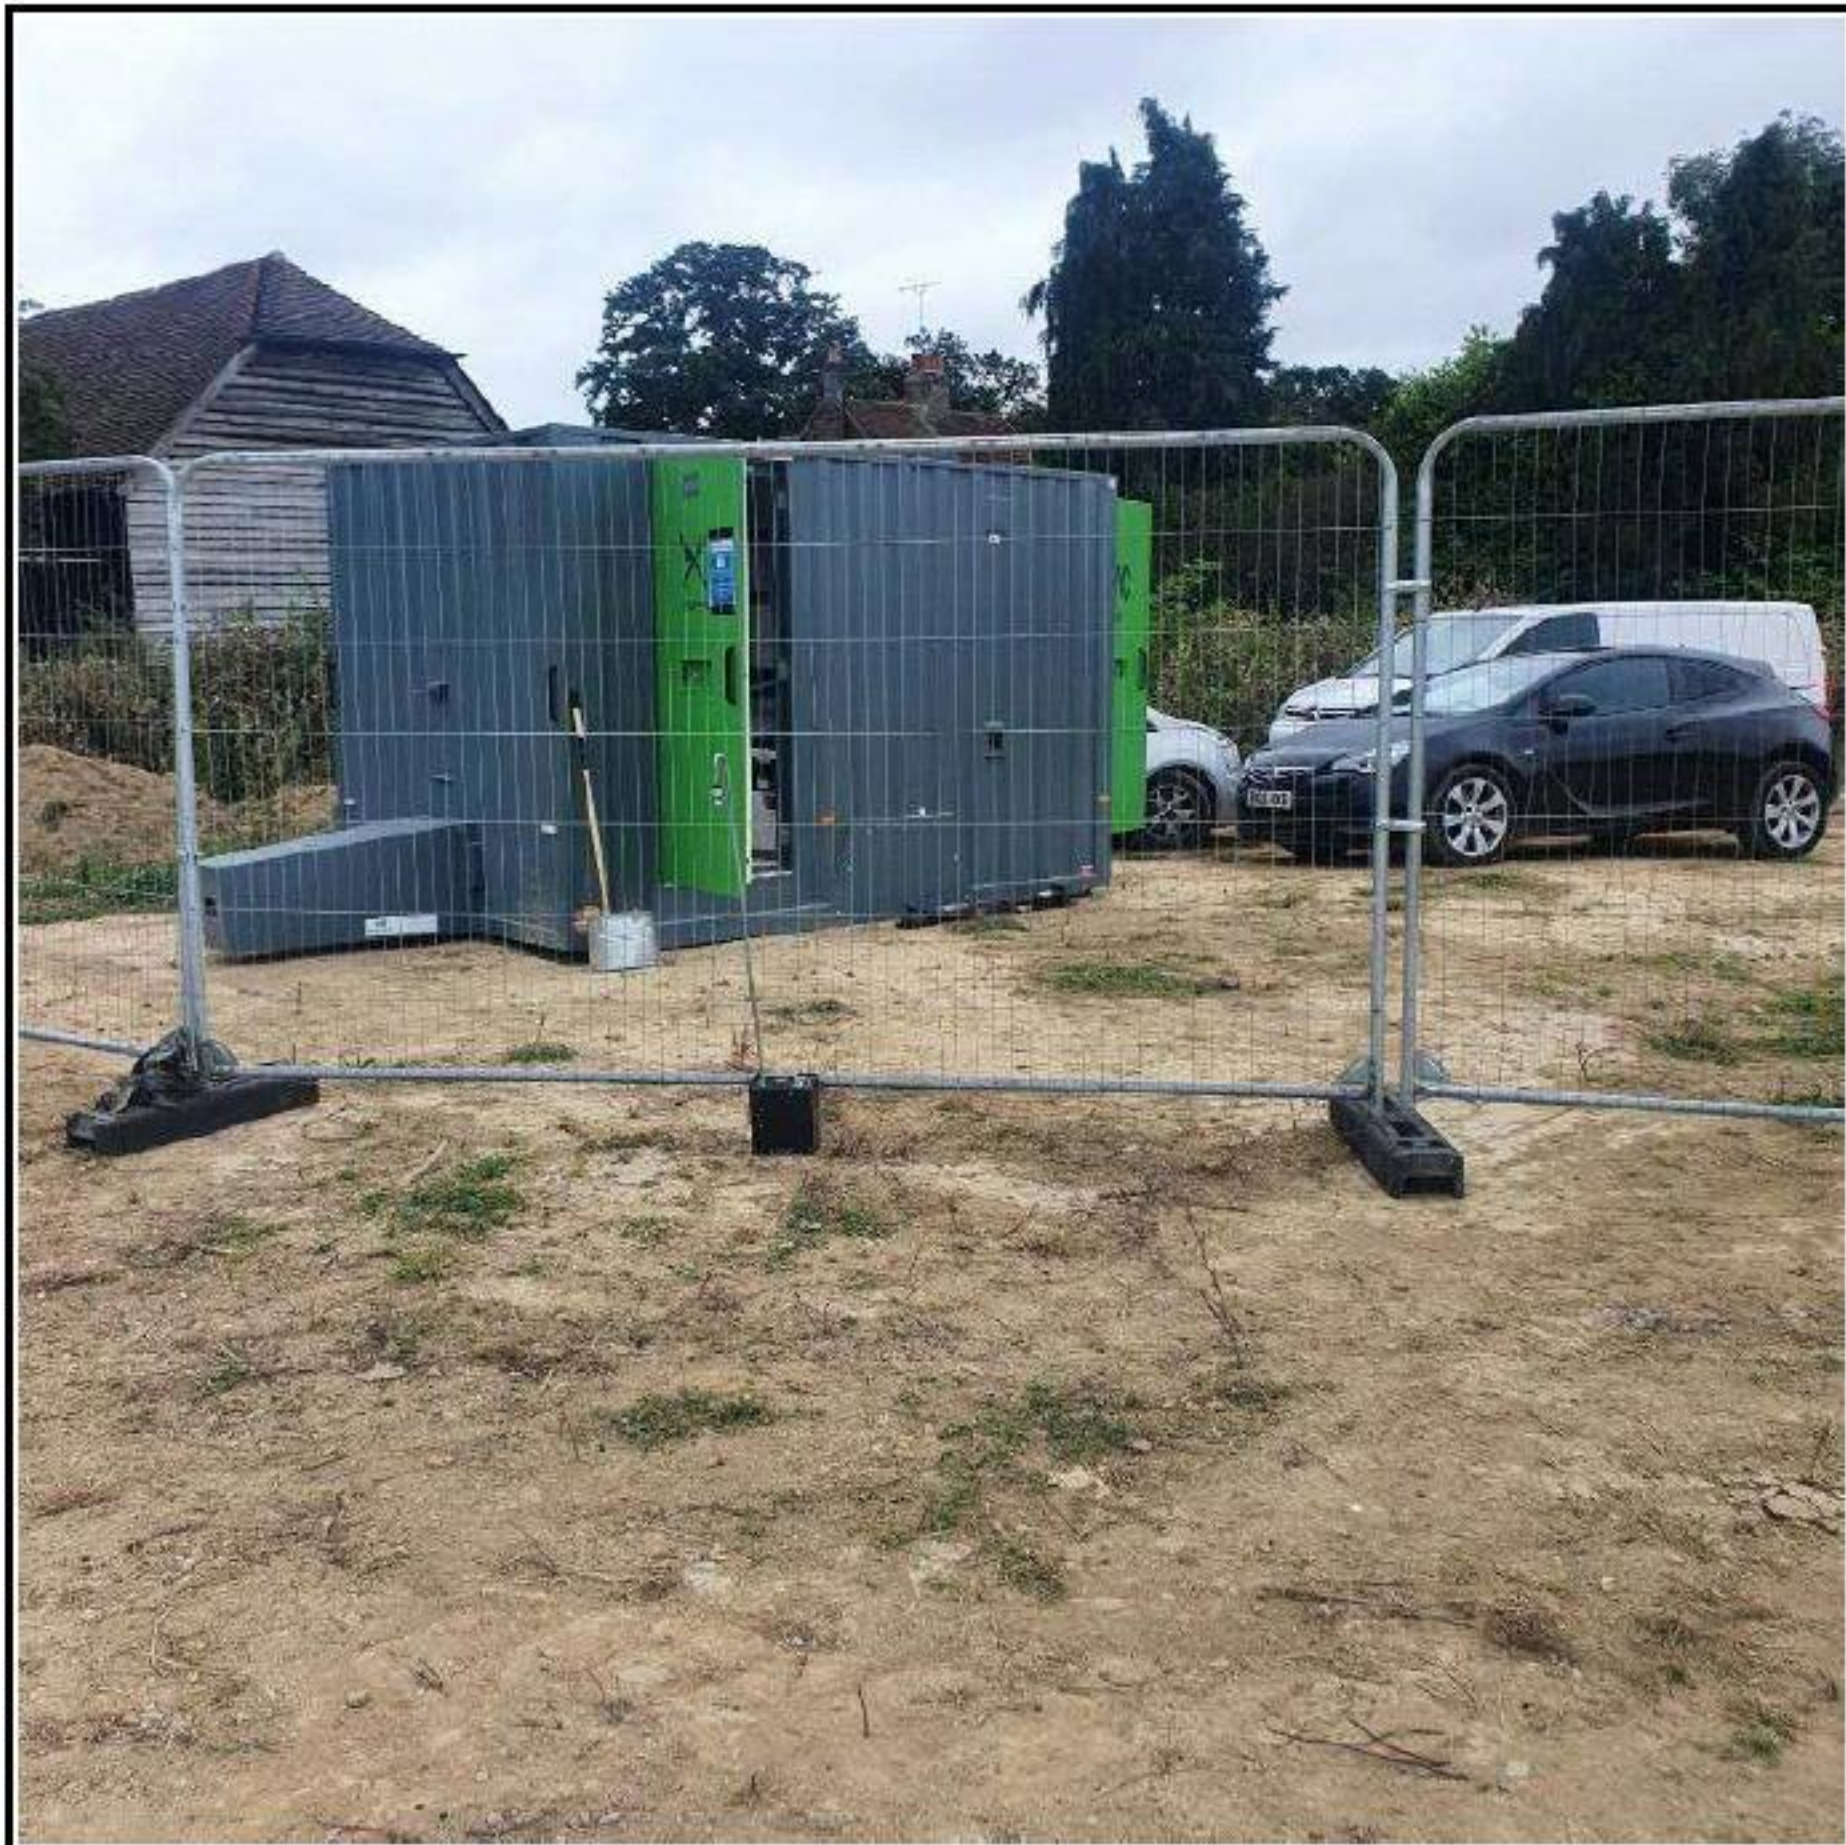
| Pump No. | Head No. | Field Reference | Sample Location | Start | | End | | Mean Flow (litres/min) | Total Test Duration (mins) | Total Volume (litres) | Fibres | Fields | Limit of Quantification (fibres/ml) | Fibre Concentration (fibres/ml) |
|---|---|---|---|---|---|---|---|---|---|---|---|---|---|---|
| 041 | MP01 | BM005480 | South East perimeter. | 09:35 | 8.3 | 11:37 | 8.3 | 8.30 | 122 | 1013 | 3.5 | 200 | 0.005 | < 0.005 |

Photograph No.404384 –  
Reassurance air sampling on the South East perimeter of site  
adjacent the site office.

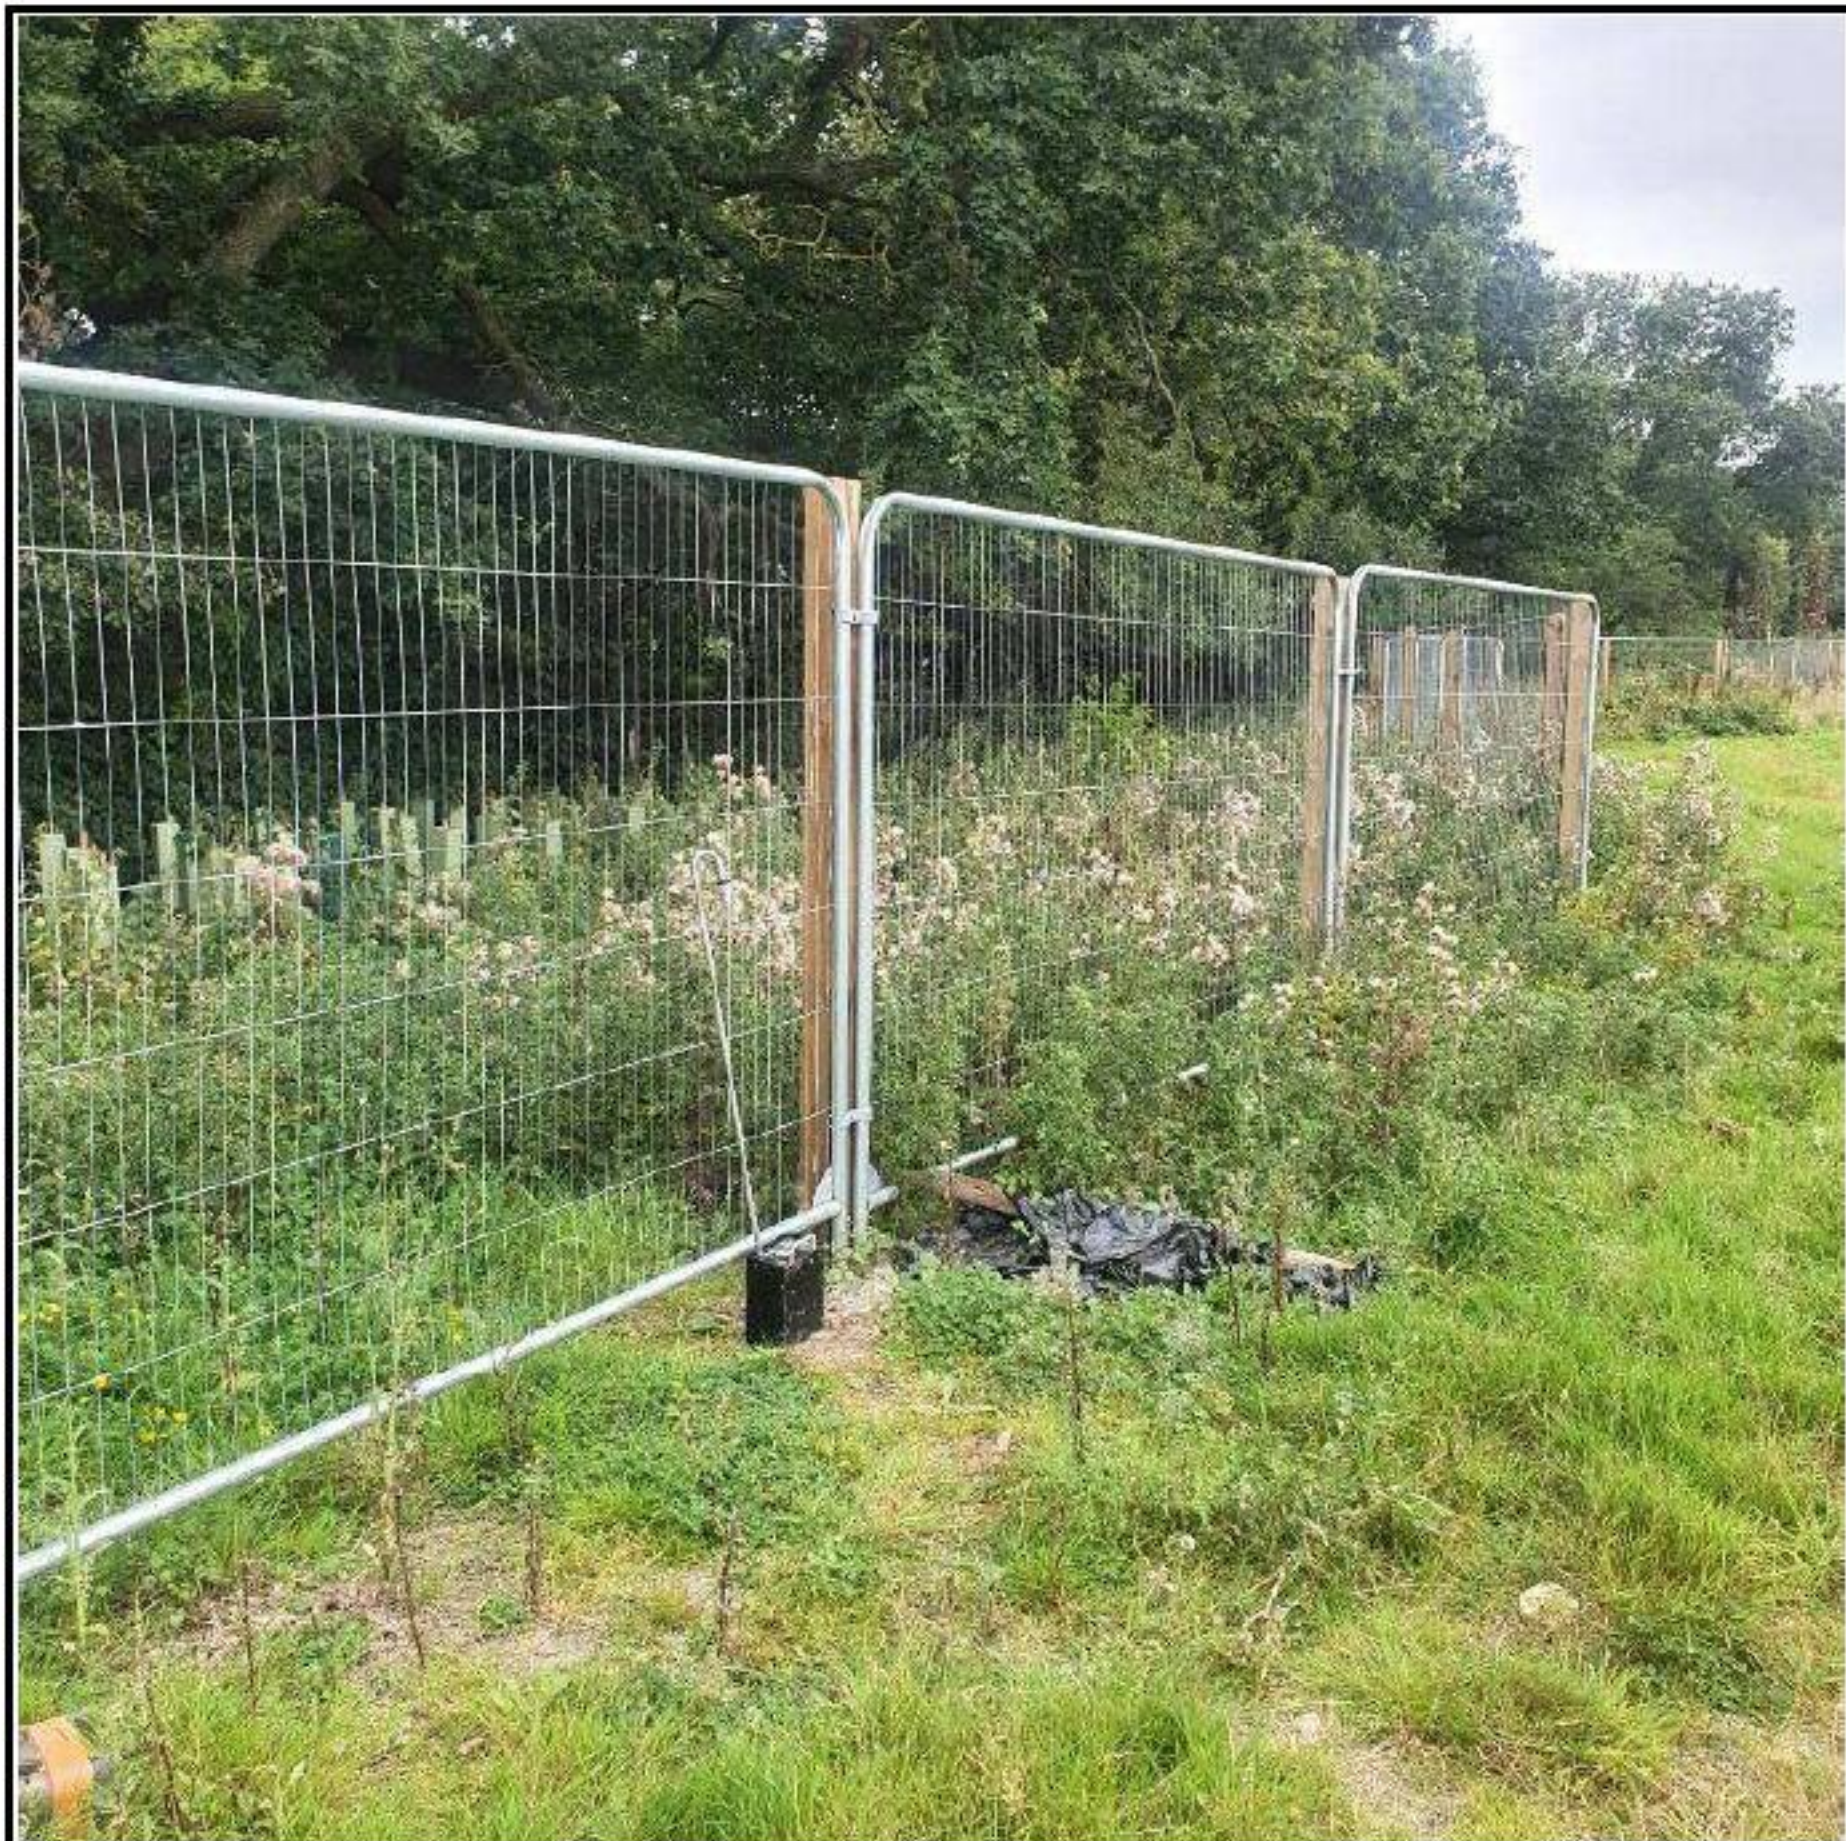
| Pump No. | Head No. | Field Reference | Sample Location | Start | | End | | Mean Flow (litres/min) | Total Test Duration (mins) | Total Volume (litres) | Fibres | Fields | Limit of Quantification (fibres/ml) | Fibre Concentration (fibres/ml) |
|---|---|---|---|---|---|---|---|---|---|---|---|---|---|---|
| 19 | MP02 | BM005481 | East perimeter | 09:37 | 8.2 | 11:38 | 8.1 | 8.15 | 121 | 986 | 6.0 | 200 | 0.005 | < 0.005 |

Photograph No.404385 –  
Reassurance air sampling on the East perimeter of site.

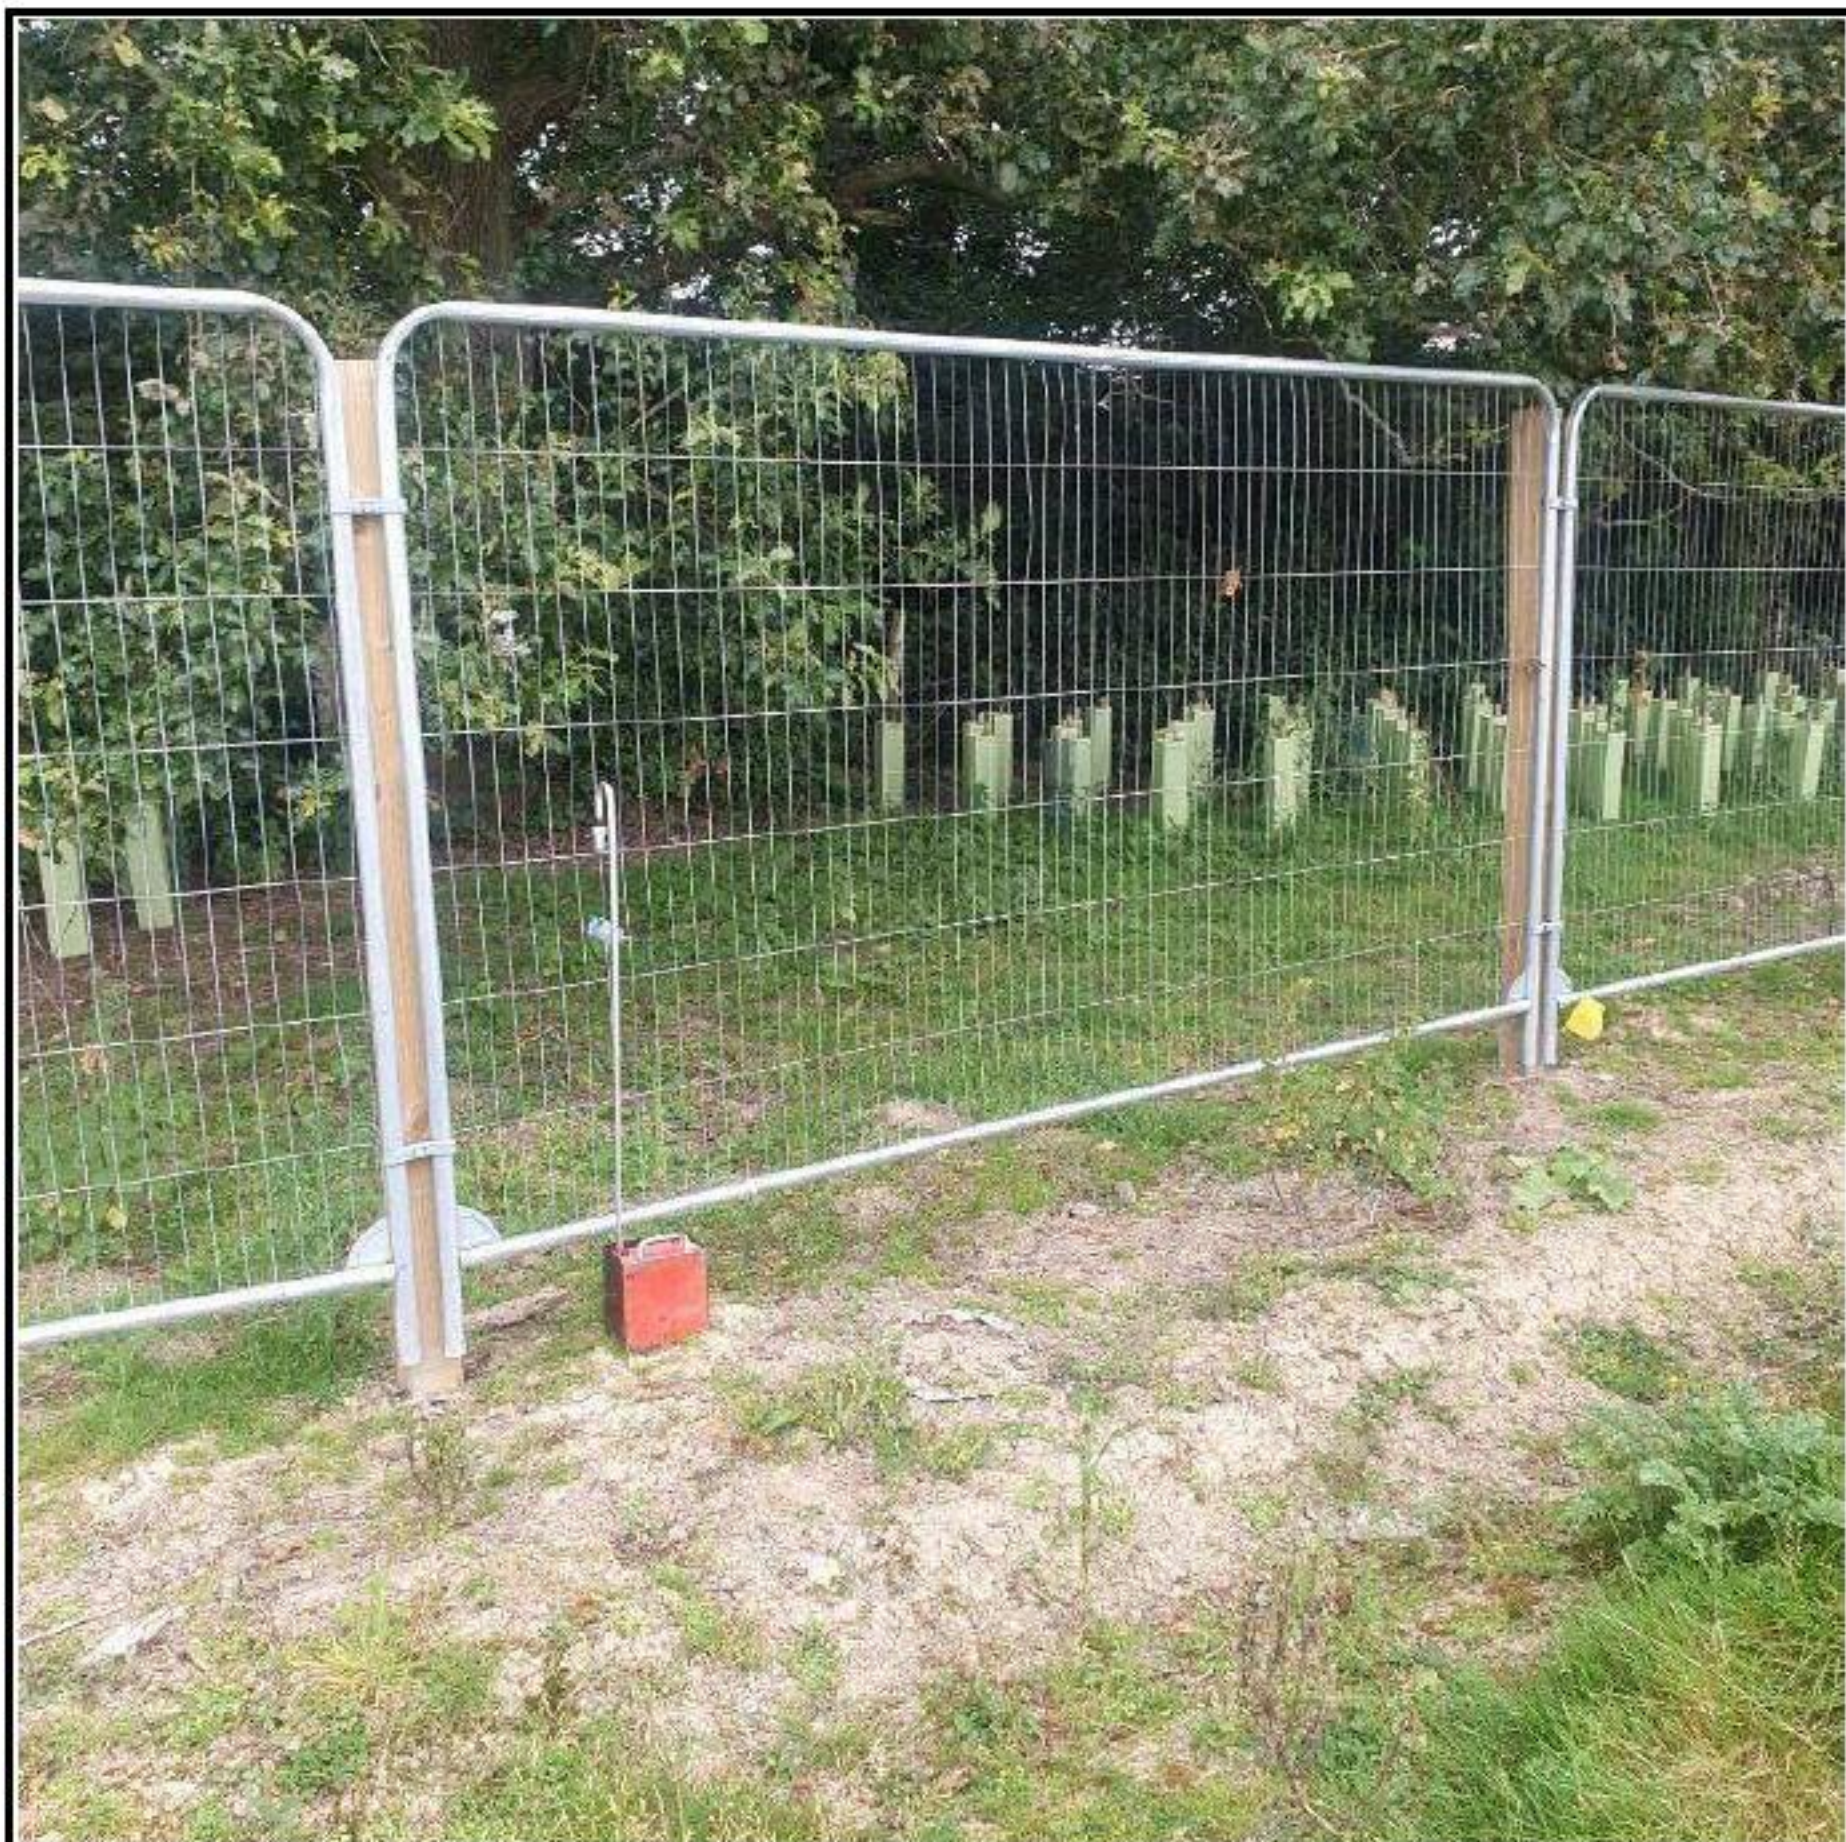
| Pump No. | Head No. | Field Reference | Sample Location | Start | | End | | Mean Flow (litres/min) | Total Test Duration (mins) | Total Volume (litres) | Fibres | Fields | Limit of Quantification (fibres/ml) | Fibre Concentration (fibres/ml) |
|---|---|---|---|---|---|---|---|---|---|---|---|---|---|---|
| 47 | MP03 | BM005482 | North East perimeter | 09:38 | 8.1 | 11:38 | 8.1 | 8.10 | 120 | 972 | 1.0 | 200 | 0.005 | < 0.005 |

Photograph No.404386 –  
Reassurance air sampling on the North East perimeter of site  
adjacent the site office.
