## JOB DETAILS

| Site Address:<br>C488 - Burgess Hill<br>Freeks Farm Landfill<br>Off Freeks Lane<br>Burgess Hill<br>RH15 8DJ | Location of Works:<br>Phase 2 site perimeter. |
| Nature of Works:<br>Reassurance air monitoring during site remediation works. | |

## DETERMINATION OF AIRBORNE FIBRE CONCENTRATION

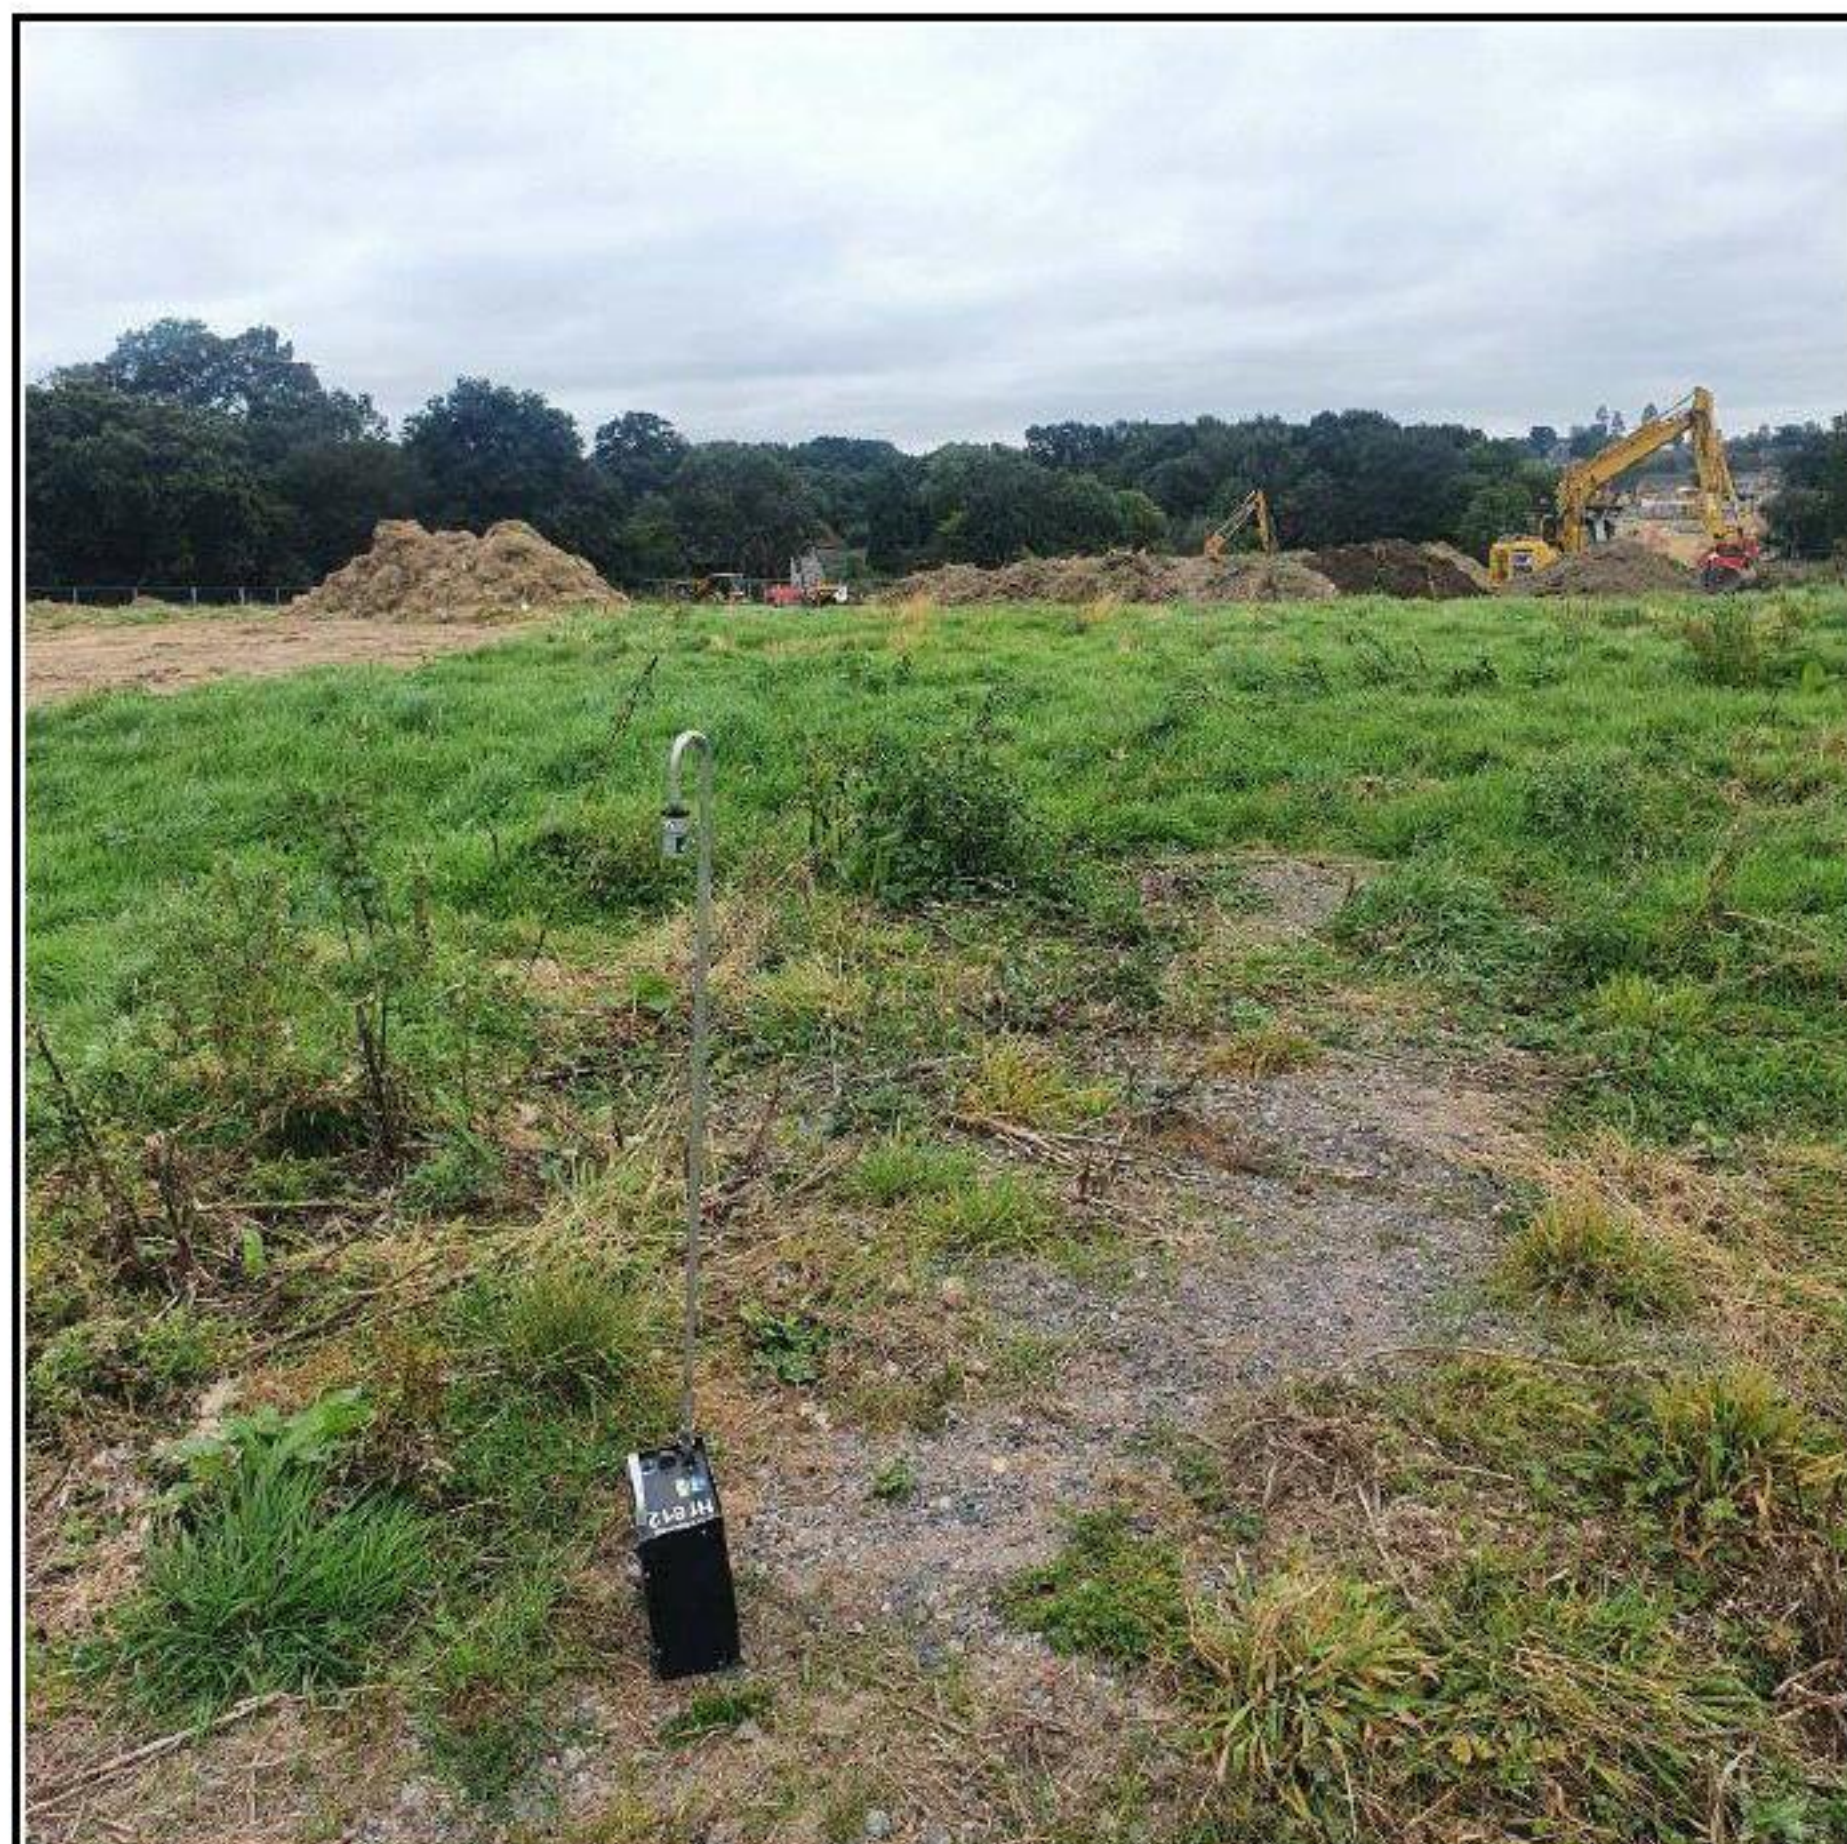
| Pump No. | Head No. | Field Reference | Sample Location | Start | | End | | Mean Flow (litres/min) | Total Test Duration (mins) | Total Volume (litres) | Fibres | Fields | Limit of Quantification (fibres/ml) | Fibre Concentration (fibres/ml) |
|---|---|---|---|---|---|---|---|---|---|---|---|---|---|---|
| 325 | MP03 | BM005483 | North West perimeter. | 09:39 | 8.3 | 11:39 | 8.1 | 8.20 | 120 | 984 | 4.5 | 200 | 0.005 | < 0.005 |

Photograph No.404387 –  
Reassurance air sampling on the North West perimeter of site  
adjacent the site office.

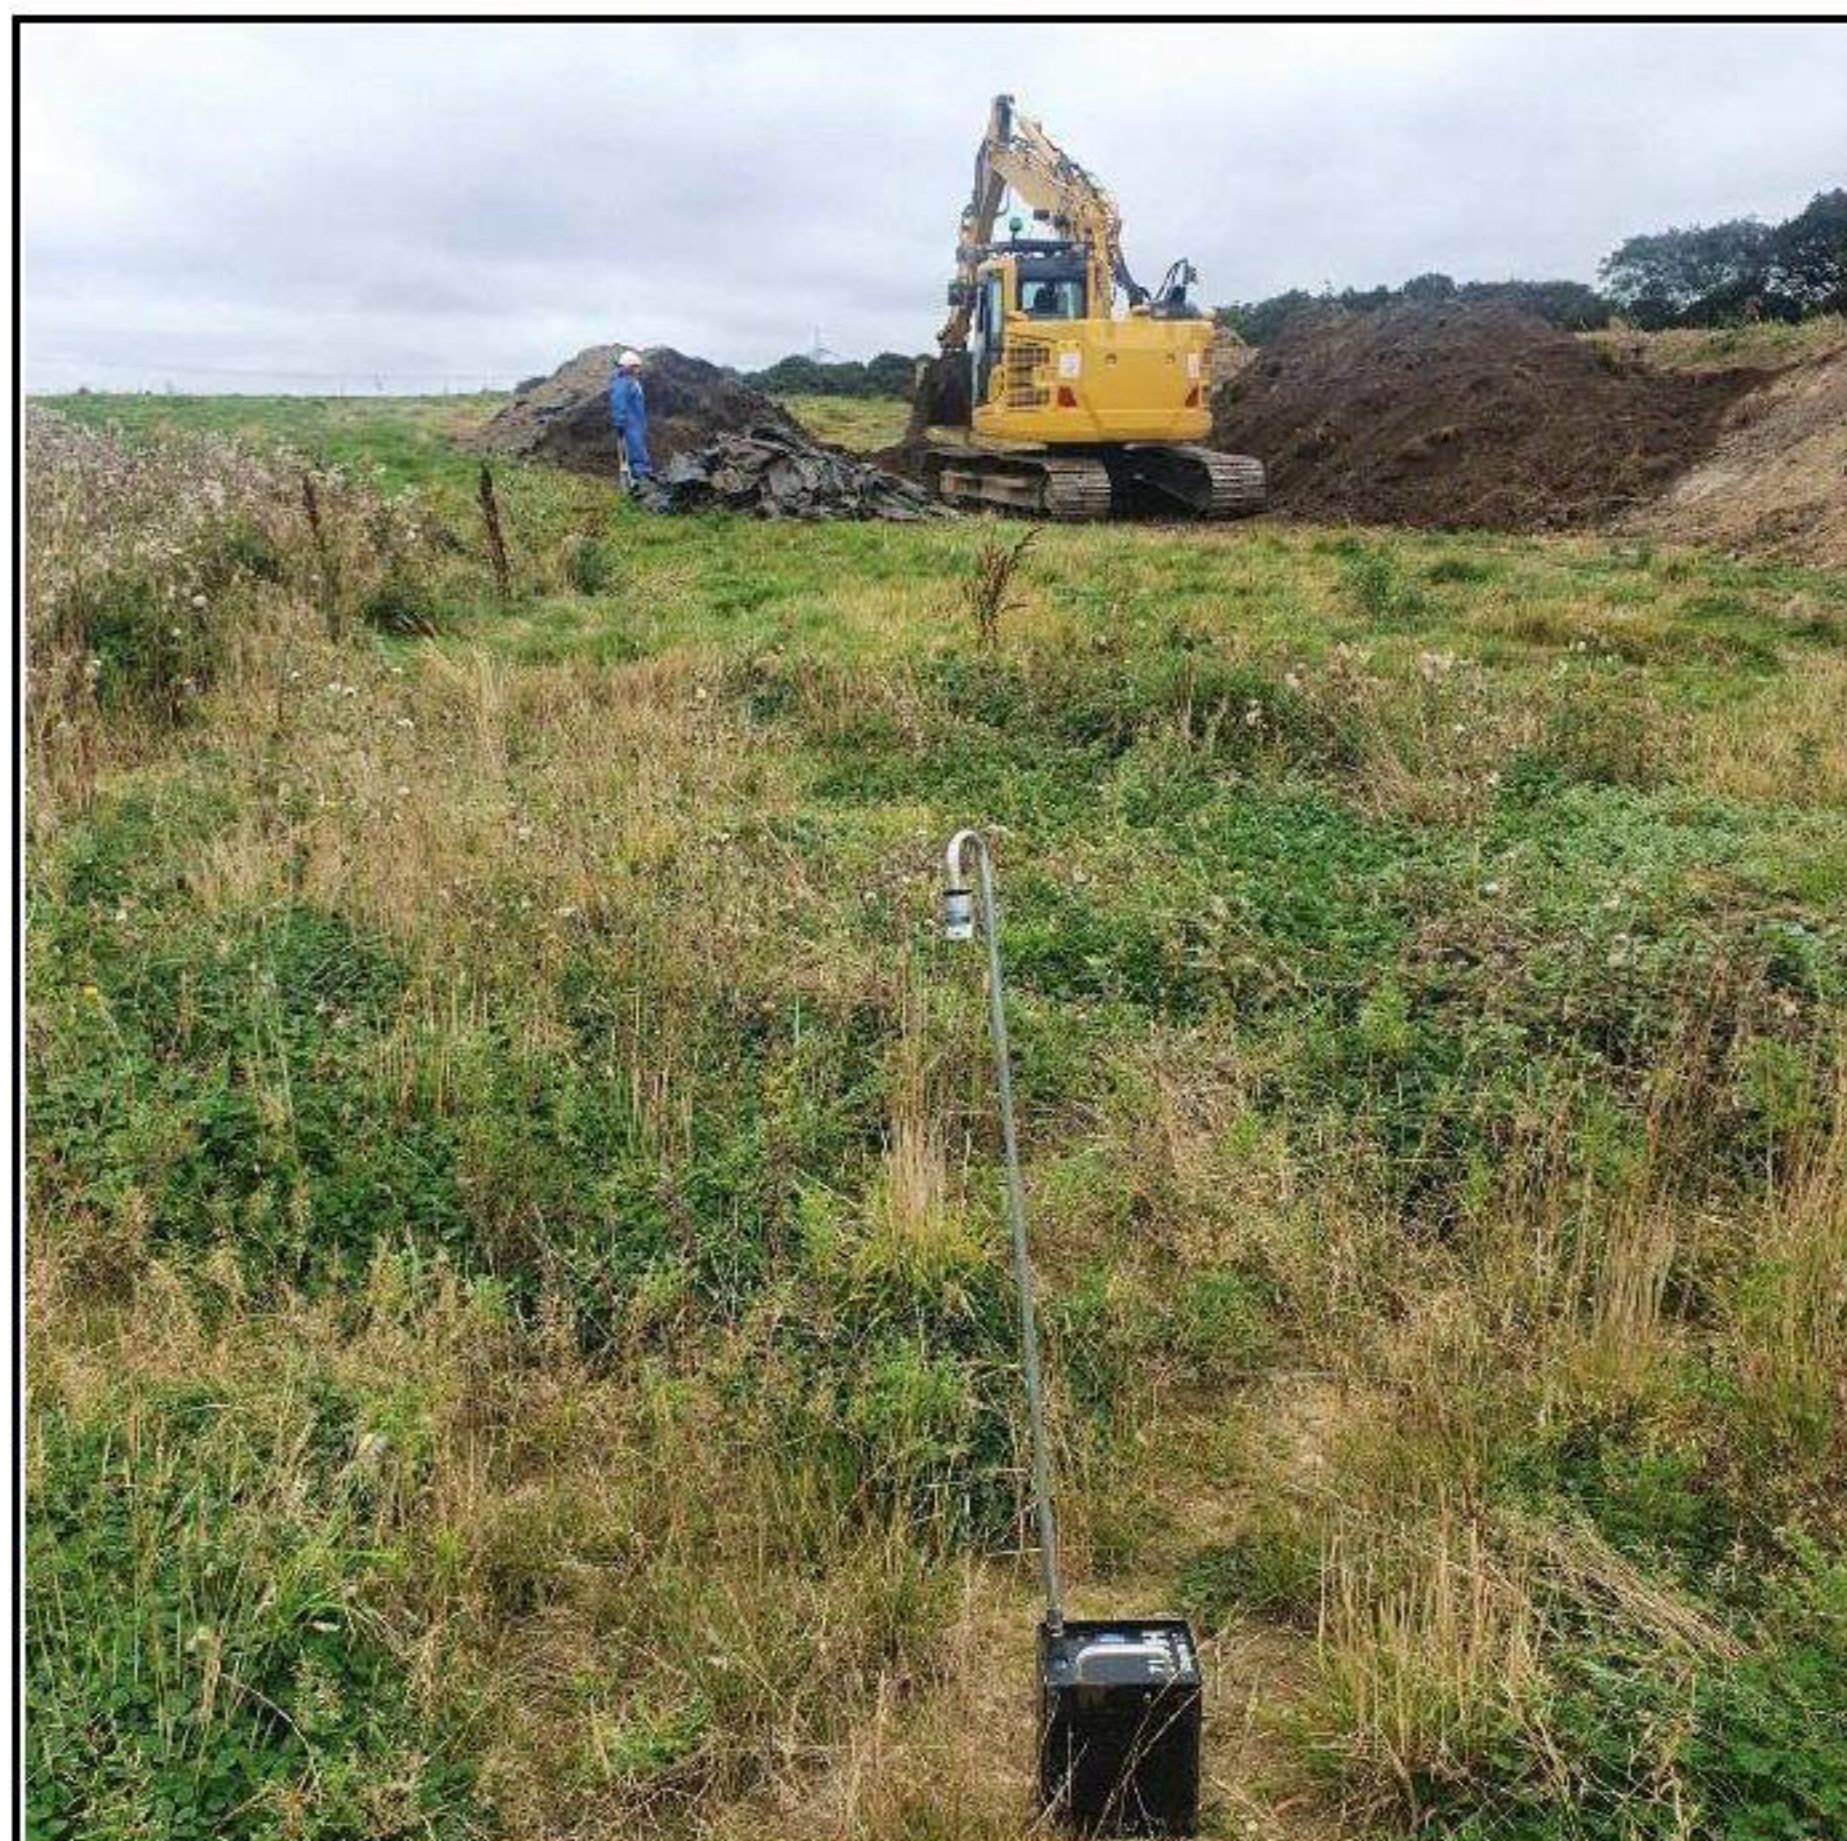
| Pump No. | Head No. | Field Reference | Sample Location | Start | | End | | Mean Flow (litres/min) | Total Test Duration (mins) | Total Volume (litres) | Fibres | Fields | Limit of Quantification (fibres/ml) | Fibre Concentration (fibres/ml) |
|---|---|---|---|---|---|---|---|---|---|---|---|---|---|---|
| 326 | MP05 | BM005484 | West perimeter | 09:41 | 8.1 | 11:41 | 8.1 | 8.10 | 120 | 972 | 2.0 | 200 | 0.005 | < 0.005 |

Photograph No.404388 –  
Reassurance air sampling on the West perimeter of site adjacent  
the site office.

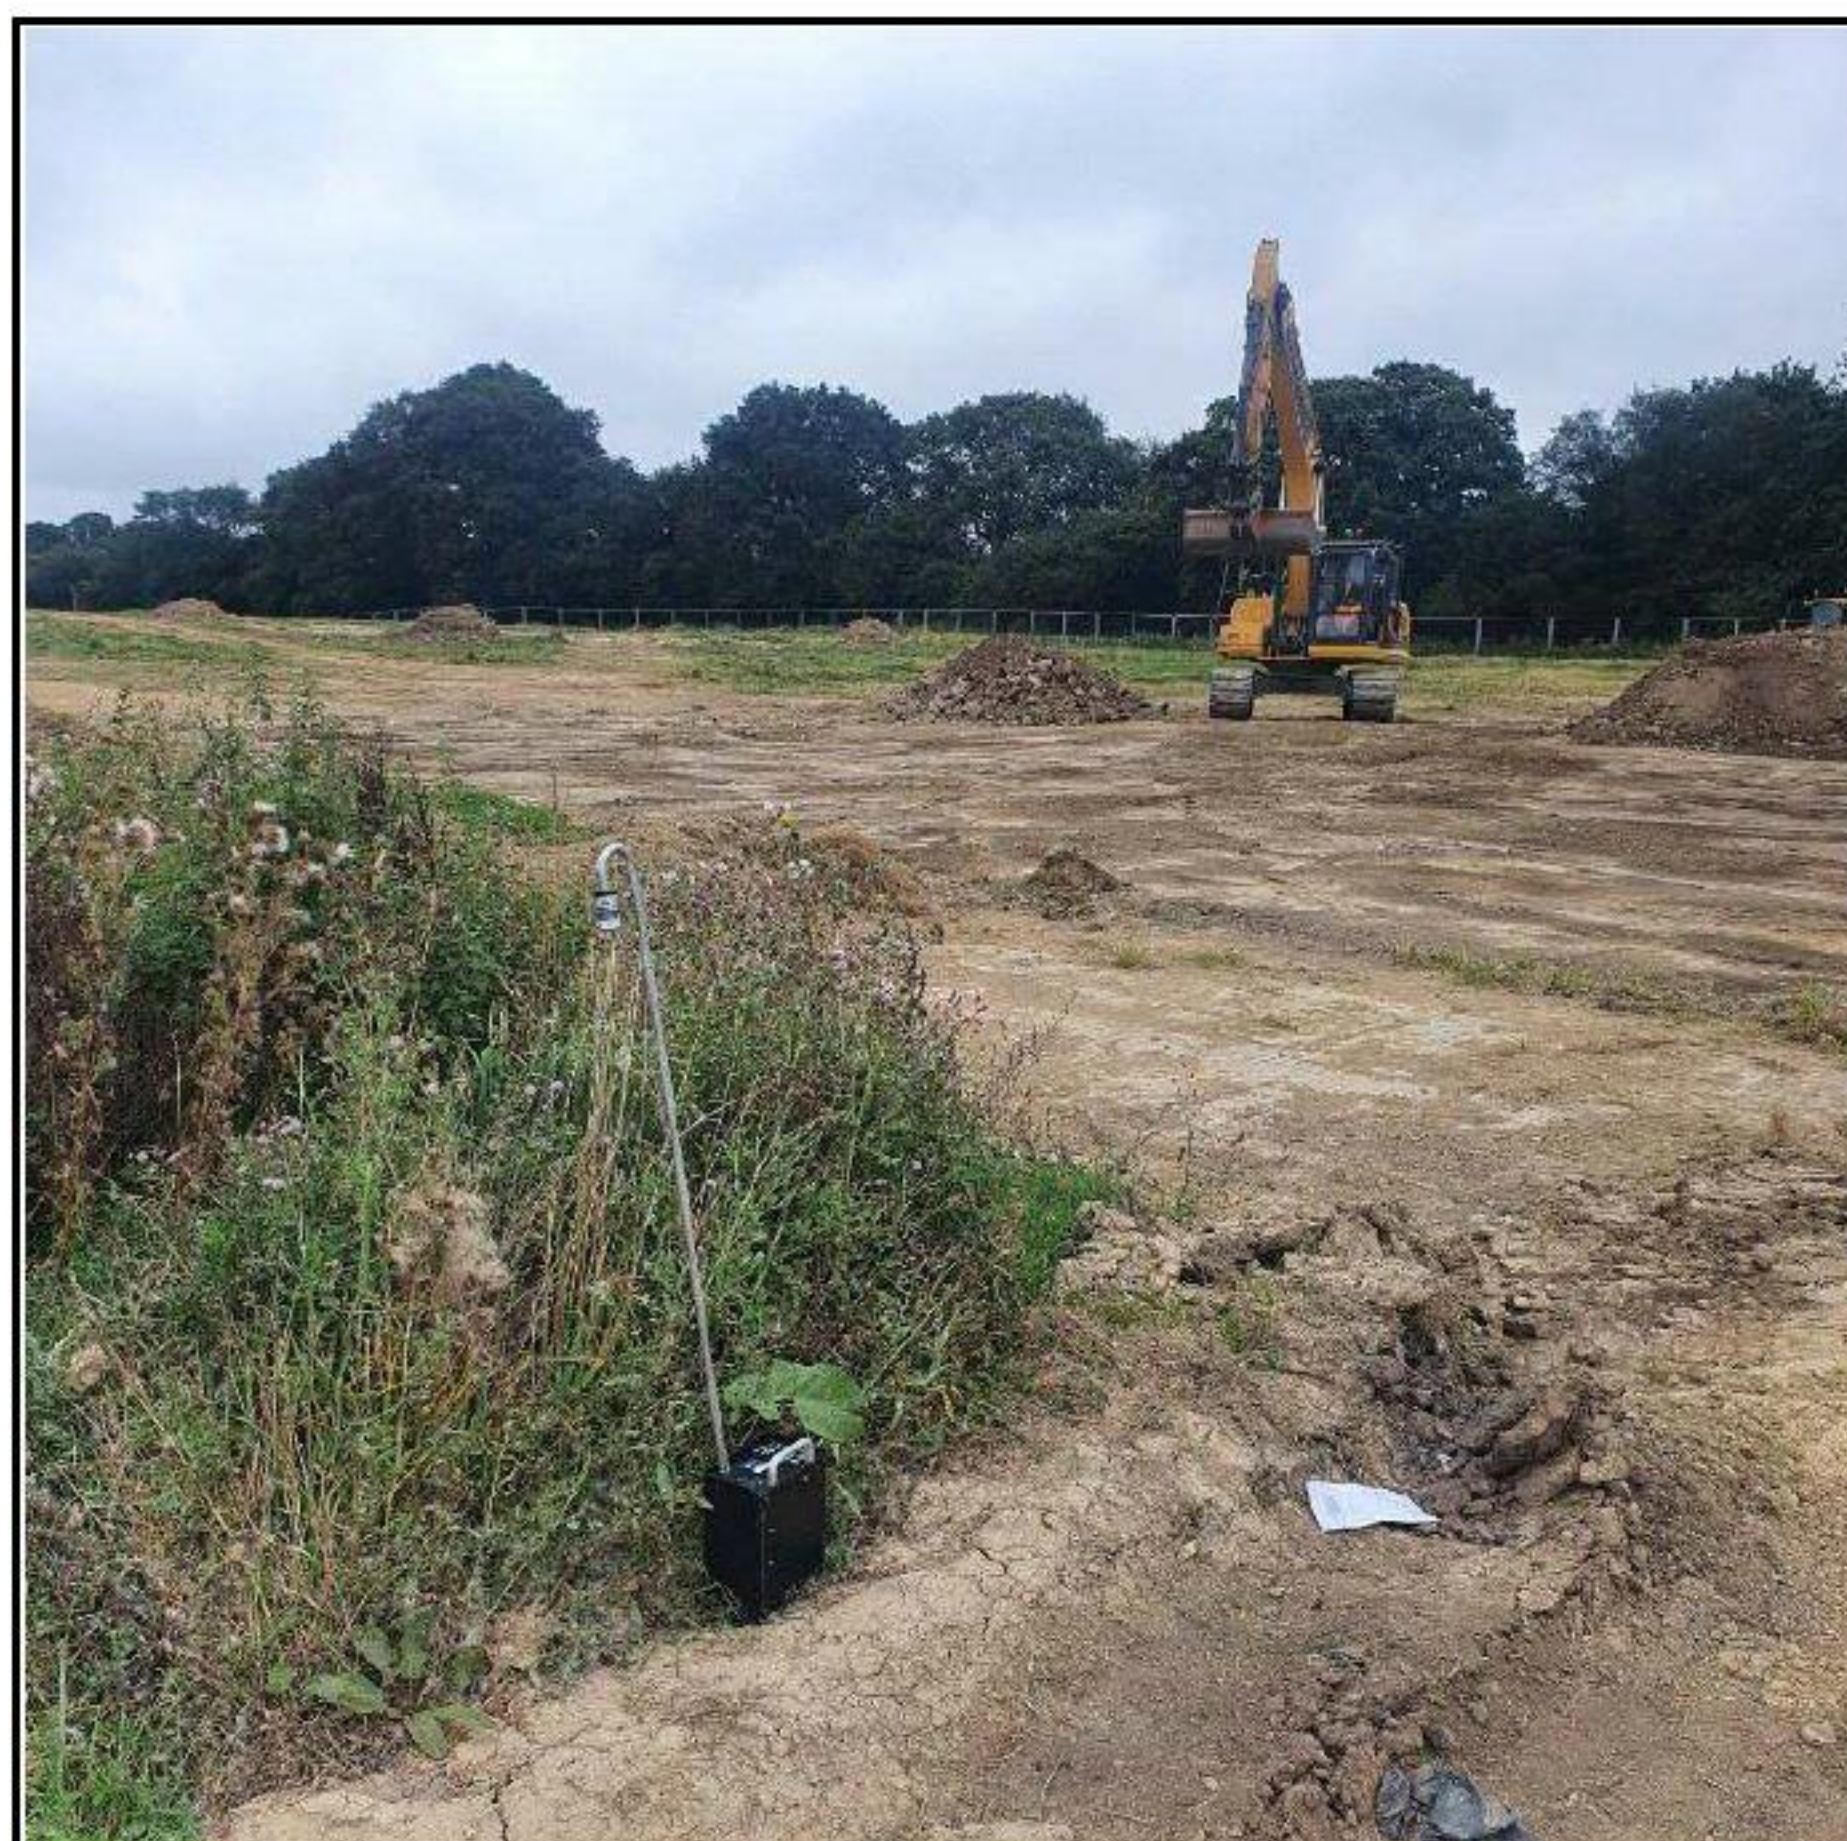
| Pump No. | Head No. | Field Reference | Sample Location | Start | End | Mean Flow (litres/min) | Total Test Duration (mins) | Total Volume (litres) | Fibres | Fields | Limit of Quantification (fibres/ml) | Fibre Concentration (fibres/ml) |
|---|---|---|---|---|---|---|---|---|---|---|---|---|
| 136 | MP05 | BM005485 | South West | Time Flow (litres/min) | 09:42 8.1 | 11:42 8.1 | 120 | 972 | 2.0 | 200 | 0.005 | < 0.005 |

Photograph No.404389 –  
Reassurance air sampling on the South West perimeter of site  
adjacent the site office.
