**Ref: The Potting Shed at The Holt, Ardingly.**

The Ecology Co-op undertook a bat scoping assessment at the Holt Property on Selsfield Road near Ardingly on the 23<sup>rd</sup> of December 2024 at the request of Philip Stinson. This assessment was undertaken further to a proposal to renovate this building, which is in a serious state of decline. The survey was undertaken in accordance with best practice guidance produced by the Bat Conservation Trust<sup>1</sup>.

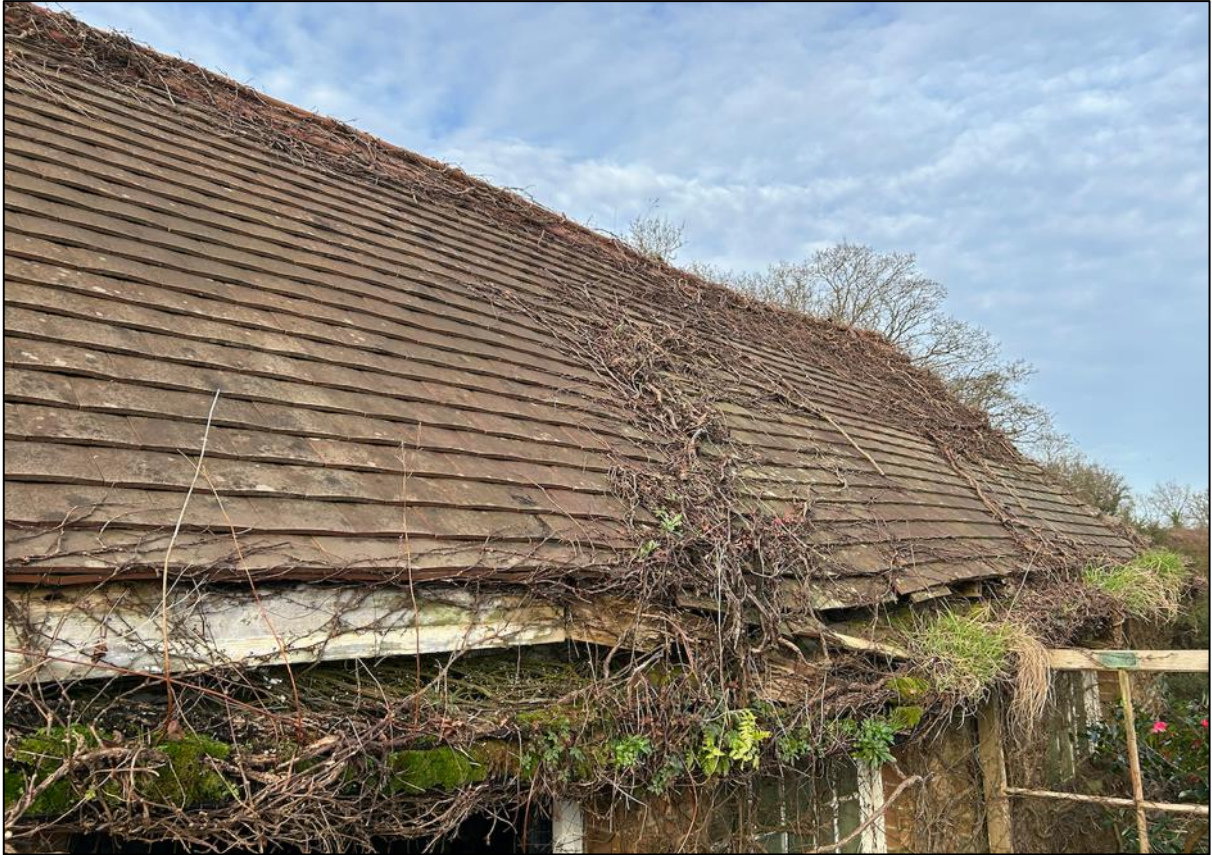
| Building section | Description of features | Assessment of suitability (Collins 2016) |
|---|---|---|
| External aspects | <p>The potting shed is traditionally brick-built and once housed a heating system for a now removed greenhouse. The roof is a simple gable structure with factory formed clay roof tiles and ridge tiles. The roof has some sagging due to degraded rafters and the soffit board along the eastern side is rotten and guttering is filled with debris and vegetation. The roof is partially covered by what appears to have been Virginia creeper (<i>Parthenocissus quinquefolia</i>) vines that are now dead. The roof on the western side could not be closely inspected due to its proximity to the B2028, however no notable gaps were visible on this roof face and it is covered in dense vines. On the eastern face the tiles were similarly largely tight-fitting, with no clear gaps sufficiently large to provide access for roosting bats.</p> <p>On the southern gable end wall, there is a very small area of hanging tiles covered in thick vines, with several large gaps visible around some of the tiles, with two slipped tiles visible. The large gaps in this location likely detract from the value of the potential roost crevices present, with access possible by other small mammals and birds, particularly due to a short catslide roof section on the side. This feature was closely inspected using a ladder and no direct evidence of use by bats was</p> | Low bat roost suitability |

**Photograph 1.** The eastern face of the potting shed roof, with generally tight-fitting roof tiles, but clear signs of decay.

The proposals include urgent repairs to the building and its refurbishment. Part of the roof on the western face has badly degraded and has slumped away from the wall plate, whilst underlying damage to the western wall was also visible. This work will include the replacement of the roof, with damage to the rafters visible.

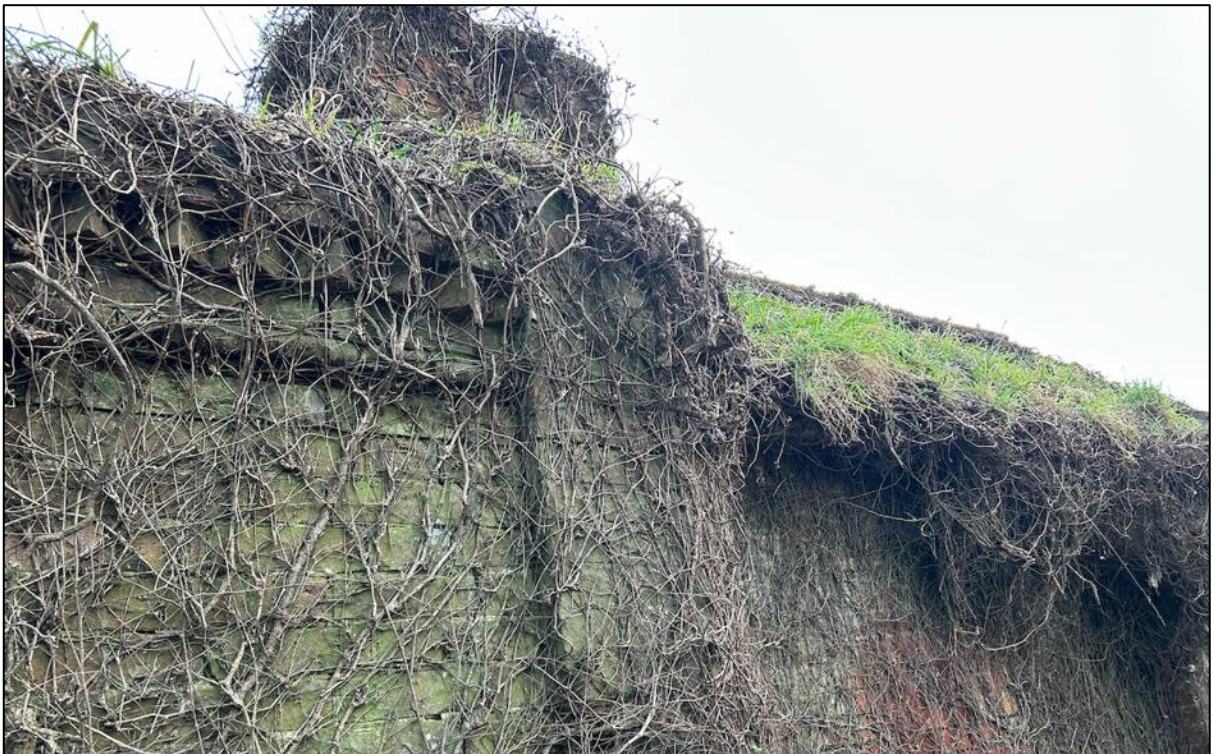
**Photograph 2.** A restricted view of the western face of the shed, which sits directly adjacent to the B2028

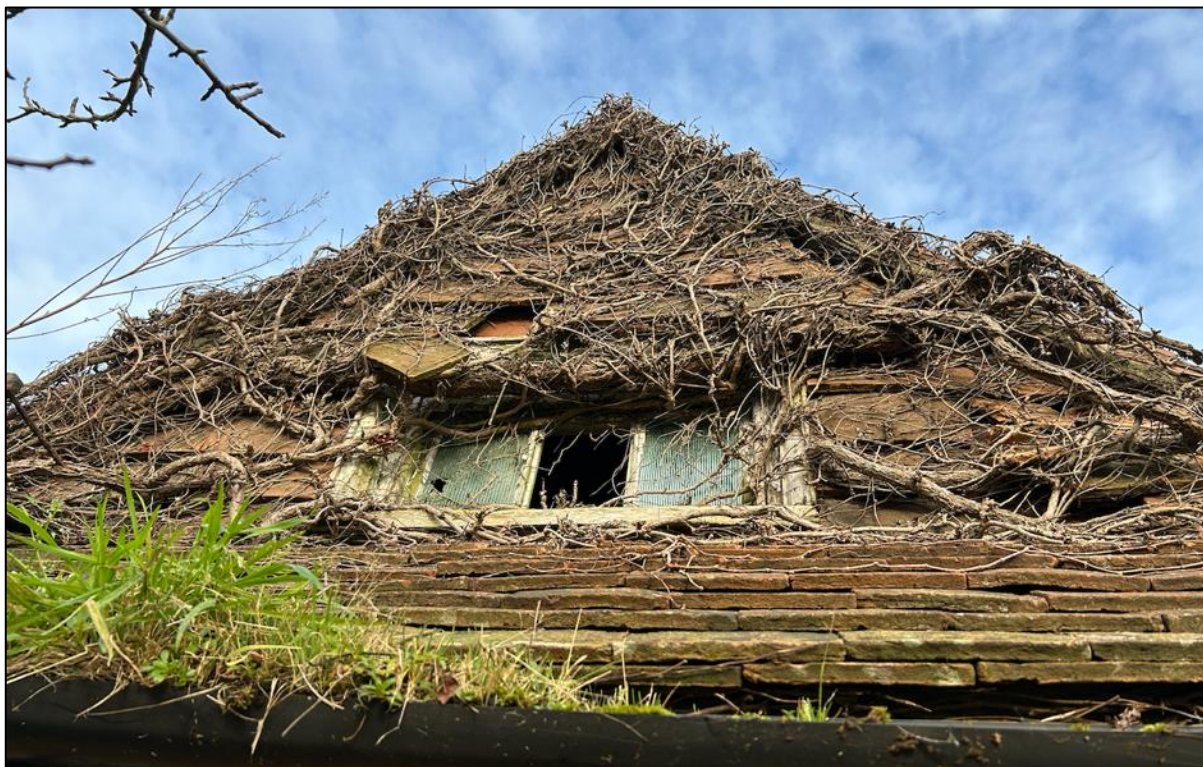
**Photograph 3.** The southern face of the building, where there are some large tile gaps there were closely inspected from a ladder. No evidence of use by bats was found.

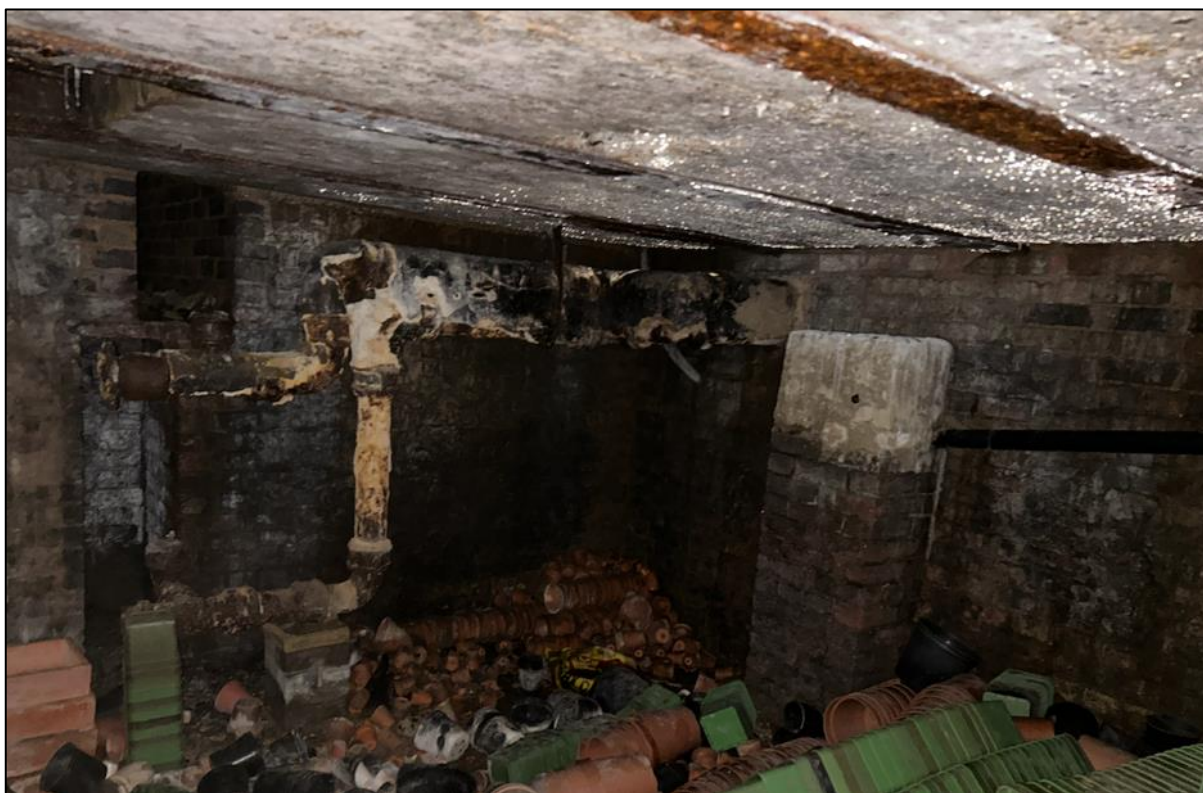
**Photograph 4.** An underground area understood to have formerly been used for heating a greenhouse.

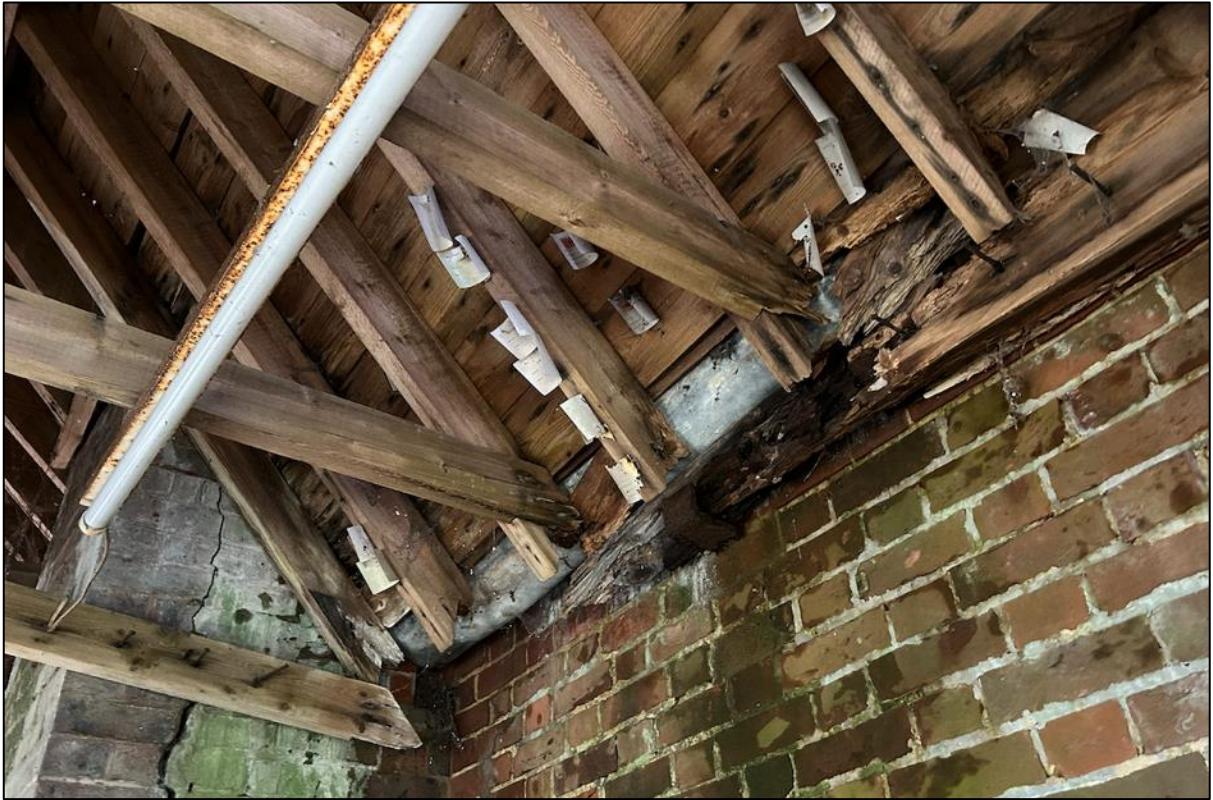
| Building section | Description of features | Assessment of suitability (Collins 2016) |
|---|---|---|
| Interior | <p>Internally the building is open to roof height and is clad with timber sarking. Some light cobwebbing was visible along the ridge of the roof. At the northwestern corner a partial collapse in the roof has led to a section of the roof dropping below the wall plate.</p> <p>A chimney breast is present on the western wall, with a large crack visible up most of its length, though this is not a sufficient crevice for bats.</p> <p>The internal aspects are lit via a small window on the northern face and two larger windows within the eastern wall.</p> <p>An underground former heating room for a former greenhouse positioned next to the potting shed was inspected for its potential to support hibernating bats. This space has a concrete lintel roof that is devoid of features that might support bats and similarly the brick walls appear largely featureless. Whilst the whole space could not be explored extensively, it appears to lack suitable features for hibernation, though of note a single egg sack for a cave spider (<i>Meta sp.</i>) was noted.</p> <p>No evidence of use by bats could be found inside the building, through close inspection.</p> | Low bat roost suitability |

**Photograph 5.** A degraded section of roof on the western side of the building where the rafters have detached from the wall plate.

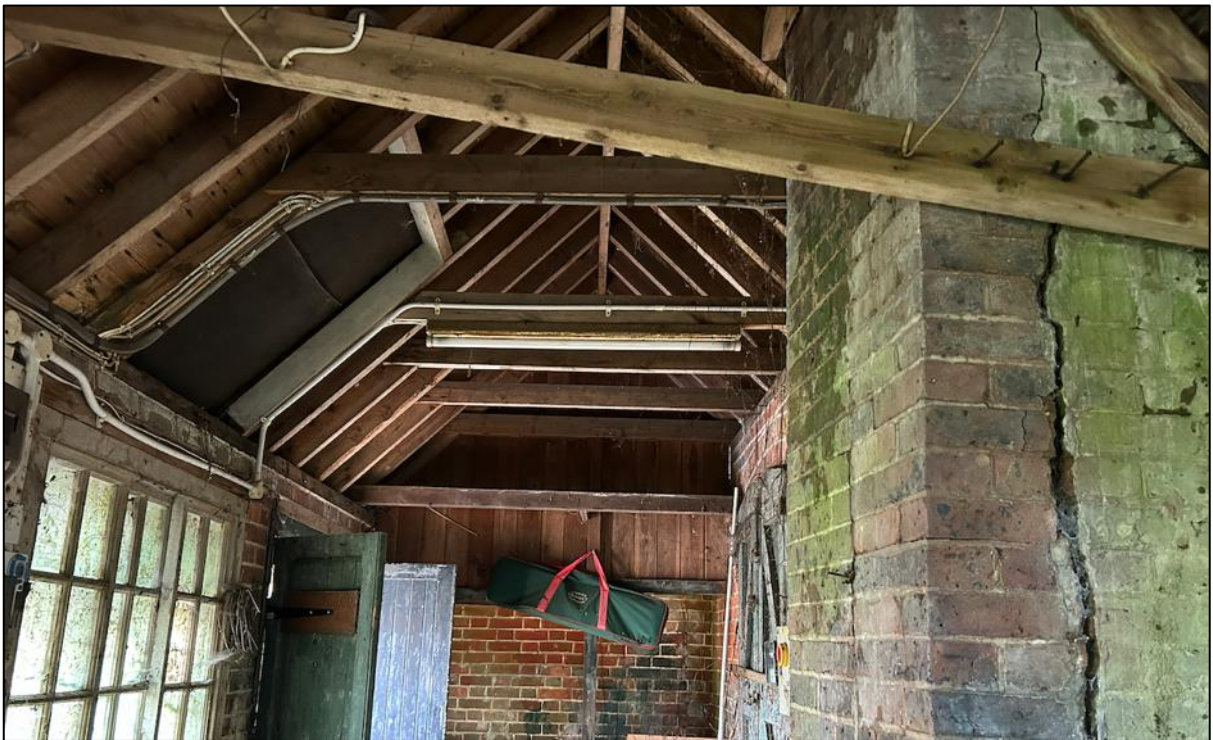
**Photograph 6.** The internal aspect of the shed, which is open to roof height and well lit.
