## Plummerden House

## Flood Risk Assessment & Drainage Strategy

241875-FRA\_DS-LB-RS-01

Project: Plummerden House  
Title: Flood Risk Assessment & Drainage Strategy  
Client: Mrs Maria Krajukhina  
Reference: 241875-FRA\_DS-LB-RS-01

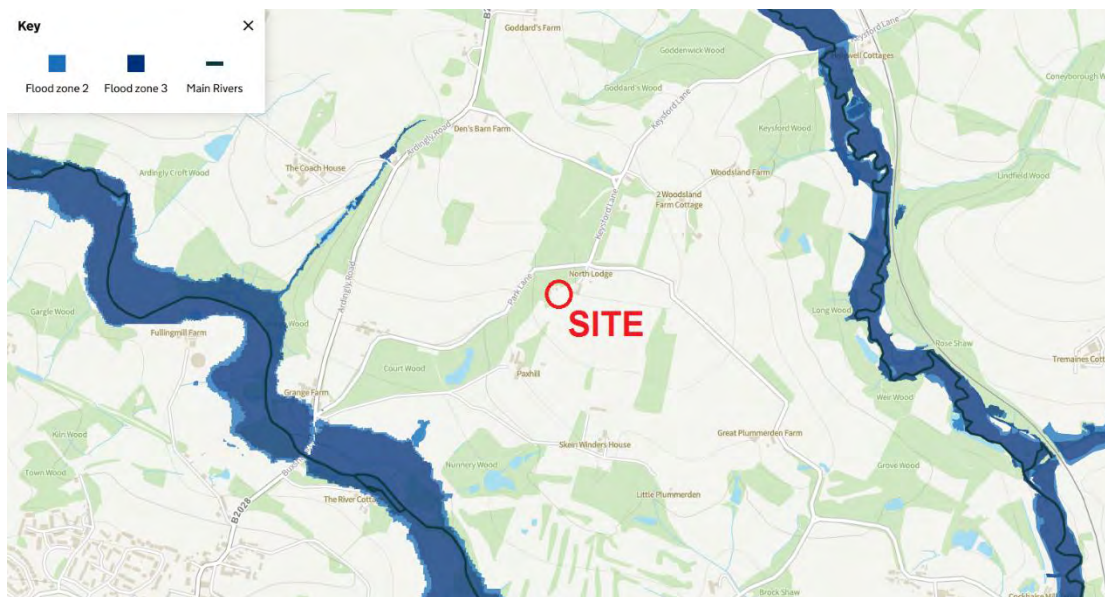
**Figure 3.1 – Flood Zone Mapping**

3.1.3 The EA mapping shows the site to be within Flood Zone 1. For Zone 1, there is a probability of less than 0.1% from river flooding. Figure 3.1 below shows the site's position in relation to the fluvial flood zones.

3.1.4 The unshaded area on the map above shows land in Flood Zone 1, it is clear that the site falls within this area, a significant distance from Zones 2 & 3. Therefore, the site has a flood probability of less than 0.1%.
