# BAT SURVEY AND ASSESSMENT

Hurstmead, 22 Lewes Road,  
Haywards Heath, RH17 7SN

## A REPORT FOR REXSTONE BUILDERS

Surveys and Assessment completed between  
April and June 2026.

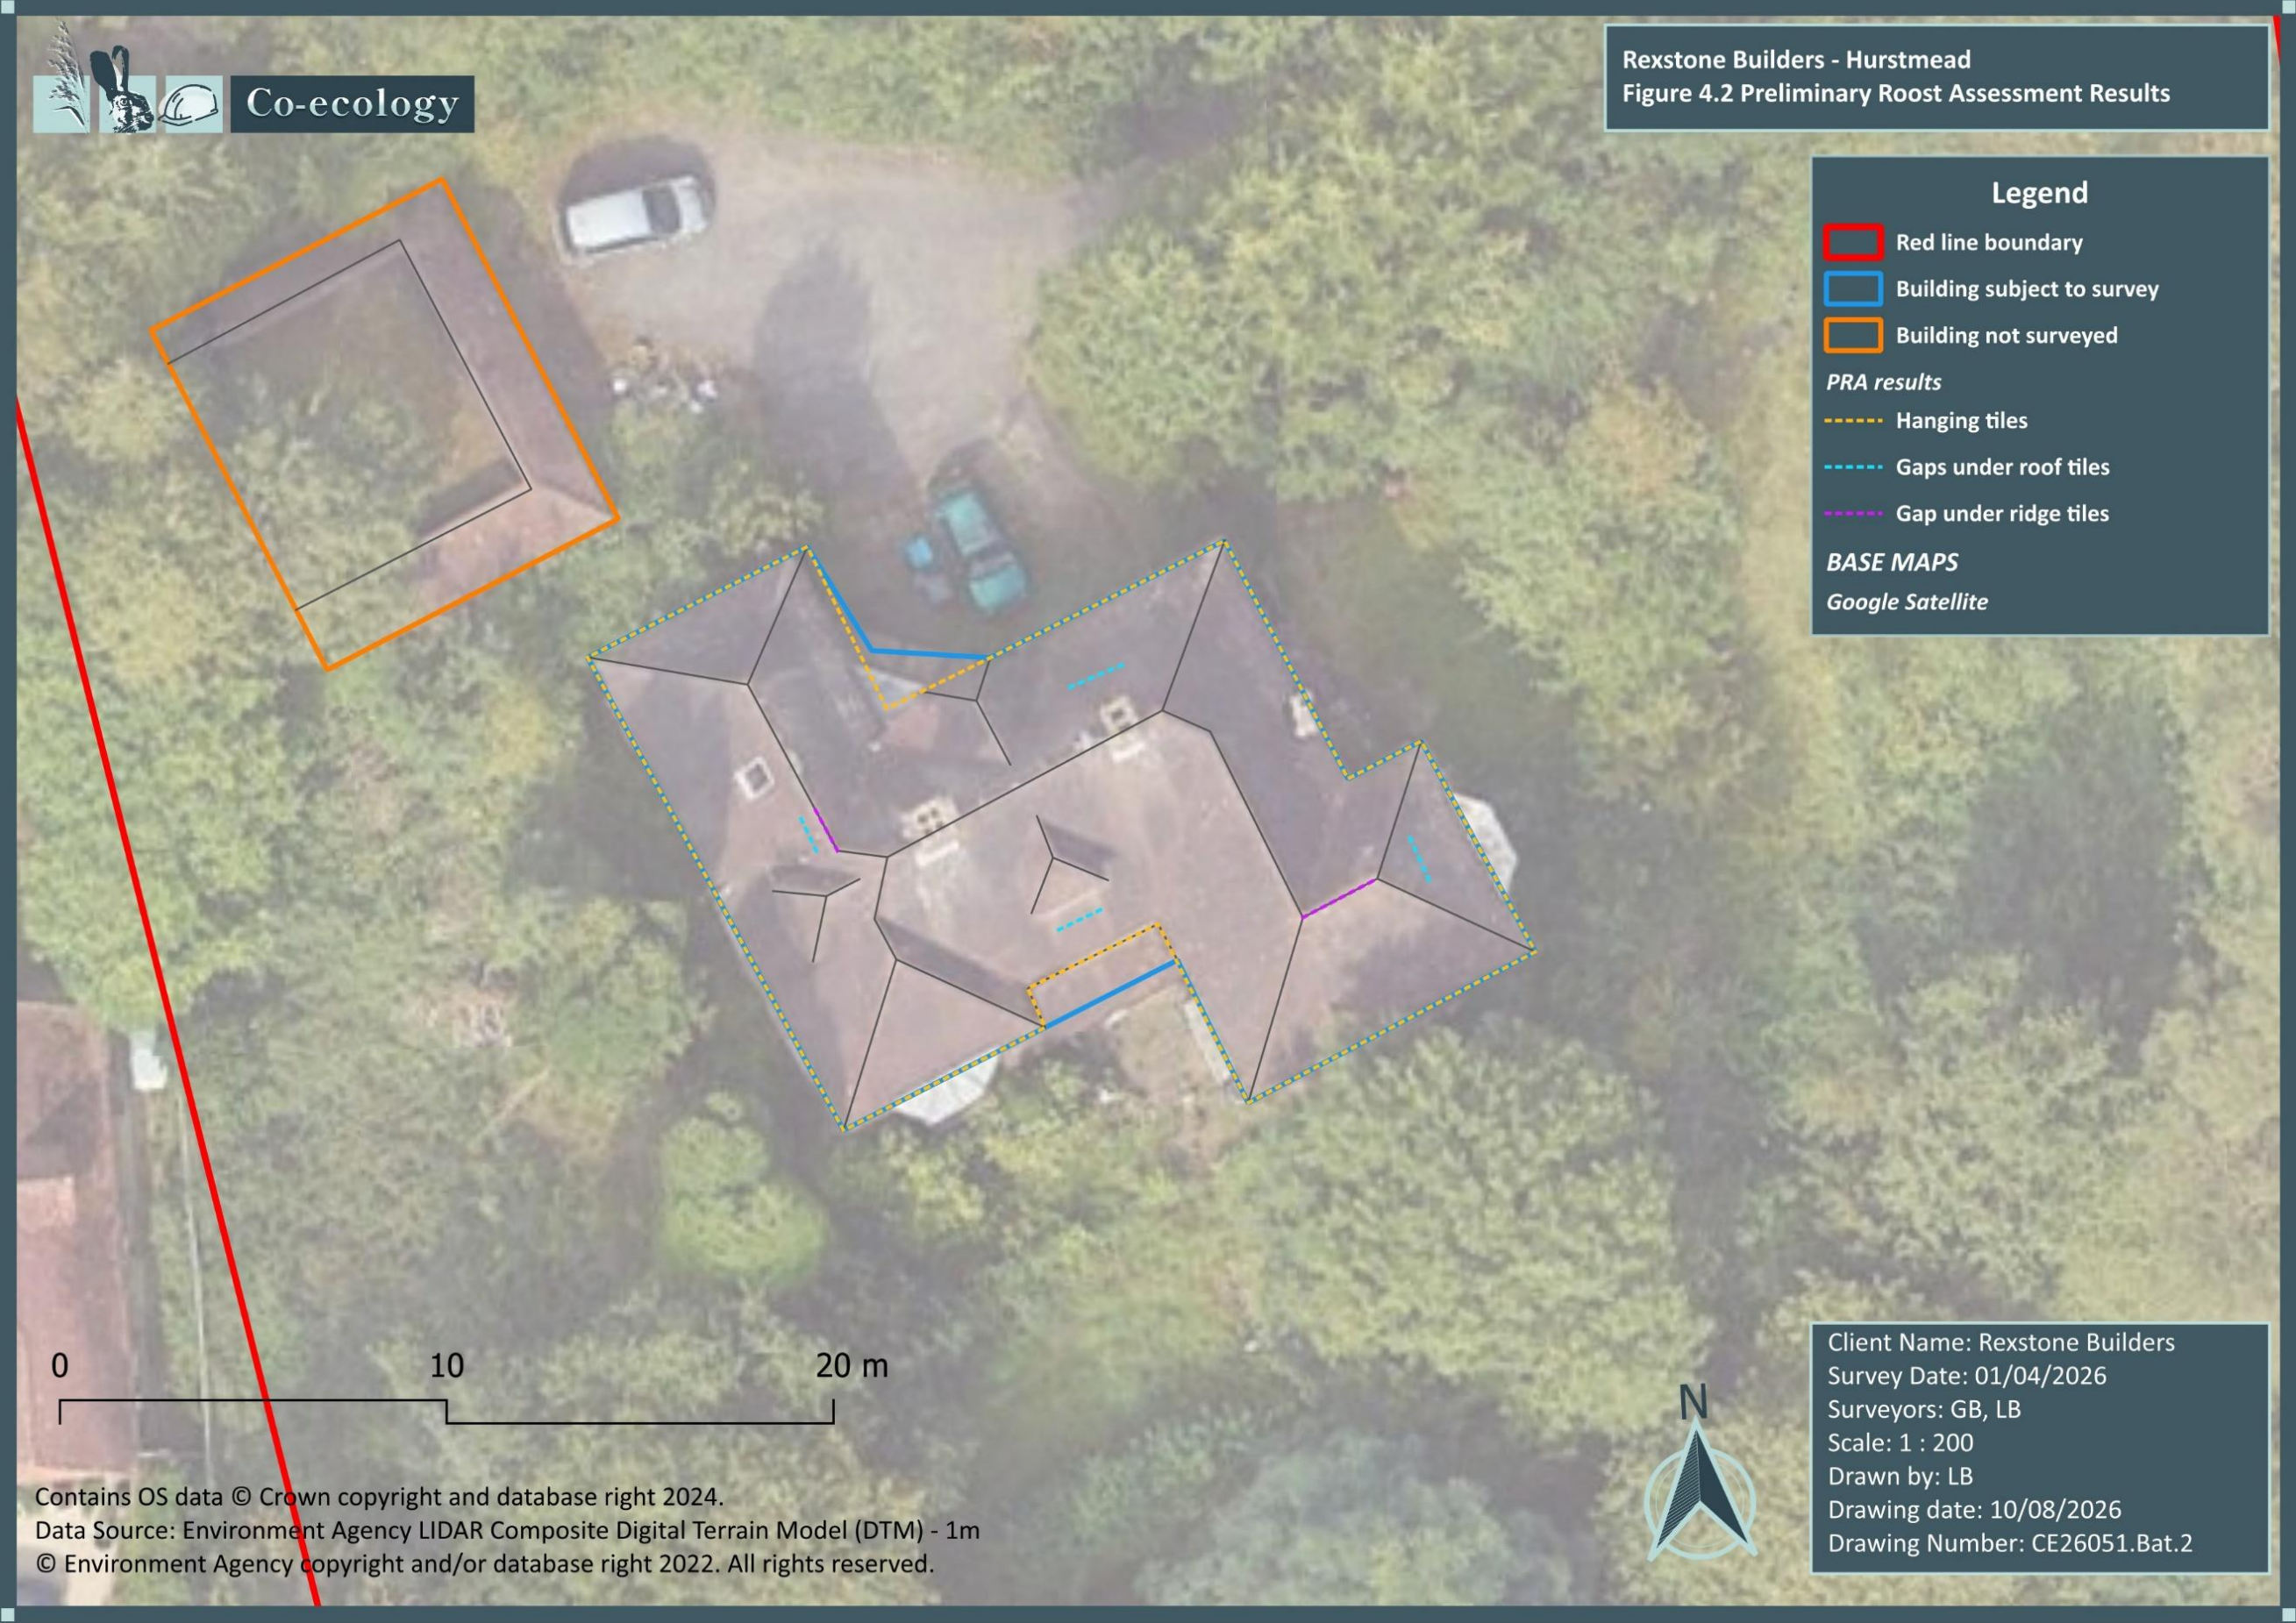
Figure 4.2 Location of roosts identified on site

| Roost Ref | Elevation | Species | Roosting feature | Survey 1 count (May) | Survey 2 count (May) | Survey 3 count (June) | Roost characterisation |
| R1 | North | Common pipistrelle | Bat re-enters roost under clay hanging tile on north elevation close to the corner of the building. | 1 | 0 | 0 | Day roost<br>Low conservation significance |
| R2 | South | Common Pipistrelle | Gap under ridge tile at the junction of the hipped roof. South west projecting wing. | 0 | 1 | ? | Day roost<br>Low conservation significance |
| R3 | South west | Common pipistrelle | Gap under ridge tile over east section of roof. | 0 | 1 | 0 | Day roost<br>Low conservation significance |
| R4 | South | Common pipistrelle | Hanging tiles below the space in between first and second floor on the western projecting wing. | 0 | 0 | 1 | Day roost<br>Low conservation significance |
| R5 | South | Common Pipistrelle | The soffit on the southwest side of the east projecting wing. | 0 | 0 | 1 | Day roost<br>Low conservation significance |

- 6.11. *Roost reinstatement*: The proposals include repair and replacement of roof tiles in a like for like manner. The day roosts were all located under tiles and will be reinstated with a suitable number of lifted tiles to enable future access.

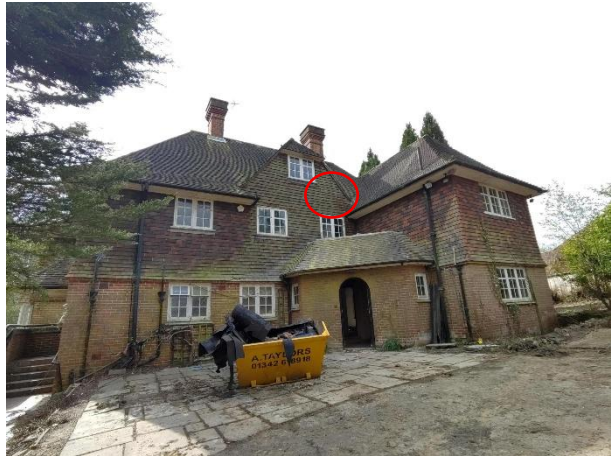
**Photograph 1.** North elevation of Hurstmead showing hanging tiles and location of bat roost circled in red.

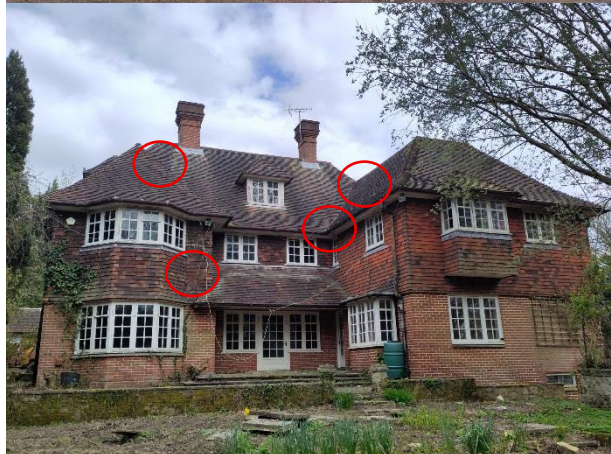
**Photograph 3.** South elevation of Hurstmead showing hanging tiles and location of bat roost circled in red.

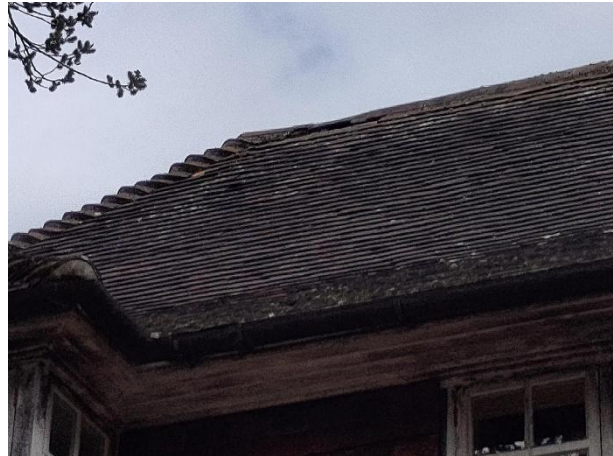
**Photograph 4.** Gap under ridge tile providing access to cavity.

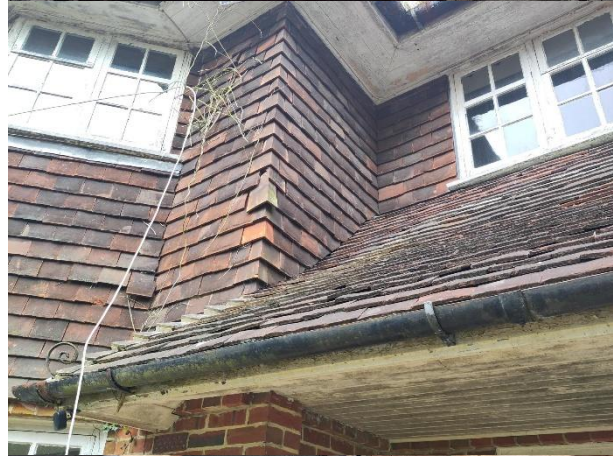
**Photograph 5.** Loose hanging tiles on southern elevation of property.

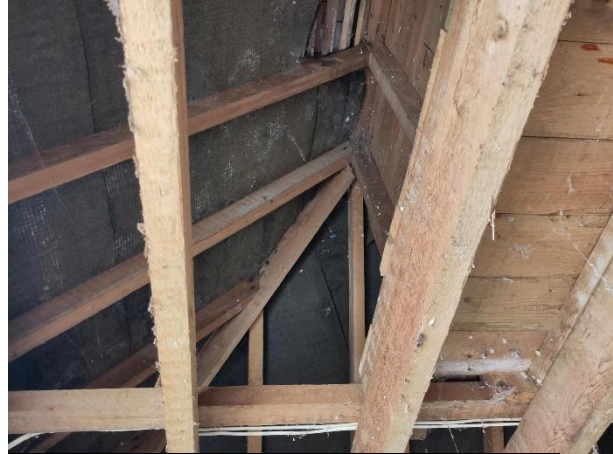
**Photograph 6.** Internal space of Hurstmead, space open to the felt lining with excessive light ingress from dormer windows.
