Project No: ITS19984  
Project Title: Land at LVS Hassocks, Sayers Common  
Title: Stage 1 Road Safety Audit – Design Organisation Response  
Ref: OT/ITS19984-014 TN  
Date: 10 February 2026

LAND AT LVS HASSECKS SCHOOL,  
B2118, SAYERS COMMON, WEST SUSSEX  
Stage 1 Road Safety Audit  
Off-site works  
J190670

Stage 1 Road Safety Audit  
Off-site works  
J190670

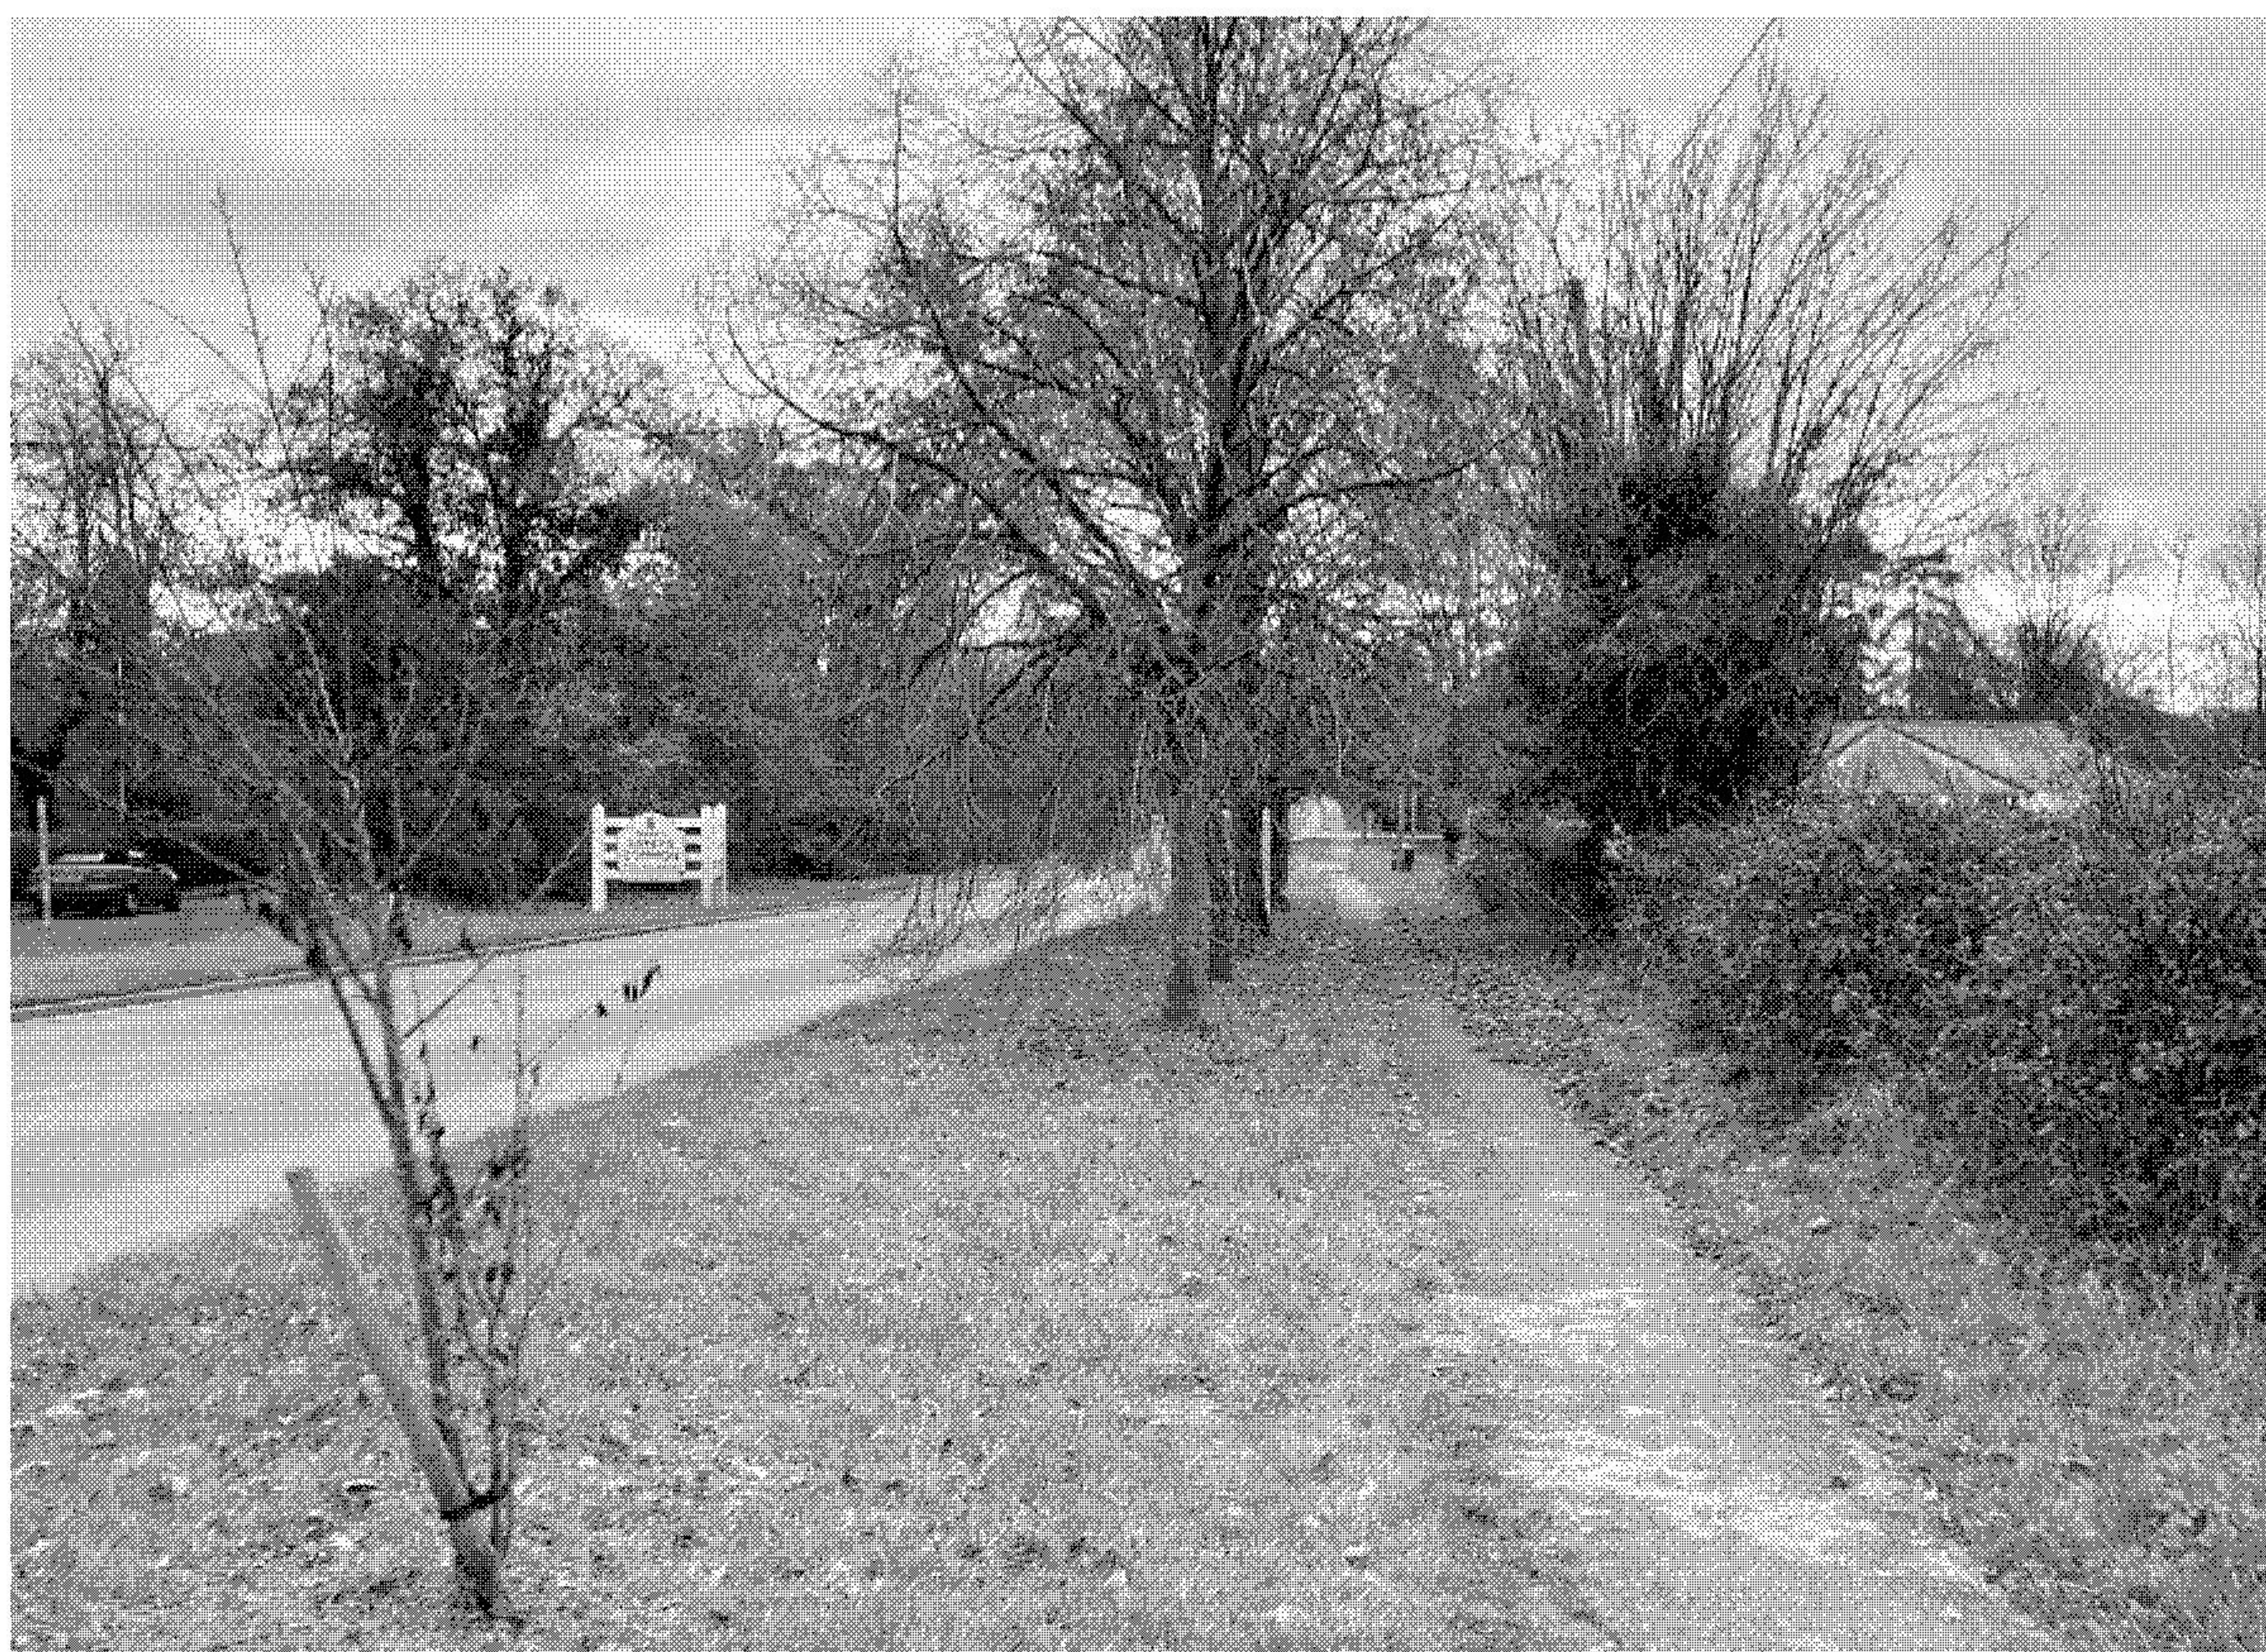
### Problem 3

It is proposed to widen the footway to provide a shared-use route. There are several trees with low canopies along the western side of the B2118. This may cause an obstruction along the new widened route. This may result in pedestrians and cyclists colliding with the branches.

| RSA Problem | RSA Recommendation | Design Organisation Response | Overseeing Organisation Response | Agreed RSA Action |
|---|---|---|---|---|
| <b>Trees.</b> It is proposed to widen the footway to provide a shared-use route. There are several trees with low canopies along the western side of the B2118. This may cause an obstruction along the new widened route. This may result in pedestrians and cyclists colliding with the branches. | Cut back and maintain low branches to be clear of the route | Agree – the trees / vegetation along this route will be maintained and cut back to ensure safe use of the route. | | |

**Recommendation**     Cut back and maintain low branches to be clear of the route.

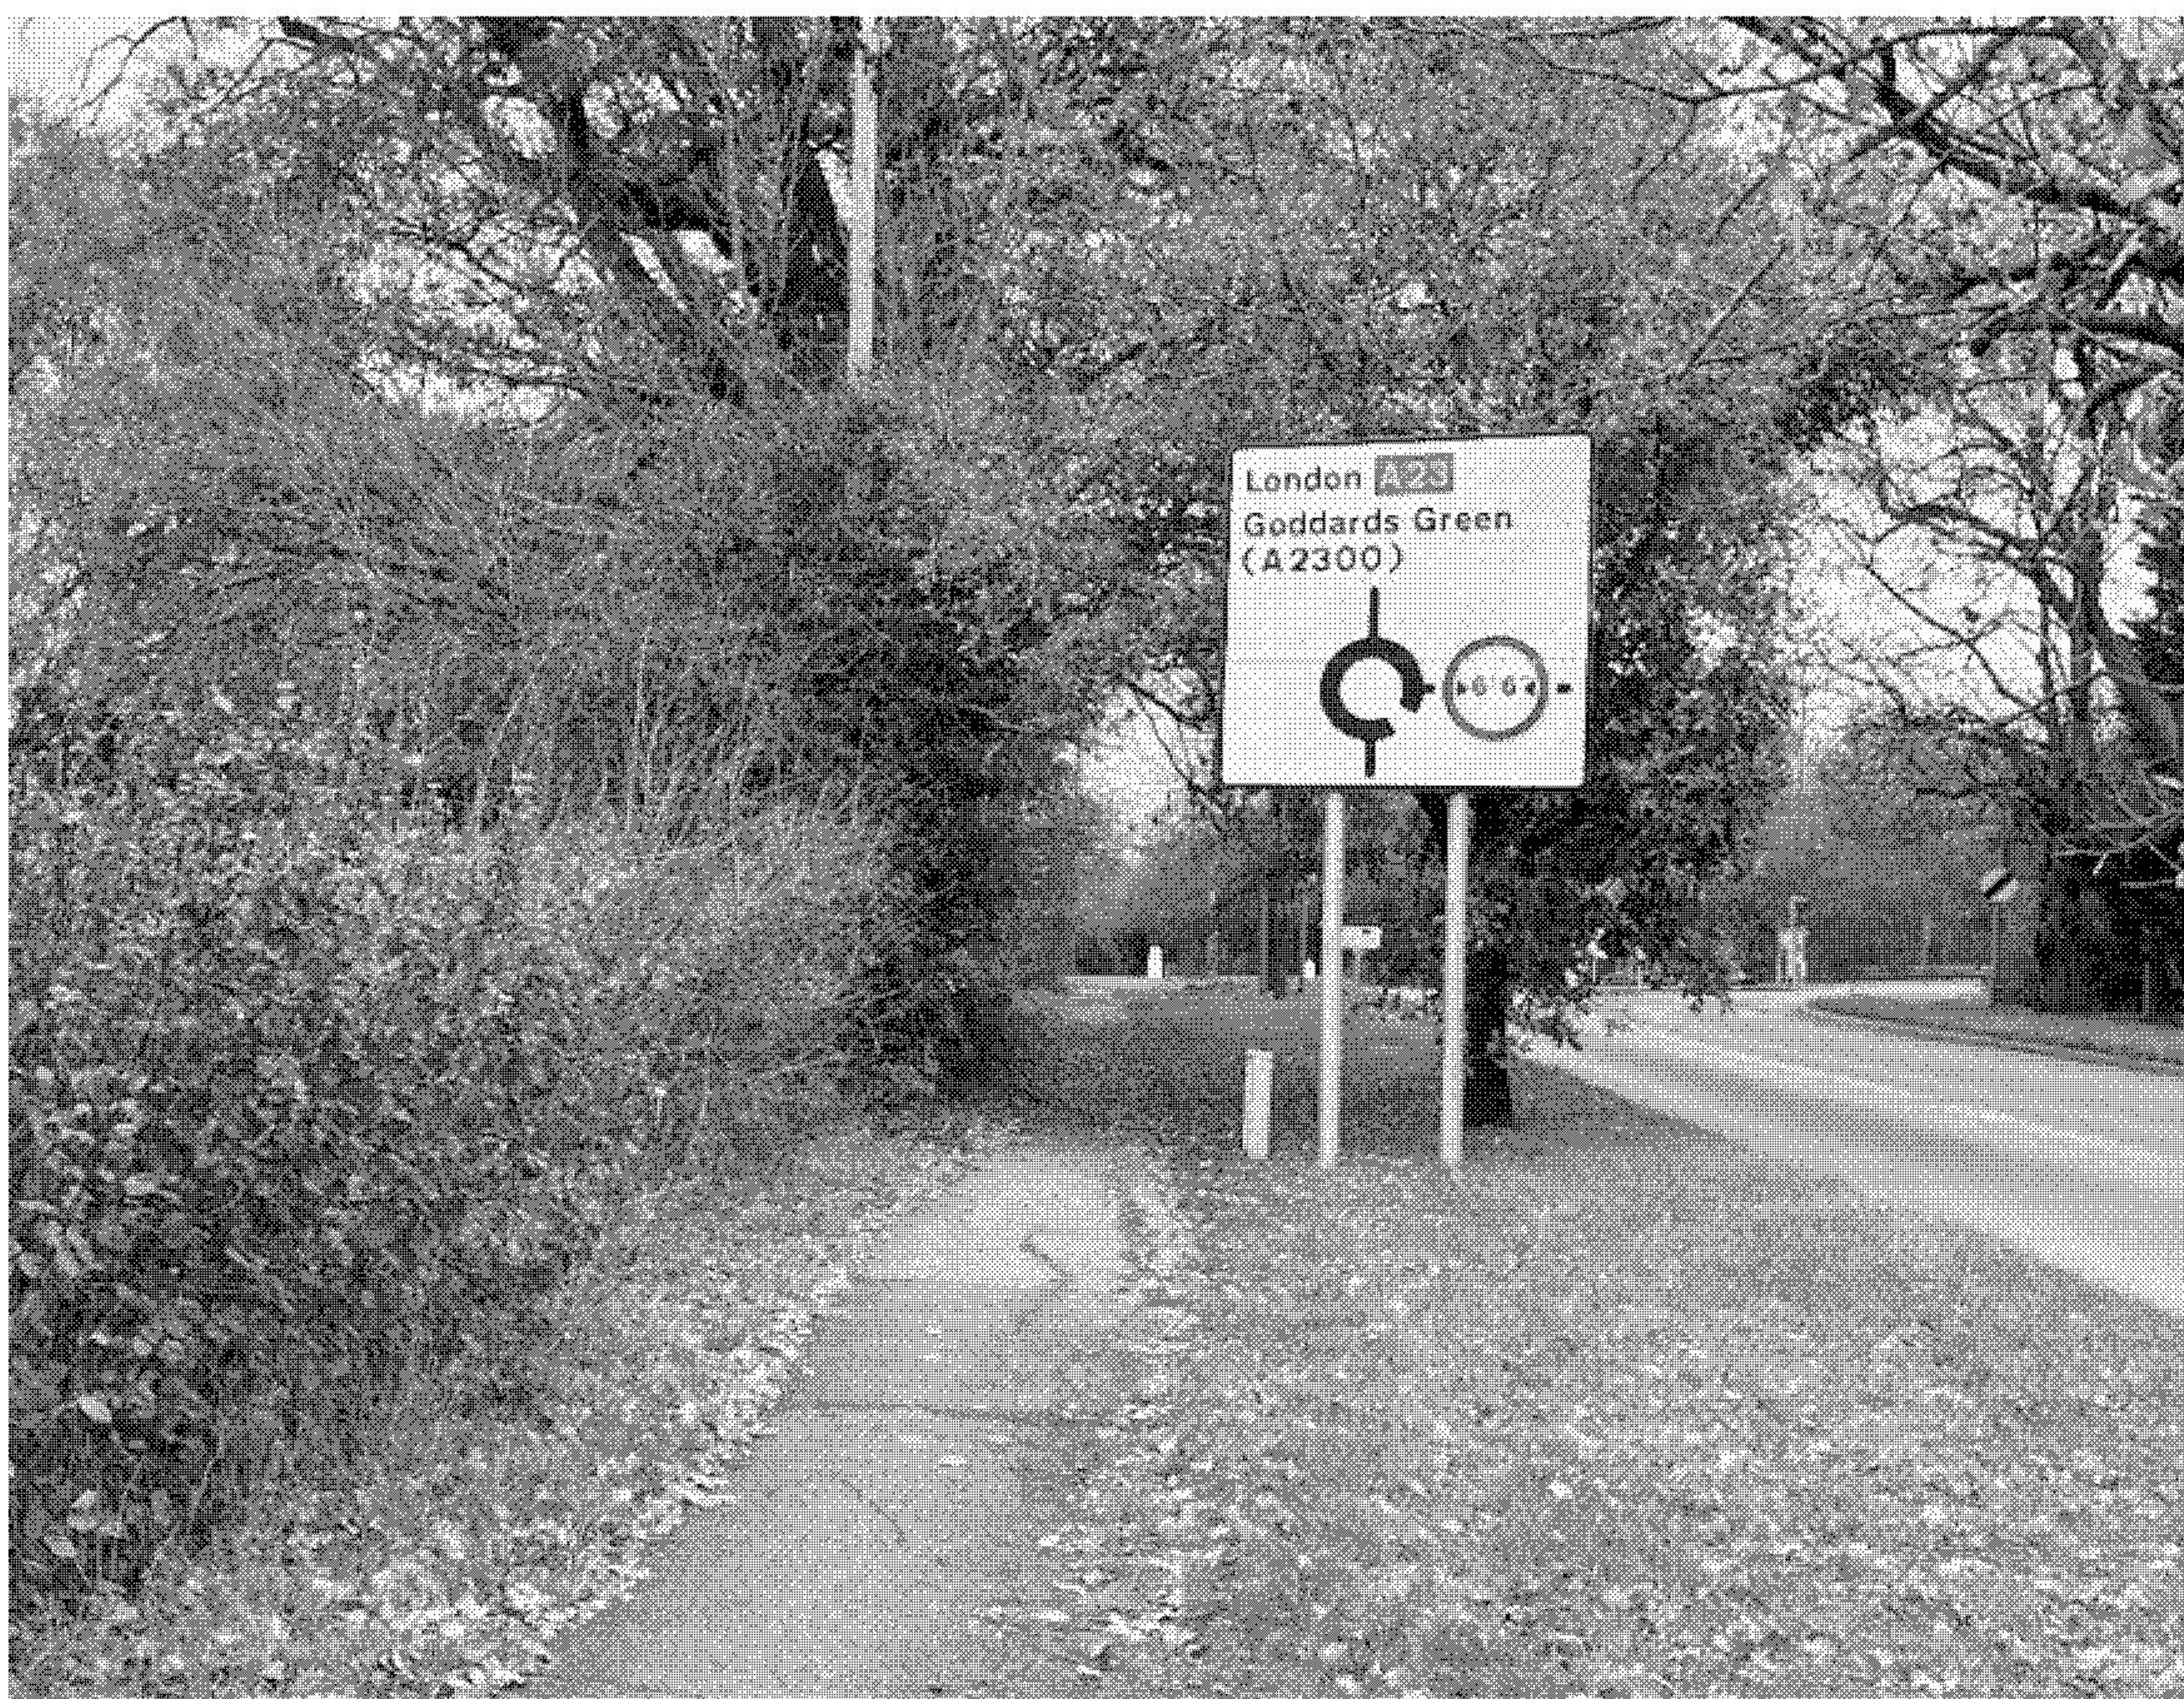
#### Problem 4

It is proposed to widen the footway to provide a shared-use route. There is an existing map-type road sign / electricity feeder pillar within the verge. This will cause an obstruction within the shared-use route and may result in pedestrian and cyclist collisions.

| RSA Problem | RSA Recommendation | Design Organisation Response | Overseeing Organisation Response | Agreed RSA Action |
|---|---|---|---|---|
| <b>Map-type sign.</b> It is proposed to widen the footway to provide a shared-use route. There is an existing map-type road sign / electricity feeder pillar within the verge. This will cause an obstruction within the shared use route and may result in pedestrian and cyclist collisions. | Ensure the shared-use route is clear of obstructions to users. | Agree – the shared use route will be kept clear of obstruction. Any signage relocation will be provided as part of the detailed design process. | | |

**Recommendation**      Ensure the shared-use route is clear of obstructions to users.

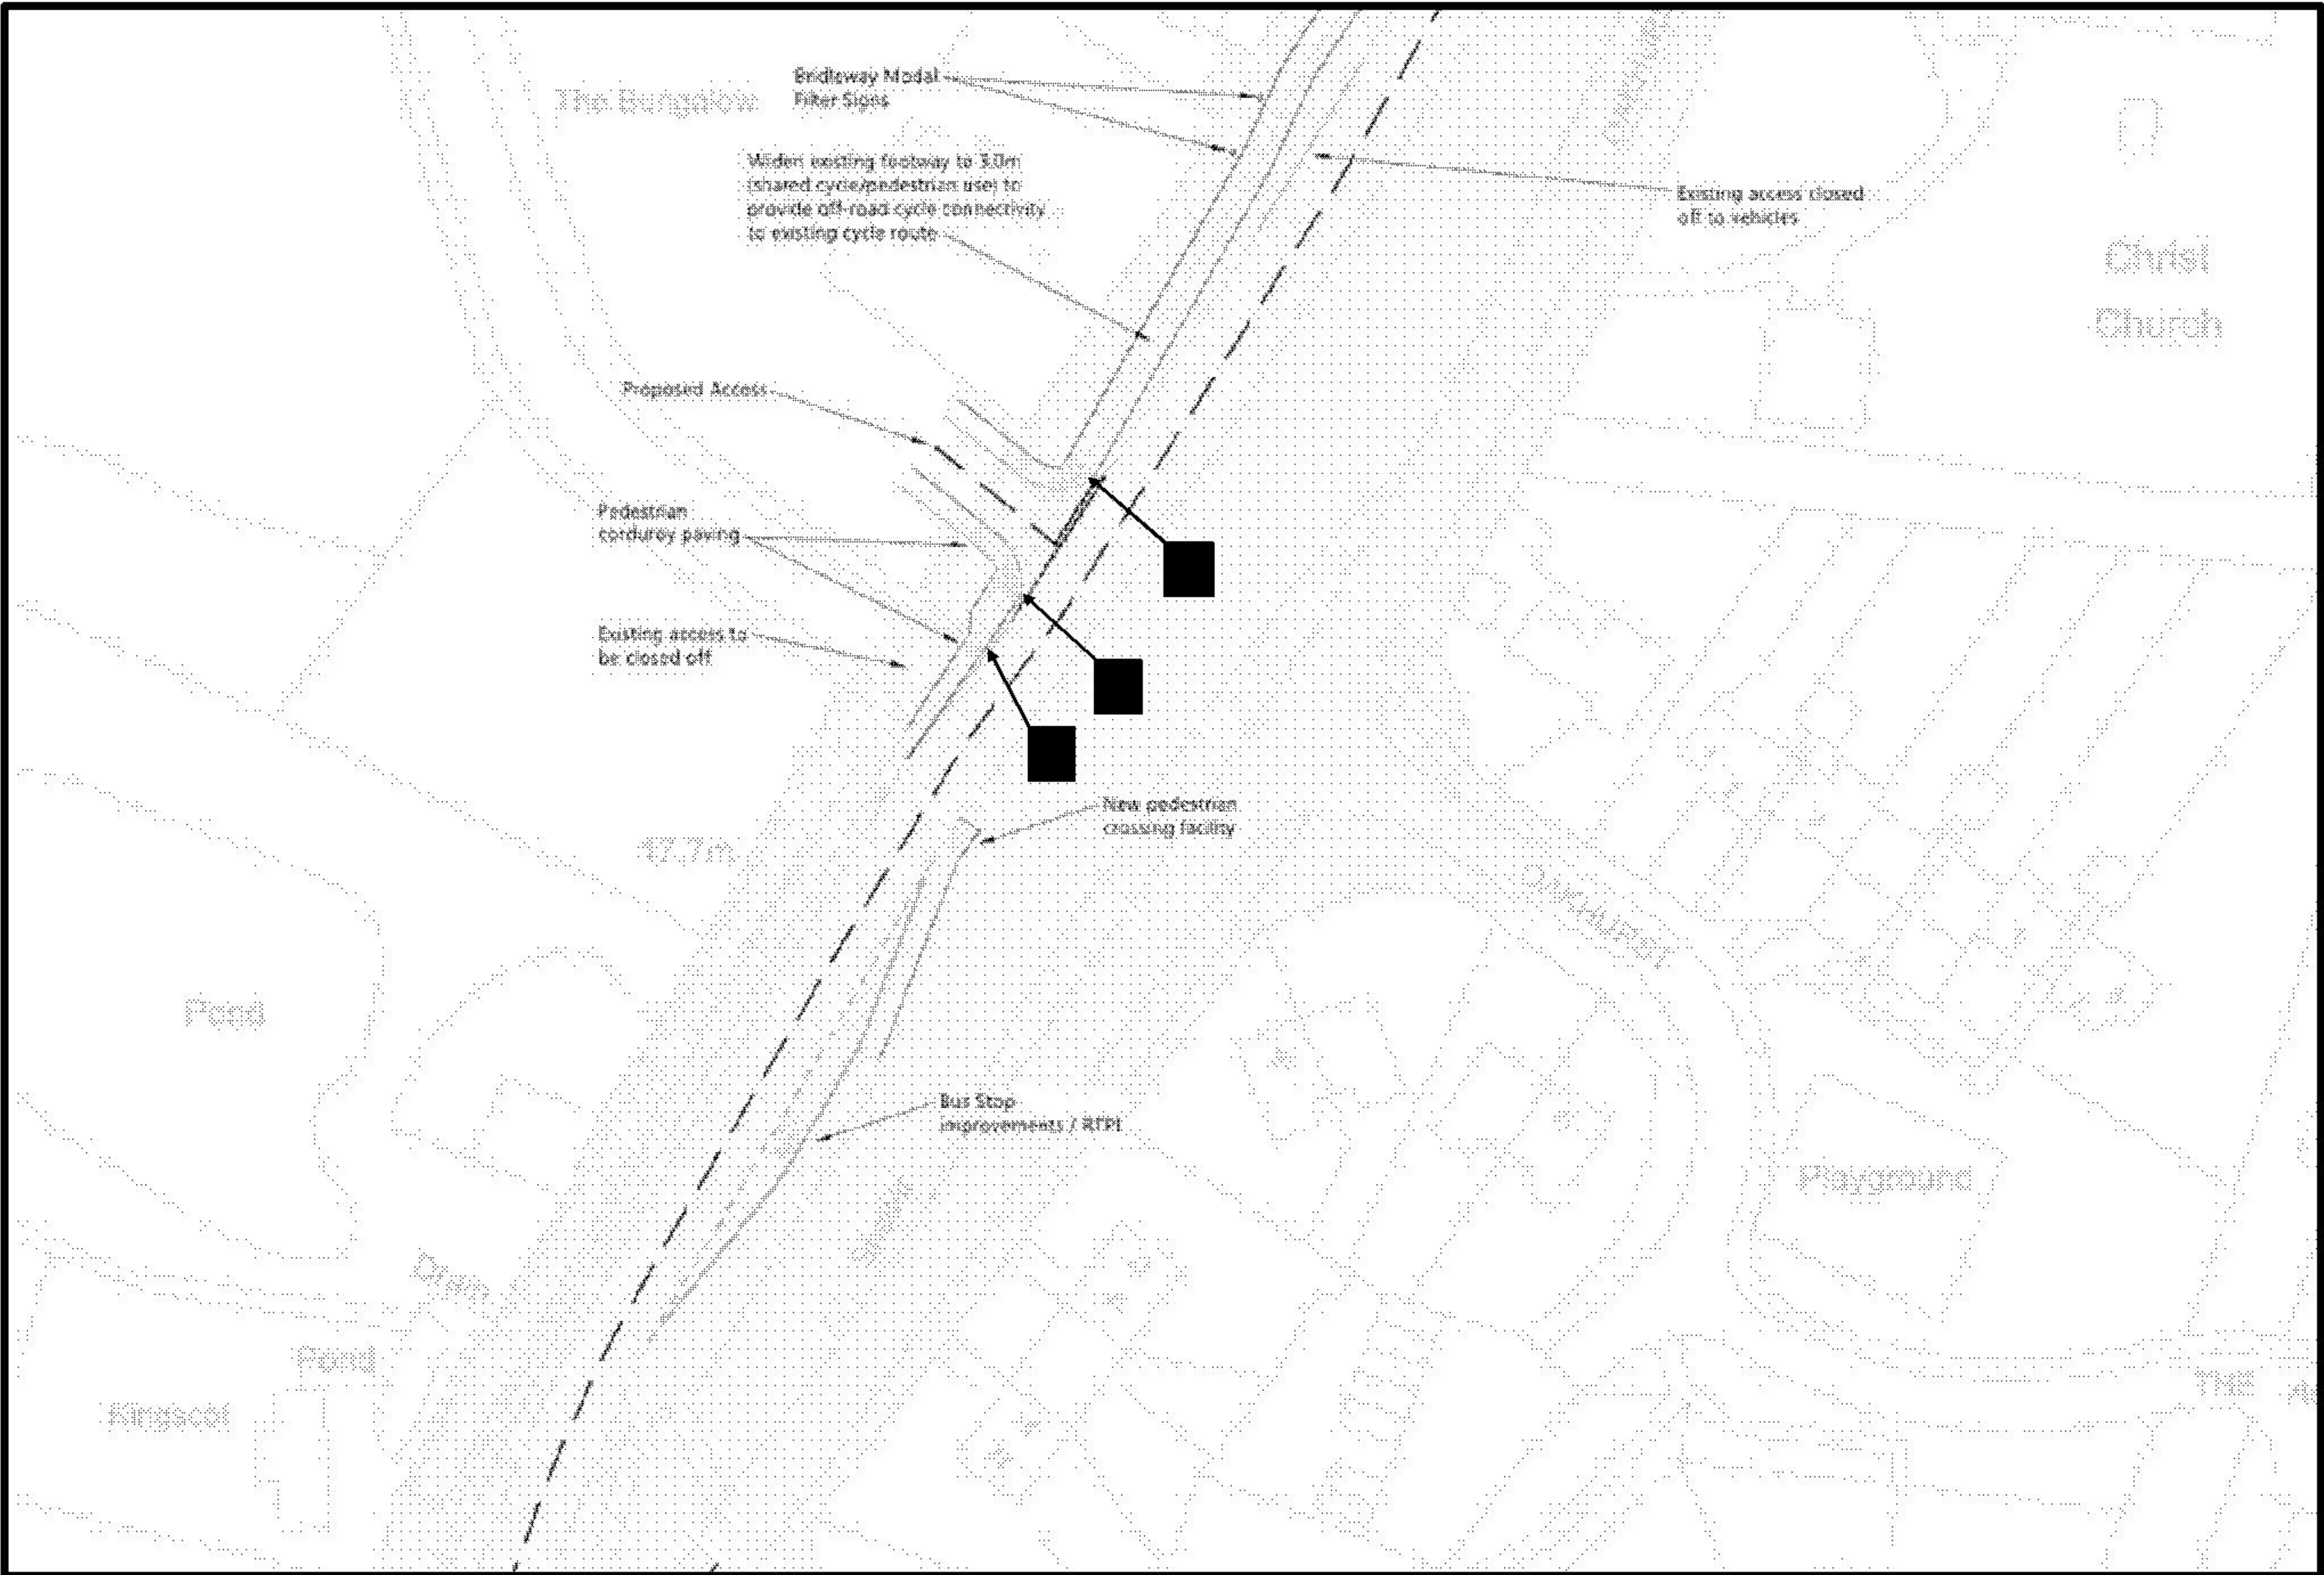
# Appendix C Problem Location Plan

- 1.8.4 The submitted design drawings have been annotated to show the location of problems identified during this Stage 1 Road Safety Audit, which are shown at **Appendix C**.
