# **Land East of Lunce's Common, Haywards Heath**

Stage 1 Road Safety Audit  
Designer's Response Report

October 2025

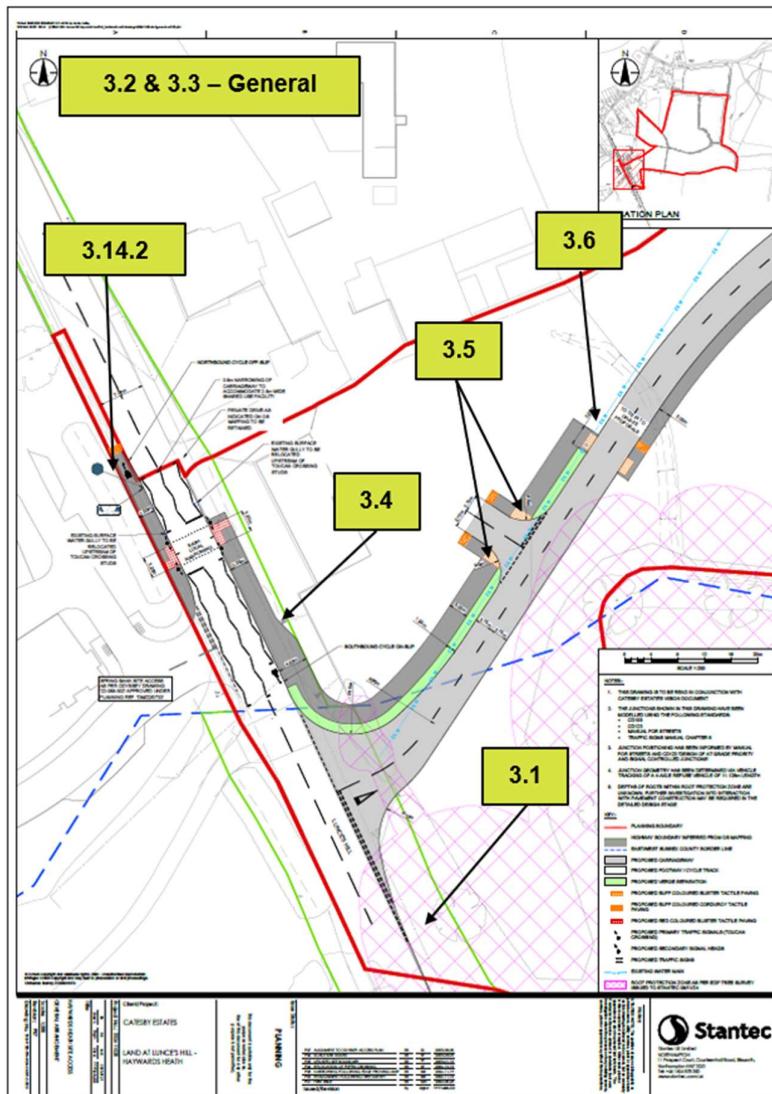
## **Appendix B Problem Location Plan**

- 1.2.1 This report lists road safety problems identified by the Stage 1 RSA. The responses from the Design Team are indicated in bold typeface.
- 1.2.2 Problems identified in this report are indicated by location and are shown on the site reference plan in **Appendix A**.

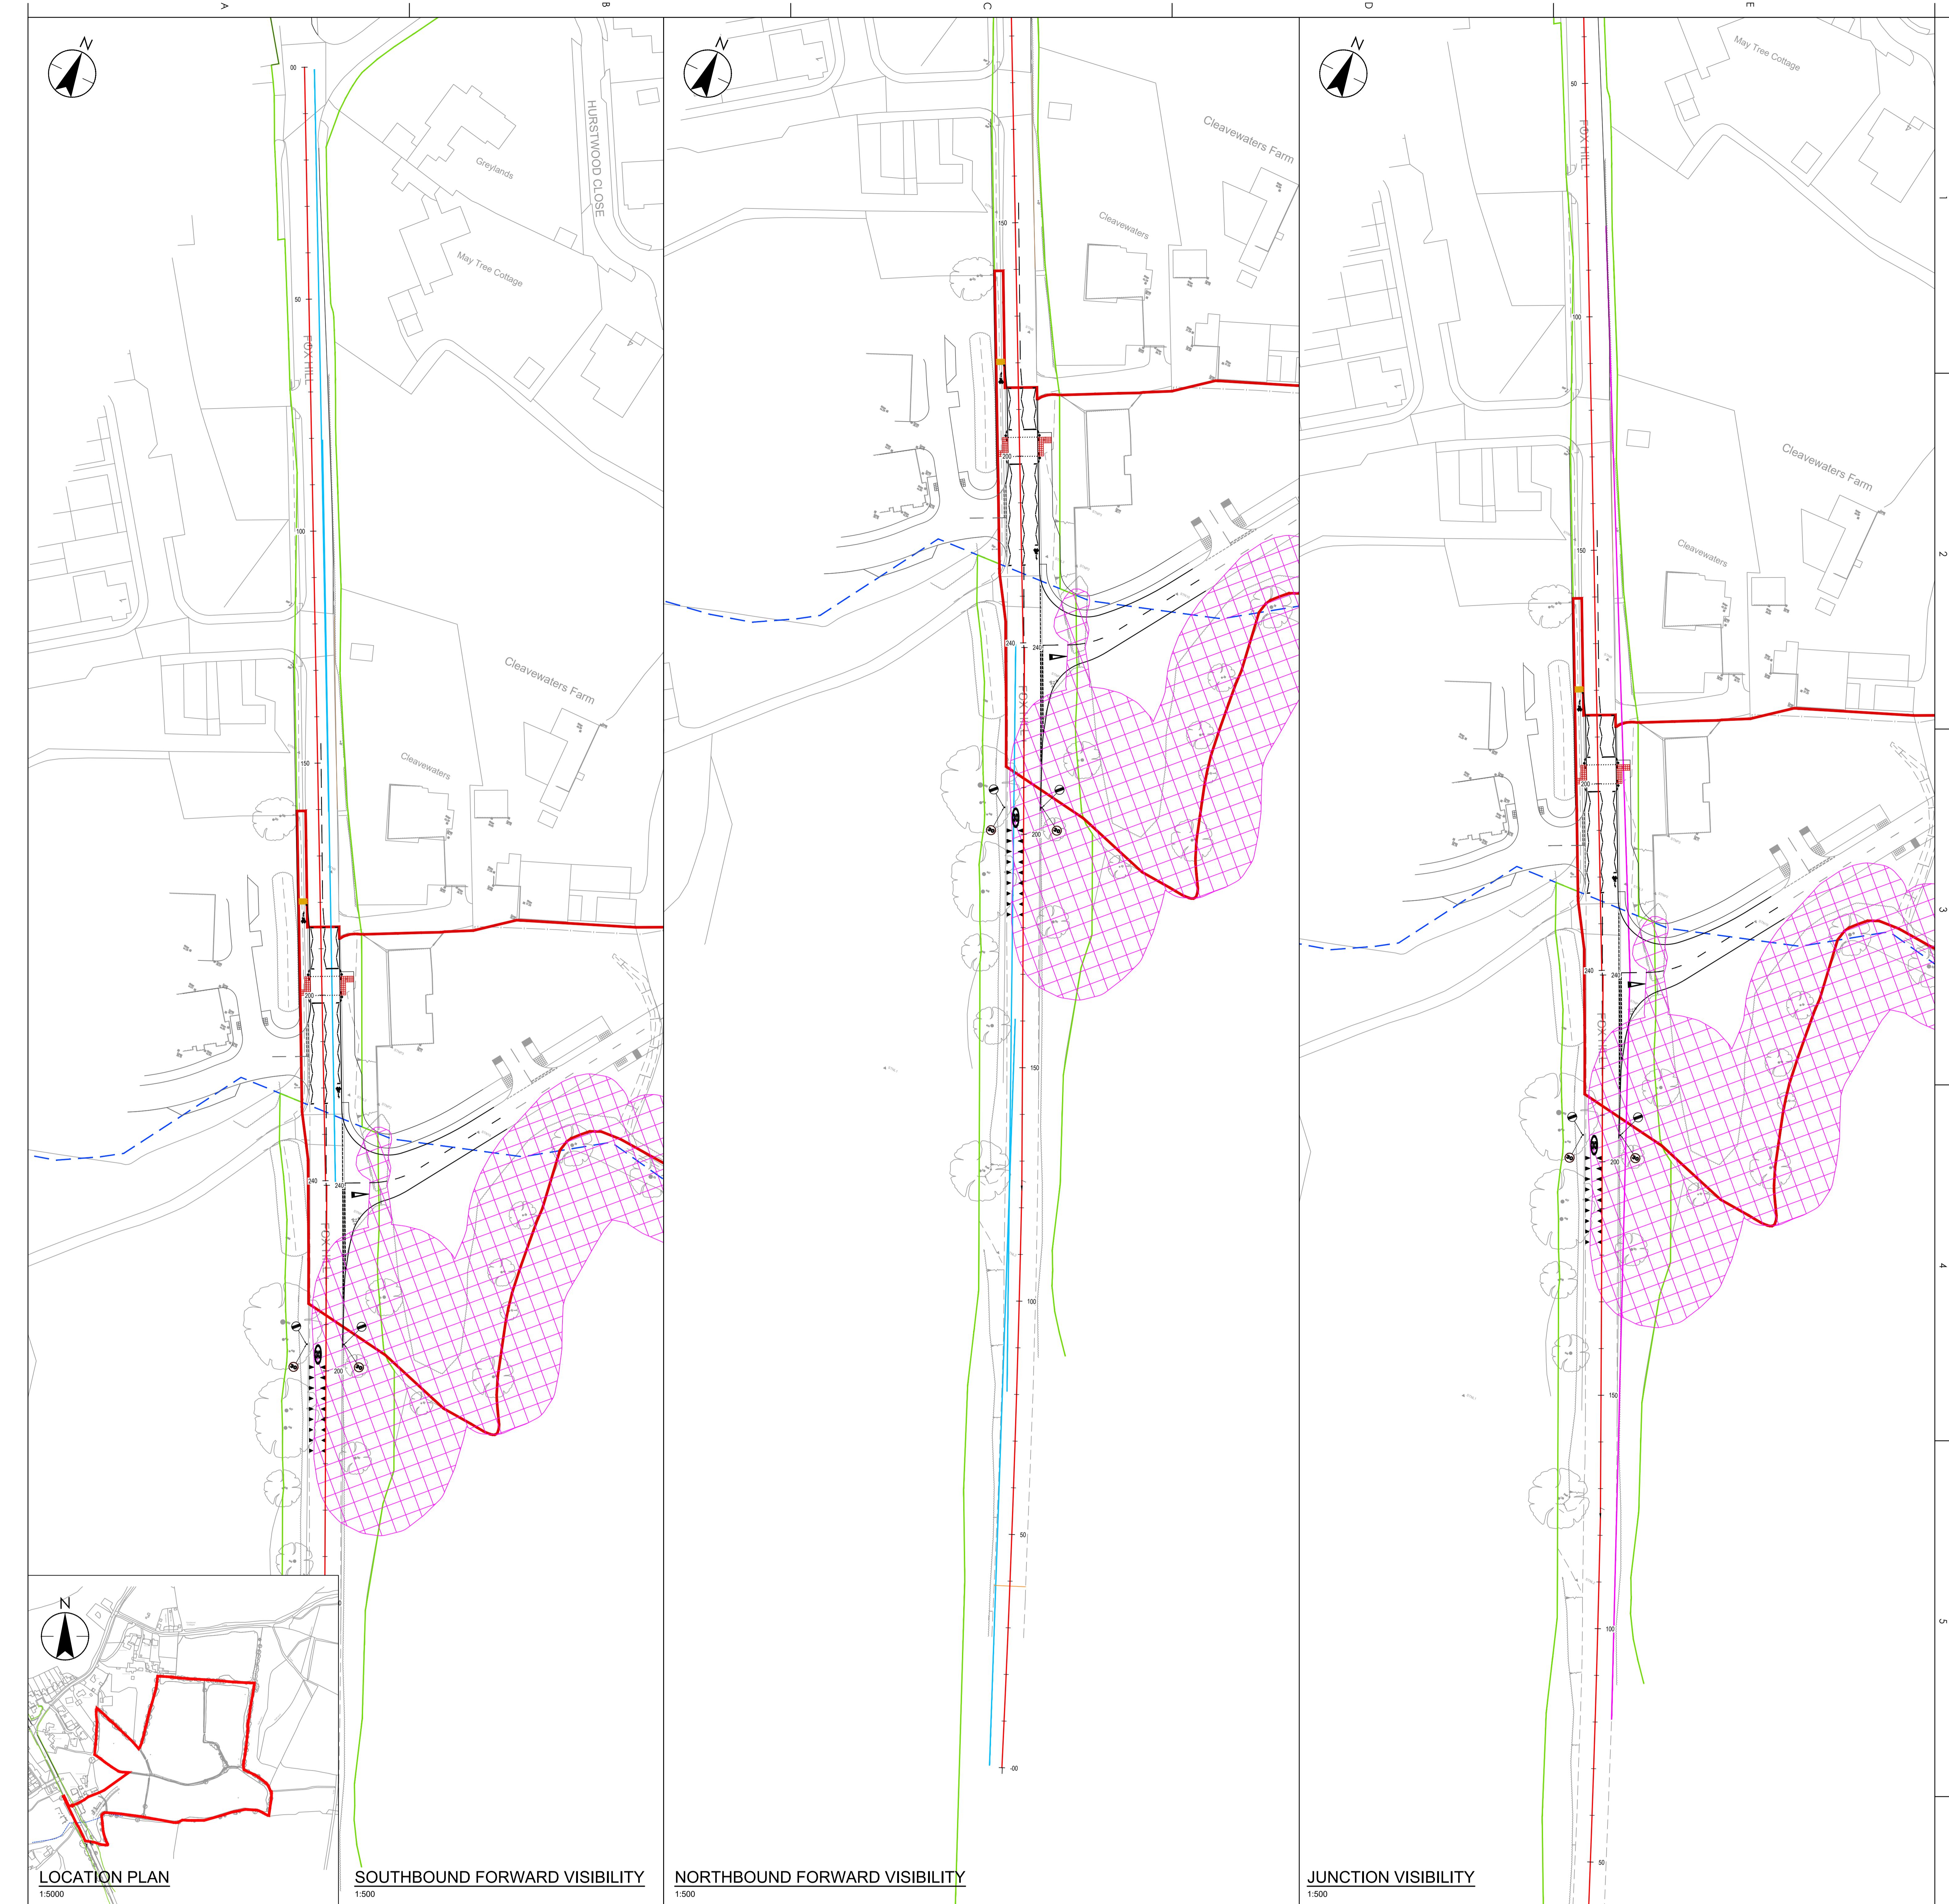
## Appendix C     **Visibilities Drawing**

1. THIS DRAWING IS TO BE READ IN CONJUNCTION WITH CATESBY ESTATES' VISION DOCUMENT.
2. IN ORDER TO MAINTAIN JUNCTION VISIBILITY, ANY AND ALL VEGETATION IN FRONT OF PLOTTED JUNCTION VISIBILITY SPLAYS IS TO BE REGULARLY CLEARED.
3. VISIBILITY SPLAYS HAVE BEEN DRAWN AS PER 85th PERCENTILE SPEEDS DERIVED FROM ATC DATA.
  - NORTHBOUND OBSERVED SPEED: 49mph
  - SOUTHBOUND OBSERVED SPEED: 38mph
4. B212 EXISTING SPEED: 60mph
5. B212 DESIGN SPEED: 85kph (50mph).

Road Safety Audit Decision Log				
RSA Problem	RSA Recommendation	Design Organisation Response	Overseeing Organisation Response	Agreed RSA Action
<b>3.1</b>  <b>Location:</b> Lunce's Hill; Site Access Junction  <b>Summary:</b> Insufficient visibility may lead to pull-out type vehicle collisions.  Visibility to the left for road users waiting at the give way line of the site access to pull-out onto Lunce's Hill is likely to be reduced by the dense vegetation within the eastern verge. Insufficient visibility may lead to pull-out type vehicle collisions.	An adequate visibility splay should be provided, with vegetation cleared within the splay envelope.  It is assumed that the gateway signs will be relocated as part of the gateway feature. This should be clarified at detailed design stage.	Noted and agreed – to be picked up at the detailed design and technical approval stage.  Drawing 332611520-STN-HGN-XX-DR-C-0102 P06 shows the visibilities at the site access, and a note has been added to the drawing regarding vegetation cut back required for the visibility splays to ensure it is picked up at the next design stage.

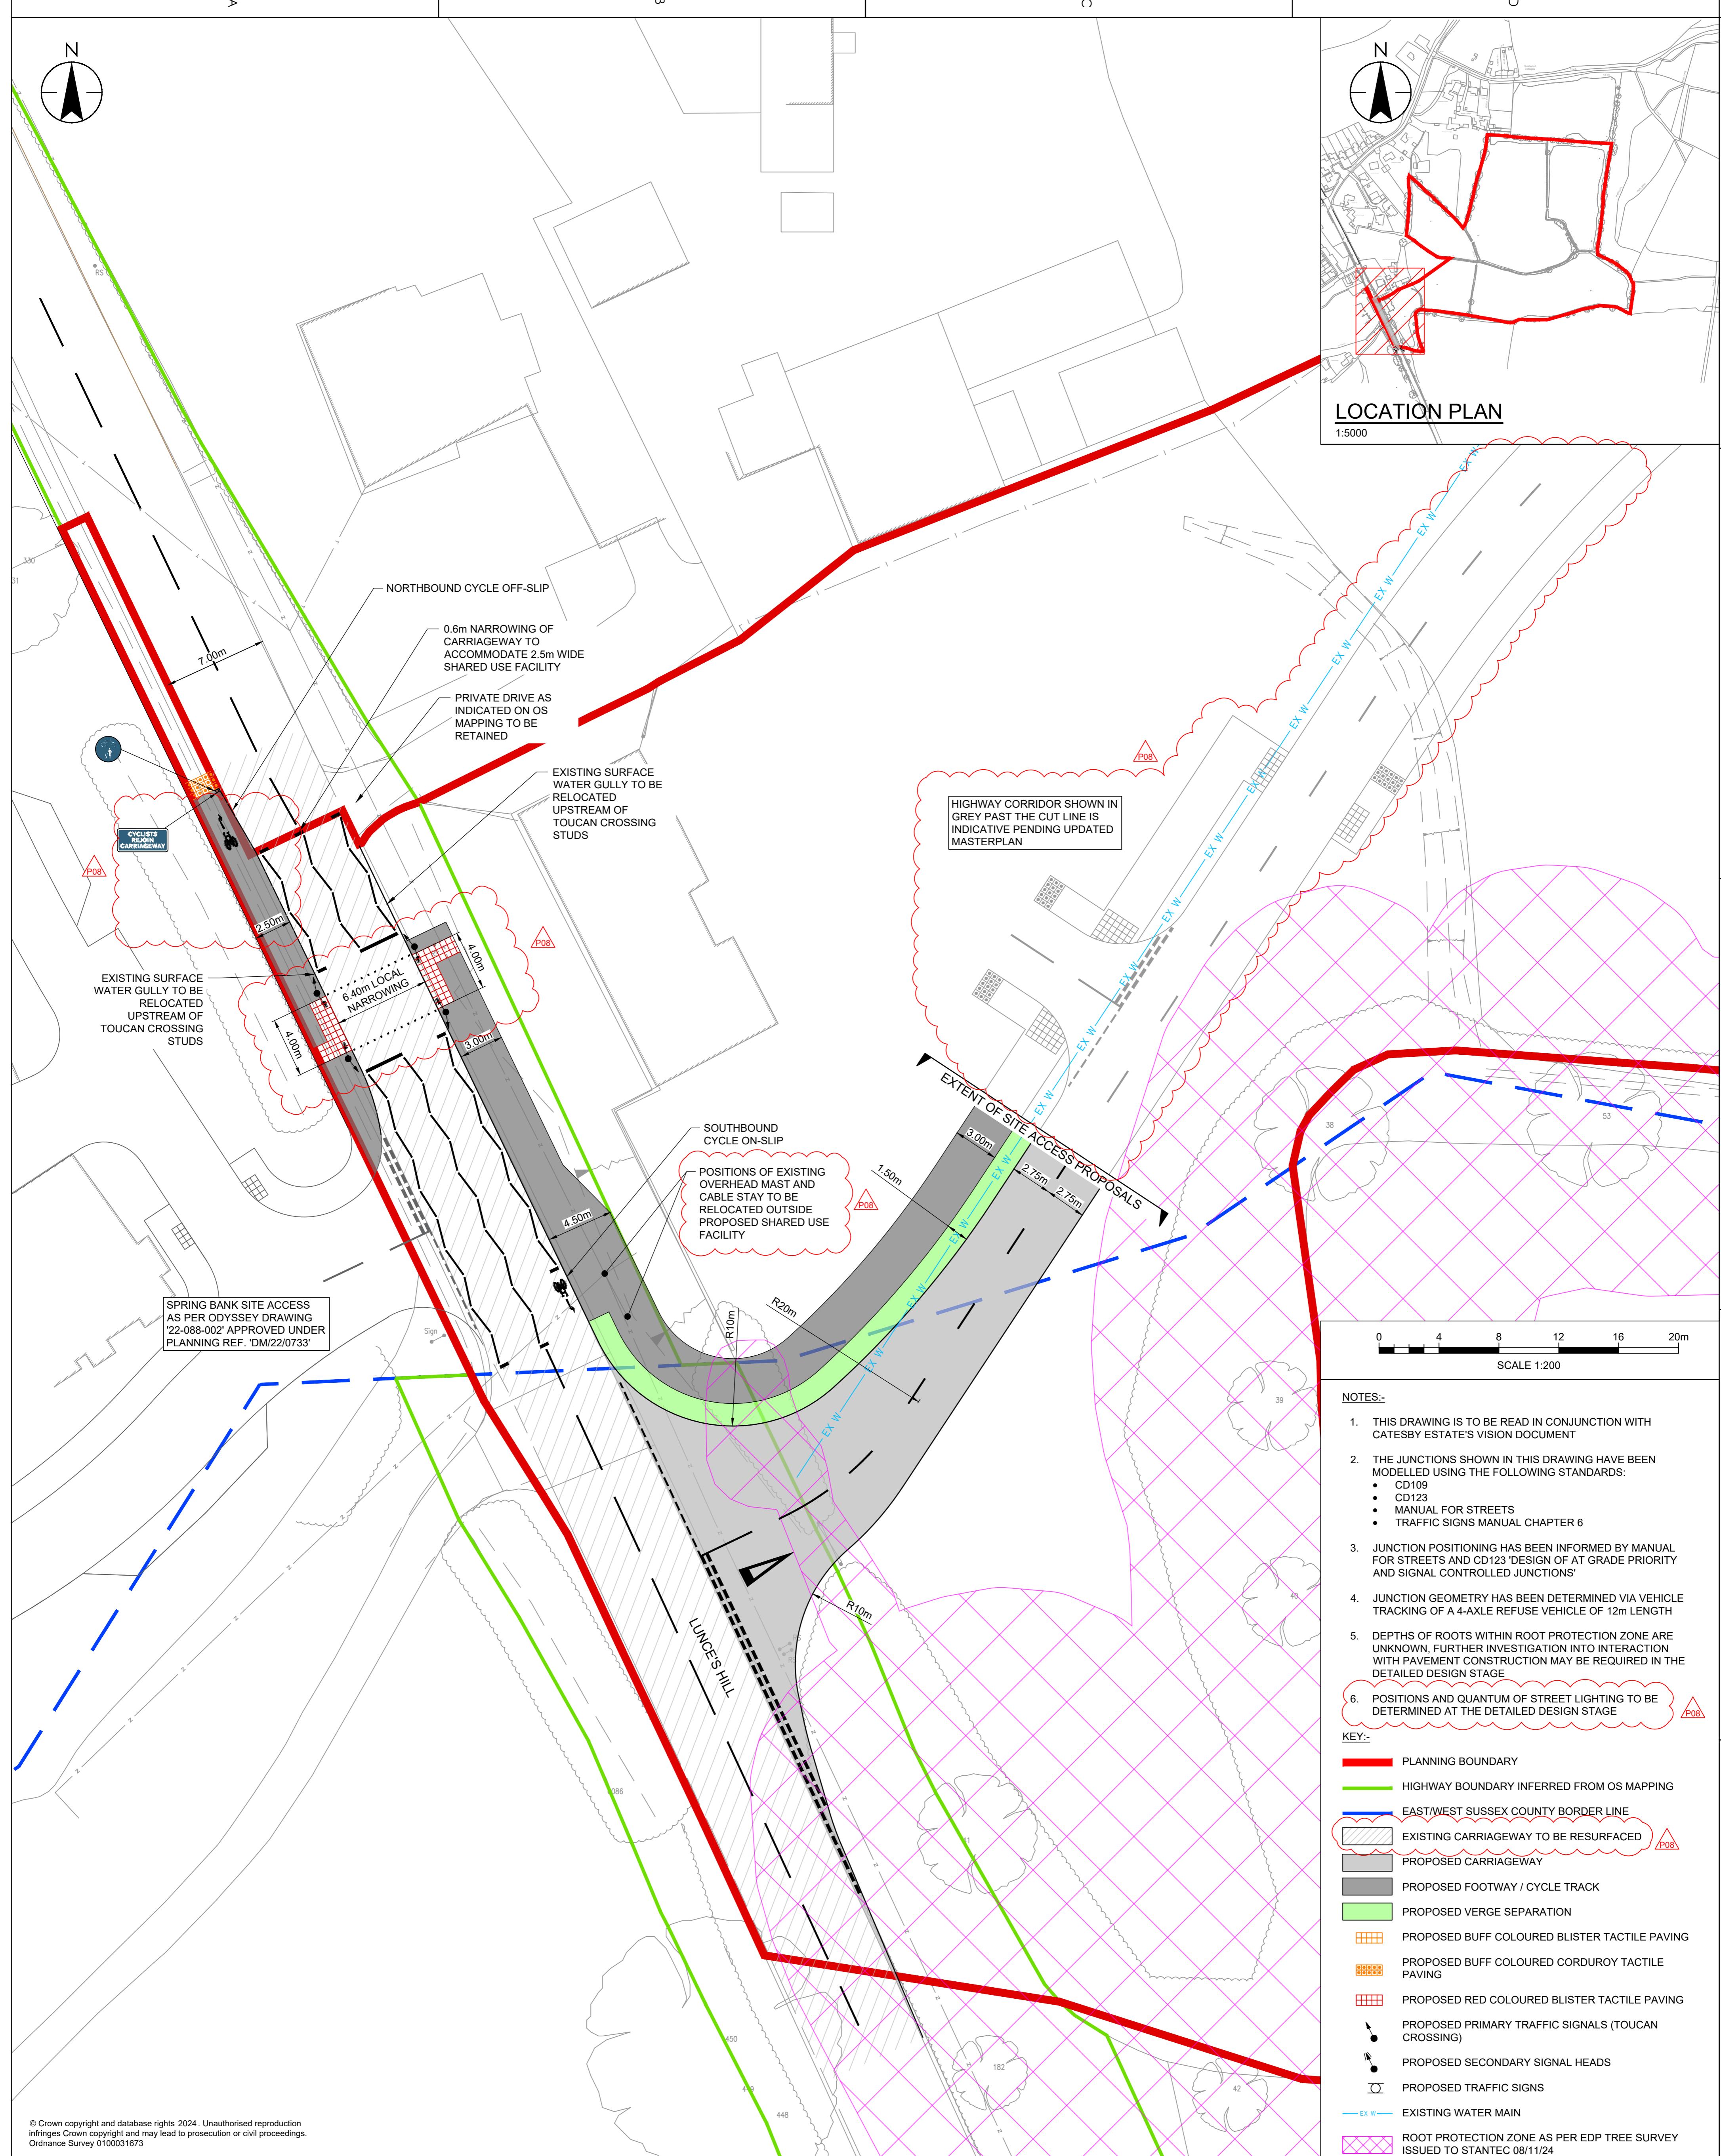
## Appendix D    Site Access Drawing

P08_UPDATES FOLLOWING TMS STAGE 1 RSA	BB	DL	2025.09.30
P07_AT/ON/NEAR TOUCAN ACCESS PLAN	BB	NP	2025.07.21
P06_SCALE BAR ADDED	BB	NF	2025.03.05
P05_UPDATED SITE BOUNDARY	BB	NF	2025.01.13
P04_RELLOCATION OF PUFFIN CROSSING	BB	NF	2024.12.13
P03_NARROWING OF EDGE PROVING MAP	BB	MH	2024.11.19
P02_REALIGNMENT FOLLOWING TREE SURVEY	BB	MH	2024.11.13
P01_FIRST ISSUE	BB	MH	2024.08.23
Issued/Revision	By	Appld	YYYY.MM.DD

*"I have reviewed the updated drawing that you sent through (C-0103 P02) and I can confirm that we do not have any additional safety comments to raised in relation to the widened toucan crossing and other minor design changes."*

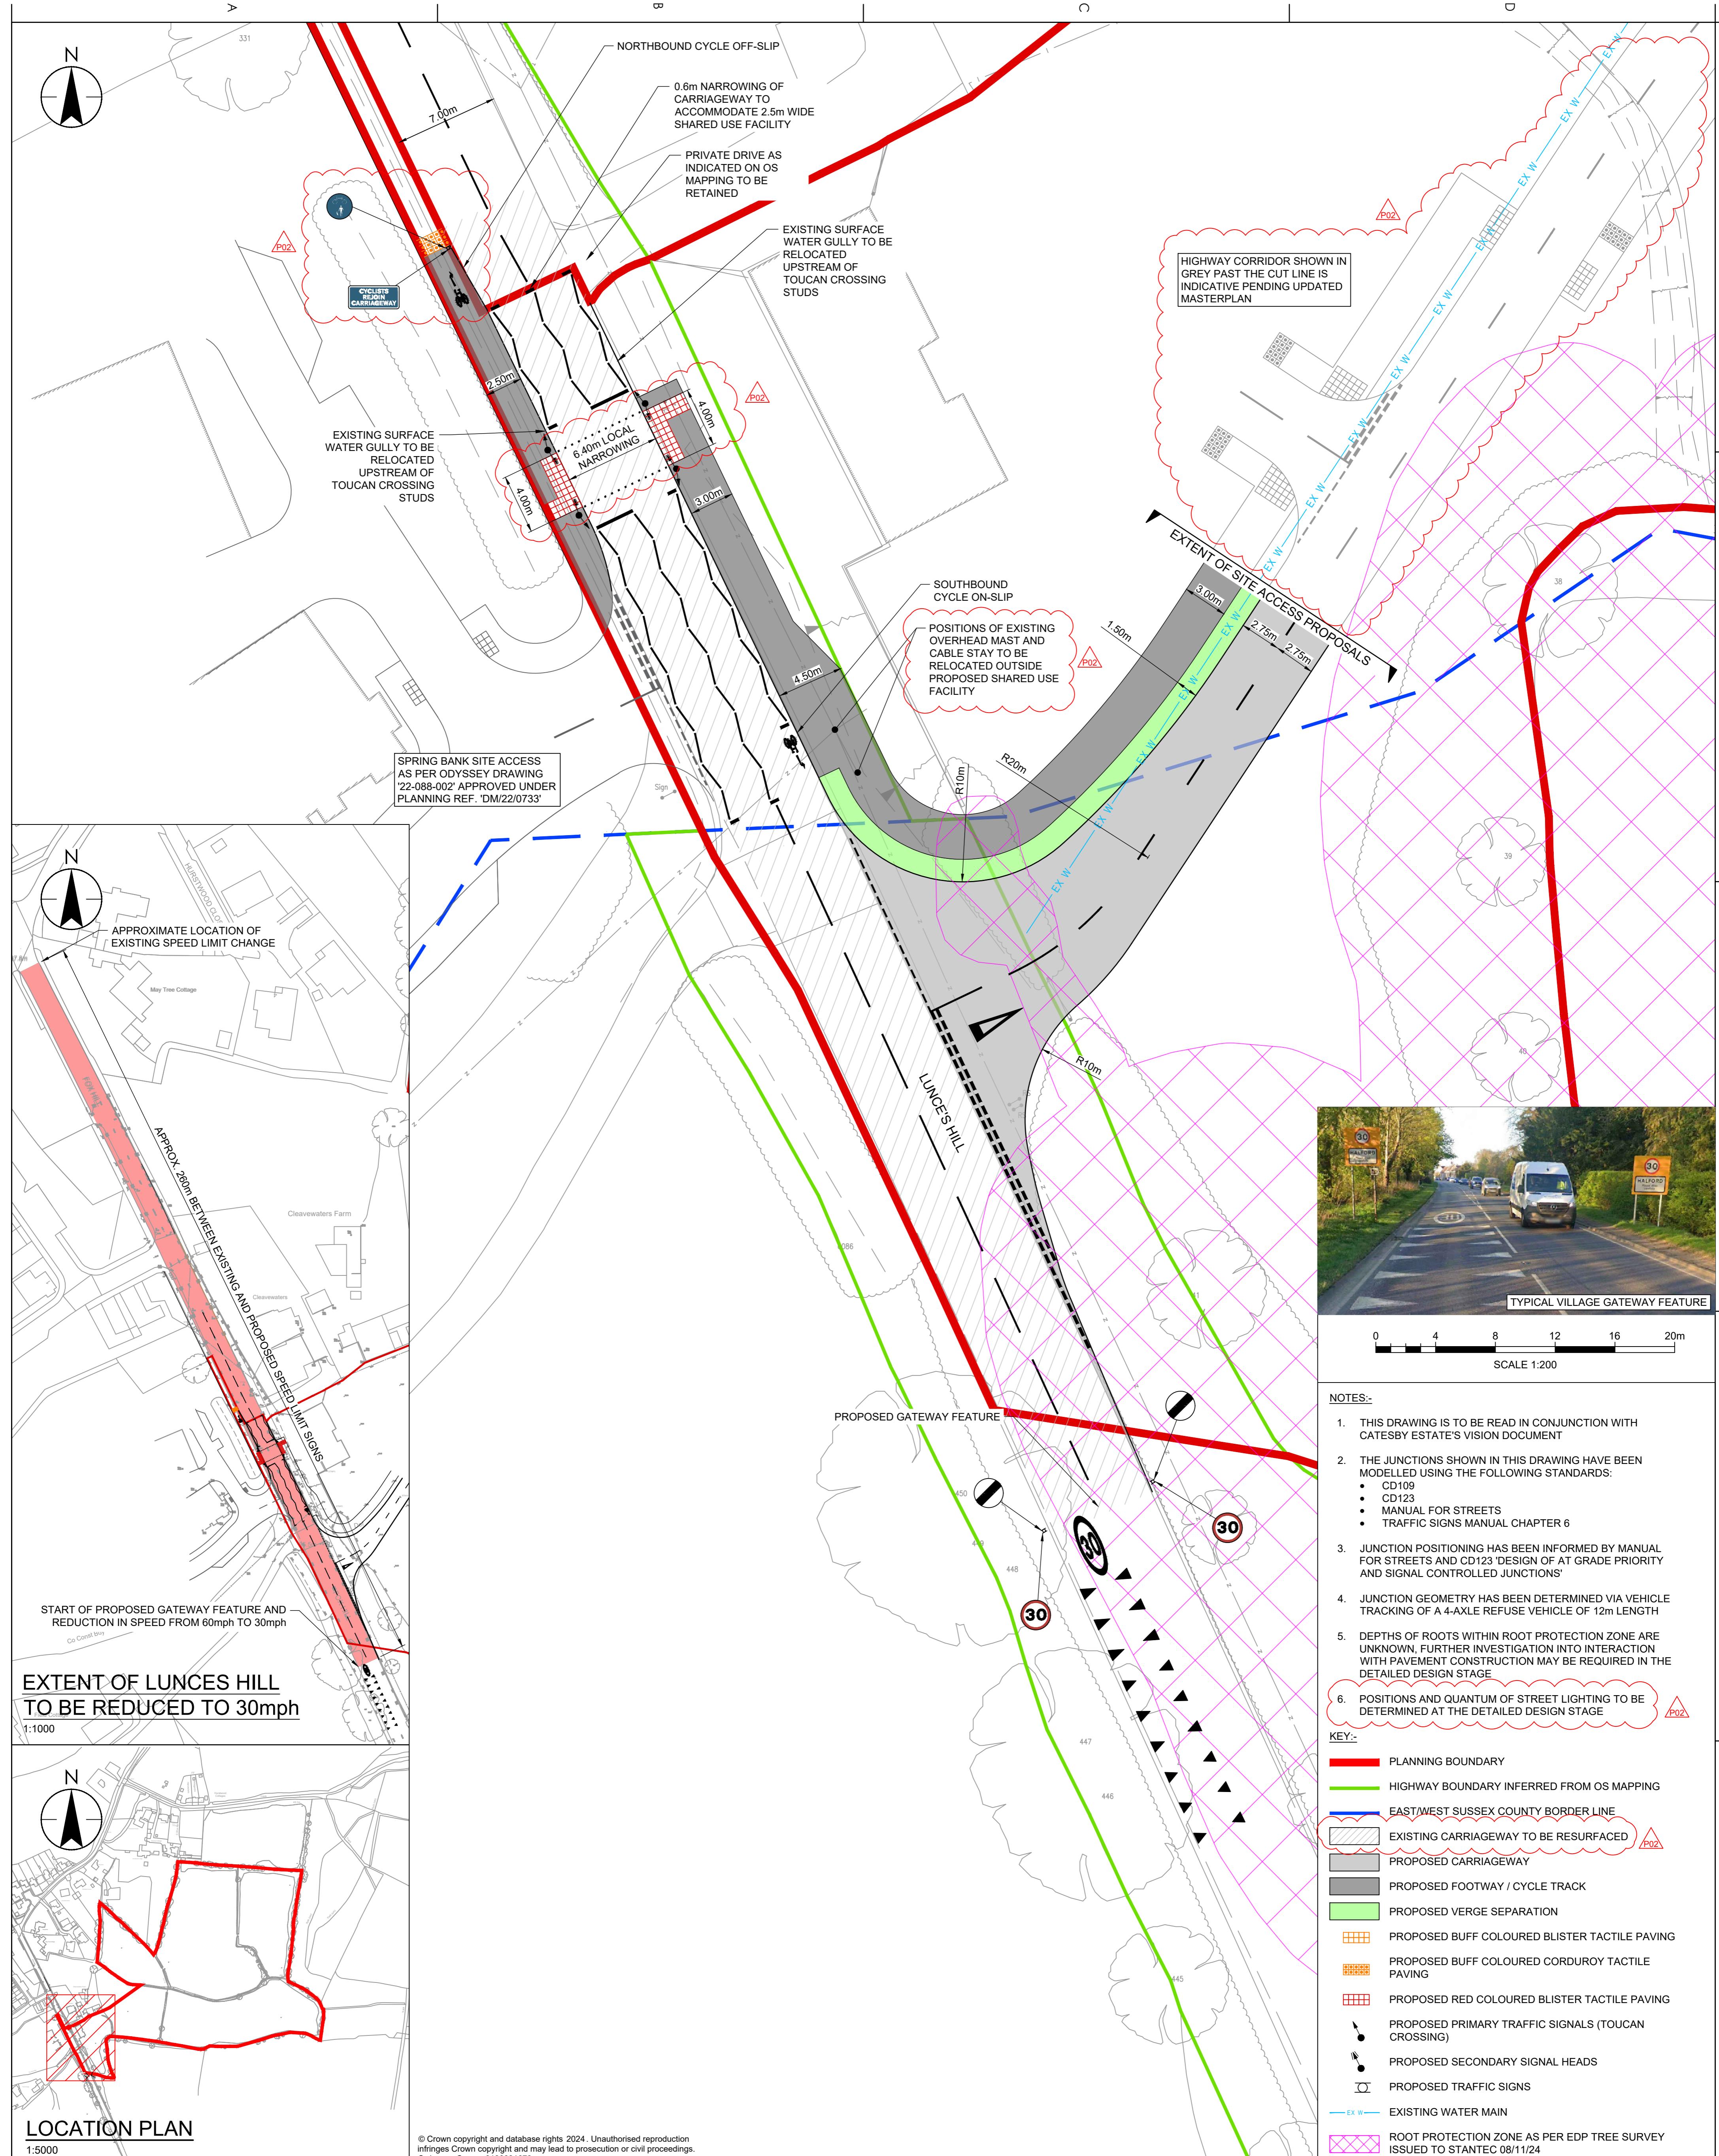
## **Appendix E      Site Access Drawing – Gateway Feature Option**

Client/Project:	Catesby Estates	Issue Status	PLANNING	Notes:
Project No.:	332611520			UNLISTED NOTE: The position of any existing public or private services, including gas, water, electricity, telephone, drainage, oil, fuel, waste, cable, and other services, and any apparatus or plant used in connection therewith, is not shown on this plan. The position of any such services or apparatus may also be present but not shown. Other such plant or investigation is therefore advised to undertake their own services, plant or apparatus may affect their operations.
Drawn:	BB	BB	2025.03.22	Drawn:
Design:	BB	DL	2025.09.30	Design:
Title:	YNTYAMDD	Appd	2025.09.21	YNTYAMDD
Feature Option:		Issued/Revision		
Haywards Heath Site Access				
General Arrangement				
Speed Limit Reduction / Gateway				
Scale: 1:200				
Revision: P01				
Drawing No. 332611520-HGN-XX-DR-C-0103

<b>3.14</b>  <b>OBSERVATION:</b>  The scheme proposed to introduce a new 30mph speed limit (down from national speed – 60mph) including the provision of a new gateway feature just to the south of the proposed site access junction on Lunce's Hill. However, it was noted on site that there is already a 30mph speed limit on this section,		<p>Noted that the 30mph speed limit extension has already been introduced.</p> <p>The site access option drawing showing the proposed speed limit extension has not been updated to reflect the actual location as this is currently unclear without topographical survey data. However, the site would still propose introducing the same gateway features identified in Drawing 332611520-STN-HGN-XX-DR-C-0103 P02 at the new speed</p>
