## Bat Emergence and Re-Entry Surveys (BERS)

Whitehouse Farm Cottage, Staplefield Lane, Haywards Heath, RH17 6AU.

“Works to the roof, the conversion of the existing north facing outhouse into a utility room and internal alterations to suit a new layout.”

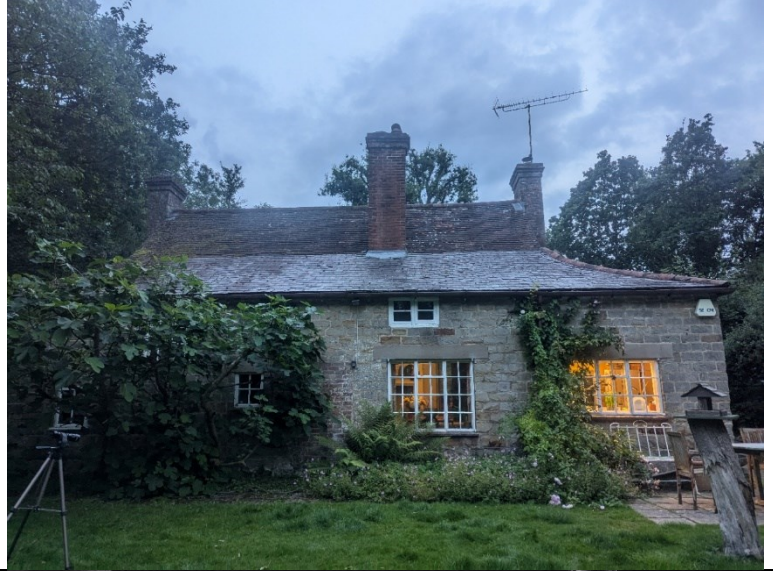
| <i>Surveyor 1</i> | <b>No emergences or re-entries seen;</b> the first bat was a soprano pipistrelle passing east to southeast at 21:11. This was the only soprano pipistrelle seen during the survey. A noctule was heard at 21:15 and seen at 21:20, passing north to south over the vegetated gardens. Common pipistrelles were recorded intermittently throughout the survey from 21:15 to 22:02, passing over the building again from east to southeast and foraging in the treeline to the northeast. A lone brown long-eared was heard but not seen at 21:29. | |

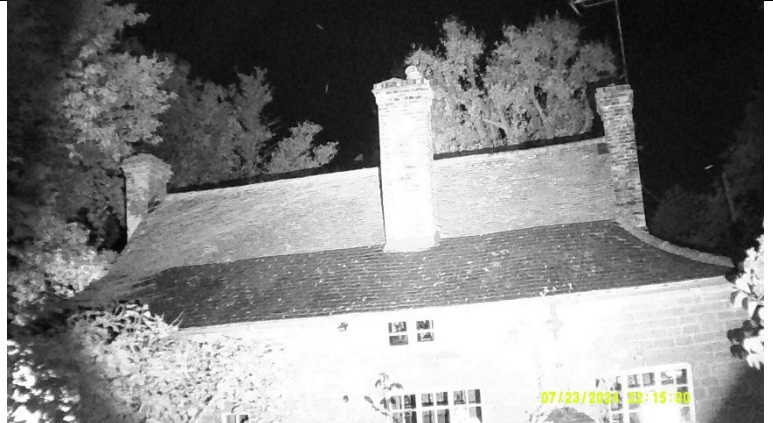
| <i>IR position</i> | No emergences or additional bat activity were recorded. | |

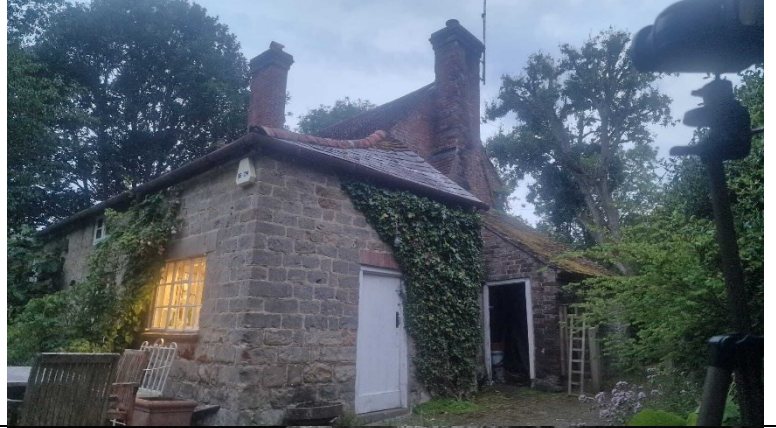
| <i>Surveyor 2</i> | <b>No emergences or re-entries seen.</b> First bat recorded was a noctule at 21:06. Two more noctules were heard but not seen at 21:17 and 21:19. The first common pipistrelle was seen at 21:11, common pipistrelle activity was intermittent throughout the evening. Final activity of the survey was a common pipistrelle heard but not seen at 22:03. | |

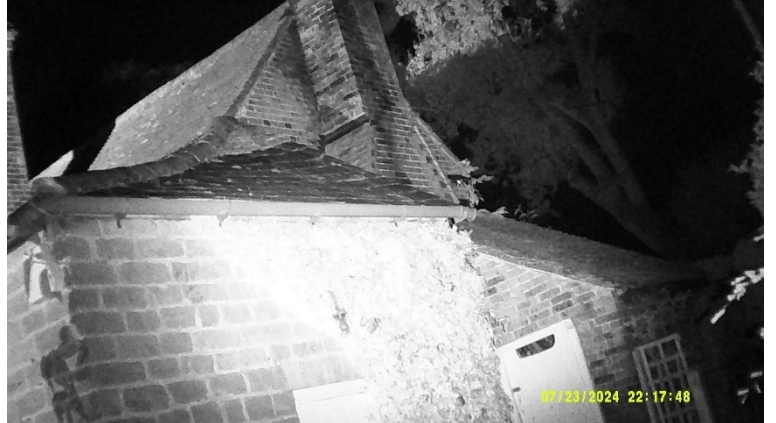
| <i>IR position</i> | No emergences or additional bat activity were recorded. | |

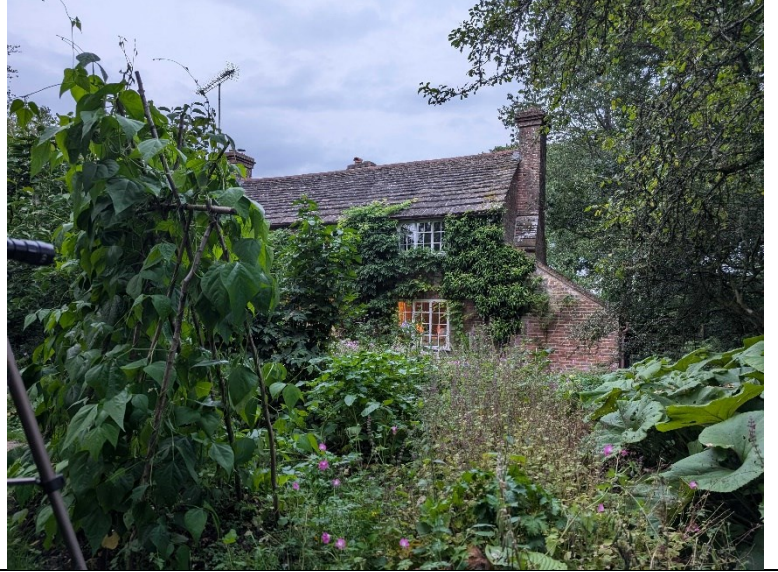
| <i>Surveyor 3</i> | <p><b>No emergences or re-entries seen.</b> The first common pipistrelle pass was at 21:02 with regular activity occurring after this foraging in the adjacent treeline. A noctule was seen at 21:17 commuting south to north above B1. The bat passed four more times at 21:20, 21:42, 22:16 and 22:23 and could be heard foraging. Common pipistrelles dominated the rest of the activity being heard and seen intermittently foraging and social calling until 22:20, circling the building and passing north to south.</p> | |

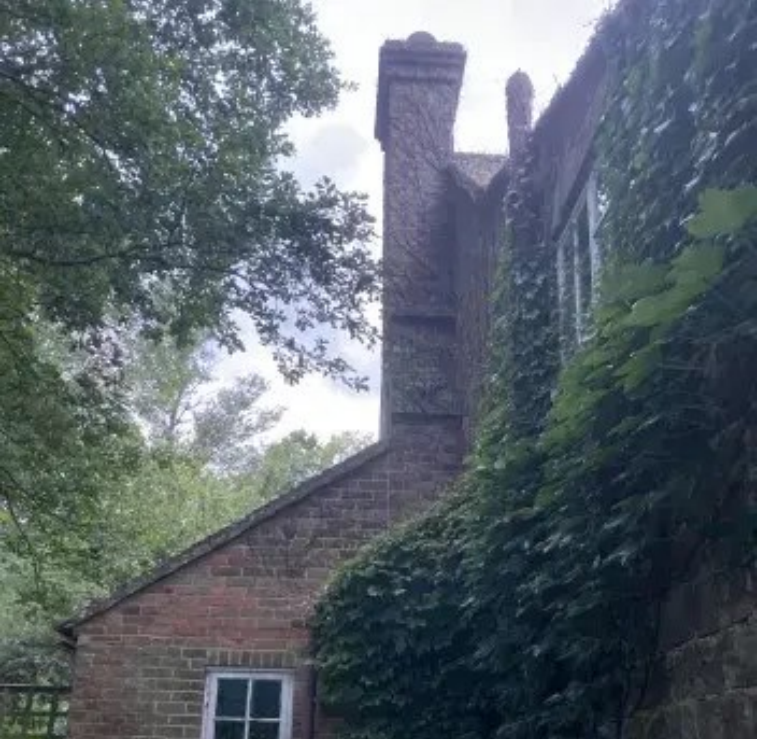
| <p><i>Surveyor 4</i></p> | <p><b>No emergences or re-entries seen.</b> First bat was a noctule that was heard but not seen at 21:06. IR review shows it pass directly behind surveyor position. Common pipistrelles were heard but not seen throughout the night (21:17, 21:19, 21:28, 21:32, 22:02). Noctules were also heard at 21:17, 21:19 &amp; 22:16. At 21:42 a Leisler's noctule was heard social calling. The final bat was a noctule that was heard but not seen at 22:23.</p> | |

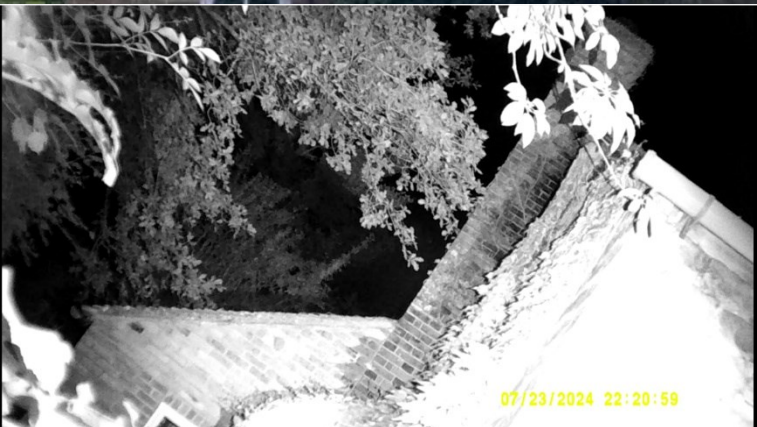
| <p><i>IR position</i></p> | <p>No emergences or additional bat activity were recorded.</p> | |

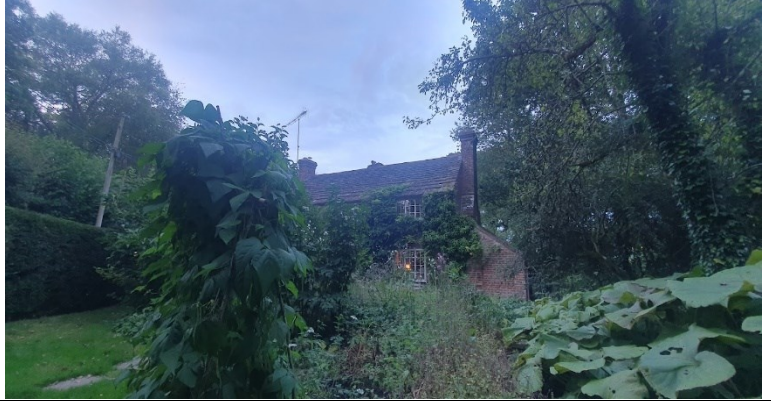
| <i>Surveyor 1</i> | <b>No emergences or re-entries seen.</b> The first bat was a common pipistrelle seen at 20:34 passing from the west and foraging over the garden for 2 minutes, before continuing east over the building. The remaining calls were all heard not seen, brief and faint. Three were common pipistrelle heard at 20:54, 21:22 and 21:27. A noctule was also heard at 21:13 and a brown long-eared was heard at 21:41. The last bat was a common pipistrelle, heard not seen at 21:55. | |

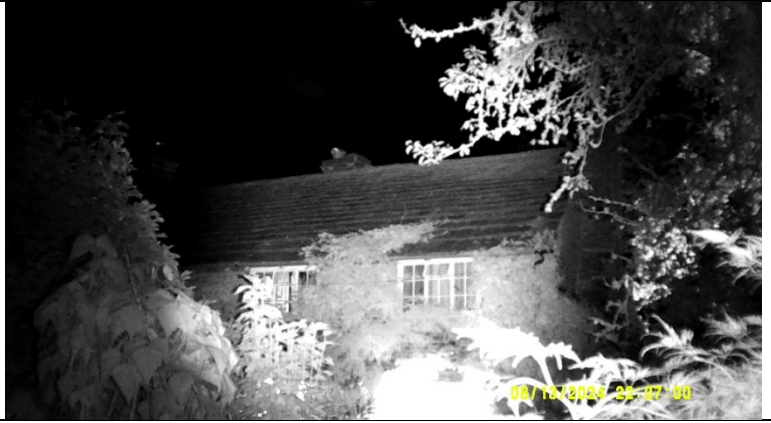
| <i>IR position</i> | No emergences or additional bat activity were recorded. | |

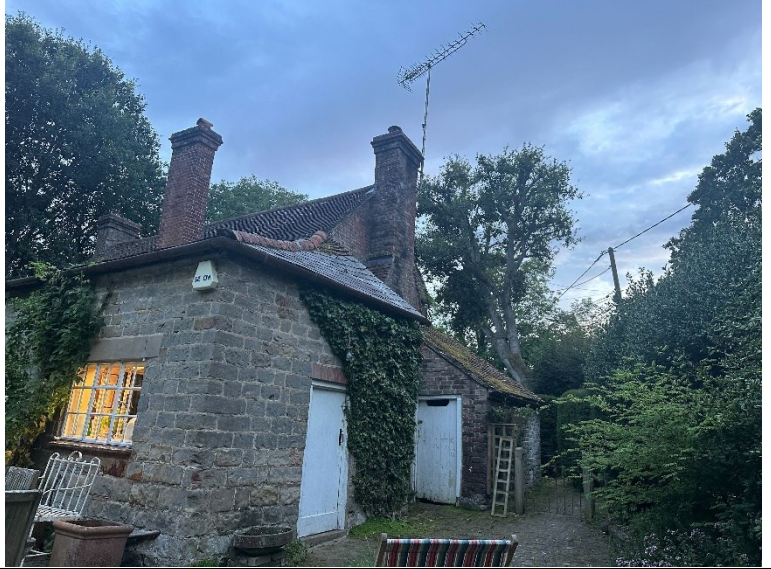
| <i>Surveyor 2</i> | <b>No emergences or re-entries seen.</b> The first common pipistrelle was seen foraging around the eastern elevation at 20:38, this was followed by frequent common pipistrelles being heard not seen until 21:42. At 20:42 a noctule was heard not seen, and at 21:25 a brown long-eared was heard not seen. The final bat activity noted was an unseen common pipistrelle at 21:42. | |

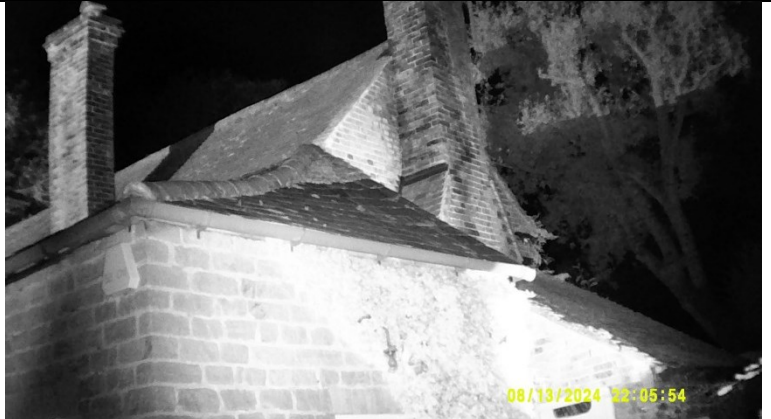
| <i>IR position</i> | No emergences or additional bat activity were recorded. | |

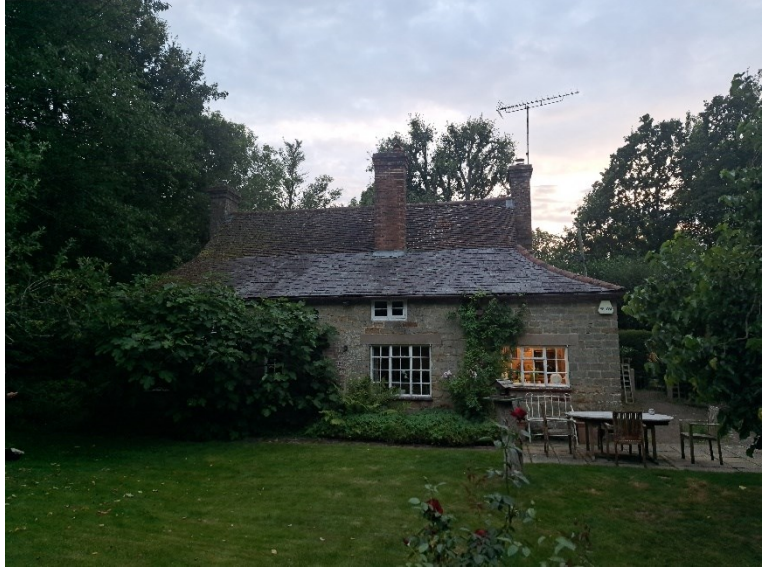
| <i>Surveyor 3</i> | <p><b>No emergences or re-entries seen.</b> The first bat was a noctule heard but not seen at 20:26. There was intermittent noctule activity heard but not seen throughout the survey. Two bats passed silently, first at 20:29 and again at 20:32, passing by the southeastern and western tree lines. Sound analysis reveals no echolocation emitted at this time. Intermittent foraging observed around the tree canopy throughout survey by all species observed. Common pipistrelles were observed foraging and social calling throughout the survey from 20:33 to 21:24 in groups of up to three in four-minute intervals. Brown long-eared bats were seen foraging around the tree on the southeastern boundary, flying in a northerly direction at 20:59 and 21:25. Another was heard but not seen foraging at 21:47. A Leisler's noctule was heard but not seen at 21:26 and 21:32. A myotis species was seen passing at 20:53 over the property from the southwest, heading in a north easterly direction.</p> <p>The last bat seen was a brown long eared bat foraging at 21:49, flying from the northwest heading towards southeast boundary. The last bat heard but not seen was a common pipistrelle at 21:55.</p> | |

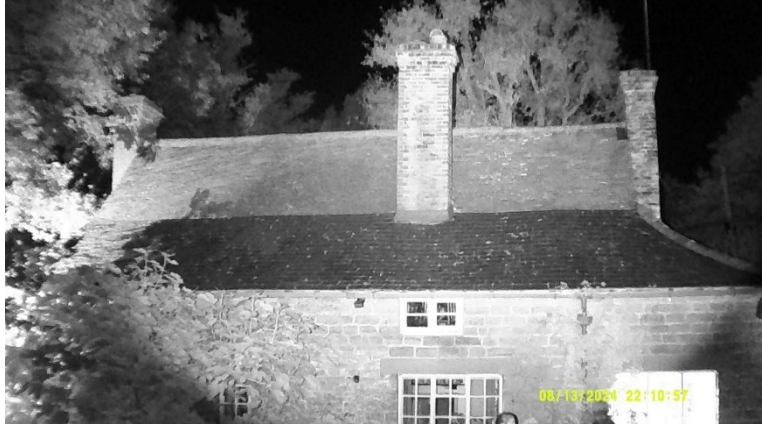
| <i>IR position</i> | No emergences or additional bat activity were recorded. | A nighttime photograph of Whitehouse Farm Cottage. The image shows the roofline with two prominent chimneys. The walls are made of stone or brick. A timestamp in the bottom right corner reads "08/13/2024 22:10:57". |

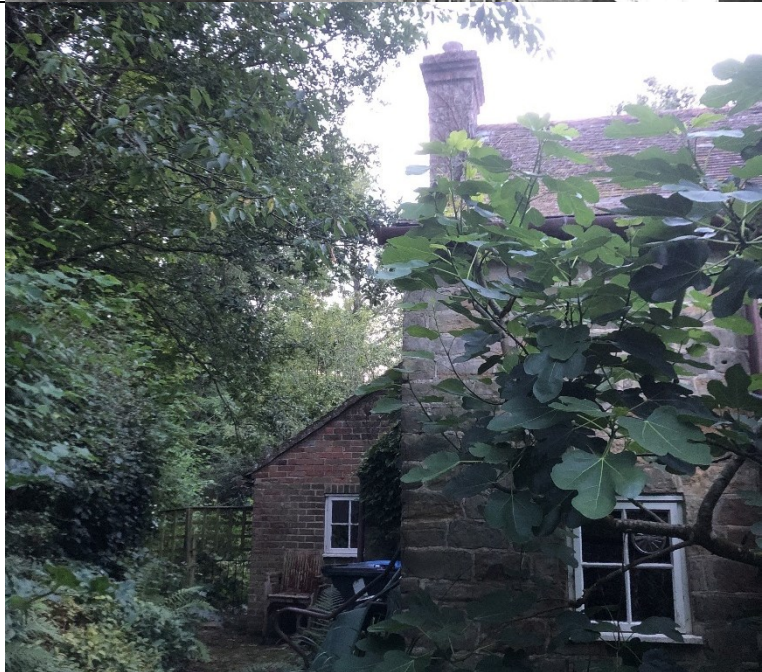
| <i>Surveyor 4</i> | <b>No emergences or re-entries seen.</b> The first bat activity was a common pipistrelle heard and seen foraging in back garden, east of B1. Common pipistrelles were heard and seen foraging occasionally along the southern elevation and in the back garden until the end of the survey. A noctule was heard not seen at 21:26. Last bat activity was at 21:55, a common pipistrelle heard not seen. | A daytime photograph of Whitehouse Farm Cottage. The image shows the side of the building with a chimney and a window. There are trees and foliage in the foreground and background. The lighting suggests it is daytime. |

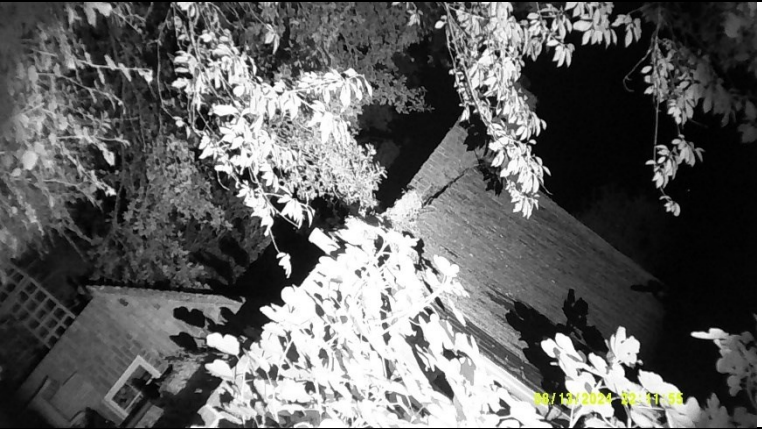
| <i>IR position</i> | No emergences or additional bat activity were recorded. | An infrared photograph showing a dark, textured roof of a building, likely the Whitehouse Farm Cottage, partially obscured by bright, leafy branches in the foreground. The background is dark, suggesting a night scene. A small yellow timestamp '08/10/2004 00:11:03' is visible in the bottom right corner of the image. |
