# Preliminary Ecological Appraisal and Preliminary Roost Assessment

**Survey site:** Badgers Brook, London Road, Bolney, RH17 5PY

**Client:** MGR Horsham Ltd

This report is prepared to inform a planning application with the Mid Sussex District Council. The proposal is described as:  
The demolition of the current buildings on site and the construction of six residential dwellings.

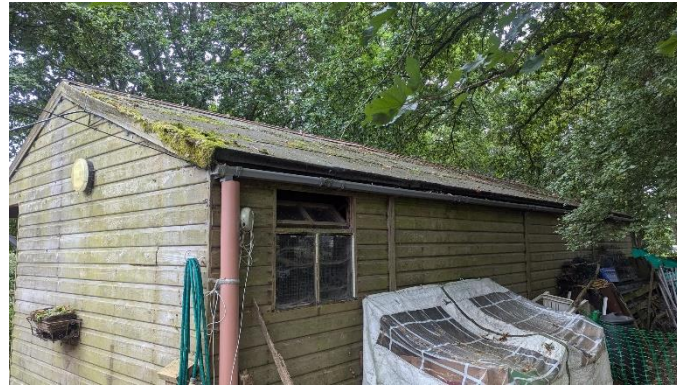
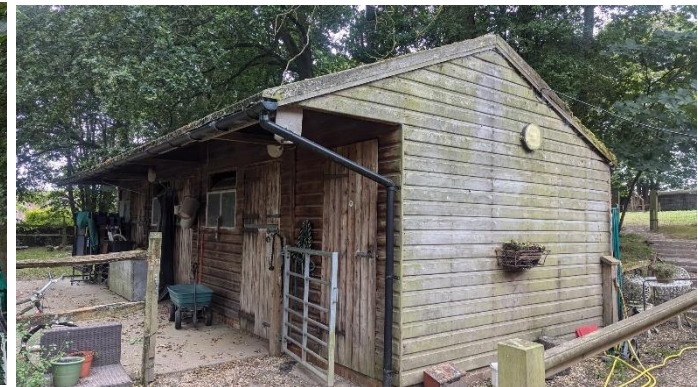
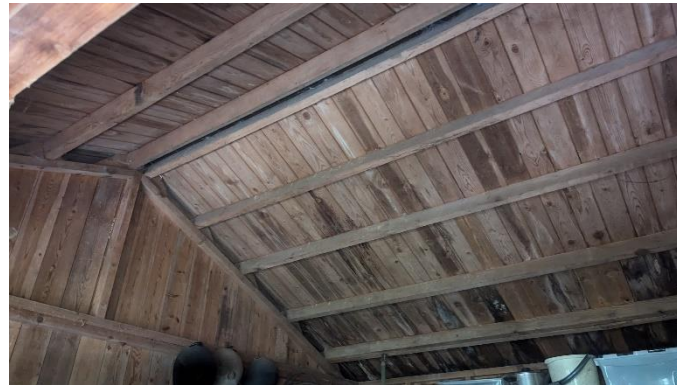
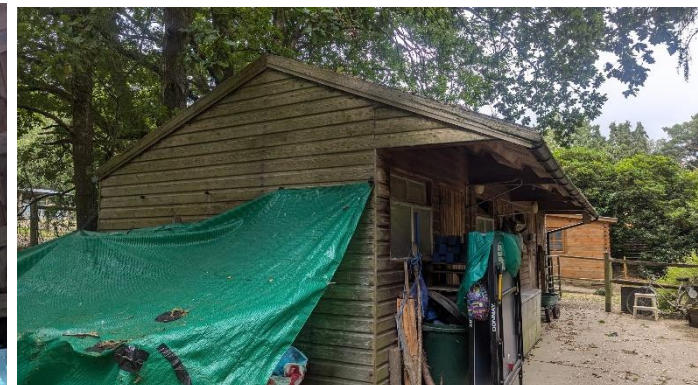
## B2

B2 is a single storey stables with a gabled, bitumen felt lined roof. The doors, windows, and cladding are all timber, with no gaps or cracks present. The roofing appears in good condition with no gaps or tears present. There are gaps present at the eaves leading into the interior of the building. Additionally, the doors of the stables are often left open providing access to the interior of the building.

The interior roof is lined with timber sarking. Although doors are left open and gaps are present which lead into the interior, the space is not suitable for roosting bats due to the abundance of light, high levels of activity, and the exposure from external conditions due to the doors left open. Therefore, B1 was found to have negligible habitat value for roosting bats.

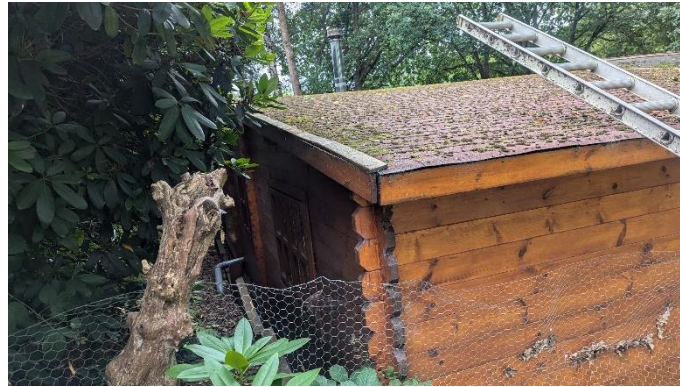
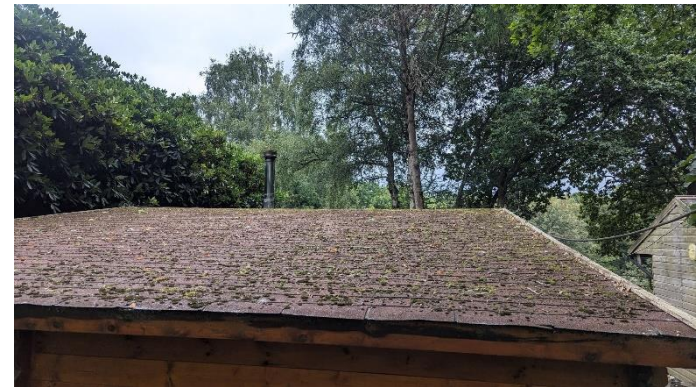
### B3

B3 is a timber cabin with a with a gabled roof lined with bitumen flet. The timber slats have no gaps underneath. The bargeboards, soffits, and window and door frames appear in good condition with no gaps present. The bitumen felt has no tears or gaps present. There is no lift space present in this building.

This building was assessed as having negligible roosting value for bats due to the lack of roosting features.

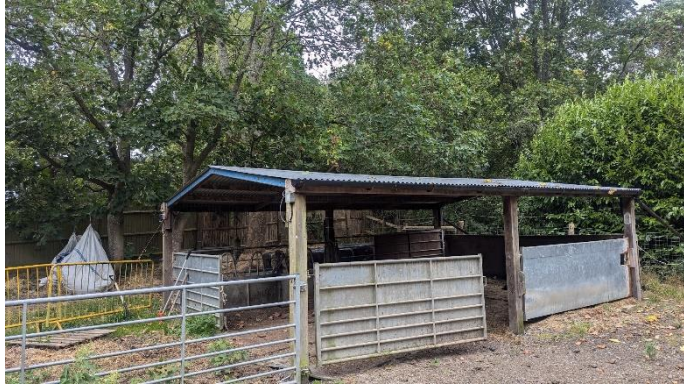
B4 is an open sided shelter constructed of timber beams and a corrugated metal roof. The roof is single skinned so no crevices are present for roosting. The interior is exposed to external conditions and light creating unsuitable habitat for void dwelling bats.

| | <p>This building was assessed as having negligible roosting value for bats due to the lack of roosting features and the abundance of light and exposure.</p> |

| <i>Foreseen Impacts</i> | B4 will be removed according to the proposed plans.. This could result in the destruction or the disturbance and subsequent abandonment of active bird nests. |
| <i>Recommendations</i> | <p>Any building or vegetation removal should be undertaken outside the period 1st March to 31st August. If this timeframe cannot be avoided, a close inspection of the vegetation should be undertaken immediately, by a qualified ecologist, prior to the commencement of work. All active nests will need to be retained until the young have fledged.</p> <p>Precautions should be taken with machinery and noise levels when working close to any retained nests so as not to disturb any nearby nesting birds during construction works. At least a 3-5m buffer should be created between any machinery and active nests until the young have fledged.</p> <p><i>Enhancements:</i></p> <p><i>To enhance nesting opportunities for birds, four bird boxes should be installed on the existing trees. It should be positioned at least 2–4 meters above ground level, away from direct sunlight, prevailing winds, and artificial lighting.</i></p> |

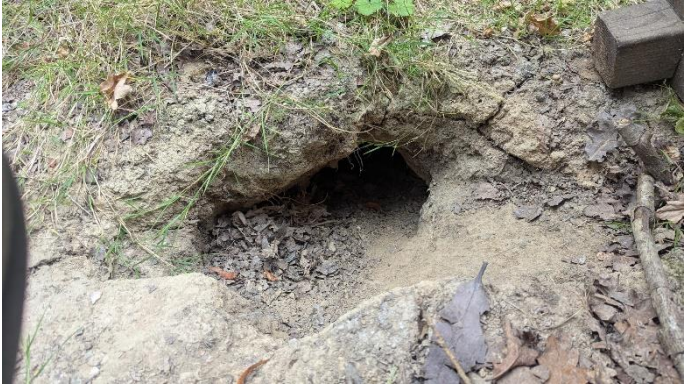
| Badger | |
|---|---|
| Summary of Survey Findings | <p>A single badger hole was present at the northern elevation of the site. The hole had leaf litter present around the entrance. Badgers often keep holes clear, so this indicated a lack of use of the hole. However, badgers often return to holes occasionally.</p> <p>Grassland, woodland, and scrub on site can provide good foraging and commuting habitat for badgers. There is good connectivity to the wider landscape due to hedgerows, grassland, and woodland.</p> |

| Badger | |
|---|---|
| Recommendations | <p>Badger surveys will be required to characterise the sett types present and the usage of the site by badgers. This will comprise the deployment of wildlife cameras over a period of 3-4 weeks and such surveys can be undertaken throughout the year, in accordance with current survey guidelines (Harris et al, 1989). Disturbance, damage or destruction of active badger setts will require a badger development licence.</p> |
