## Plummerden House

## Flood Risk Assessment & Drainage Strategy

241875-FRA\_DS-LB-RS-01

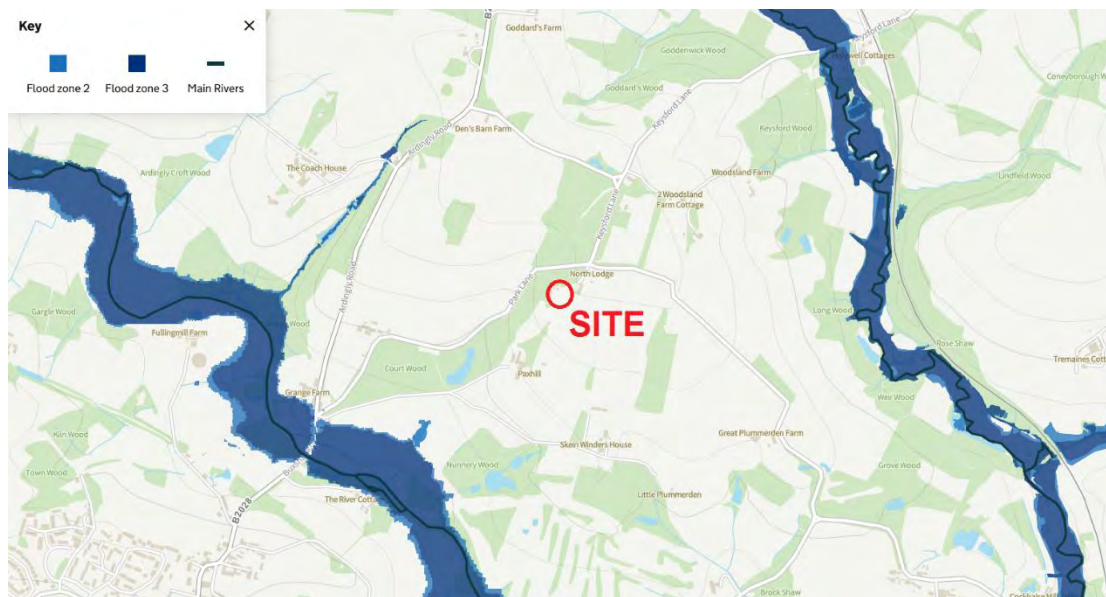
**Figure 3.1 – Flood Zone Mapping**

3.1.3 The EA mapping shows the site to be within Flood Zone 1. For Zone 1, there is a probability of less than 0.1% from river flooding. Figure 3.1 below shows the site's position in relation to the fluvial flood zones.

3.1.4 The unshaded area on the map above shows land in Flood Zone 1, it is clear that the site falls within this area, a significant distance from Zones 2 & 3. Therefore, the site has a flood probability of less than 0.1%.

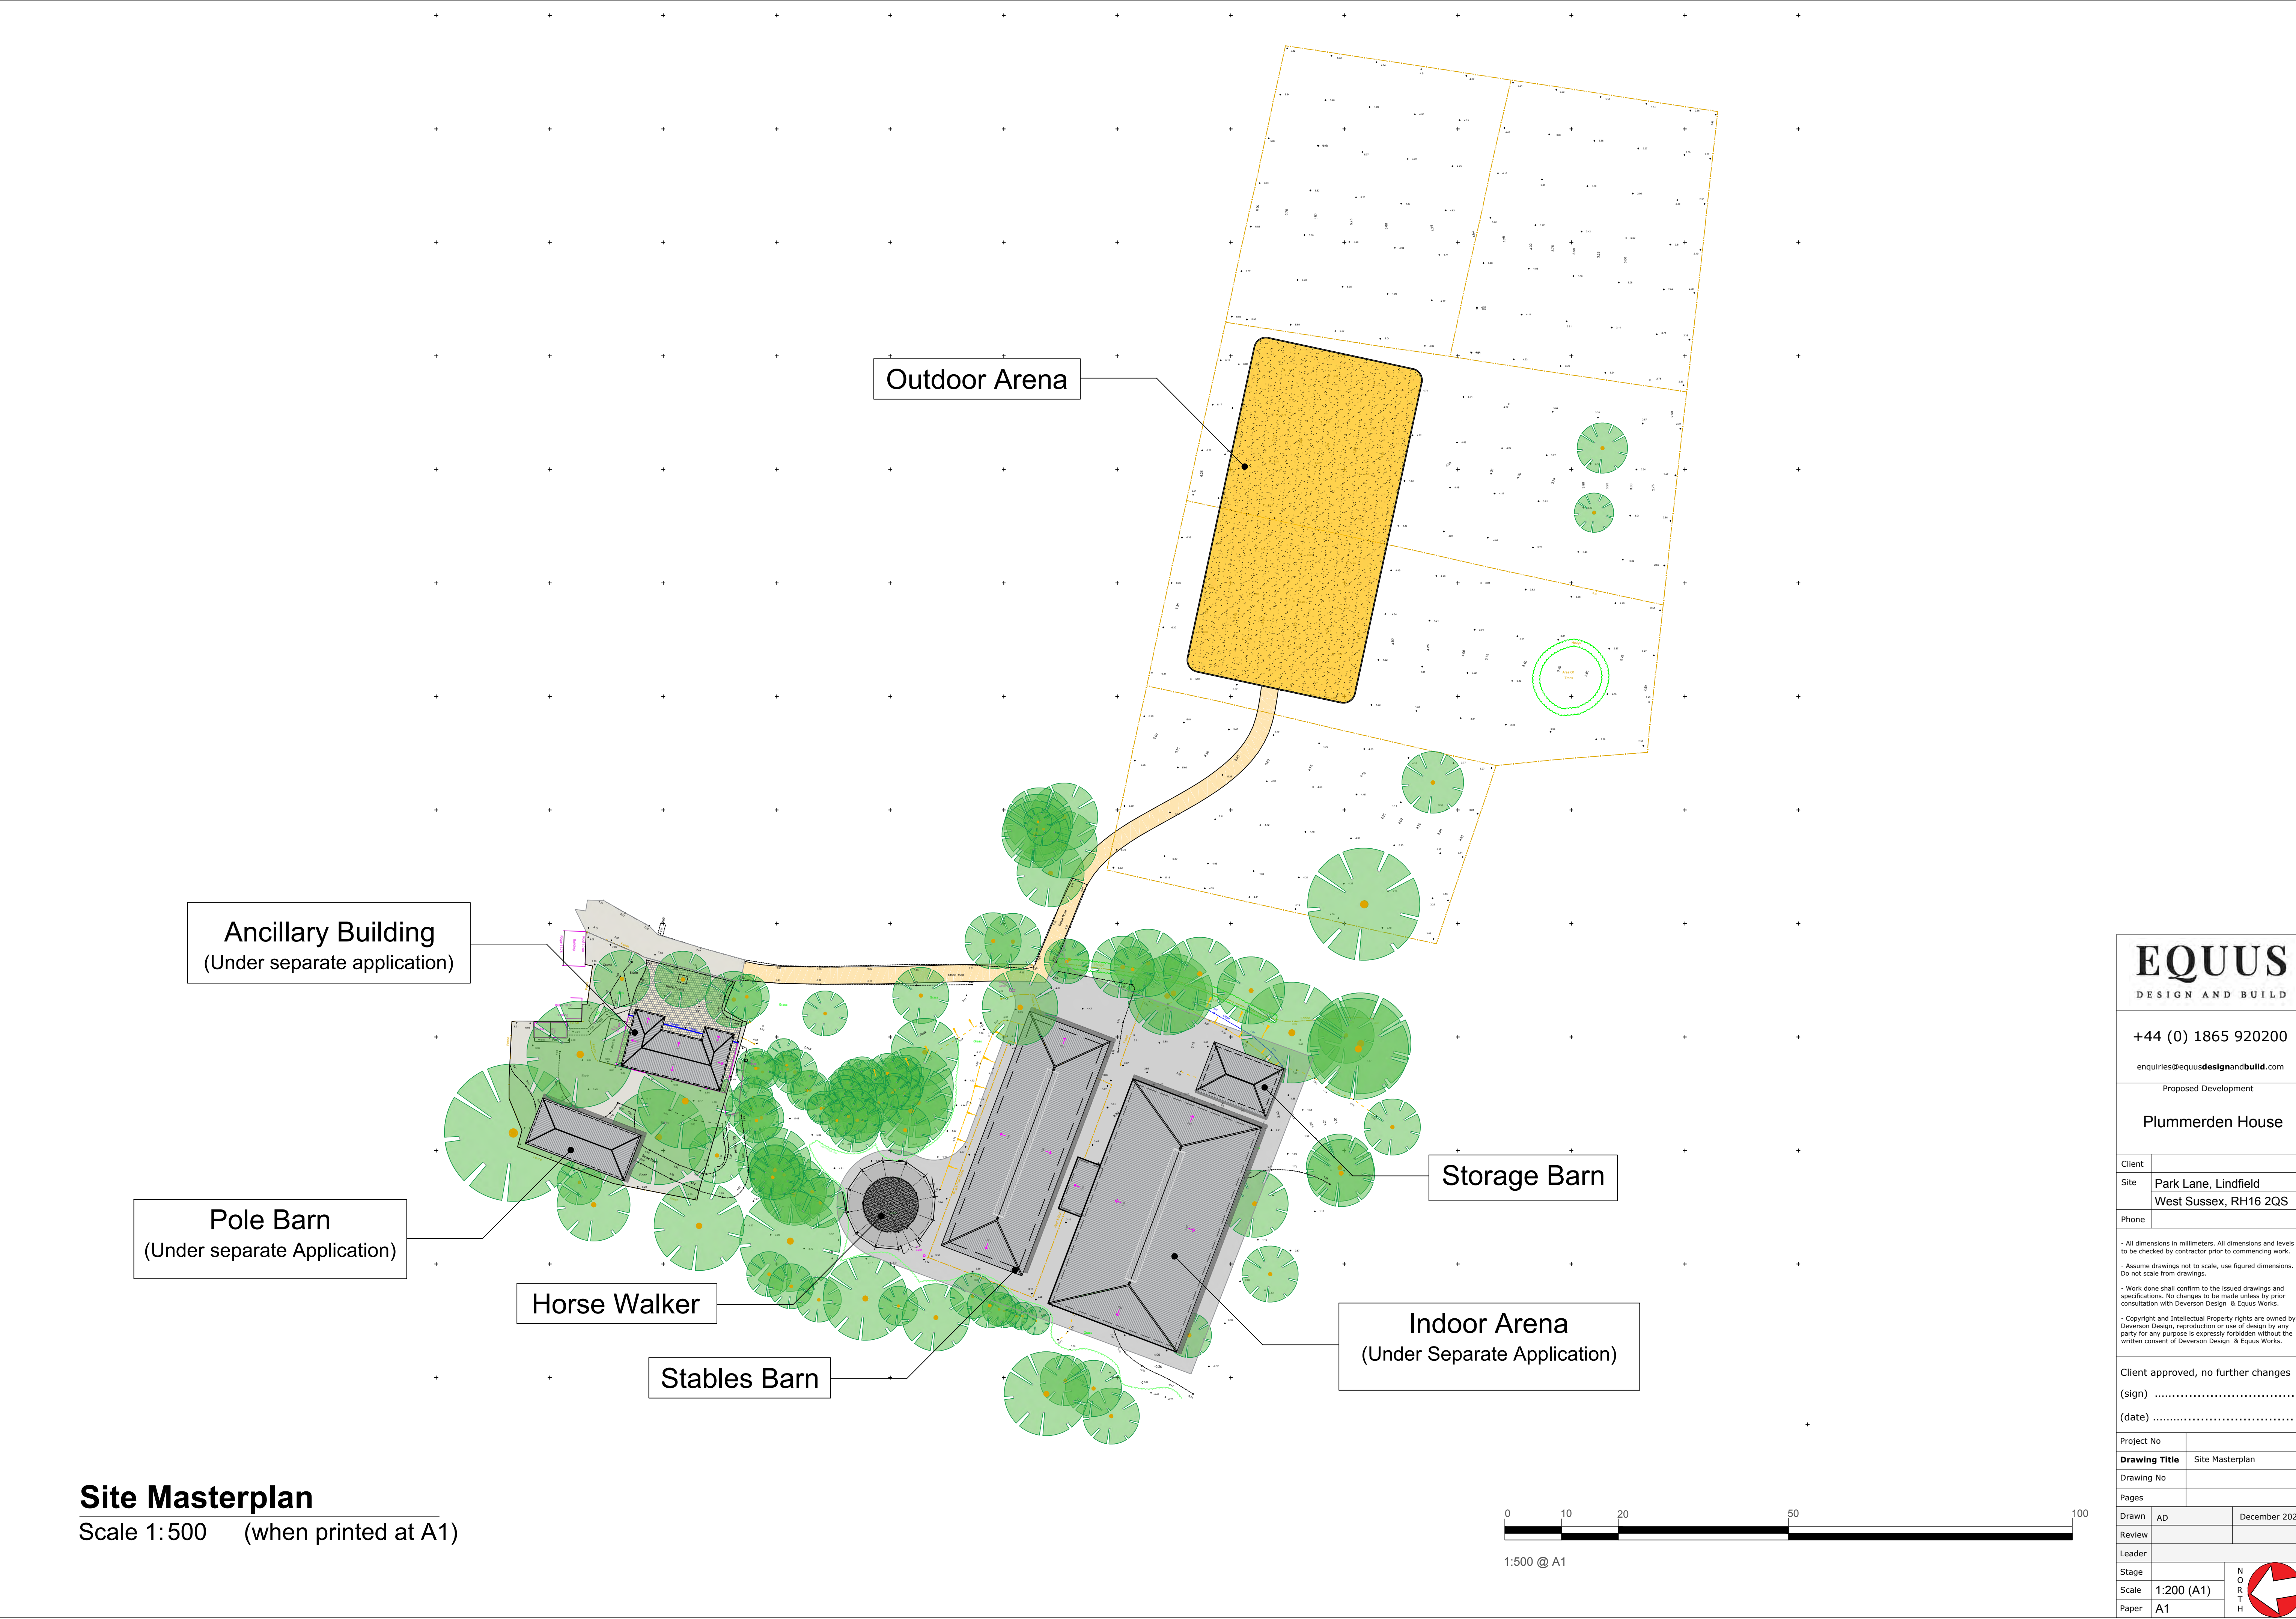
Site Masterplan

2.2.1 The application seeks approval for the construction of an American Barn, Horse Walker and Outdoor Arena, as well as Indoor Arena, Ancillary Building, Pole Barn and Pump track. A site masterplan is included in Appendix A.
