# Bat Emergence Survey Report

Hollyrood

Haywards Heath

10<sup>th</sup> July 2025

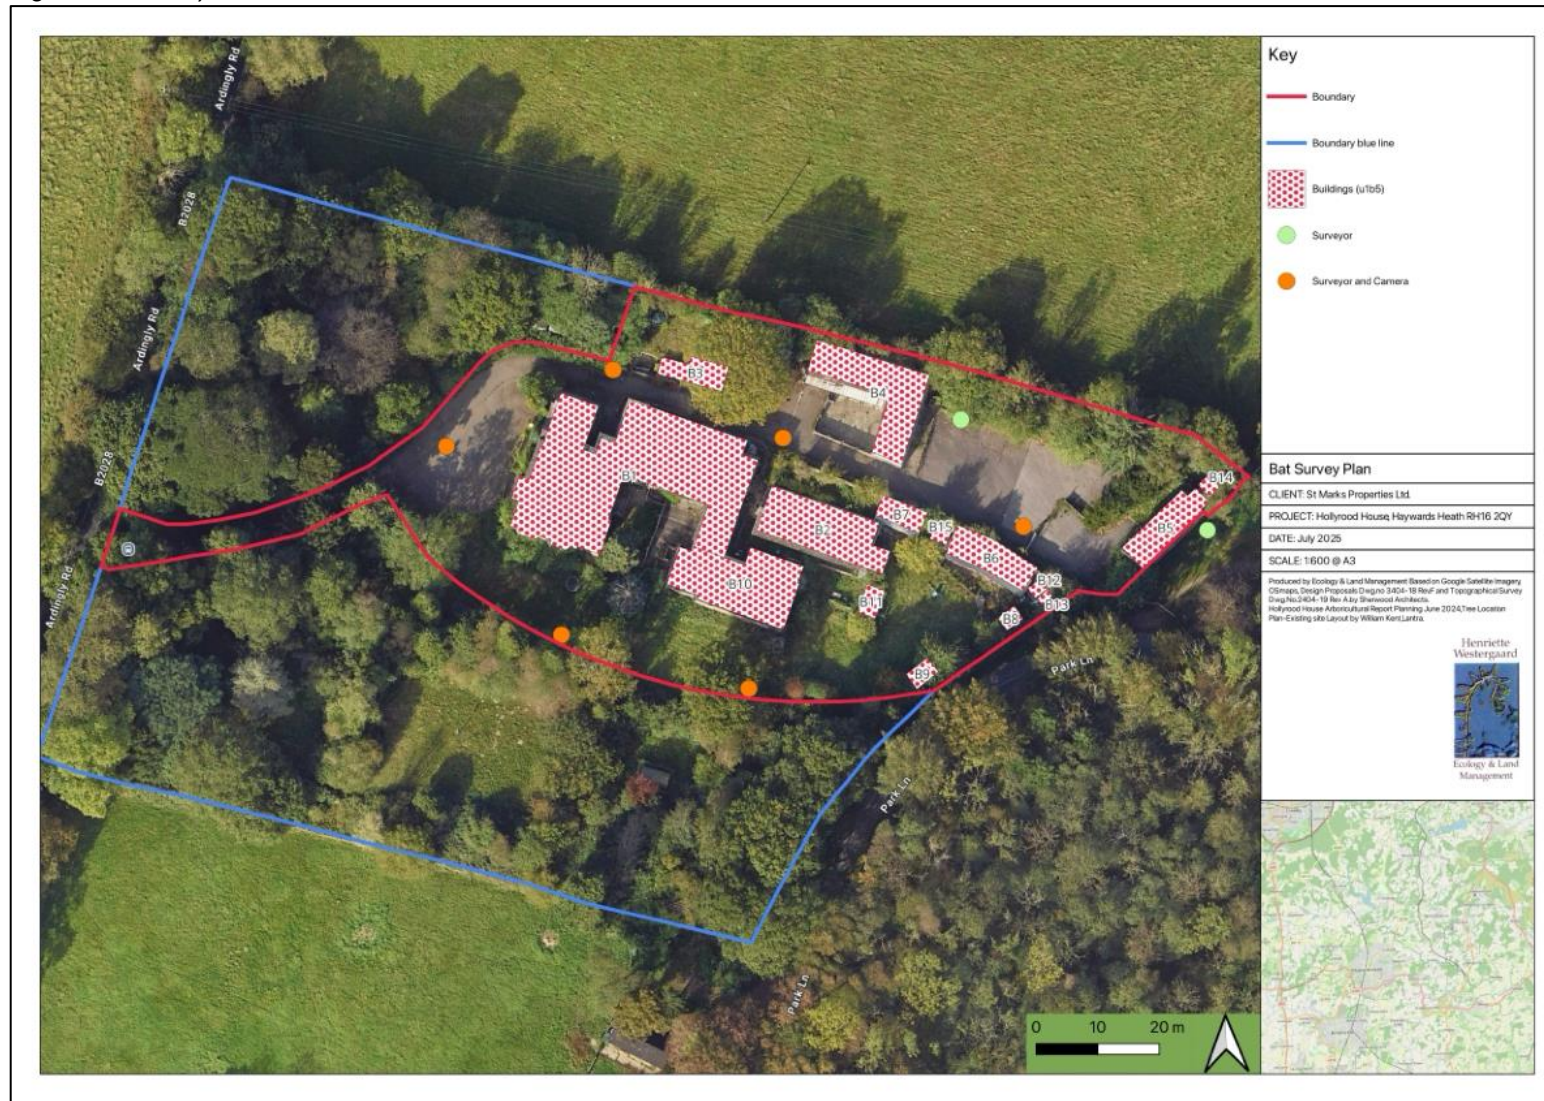
Figure 2: Surveyor and Camera Positions

- 3.4 The night vision observation equipment gave a view of the features of the building surveyed that was not possible with the naked eye, enabling effective observation to continue in the dark. The cameras were installed on tripods, which enabled the surveyor to work normally without having to hold the camera steady. The cameras enabled a live feed to be viewed and recorded directly through a suitable tablet, which in this incidence was a mounted monitor for the Guide TK612. The Guide TK612 thermal camera provided a wide angled view which is also recorded and fixed throughout the survey.

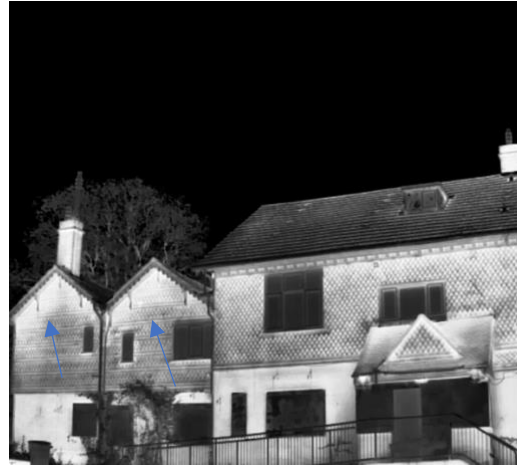
*Plate 2: End View with emergence locations*

| Time | Species/<br>Frequency | Passes | Comments |
|---|---|---|---|
| 21:08-14 | CPx4 | Multiple | Four emergences from hanging tiles on entrance side of building |

- 4.3 The bat activity survey recorded passes by common pipistrelle, soprano pipistrelle, Serotine, and a single pass from a Leisler. Confirmed emergences of 4 common pipistrelles was observed between 21:08-21:14 from beneath hanging tiles on the north western face of the building, indicating the presence of a roost. Subsequent activity included foraging and commuting behaviour in all areas where trees were present close to the survey area. Several additional detections of common pipistrelle, soprano pipistrelle, and serotine were heard but not seen, suggesting continued activity in the area. These results confirm the building supports a common pipistrelle roost and is used by foraging and commuting bats.

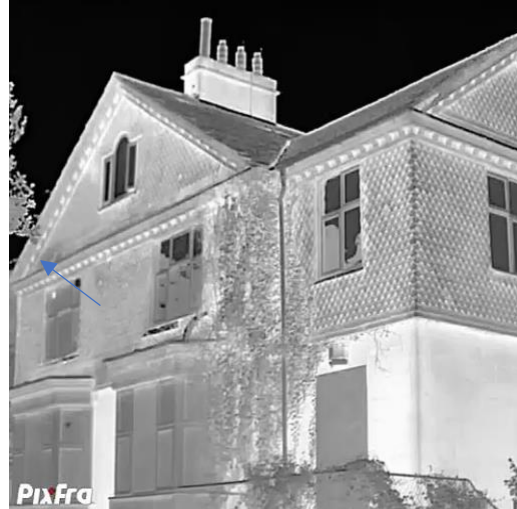
*Plate 4: End View with emergence locations*

| Time | Species/<br>Frequency | Passes | Comments |
|---|---|---|---|
| 21:17 | CPx1 | 1 | One emergence from hanging tiles of eastern gable end |
| 21:29 | CPx1 | 1 | One emergence from hanging tiles of eastern gable end |

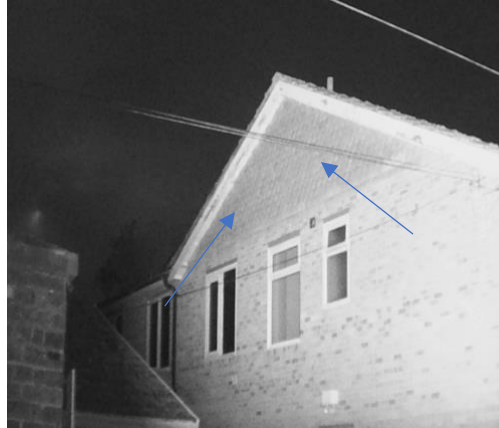
**Plate 8: End view with emergence points**

| <b>Time</b> | <b>Species/<br/>Frequency</b> | <b>Passes</b> | <b>Comments</b> |
|---|---|---|---|
| 21:45 | CPx1 | Multiple | One emergence from broken hanging tiles near left side of cornice during constant CP activity along southern treeline |
| 21:59 | CPx1 | Multiple | One emergence from broken hanging tiles near left side of cornice during constant CP activity along southern treeline |

5.1 Four common pipistrelles were observed emerging from the northwestern elevation of the main building B1 closest to the entrance drive. Two were recorded emerging from the eastern elevation under the hanging tiles, and the last two from the south western elevation under broken hanging tiles above the cornice in the left corner. The main body of activity consisted of common pipistrelle and soprano pipistrelle commuting and foraging activity observed and recorded during all surveys within the location area, with a small amount of serotine activity during survey one and two and passes from a Leisler during survey one, with brown long-eared plus multiple myotis passing in survey three.

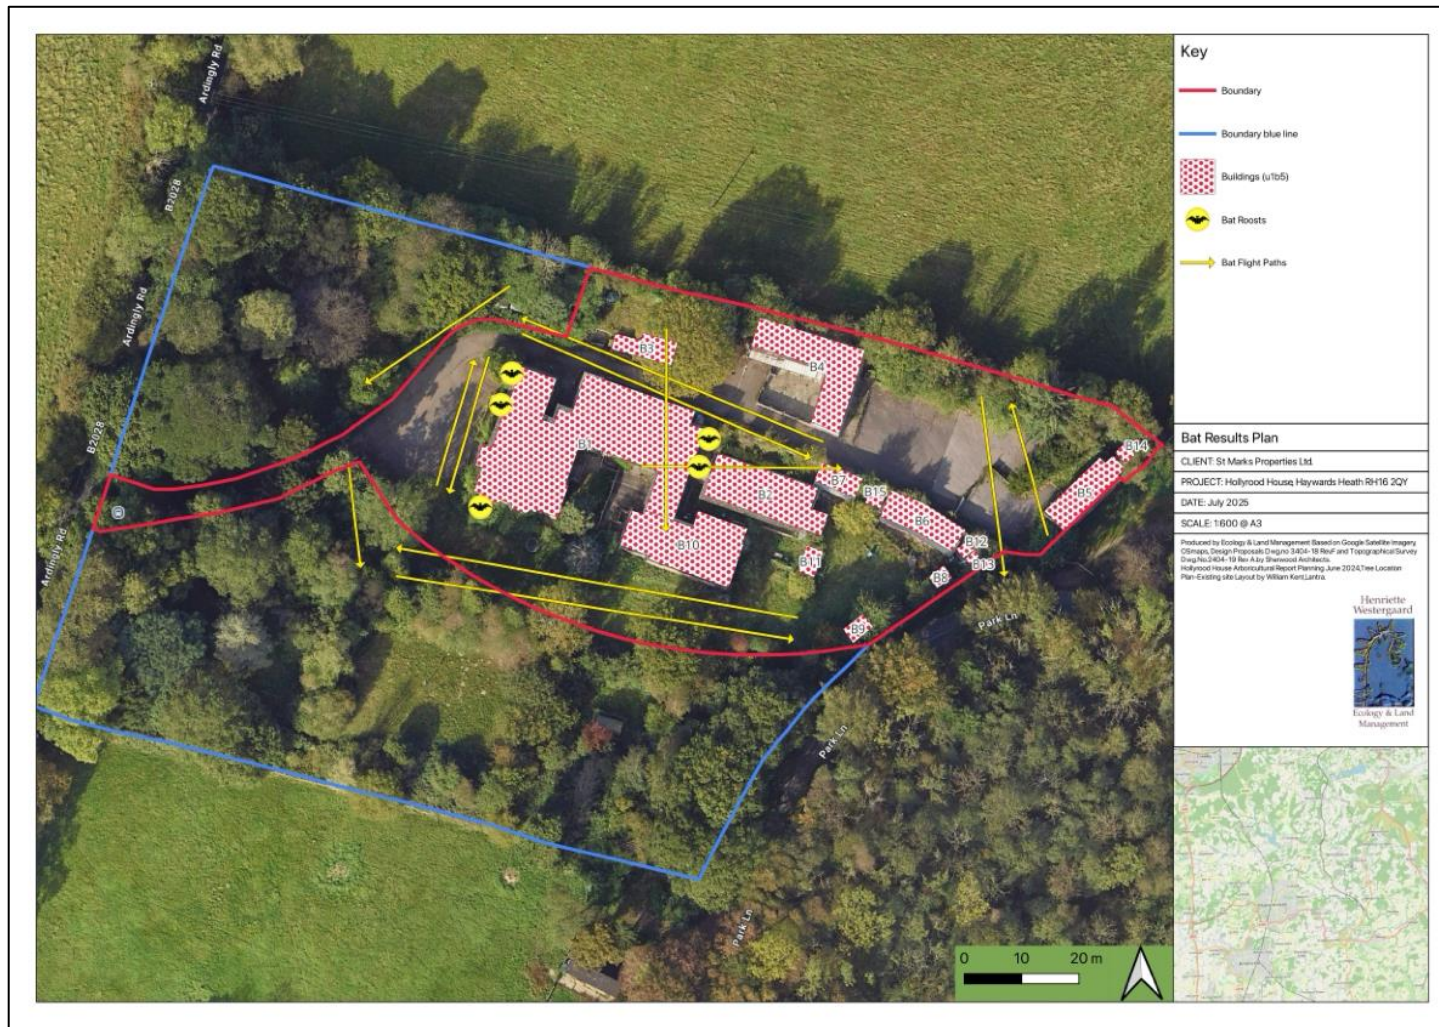
## 9.0 SUMMARY MAP OF BAT ACTIVITY

5.9 Eight common pipistrelle were confirmed emerging from beneath normal and broken hanging tiles across the north western, eastern, and south western elevations confirming the presence of five day roosts. Further activity from common pipistrelle and soprano pipistrelle was recorded across all survey visits, with other species such as brown long-eared, serotine, Leisler, and a *Myotis sp.* also being recorded entering the site. Observations of foraging and commuting, particularly along the treeline in the southern area of the site was frequent. The roost was assessed as a day roost of low conservation value, with no evidence of a maternity colony. Any unlicensed disturbance or destruction of the roost would constitute an offence under wildlife legislation.
