# JAMES CLAGUE

## ARCHITECTS

### **Samples of Materials for replacement wall tiles to supplement defective tiles**

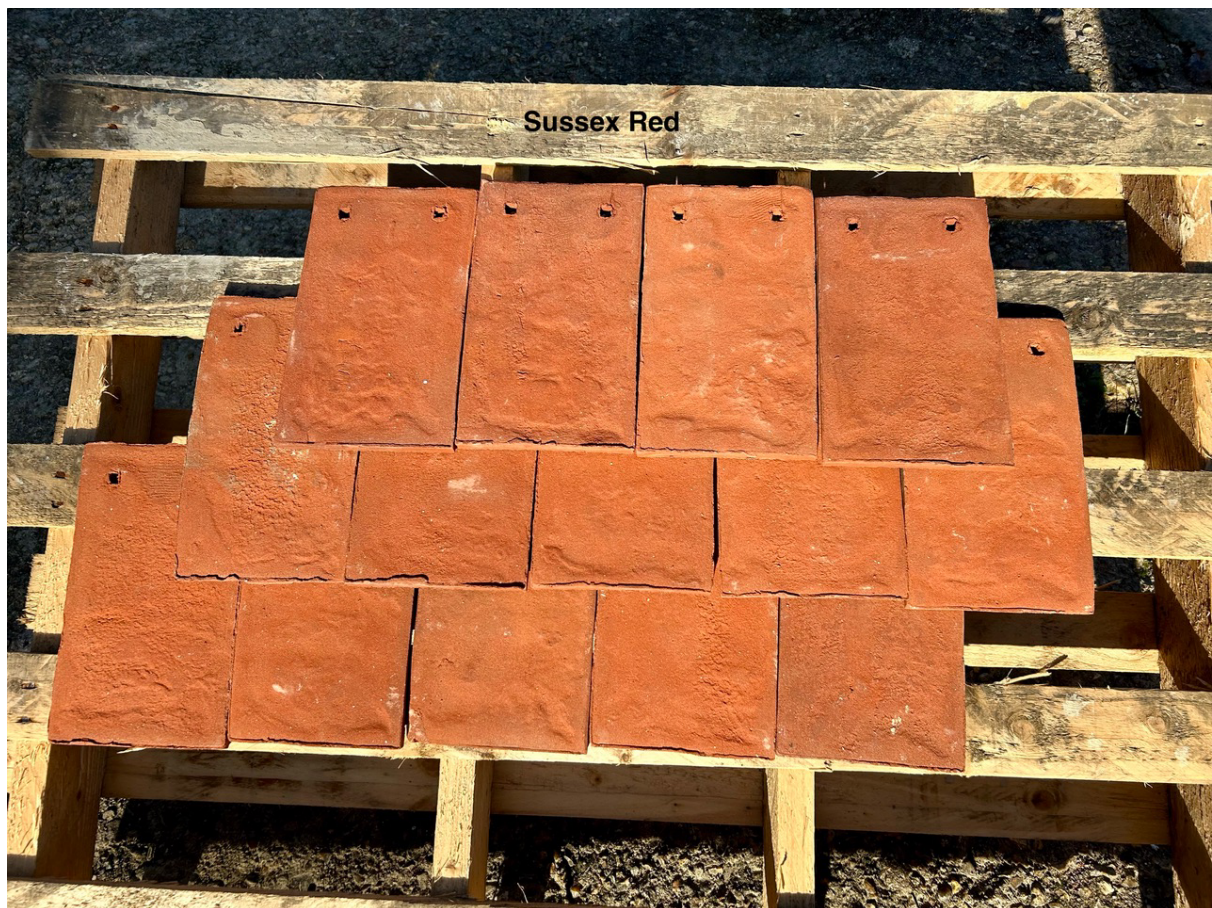
*Figure 1 sample of new tiles*

Sussex Red peg tiles by Tudor Tiles see: <https://www.tudorrooftiles.co.uk/colours.html>

To be nailed to horizontal battens to match existing gauge and haired lime mortar bedded to match existing detail. Corners to be finished with timber cover batten to match existing detail.

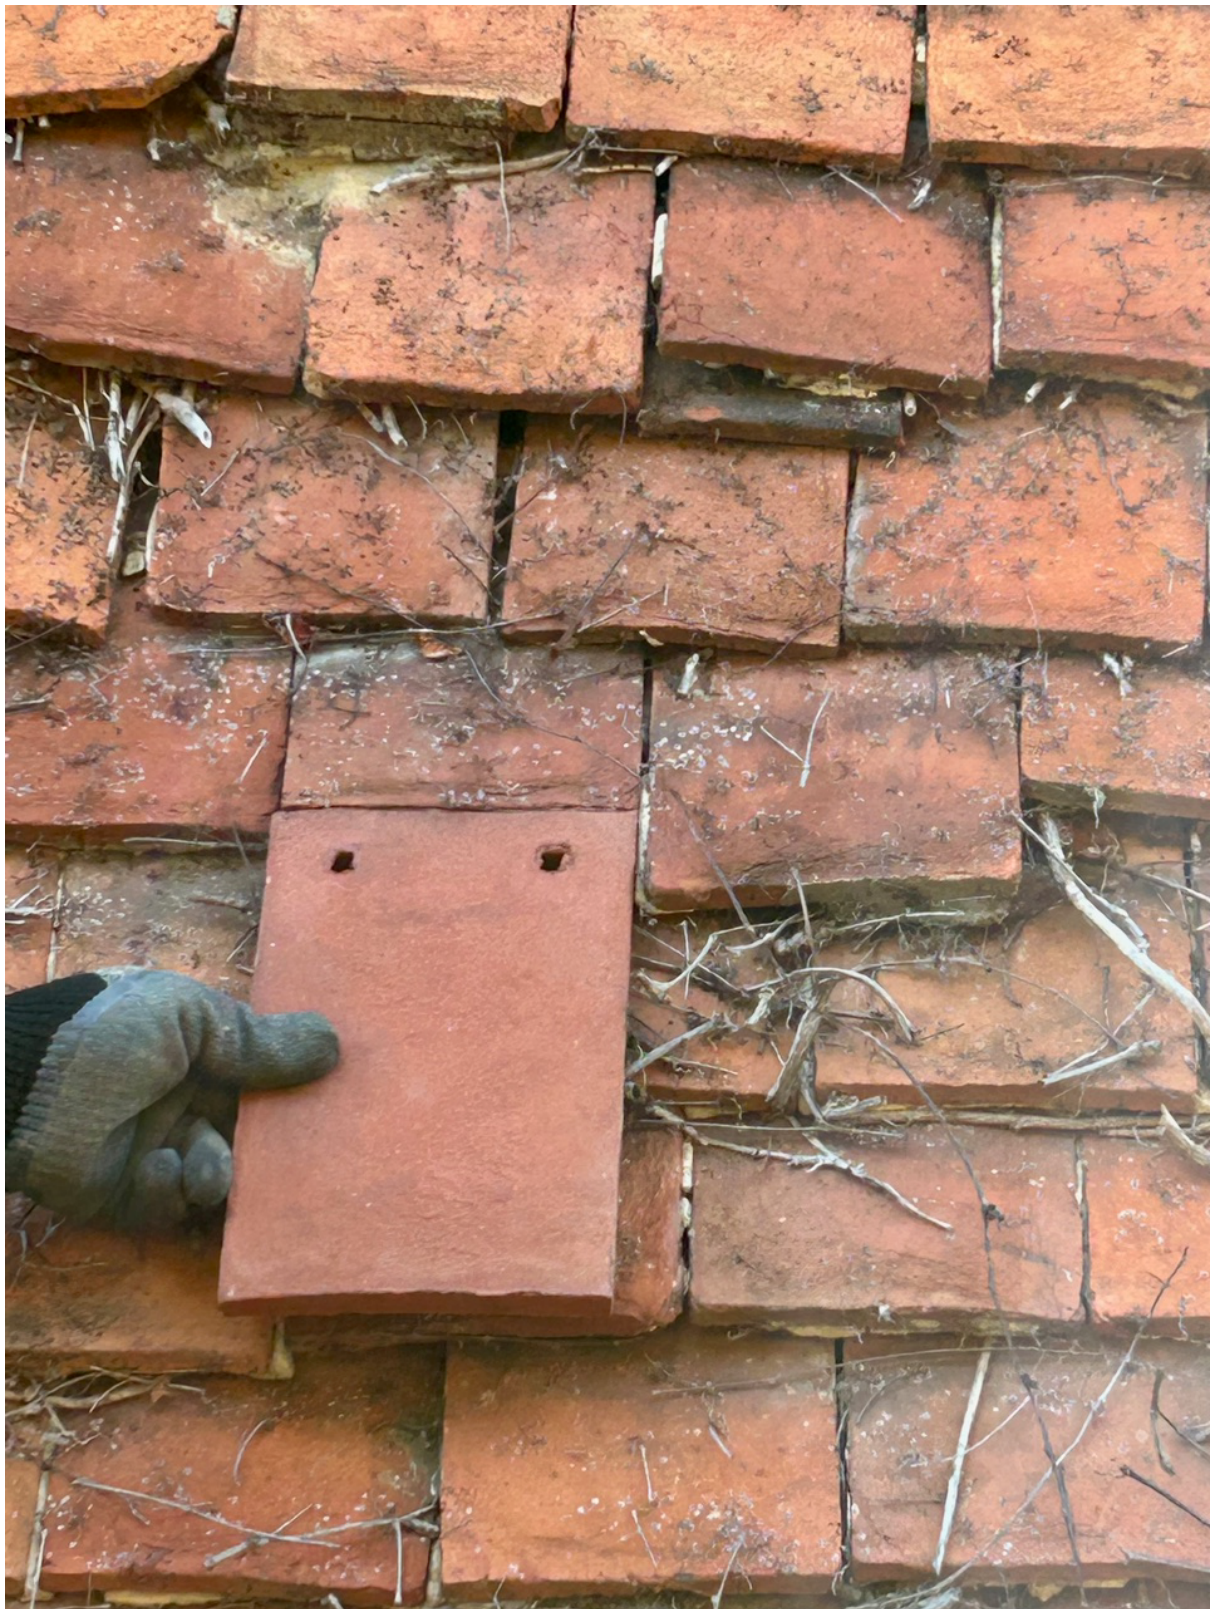
*Figure 2 Tudor Sussex Red tile against existing in-situ*
