# Site Topographical Survey

### Site Visit Photographs and Accompanying Figures

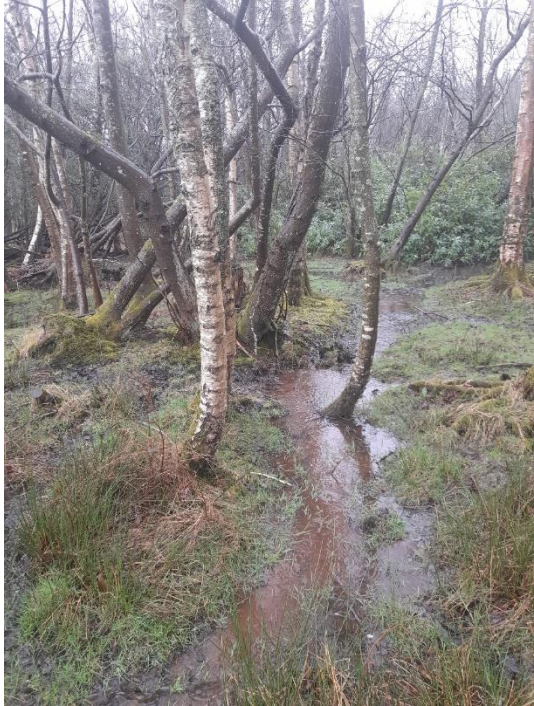
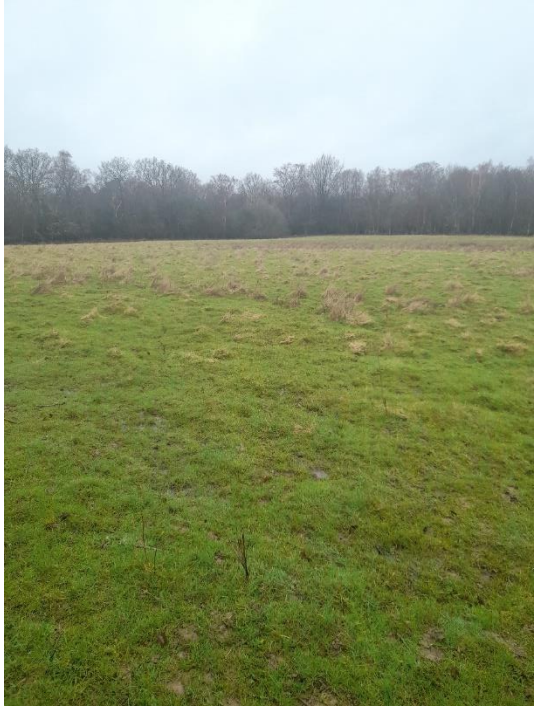
| <div data-bbox="210 358 745 1061" data-label="Image"></div> <div data-bbox="167 1081 708 1151" data-label="Caption"><p><b>5.</b> Surface water flooding in the north of the site. Looking west. Flow observed to be east to west.</p></div> | <div data-bbox="847 358 1382 1061" data-label="Image"></div> <div data-bbox="805 1081 1414 1187" data-label="Caption"><p><b>6.</b> View of Catchment A looking northwest from the south of the catchment. Land shown to be sloping from southeast to northwest.</p></div> |
