# Report on a **PHASE 4 VALIDATION**

Ref: 24/39368 Rev 1 | Date: January 2025

For the site:  
**Land to the Rear of North Road**  
**Haywards Heath**  
**West Sussex**

Prepared for:  
**Kauto Homes Limited**

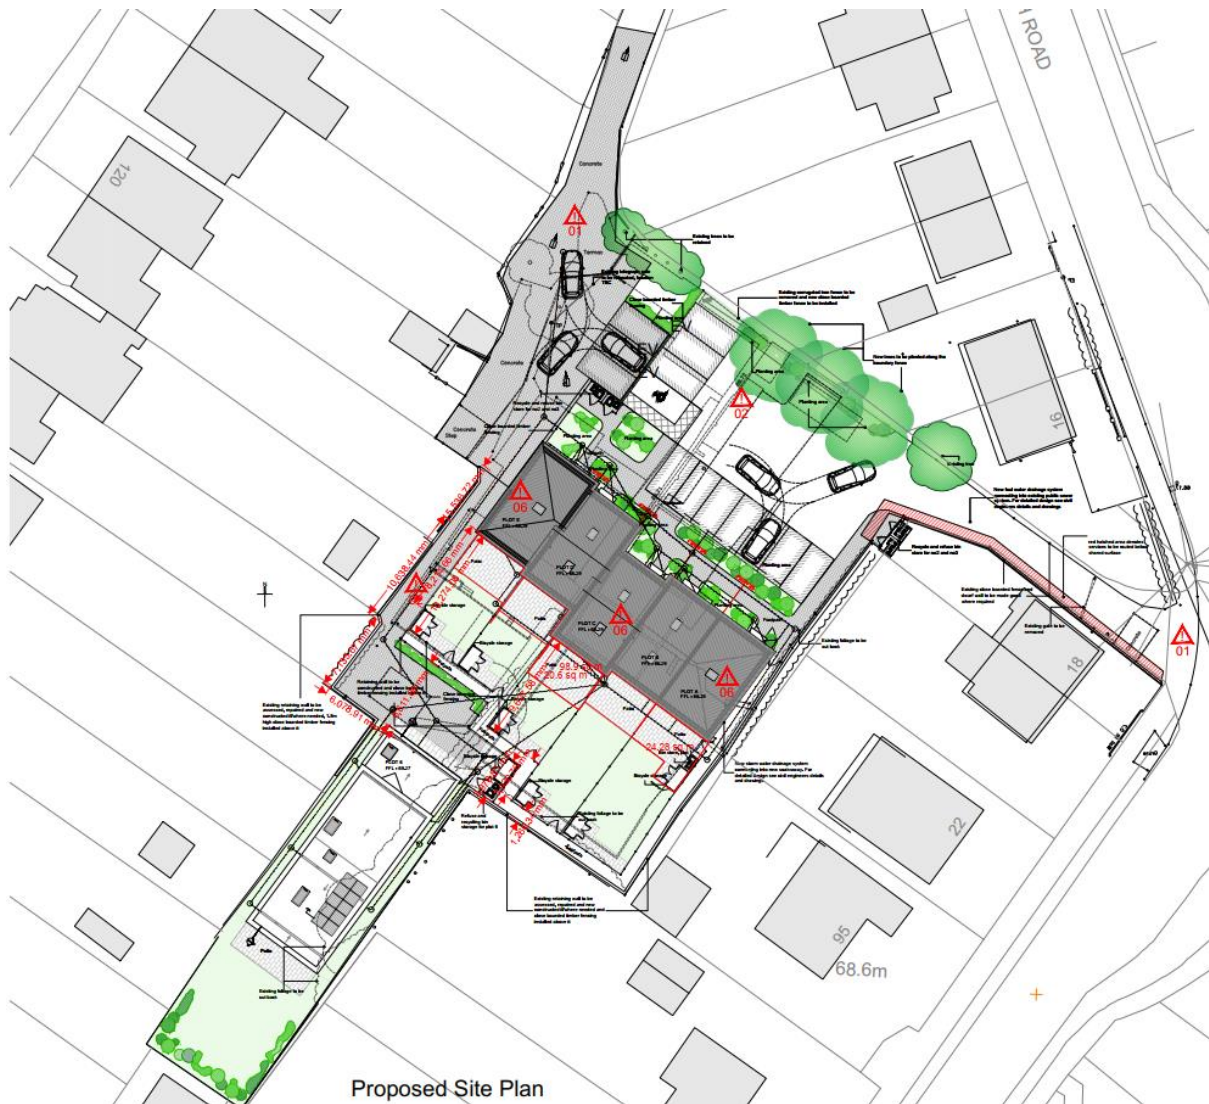
Figure 2: Development Layout Plan

- It is proposed to redevelop the site located at North Road, Haywards Heath, West Sussex. The development proposals comprise the demolition of the existing buildings and the construction of 5 terraced houses and a single detached house, together with associated car parking, gardens and landscaping.

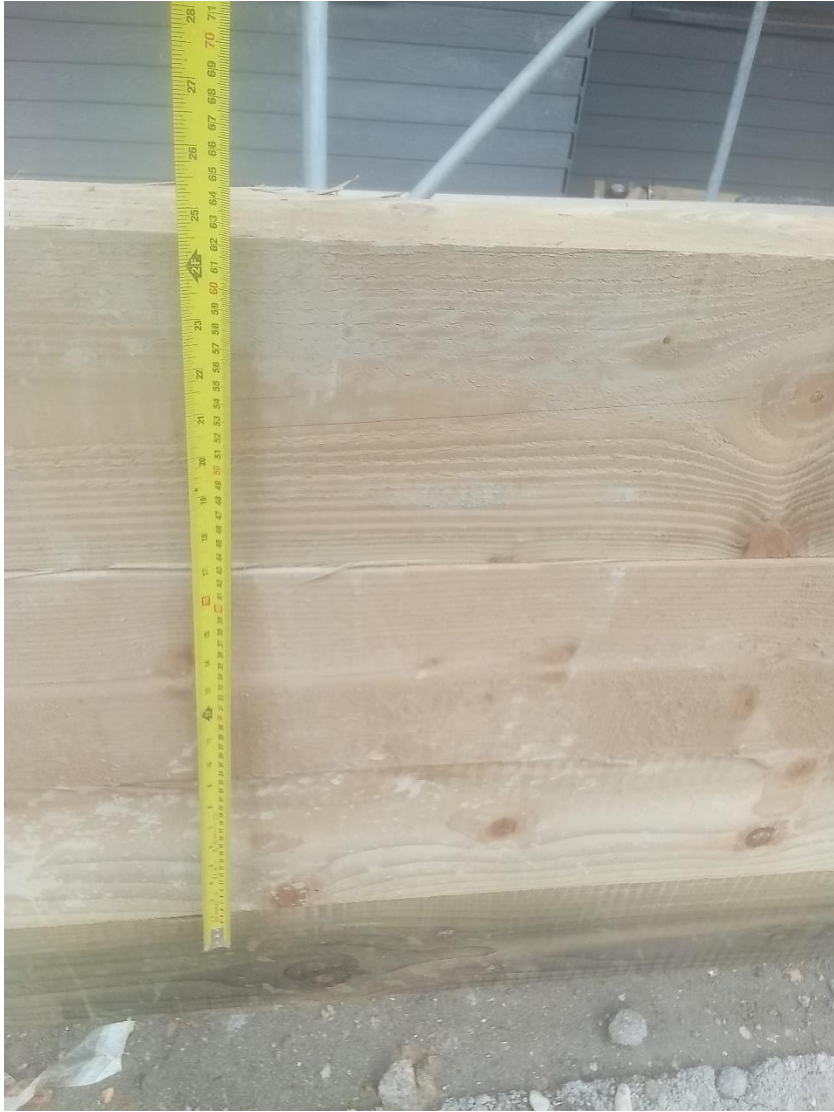
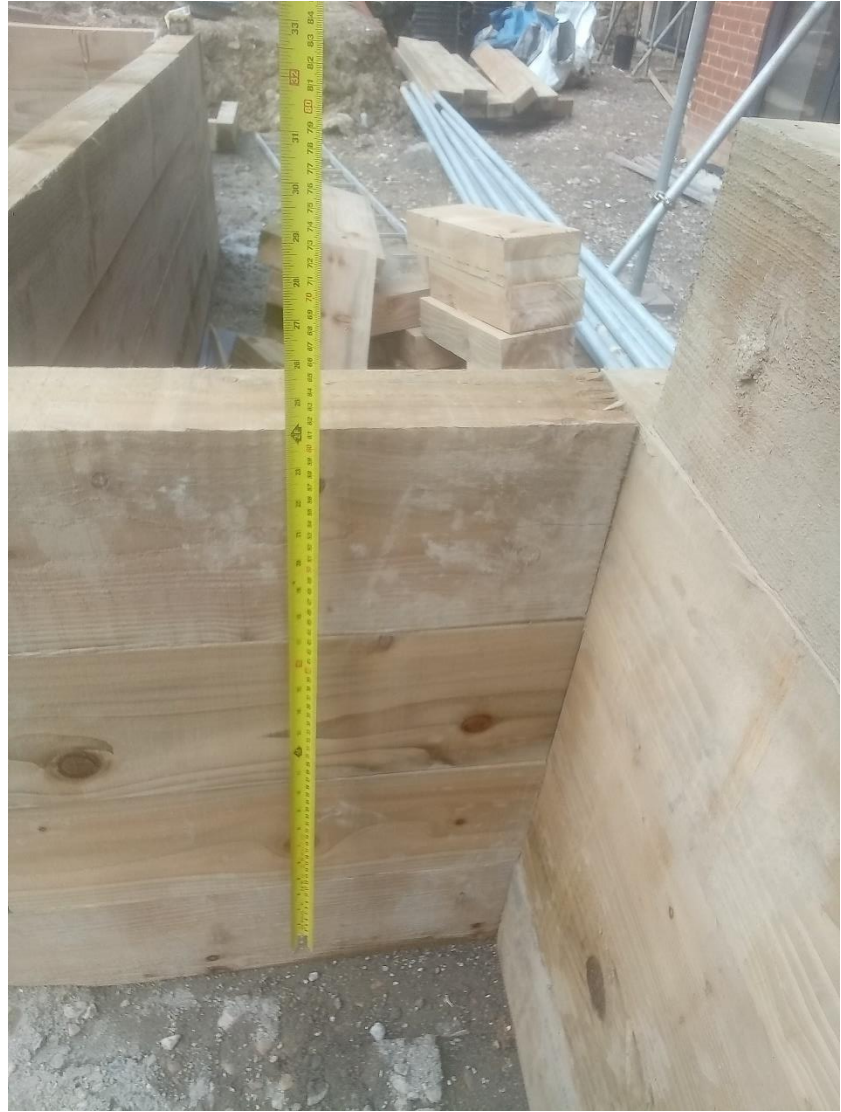
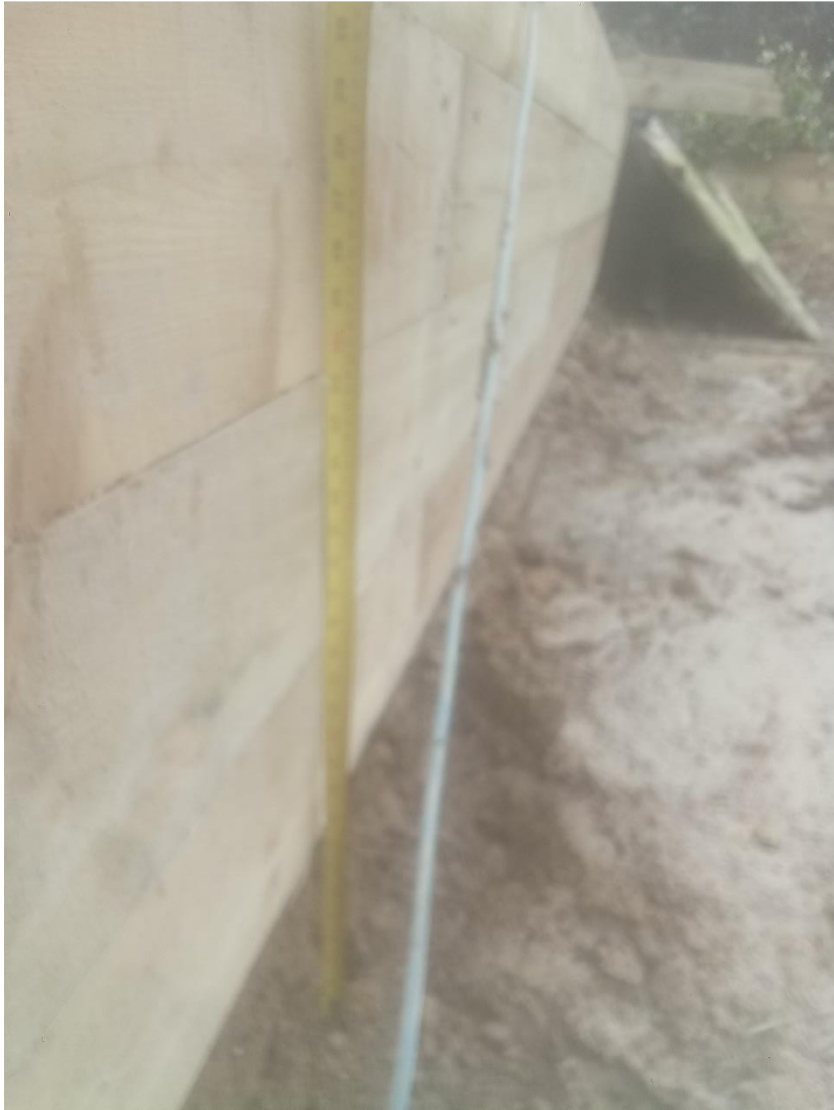
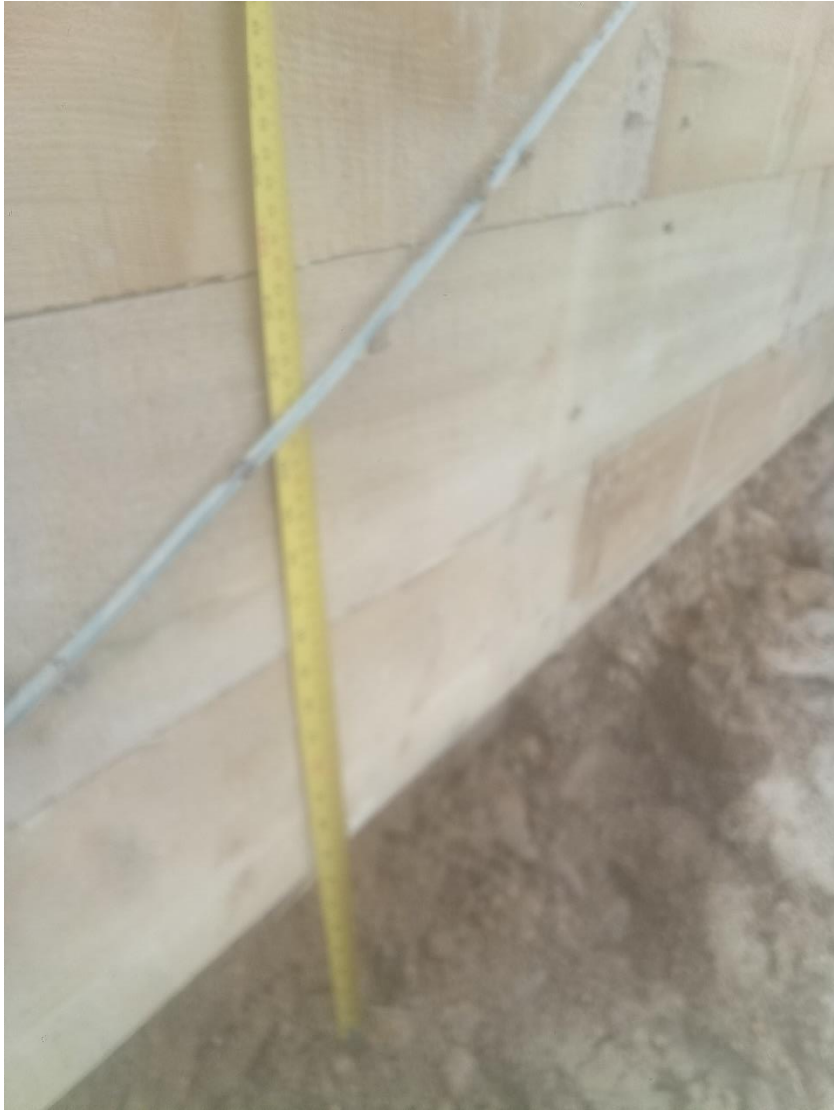
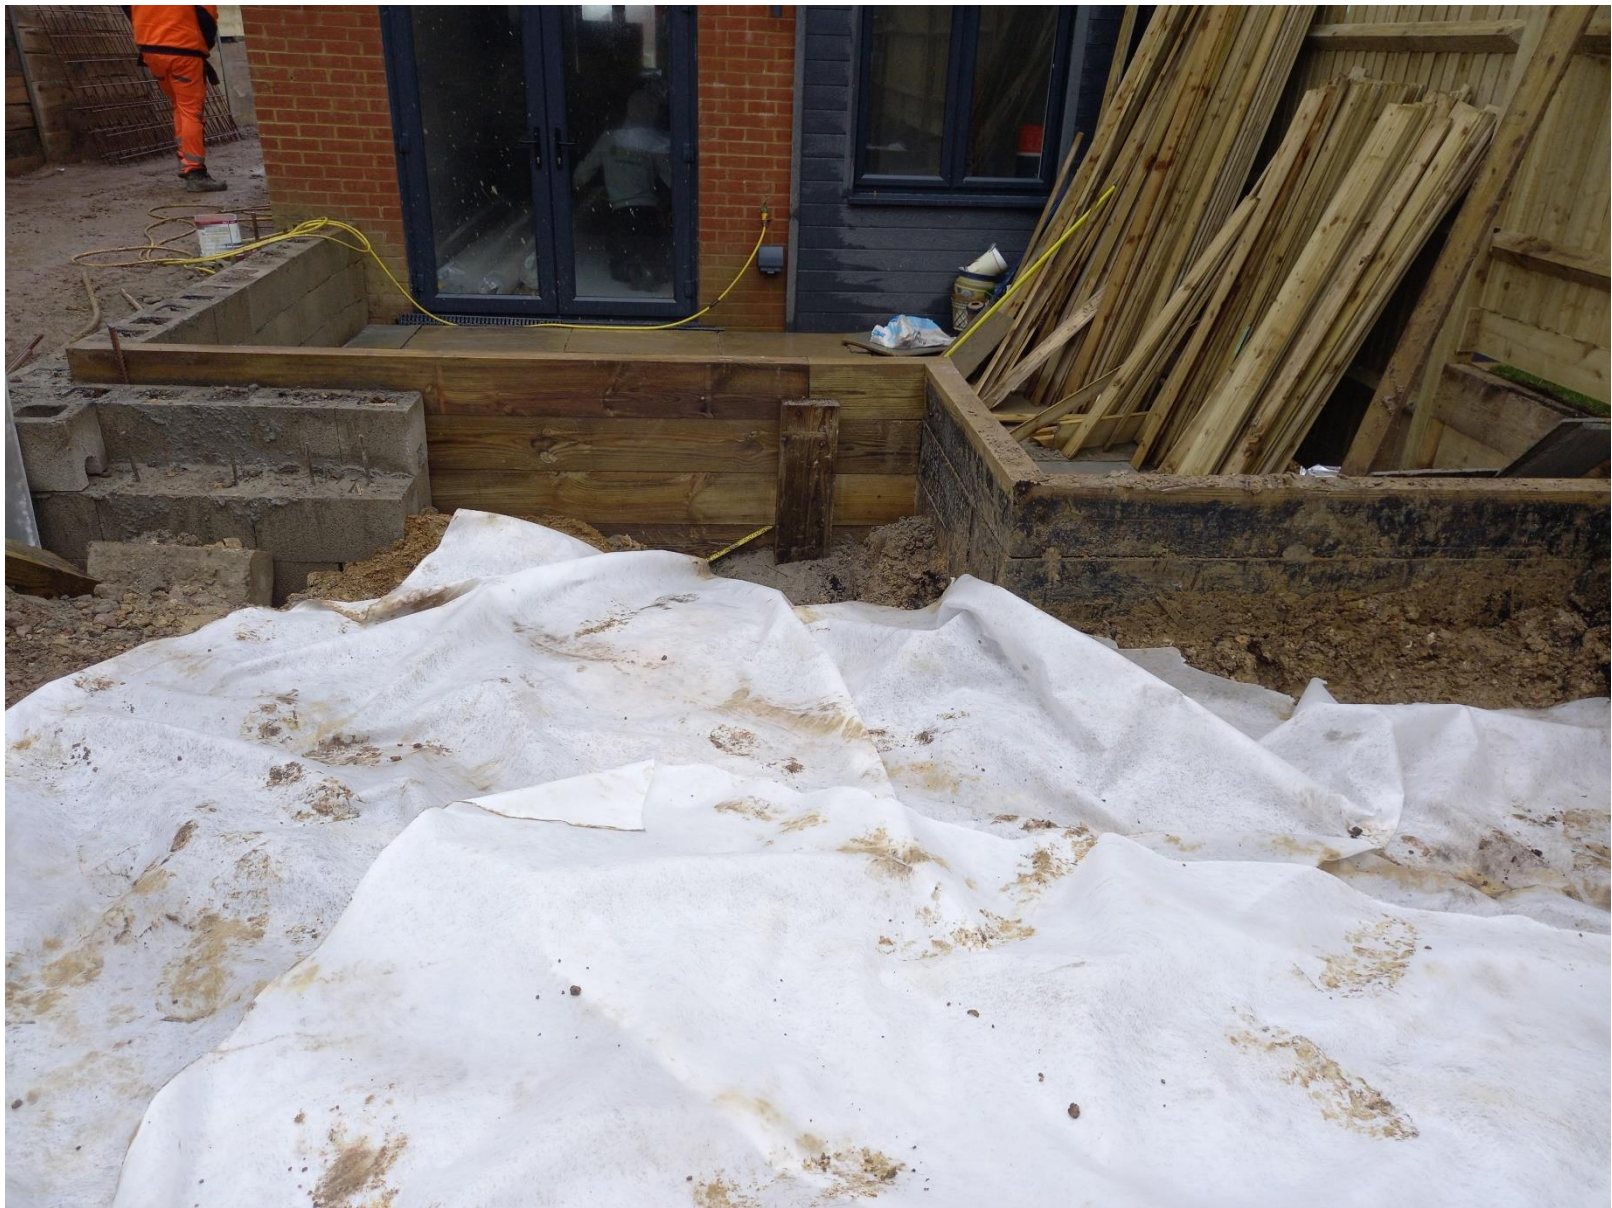
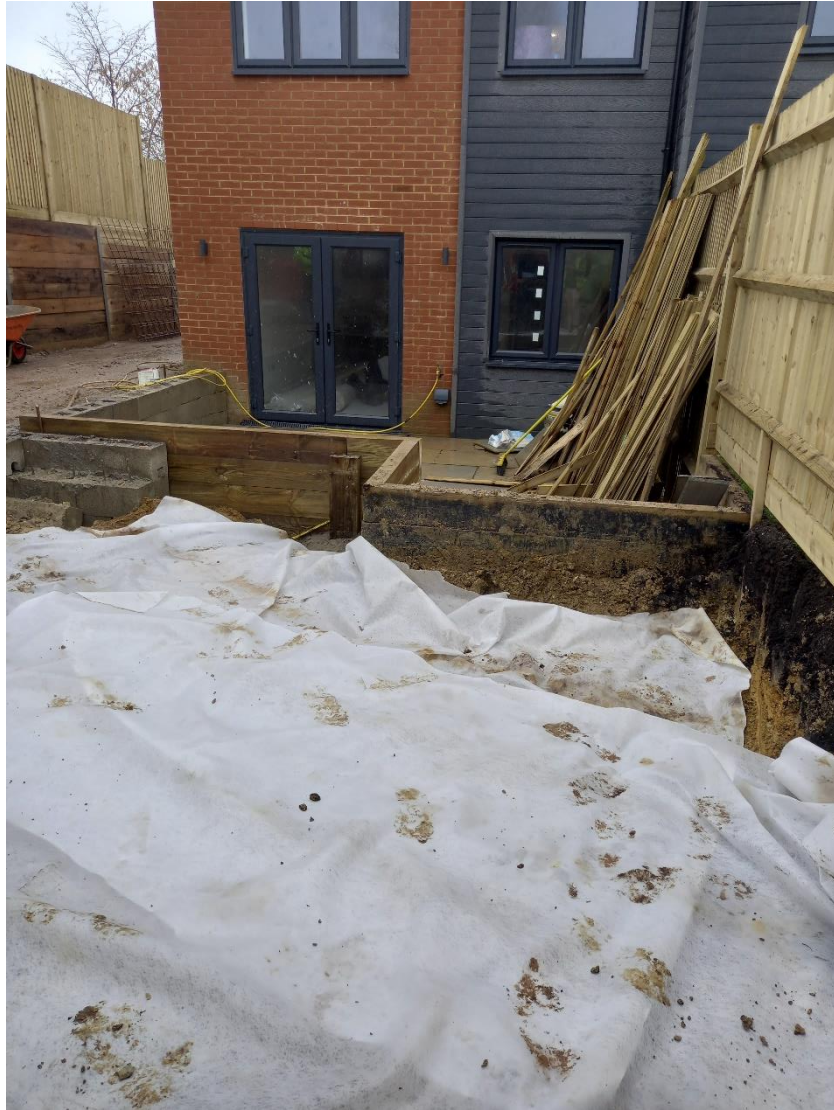
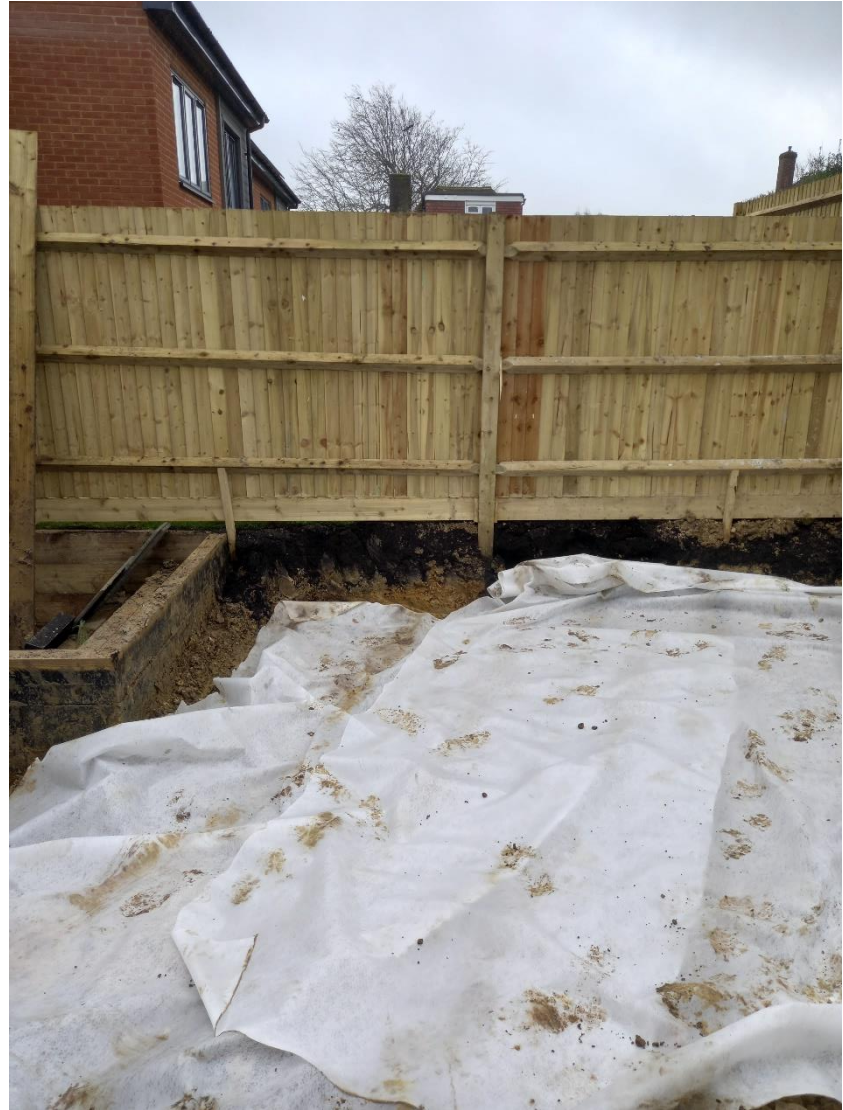
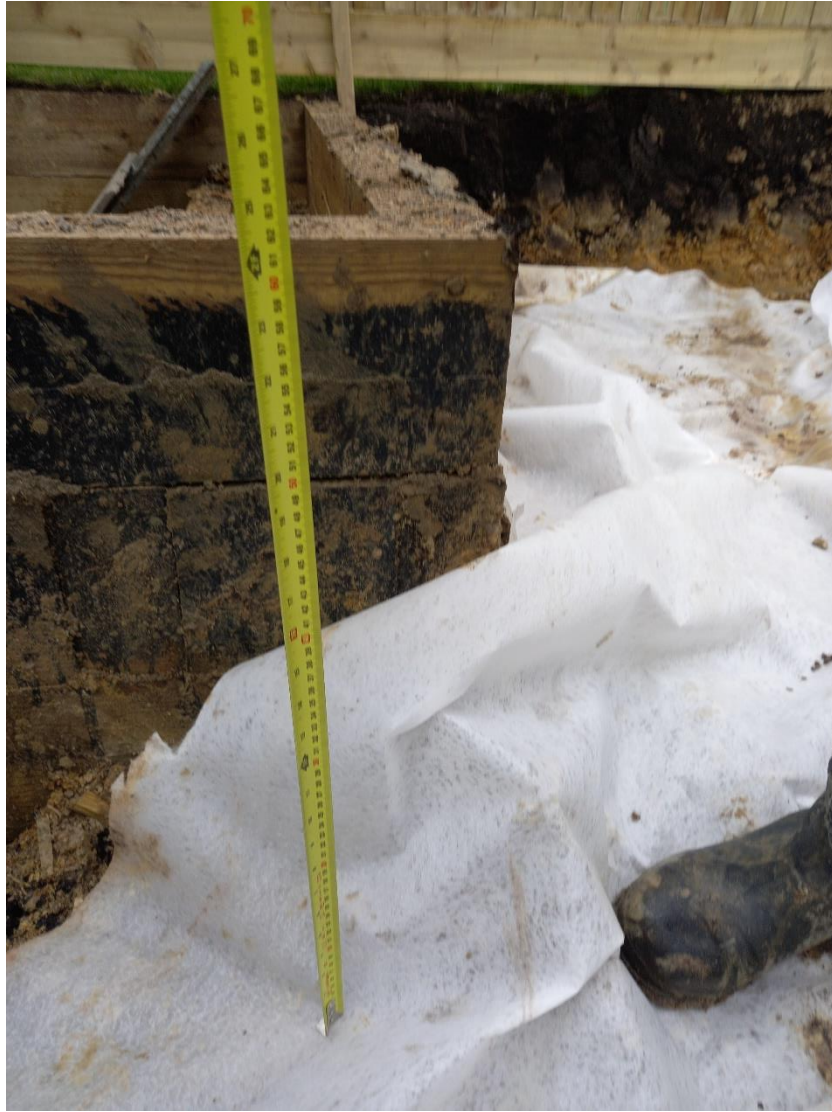
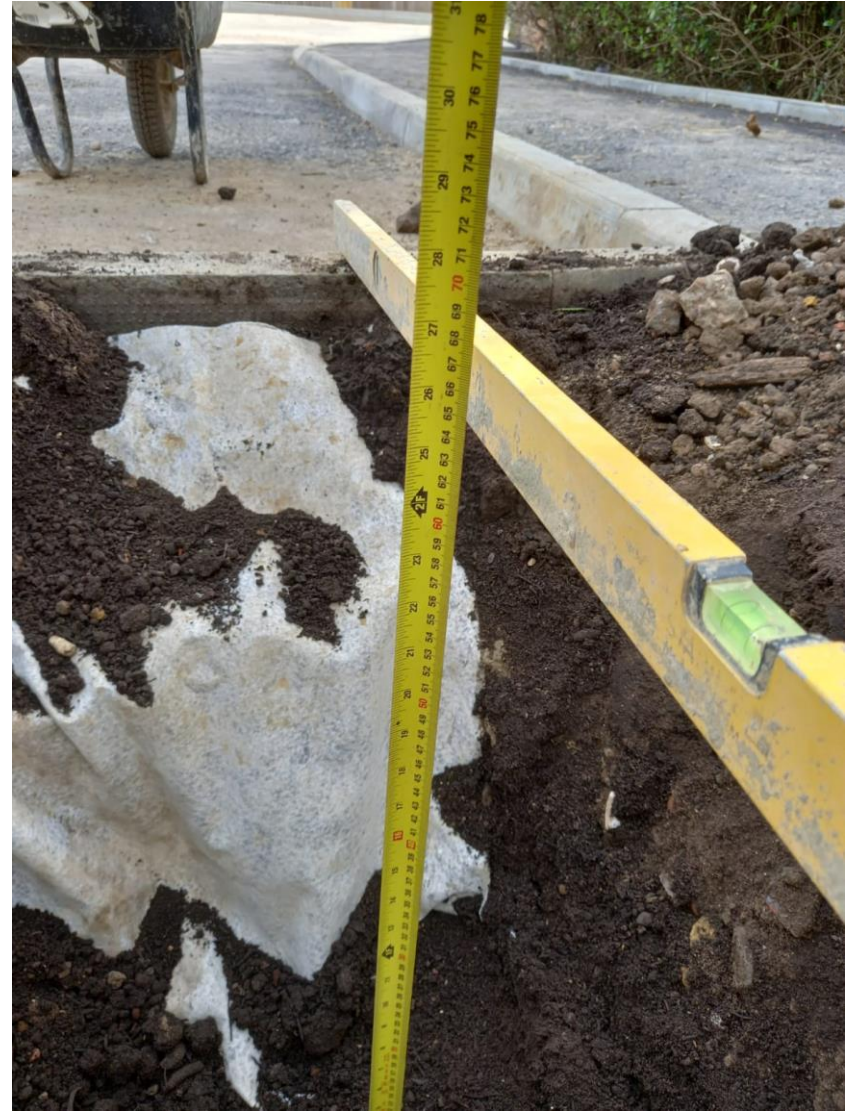
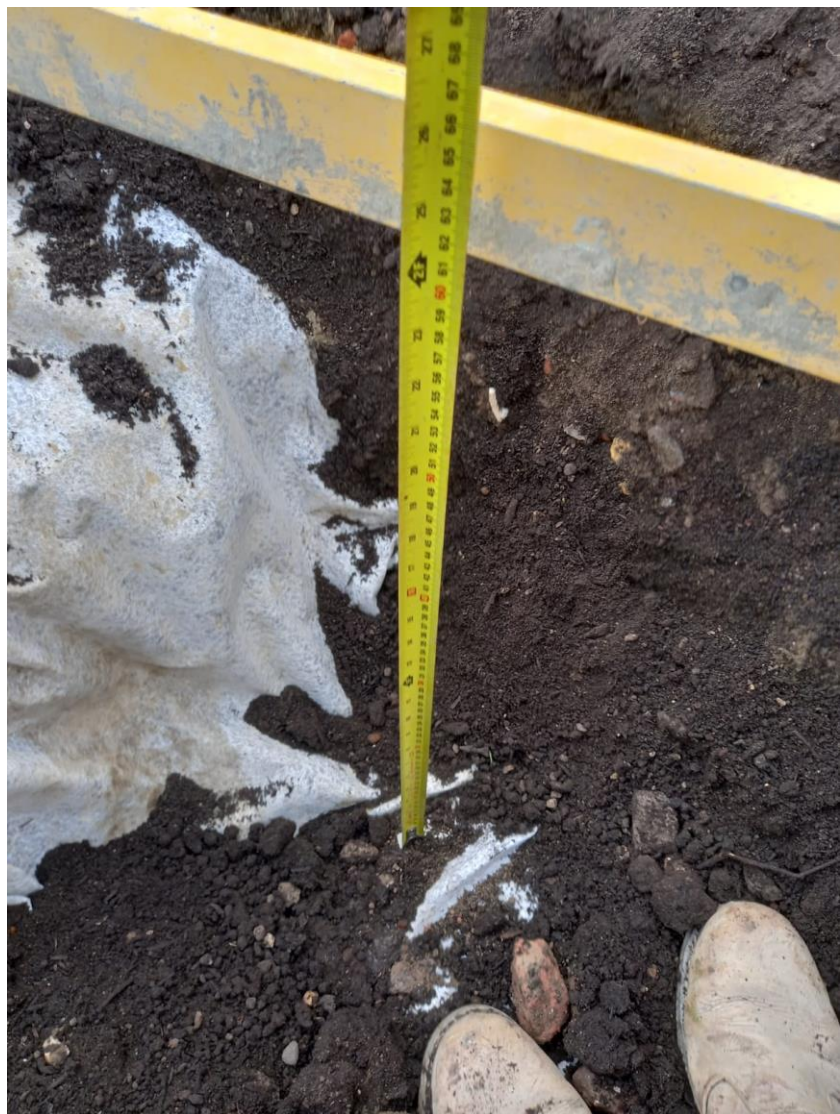
## Photographs

Photographic evidence of the landscaping and planter depths is presented in Appendix A of this report. The geotextile is clearly visible in the photographs.

Soft landscaping around the site was created as part of the development in the form of a number of raised planters. Photographic evidence also indicates that at least 600mm has been created.

A 300gsm non-woven geotextile was laid beneath the topsoil/subsoil layer in areas of soft landscaping. The purpose of the geotextile was to provide a visible barrier and prevent mixing of the layers above and below the geotextile. The geotextile is visible in the photographs.
